Veolia Emerald Park Landfill
City of Muskego

2011 Veolia Emerald Park Landfill Year End Compliance Officer Report and Audit Summary

TO: Veolia Emerald Park Standing Committee
FROM: Jo-Walter Spear, Jr., P.E.
COPIES: File
DATE: 04/02/2012
PROJECT NUMBER: 1012.10030

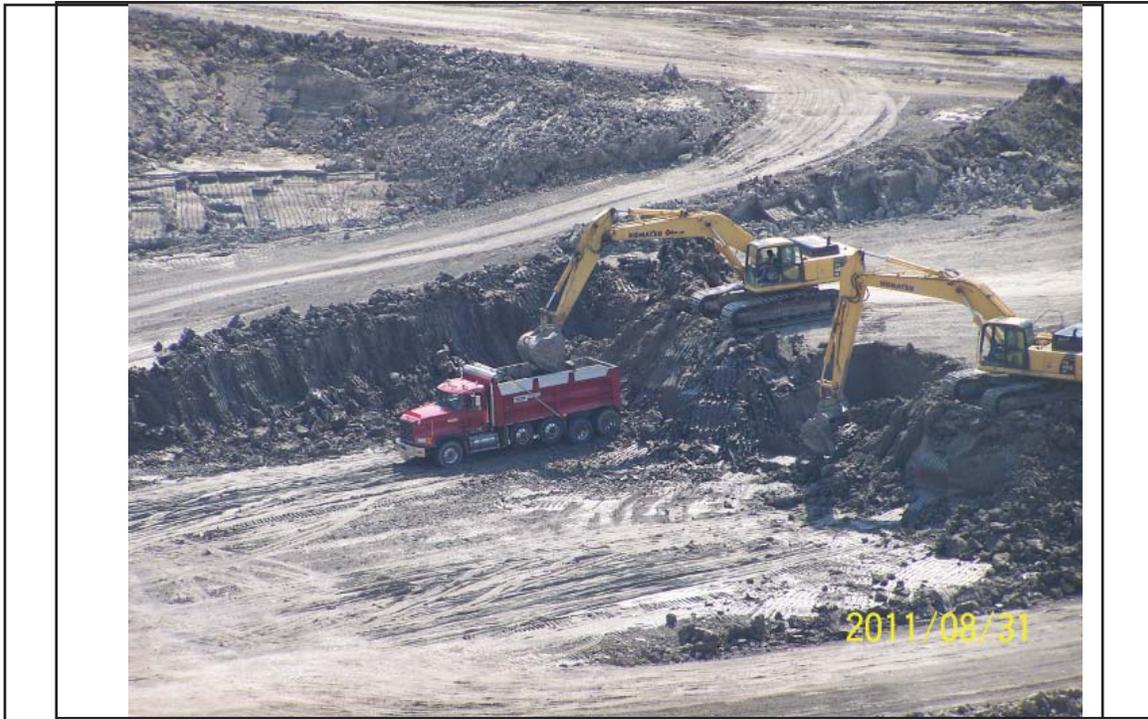
Excavation of Phase 7

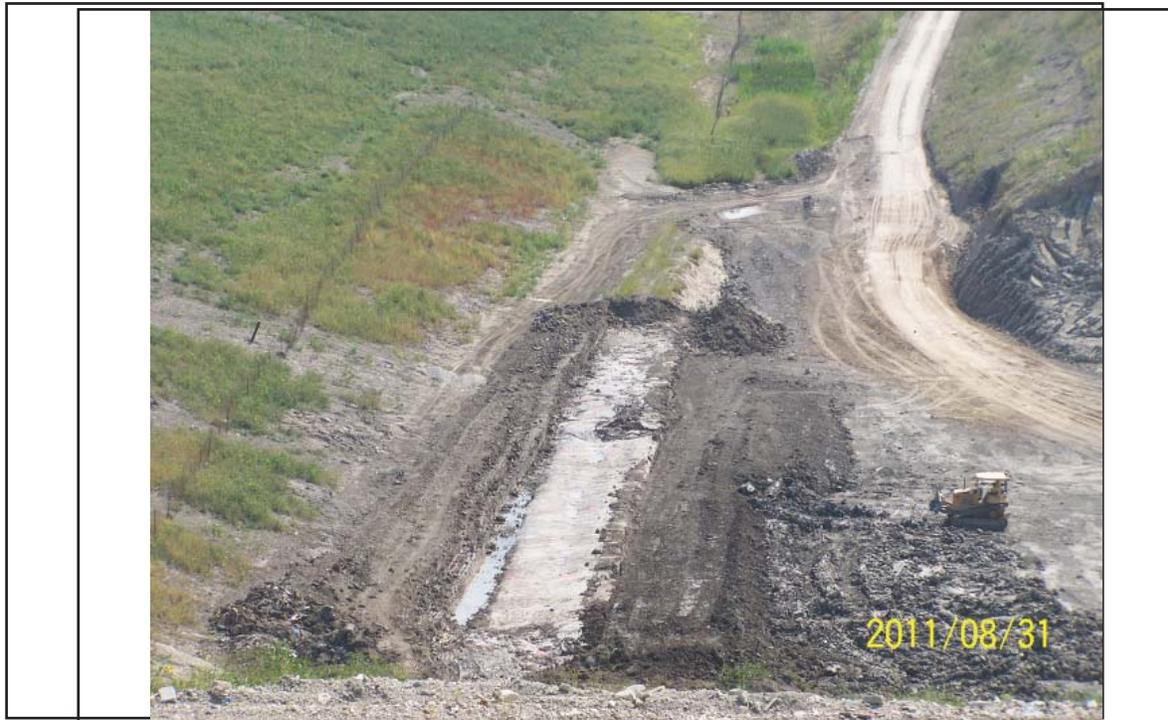
Intersection of Phase 6 & 7

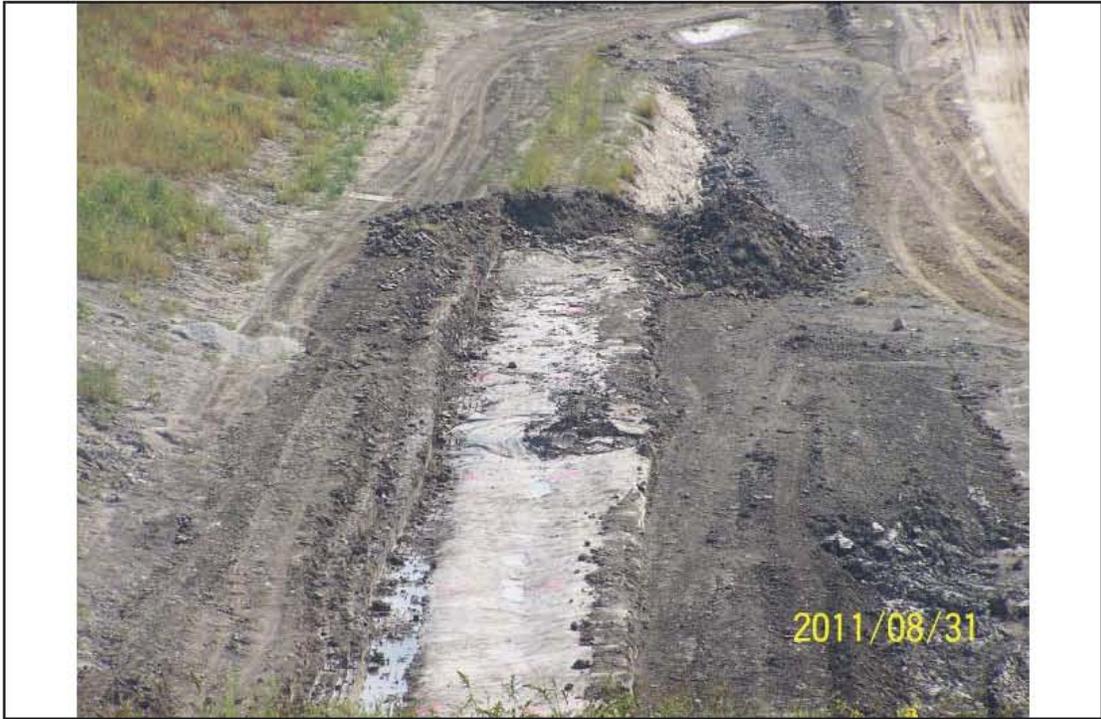
Exposed liner for connection to Phase 7

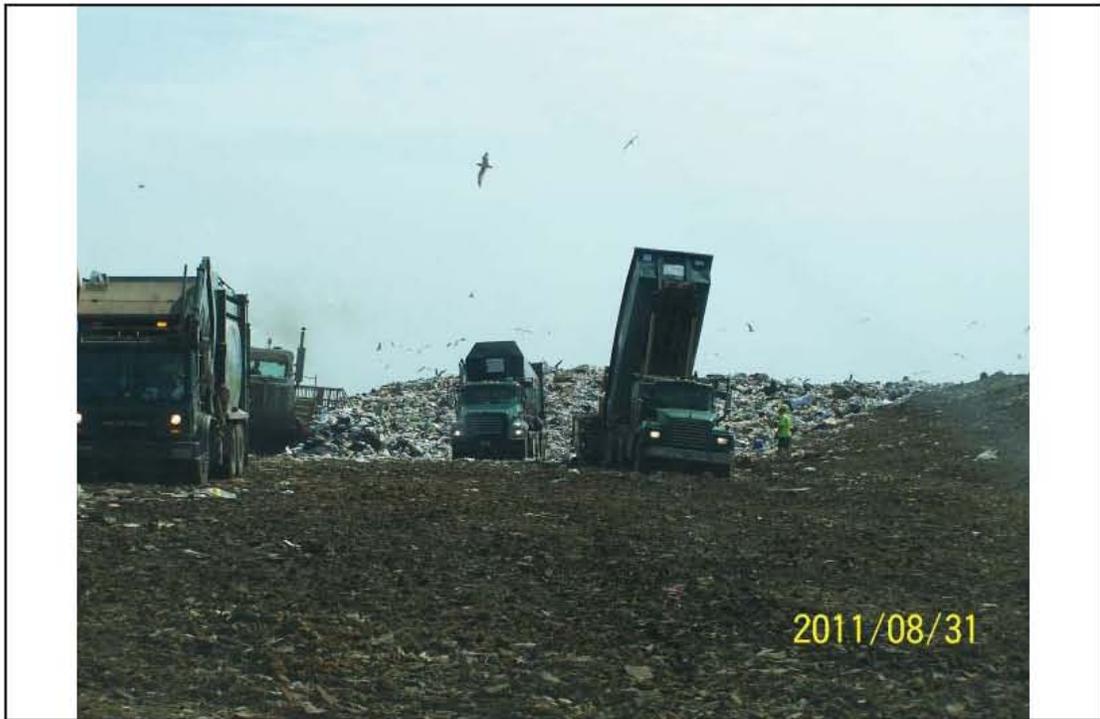
Working face receiving two trucks and compactor active

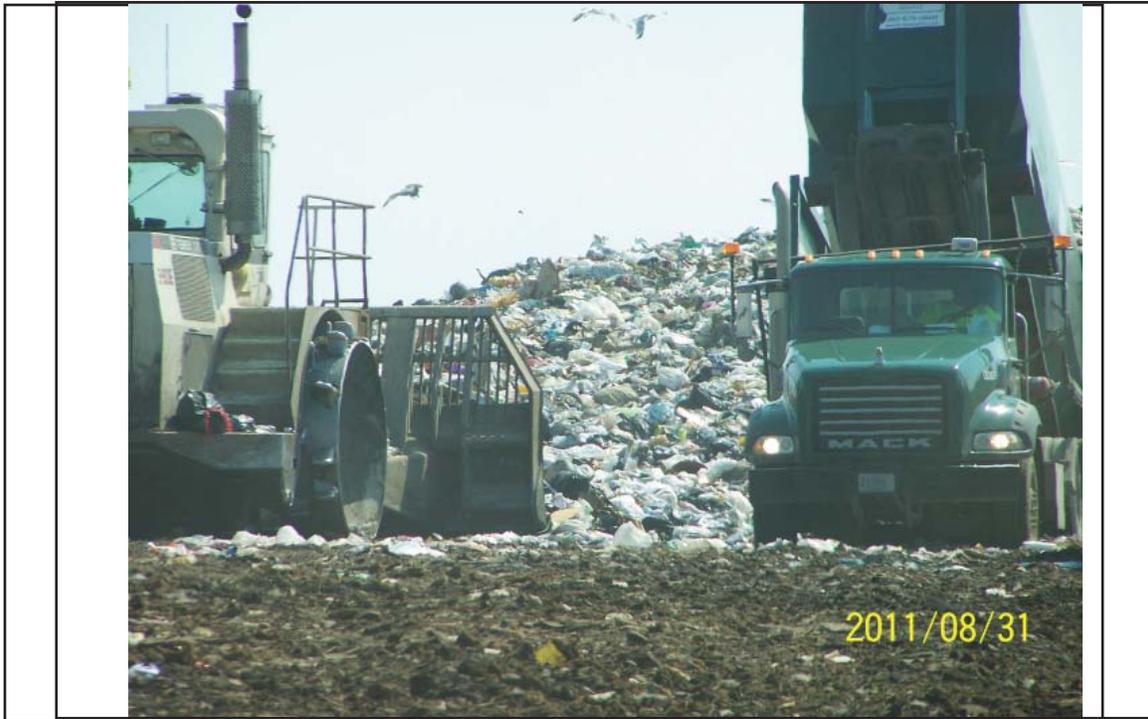
Working face, approximately 3 truck widths wide

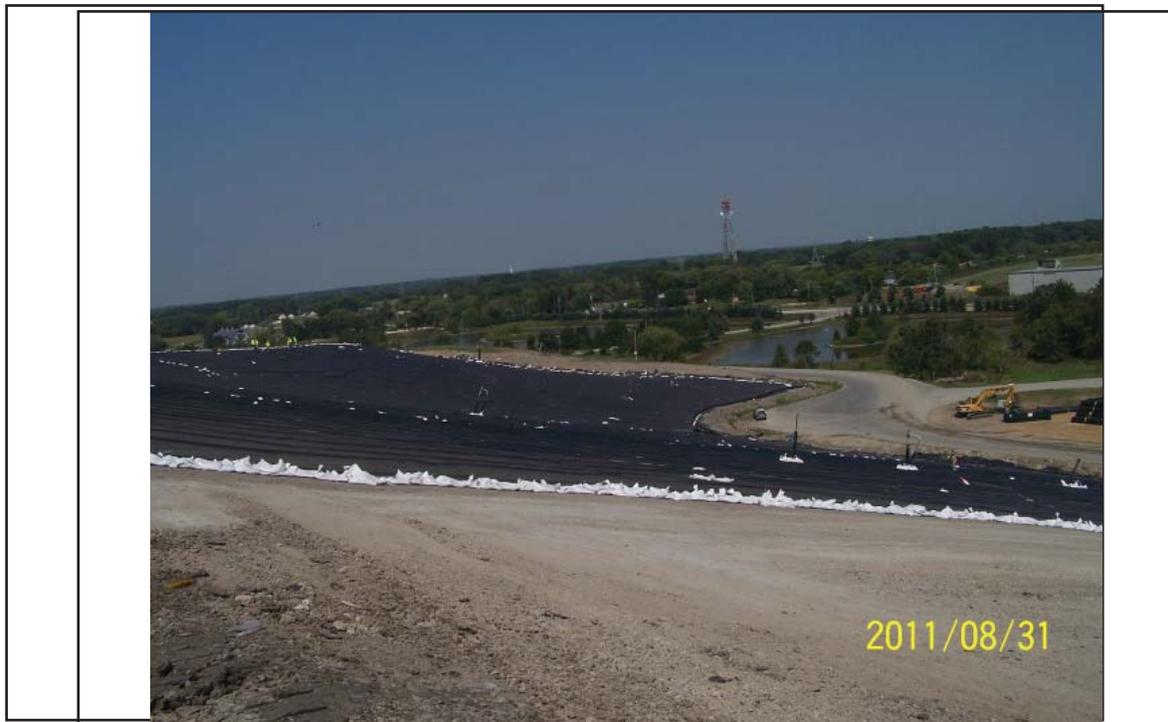
LLDPE placement too date

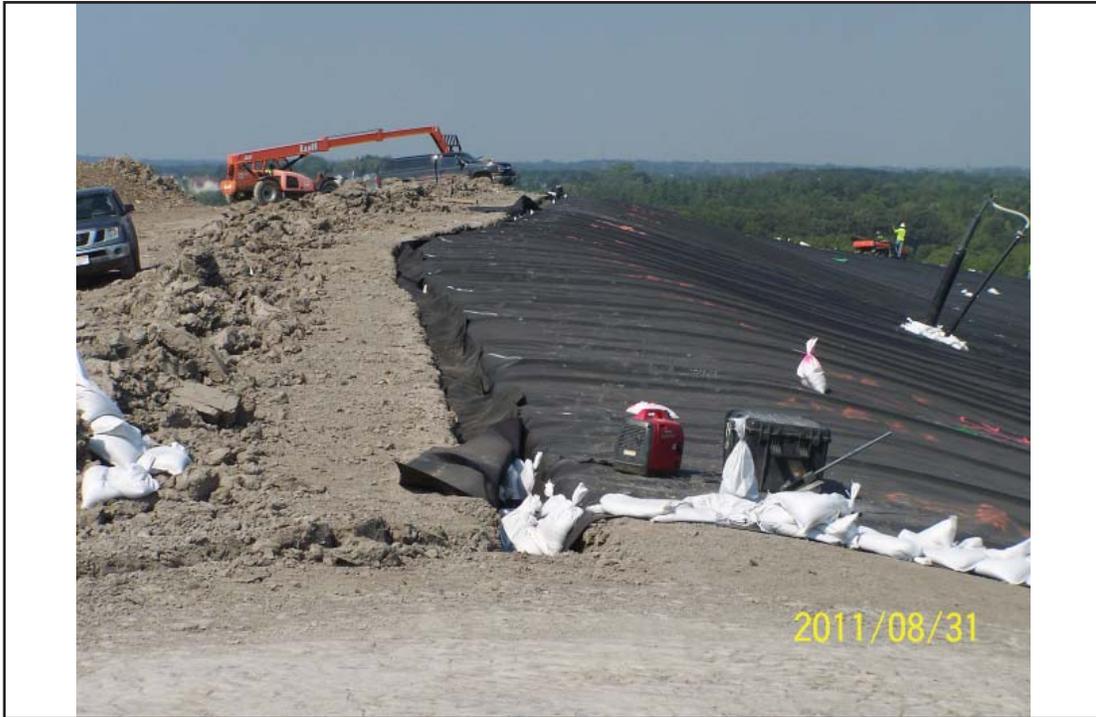
Top of slope anchor trench

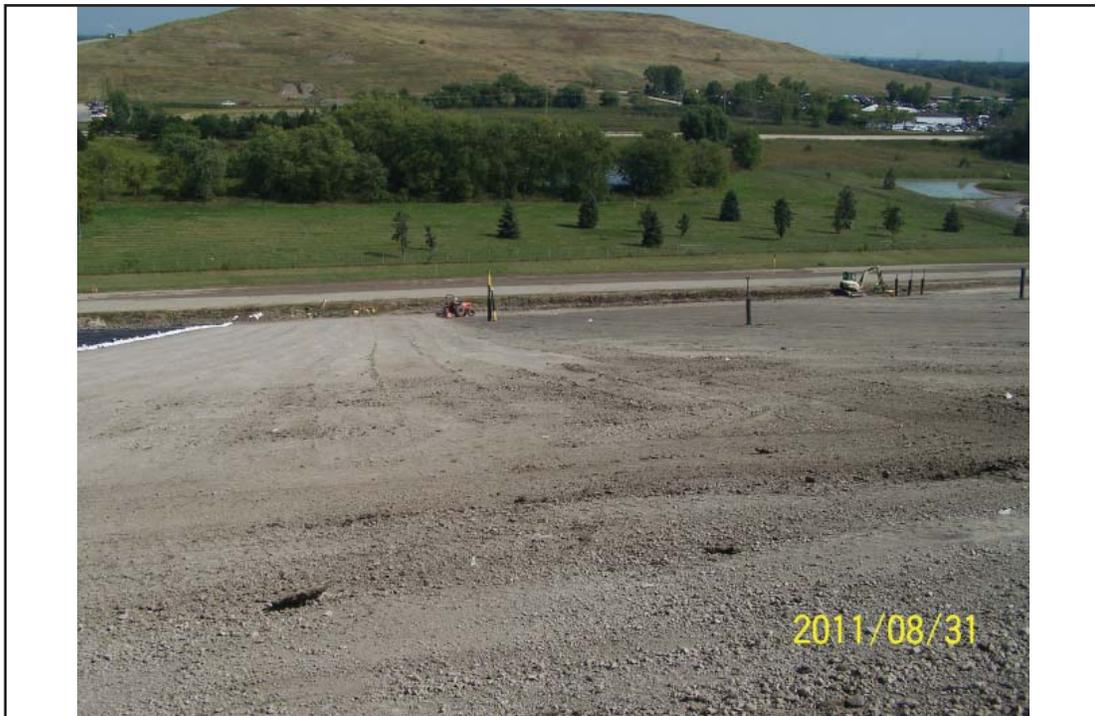
Clay nearly ready for LLDPE placement, still removing stones and filling low areas.

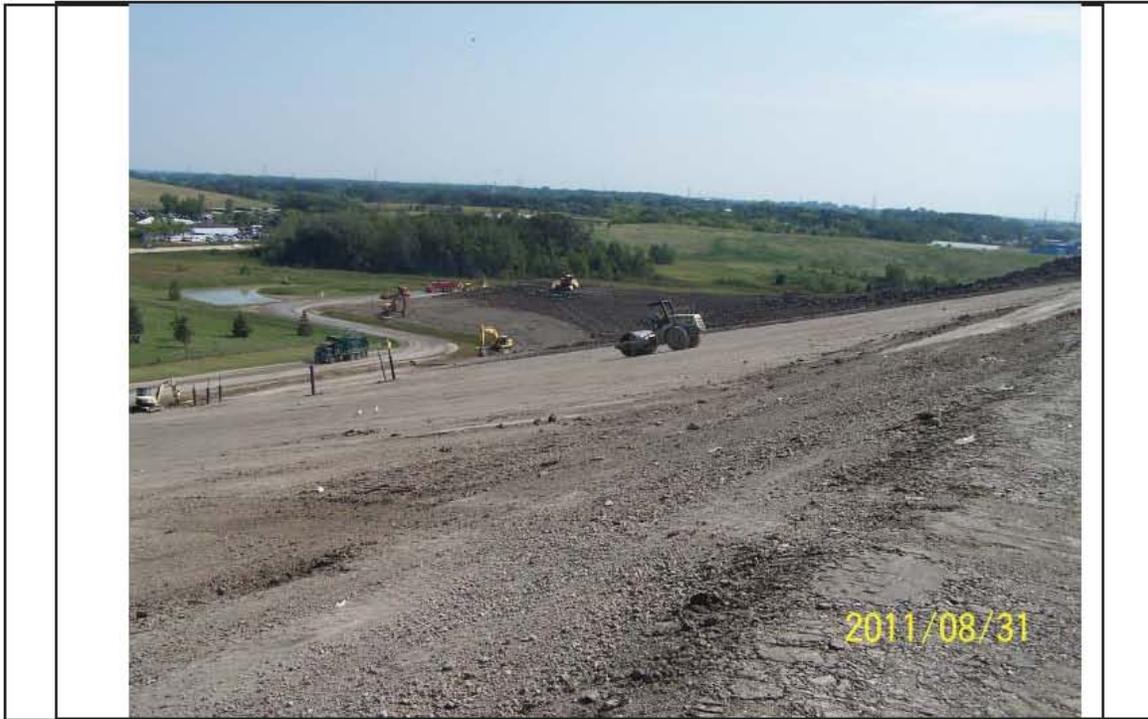
Clay cap being prepared for LLDPE placement

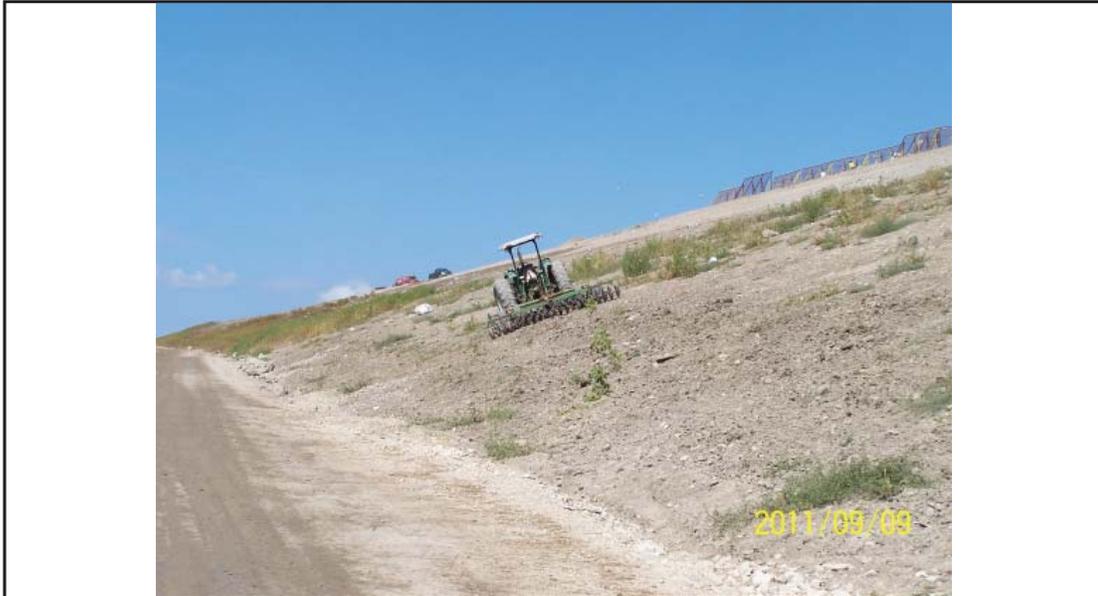
Tractor used for discing in seed, being performed on Phase 5 and 6 slopes

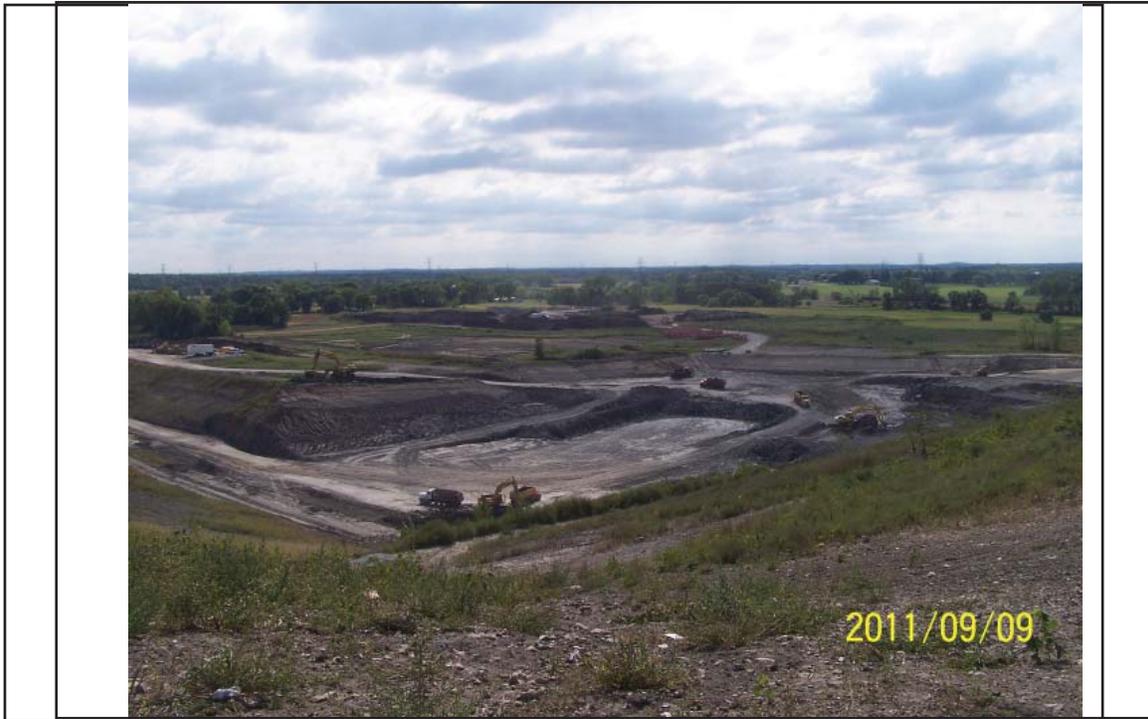
Excavation of Phase 7

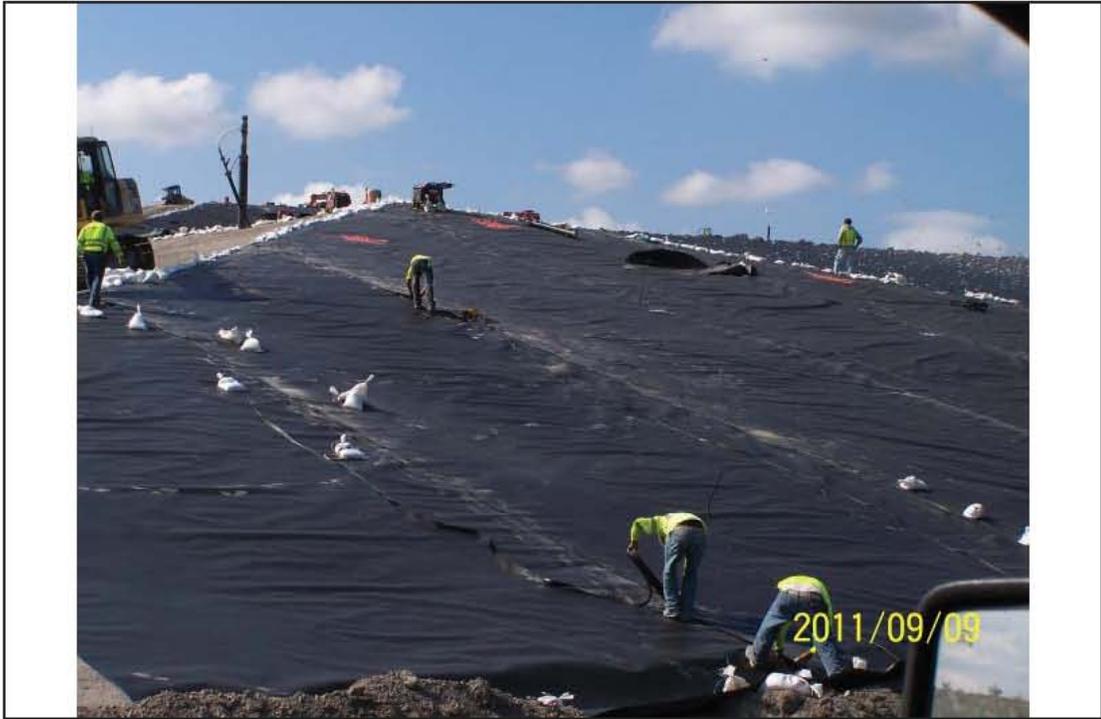
Panels being cut and set into place

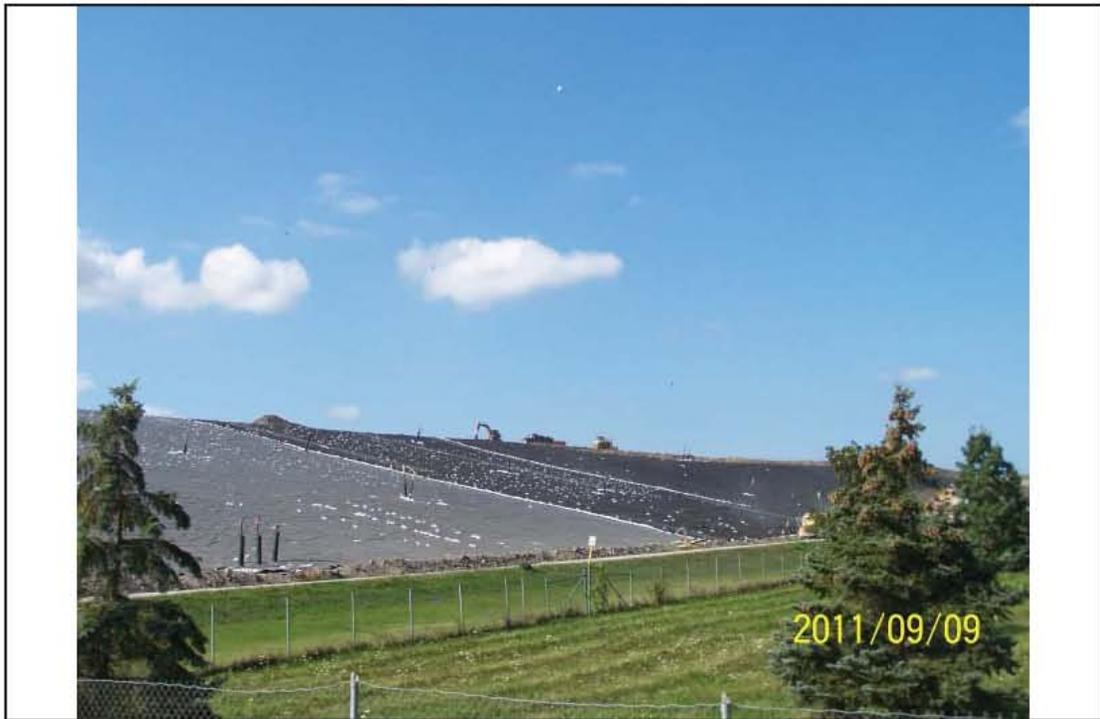
LLDPE Cover/Cap nearly completed, Geocomposite layer being placed

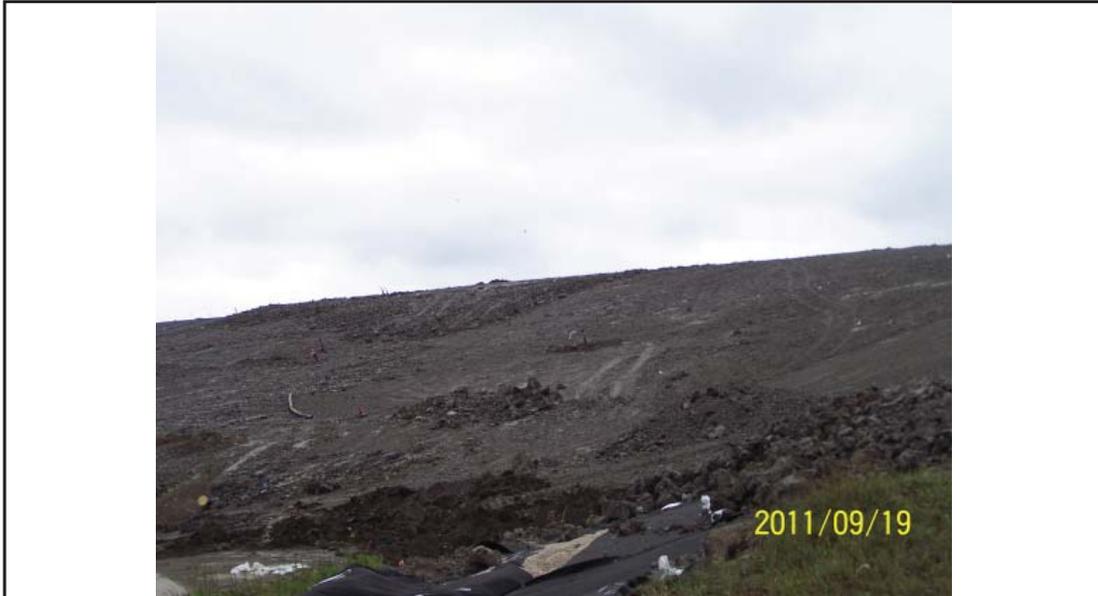
Final cover clay placement at North end of Phase 5

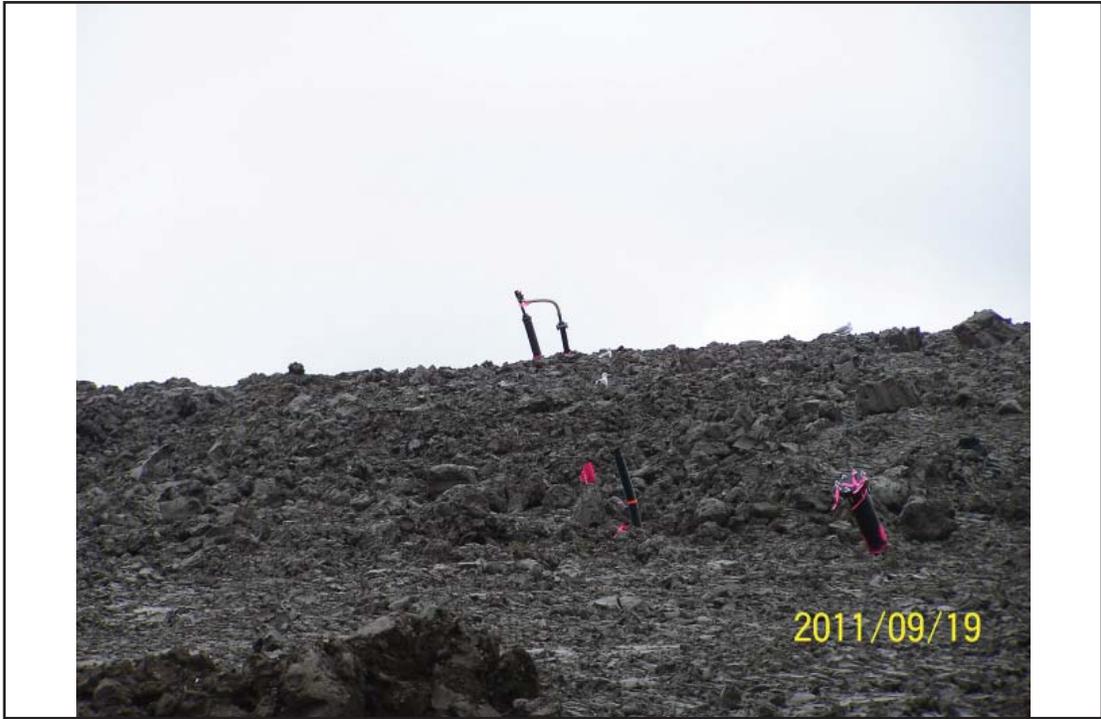
Final cover clay, and location of well 35.

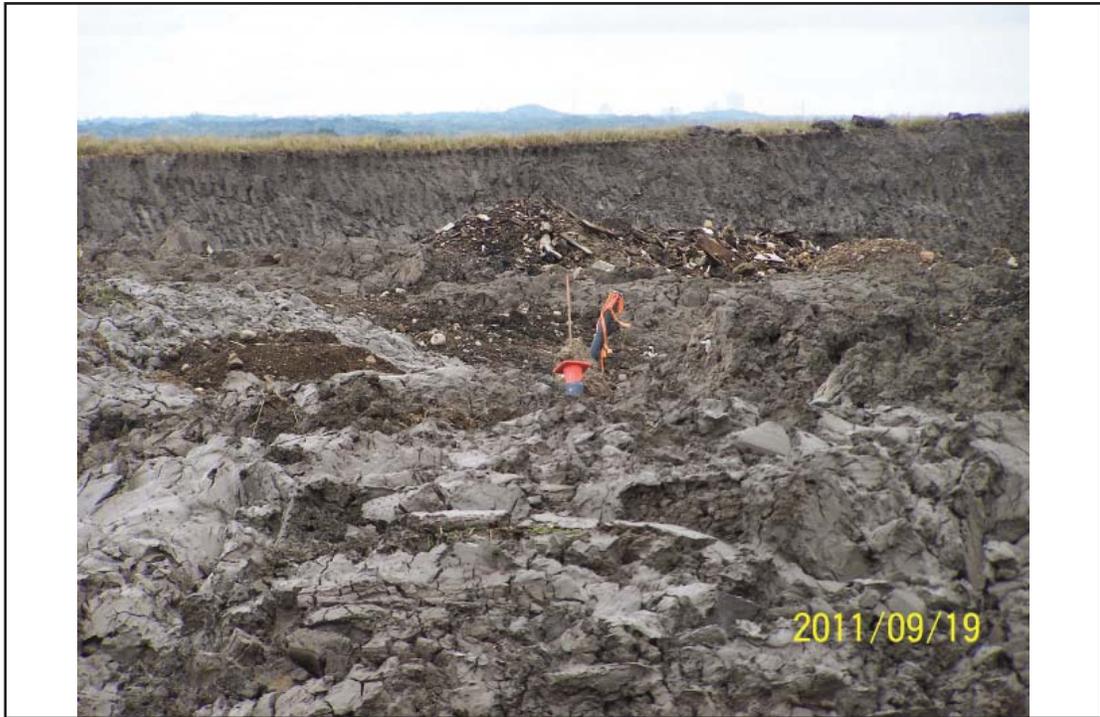
Well lost and abandoned.

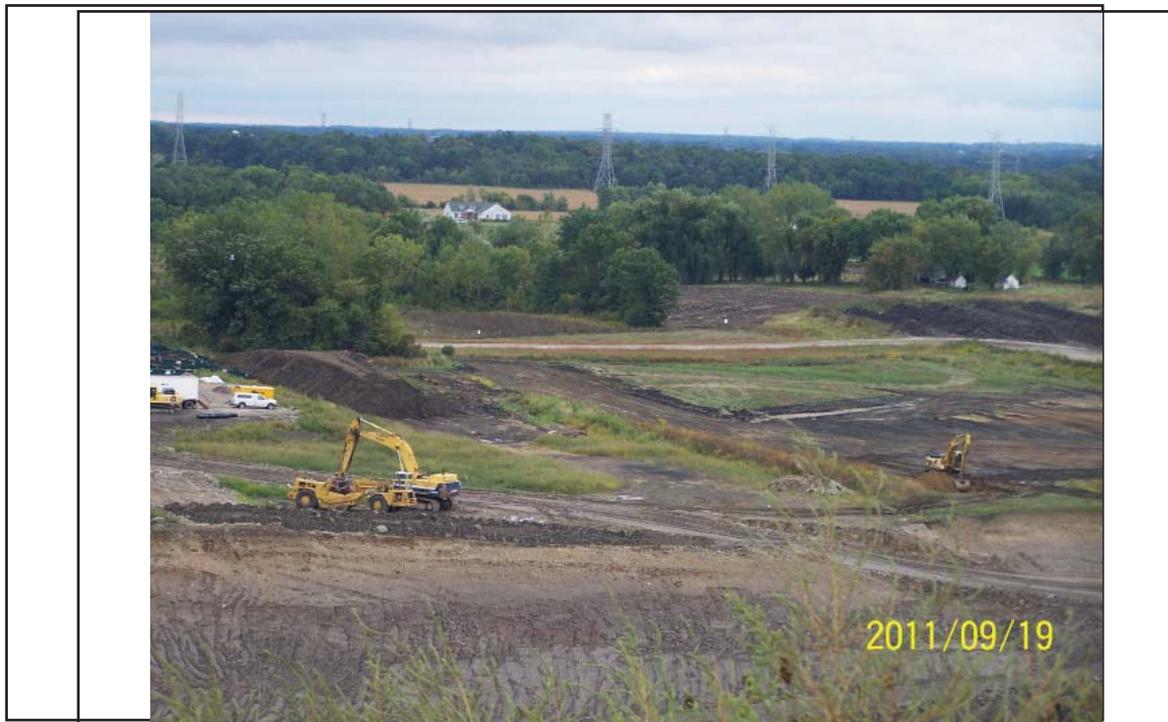
Topsoil being stripped from field for use in cover

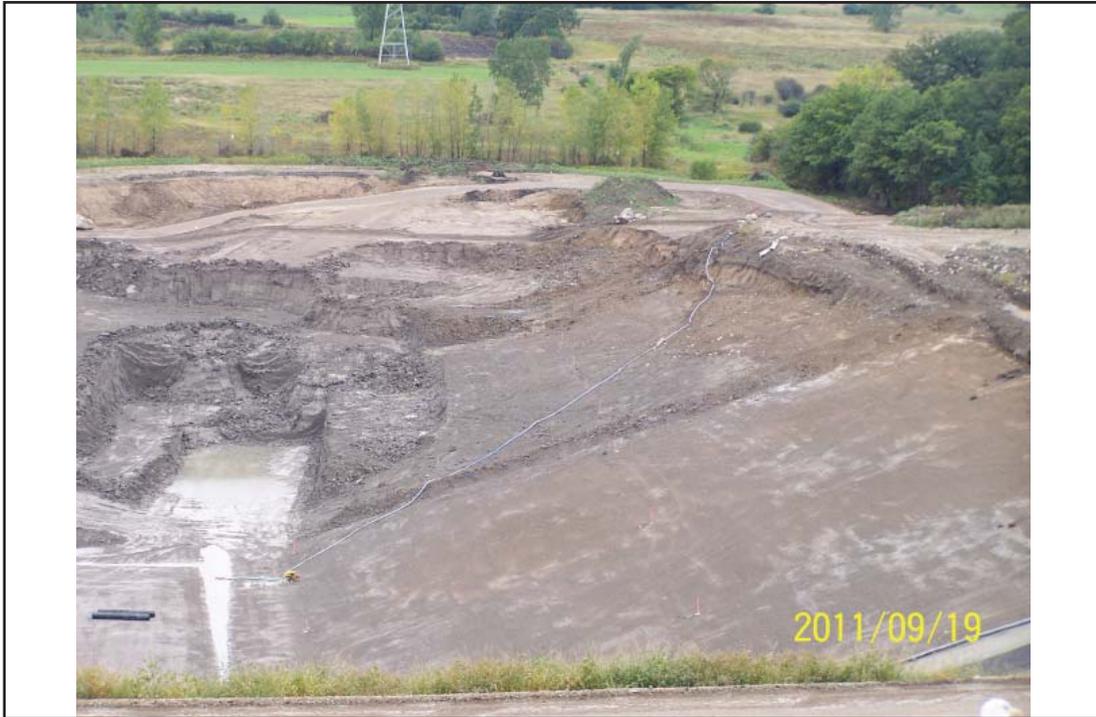
Nearly completed side slopes, awaiting clay placement for subgrade

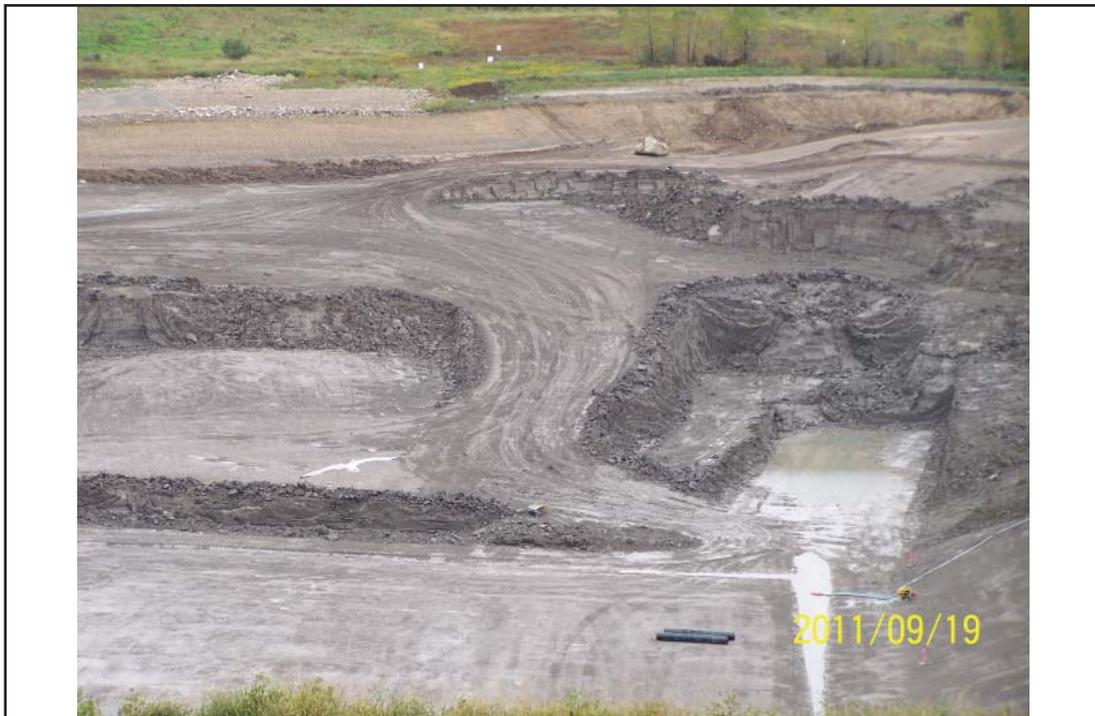
Ongoing excavation of future Phase

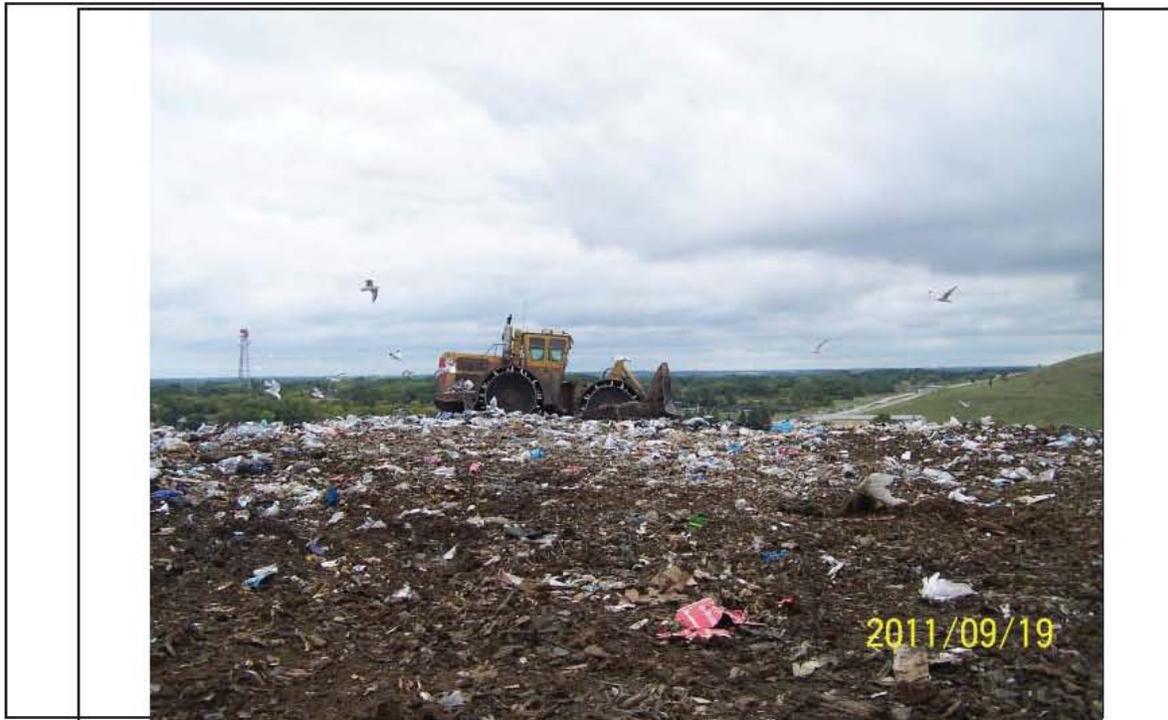
Compactor in working face

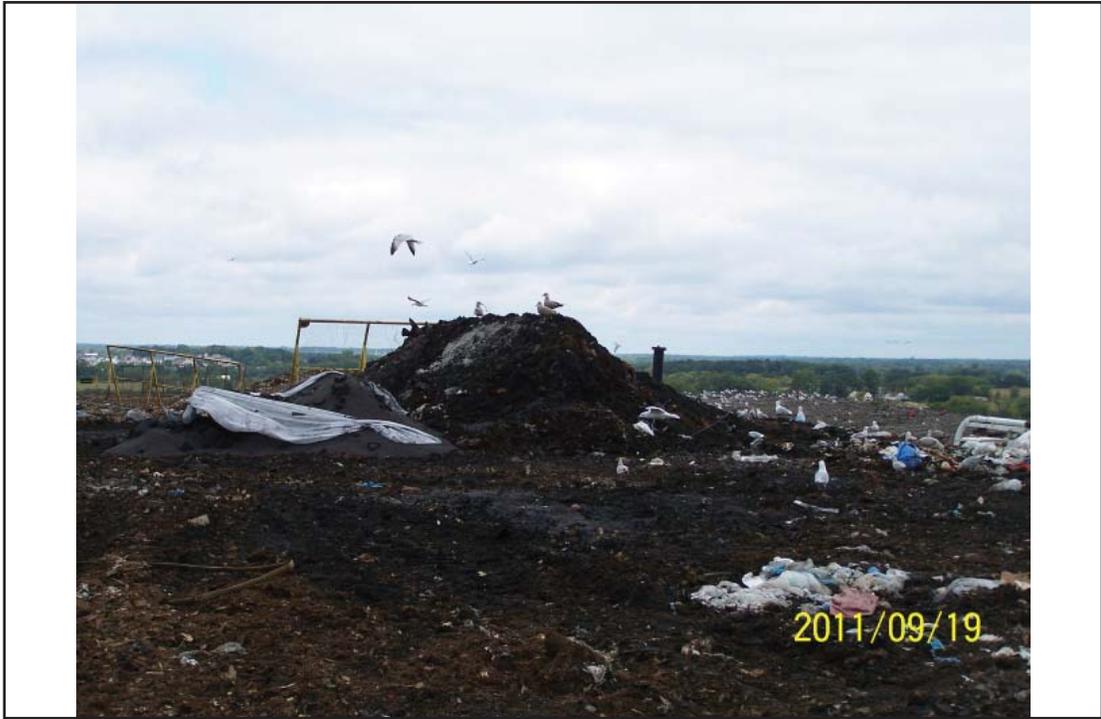
- Autofluff & foundry sands stockpiled
- Leachate discharged to MMSD, some surface application
- Flare in operation during audit, no shut downs, ~1600 cfm

Stockpiled foundry sand

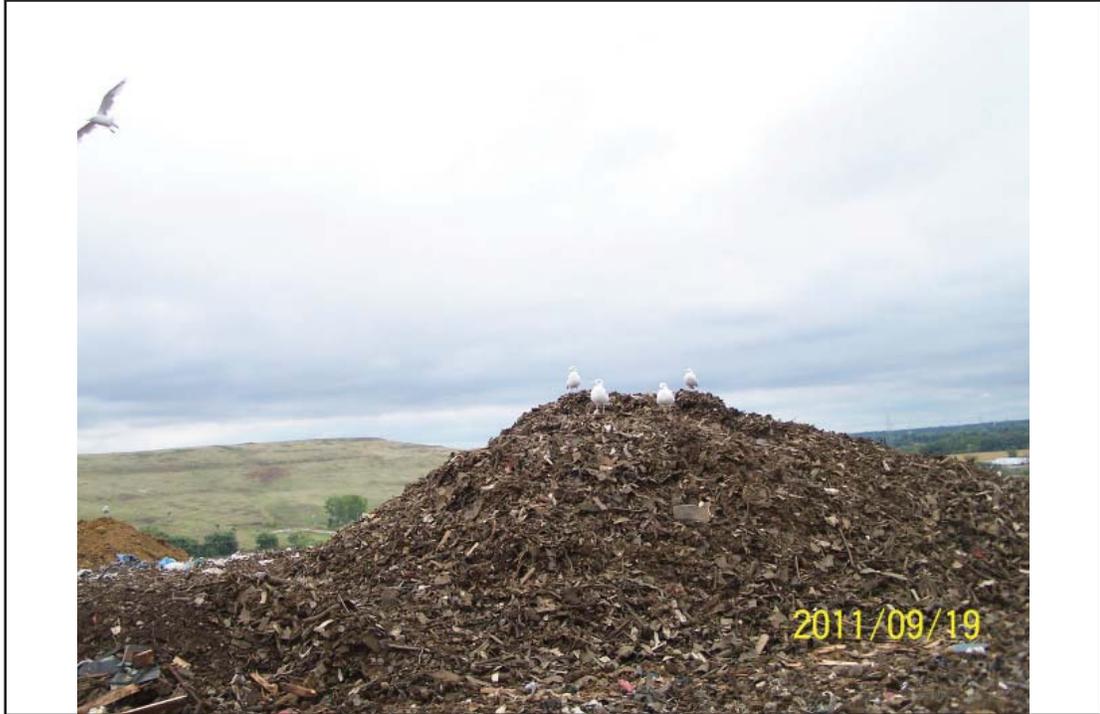
Stockpiled auto fluff

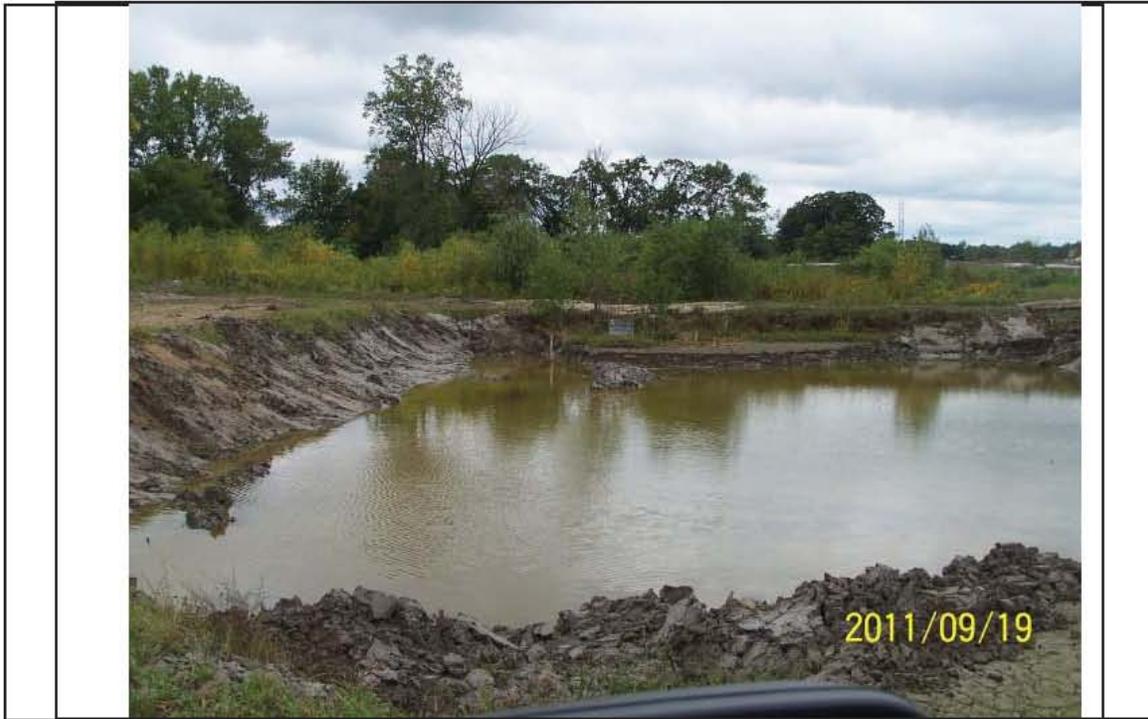
- Vegetation in good condition
- One storm event since last audit, ~1/2"
 - Basin 1 being cleaned as weather permits, ~2" of sediment to be removed
- Gas odor at Phase 6 south end

Basin 1 being cleaned

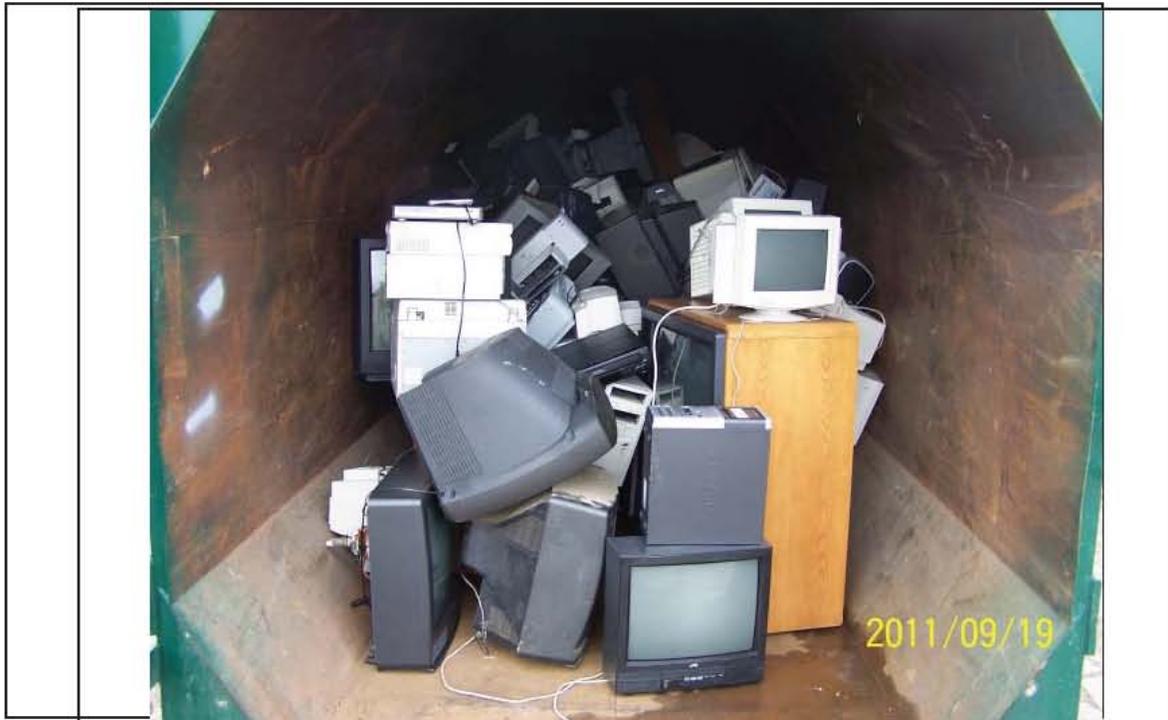
E-waste collected at residential drop off

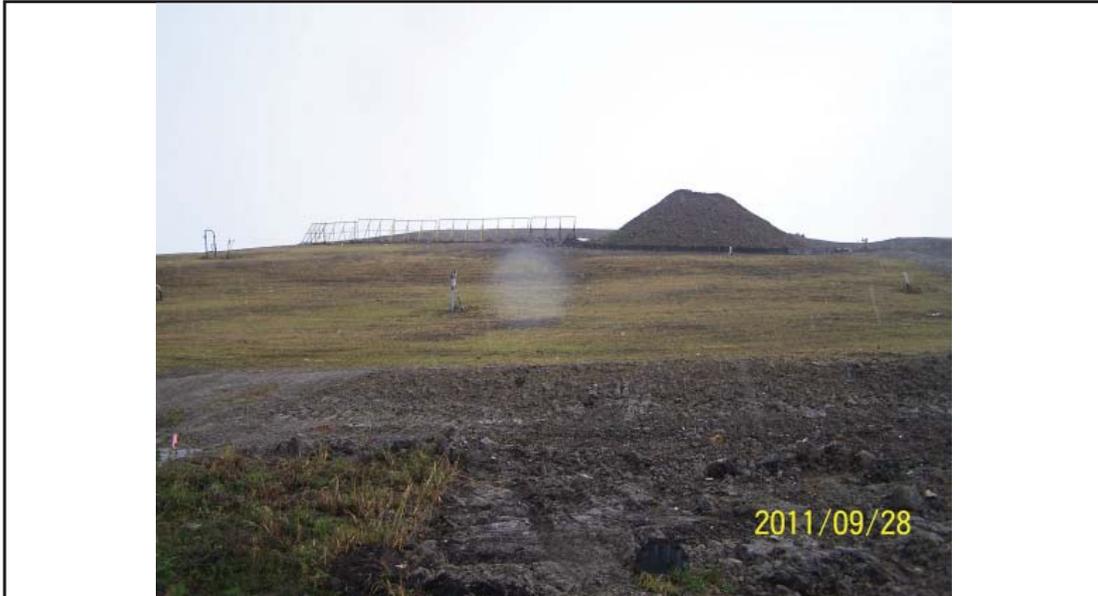
Green slopes after seeding

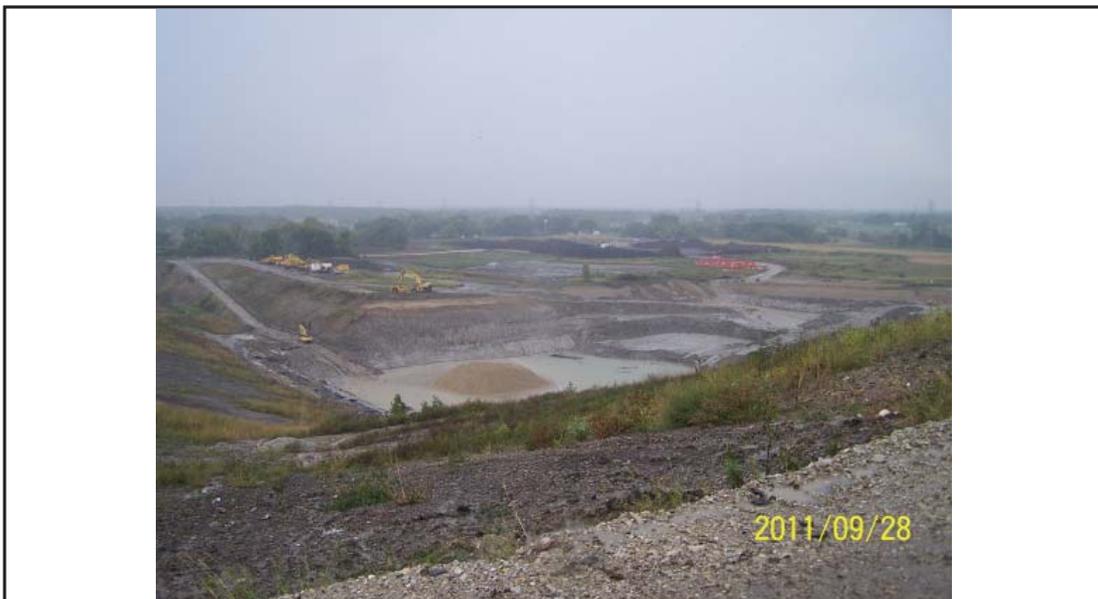
Excavated area of Phase 7 contaminated with leachate

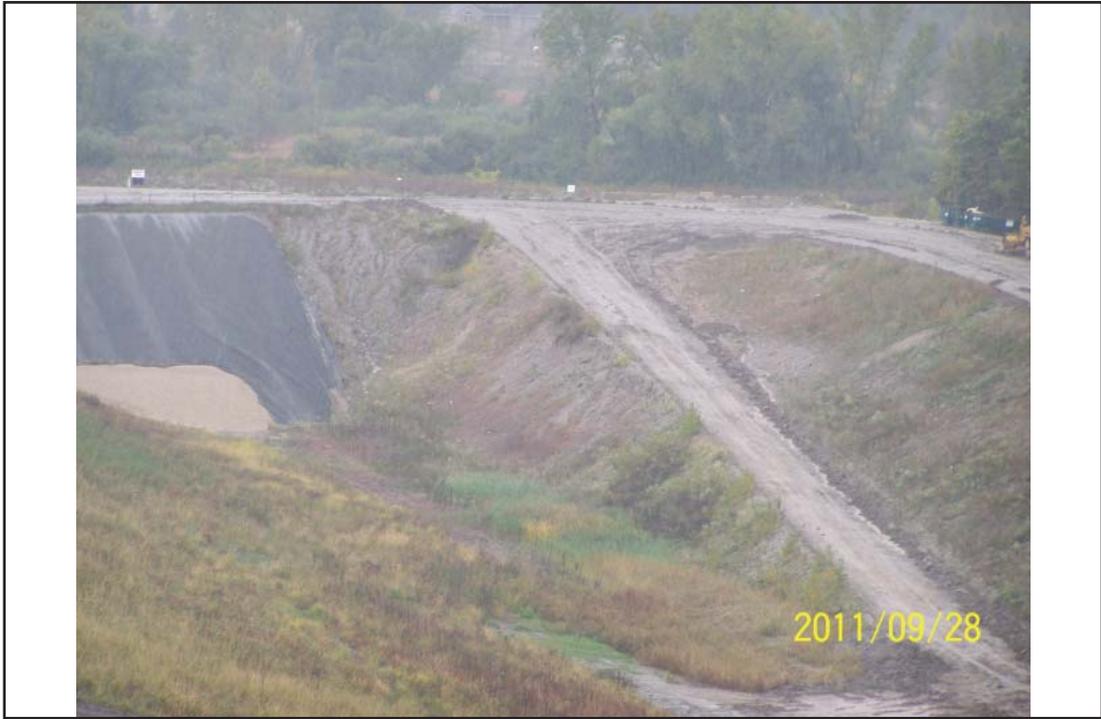
Phase 6/7 junction unexcavated.

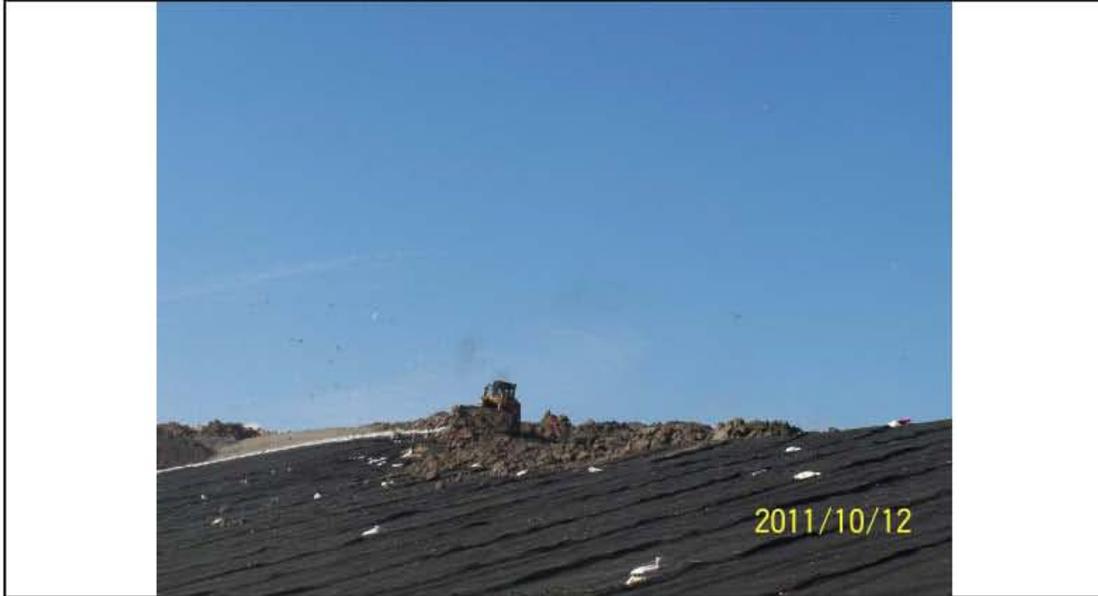
Clay being placed on closure area III

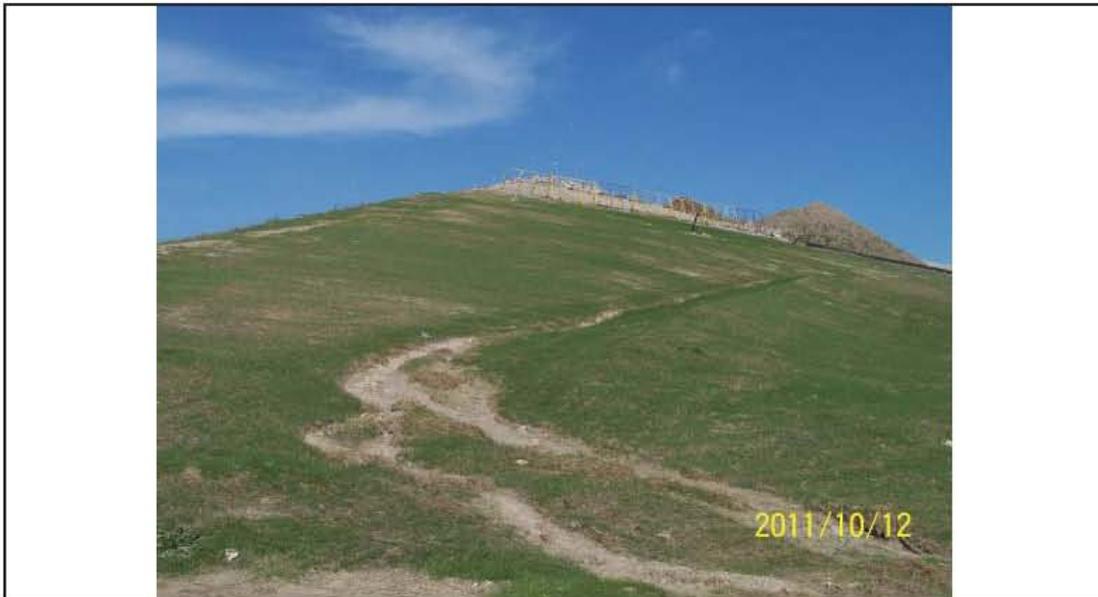
Minor erosion along diversion berm area
