Veolia Emerald Park Landfill
City of Muskego

2011 Veolia Emerald Park Landfill Year End Compliance Officer Report and Audit Summary

TO: Veolia Emerald Park Standing Committee
FROM: Jo-Walter Spear, Jr., P.E.
COPIES: File
DATE: 04/02/2012
PROJECT NUMBER: 1012.10030

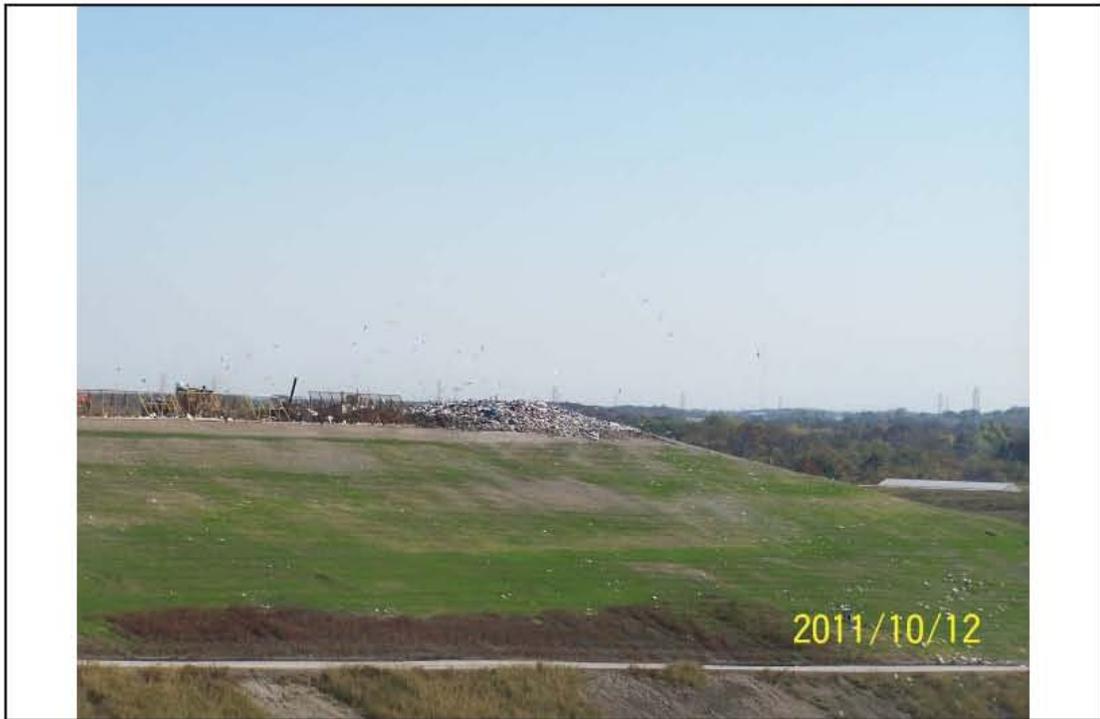
Working face at South edge of Active Area

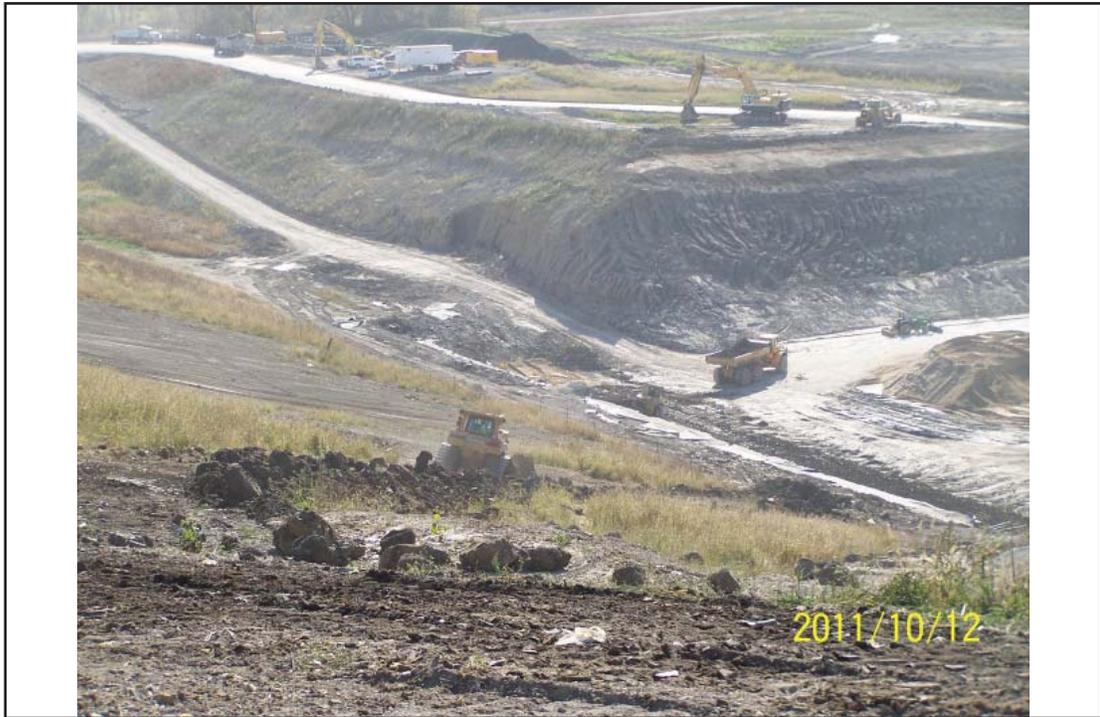
Clay being laide over sand

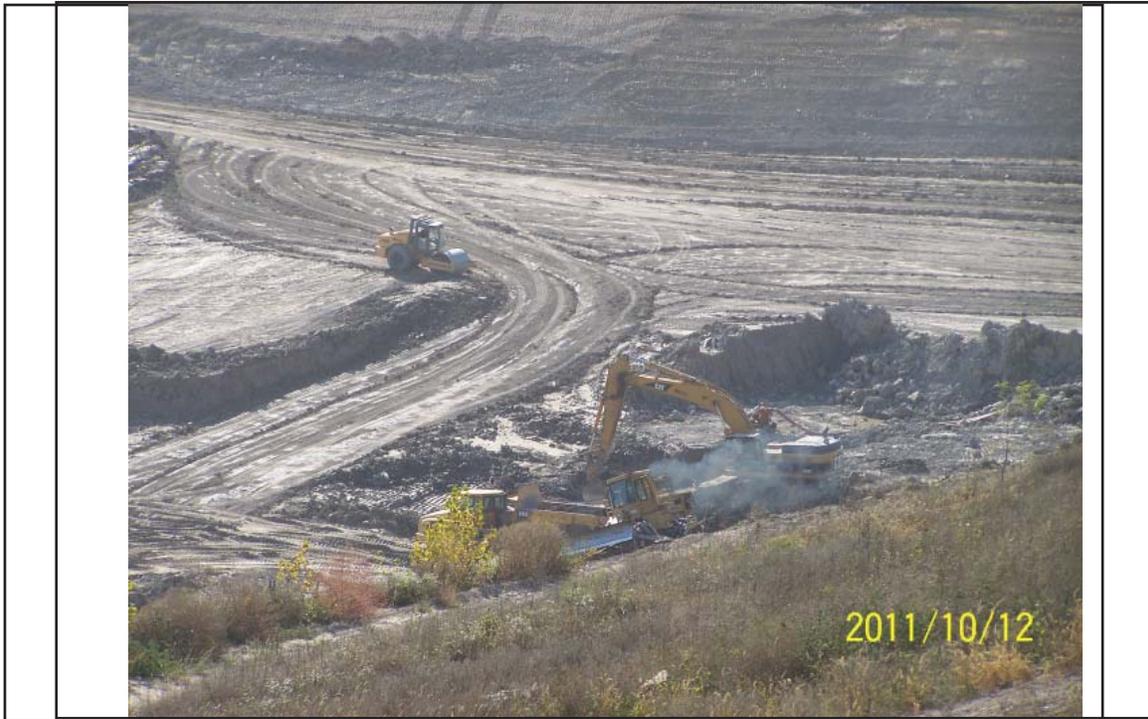
Phase 7 excavation at West edge

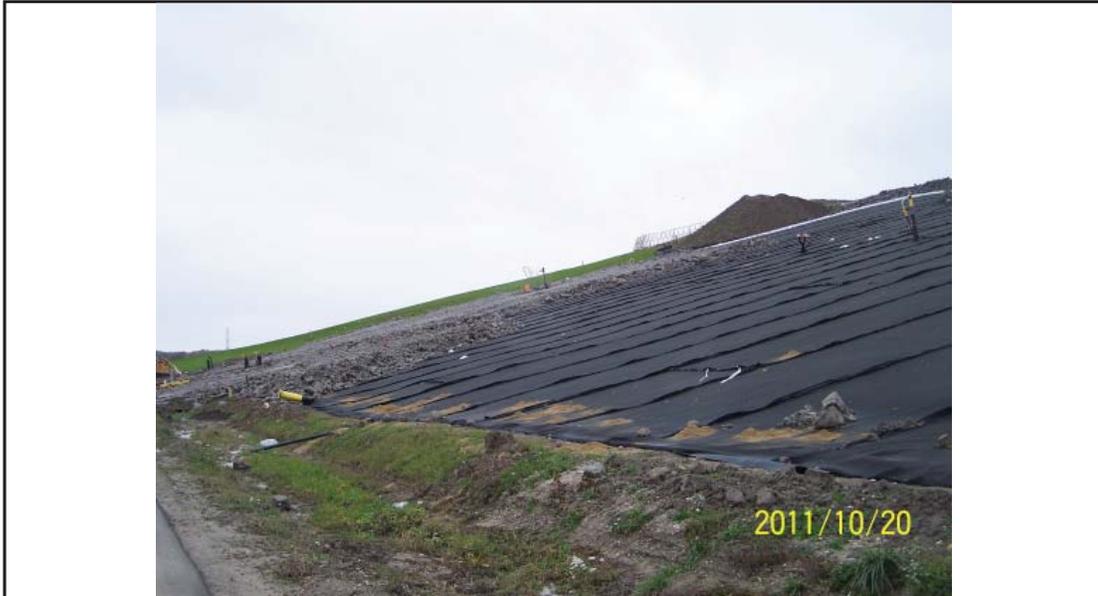
Closure Area III South slope

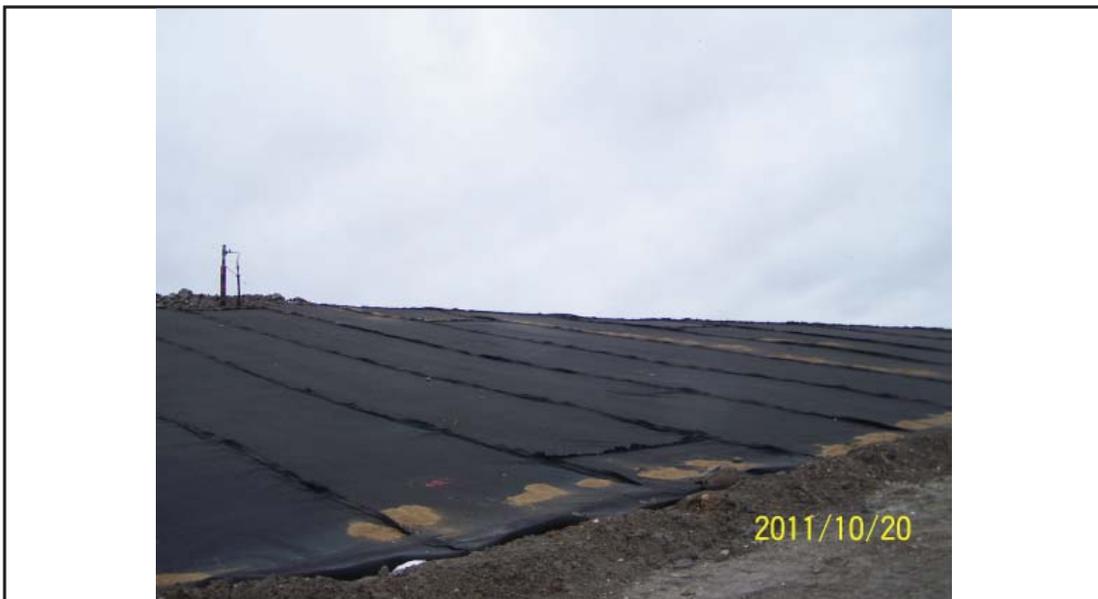
Closure Area III Southeast corner

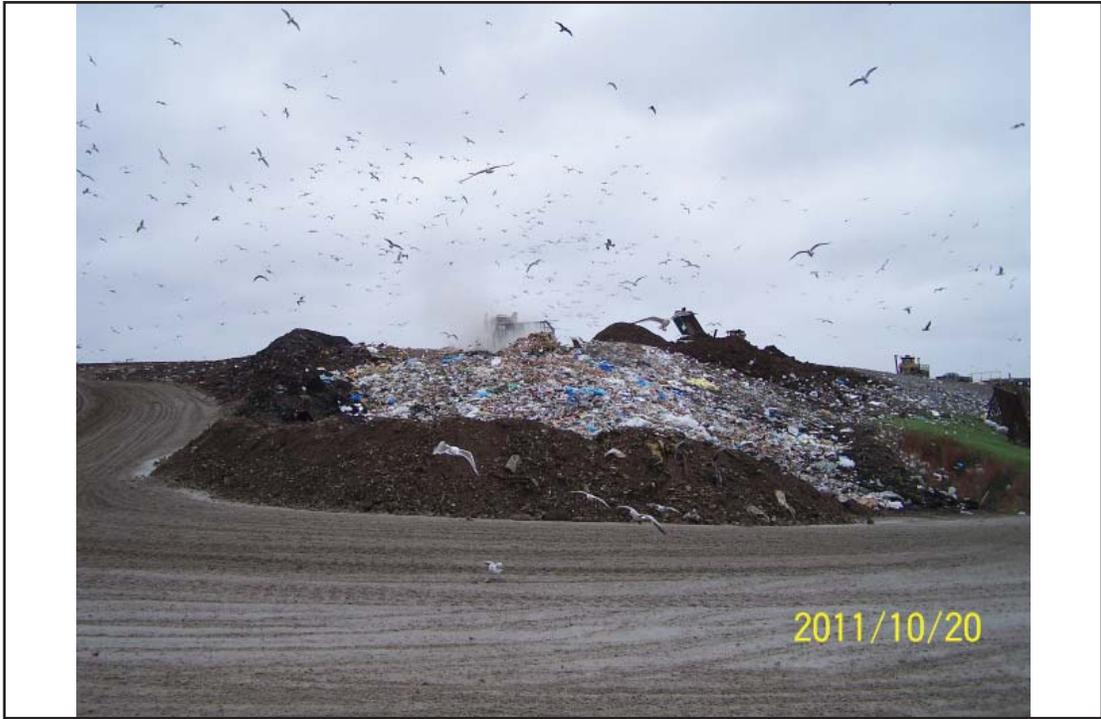
Working face on slope

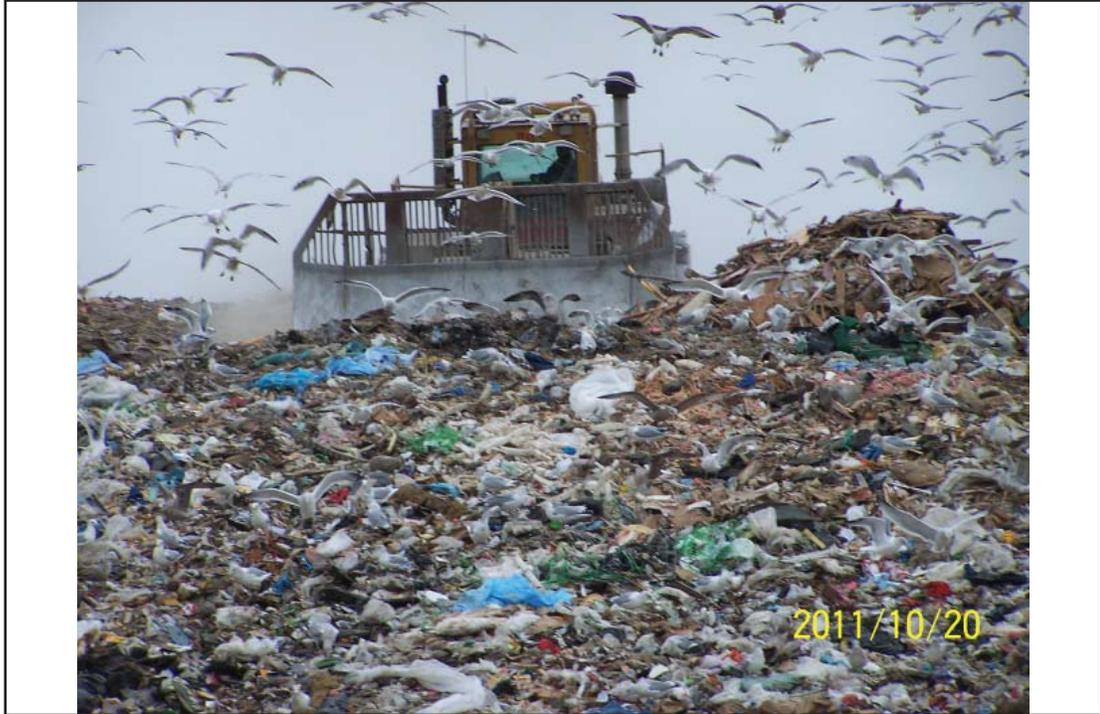
Working face

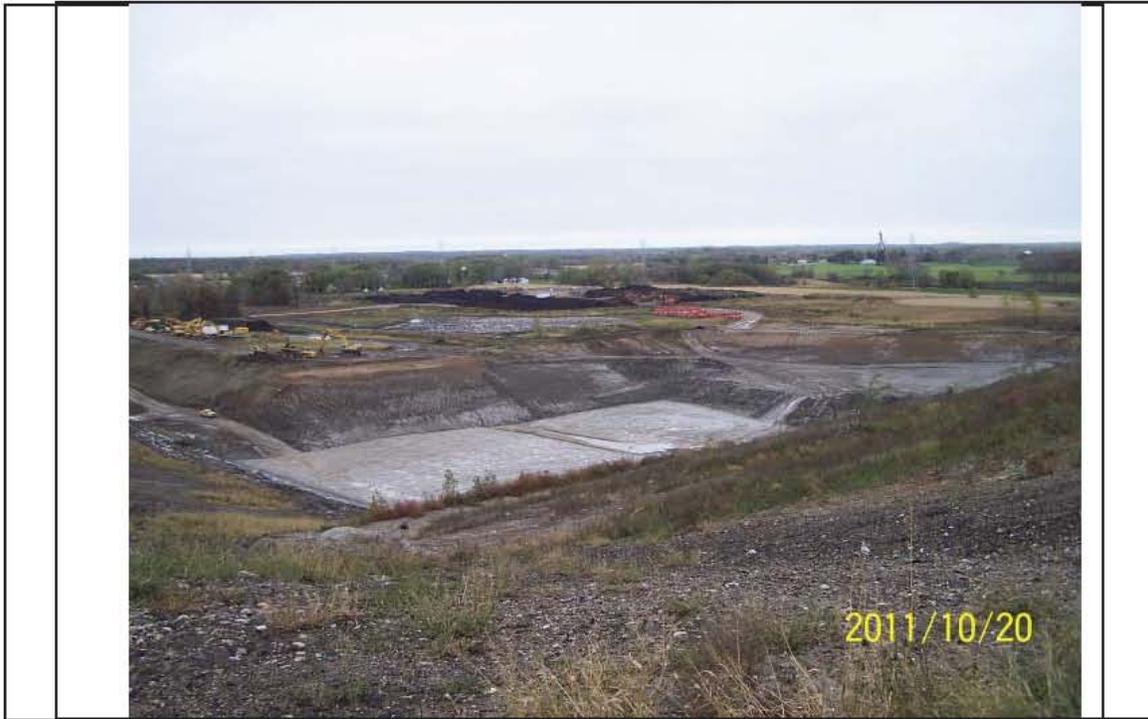
Phase 7 construction

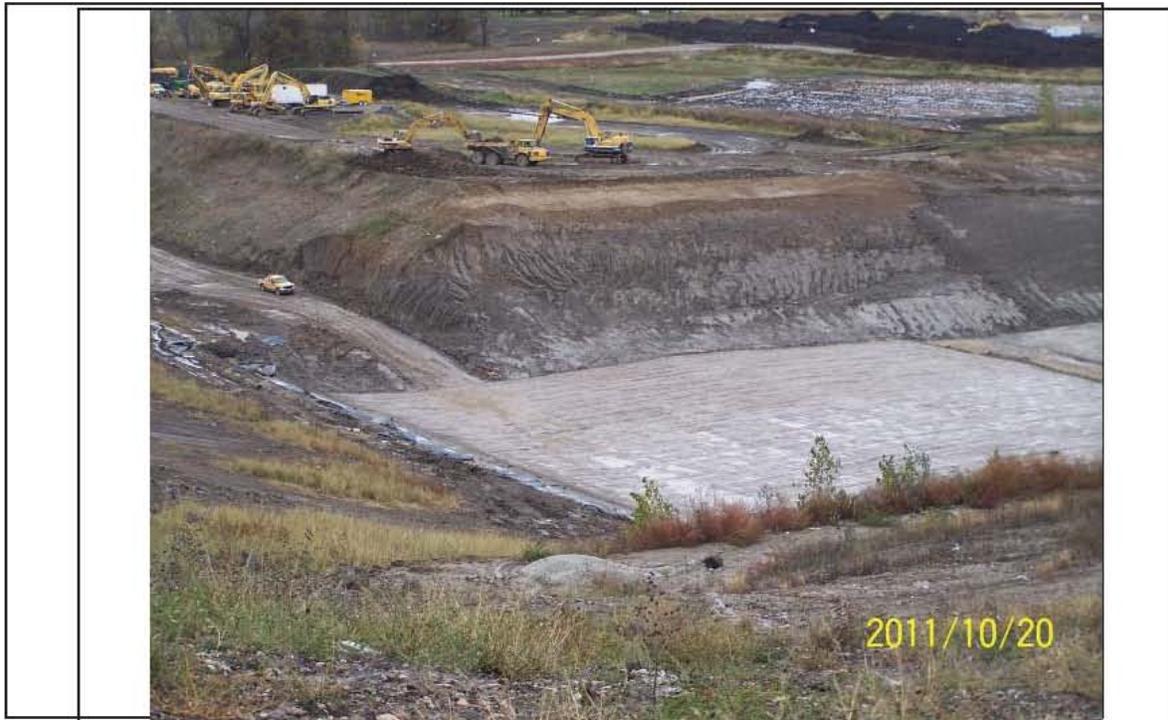
Phase 7 Construction

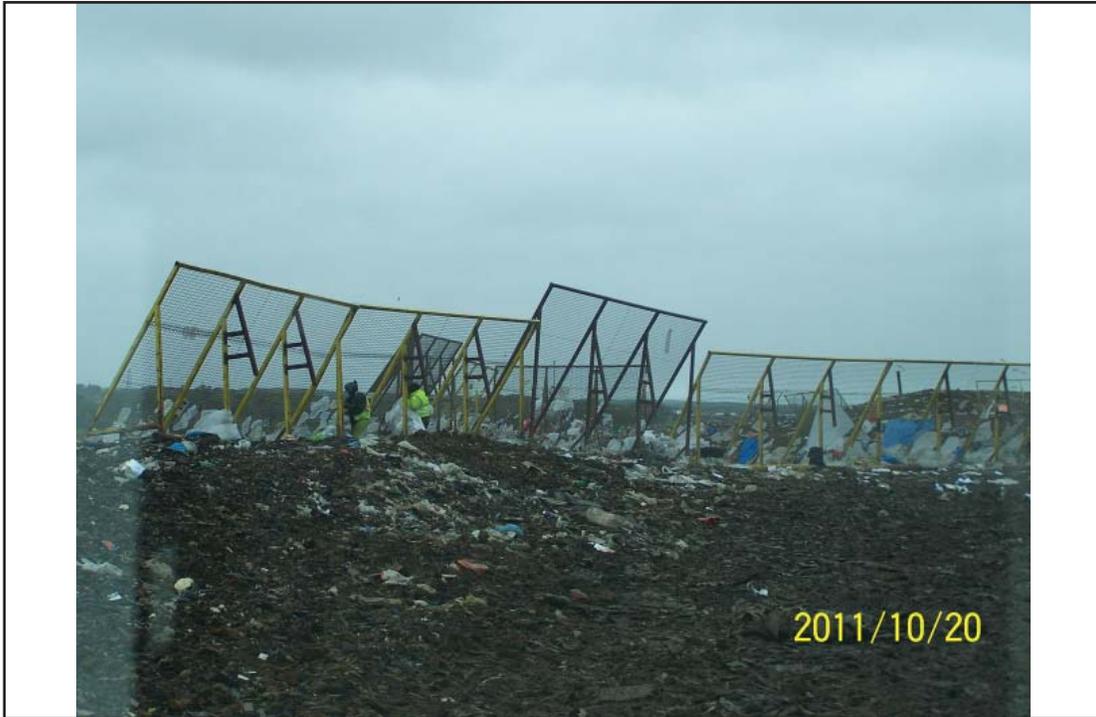
Active area litter fence border

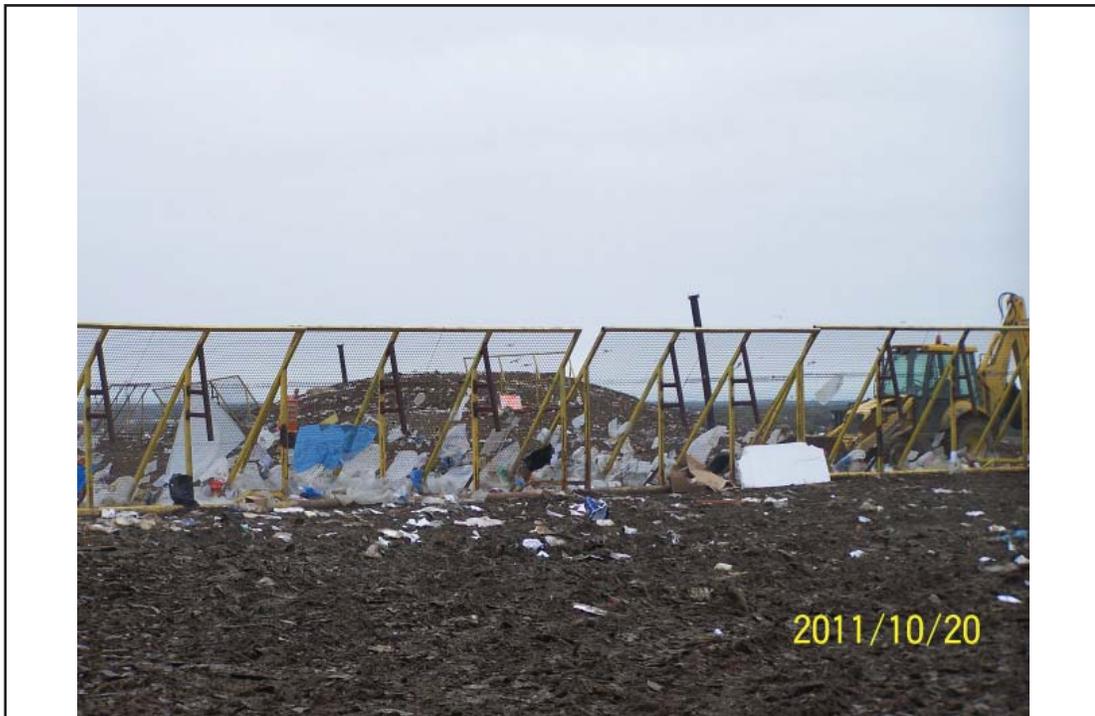
Active area litter fences downwind

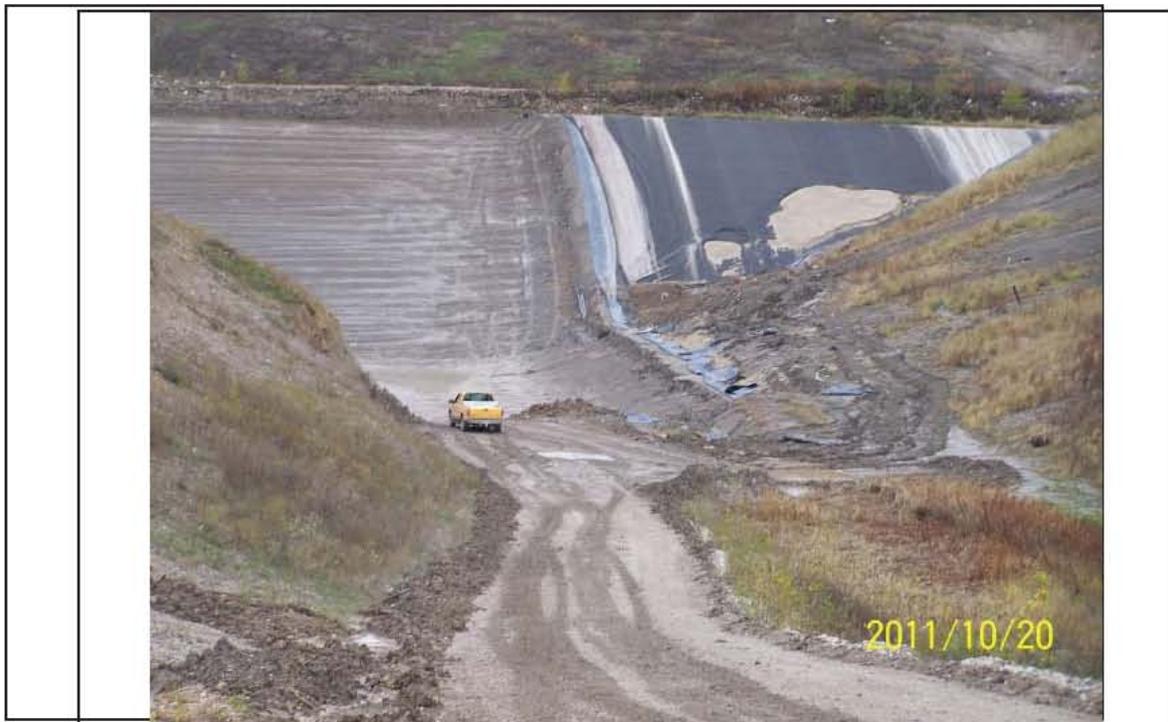
Between Phases 6 and 7

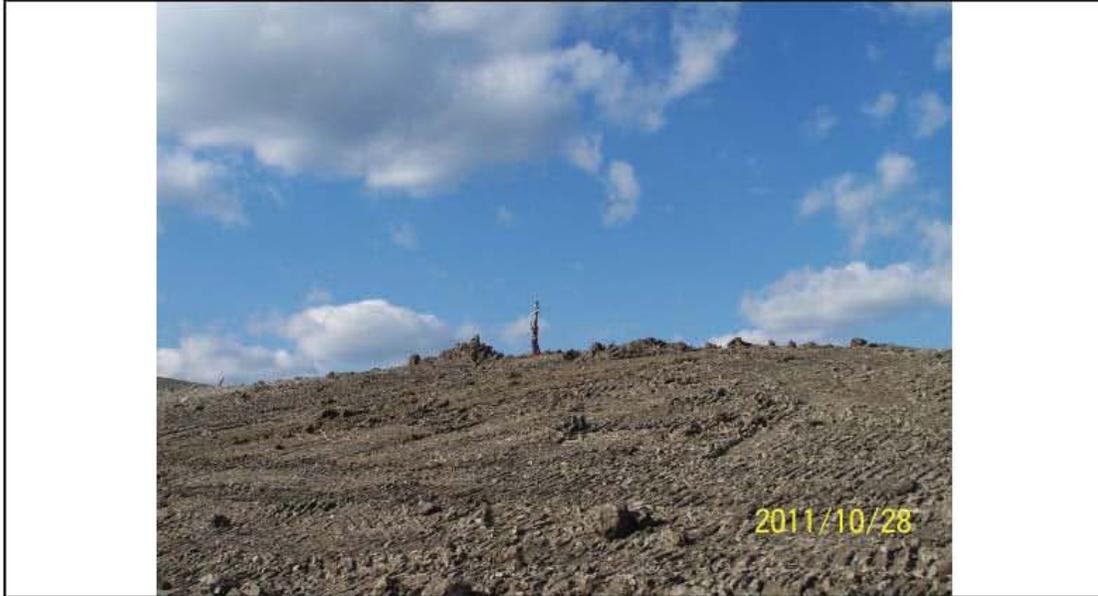
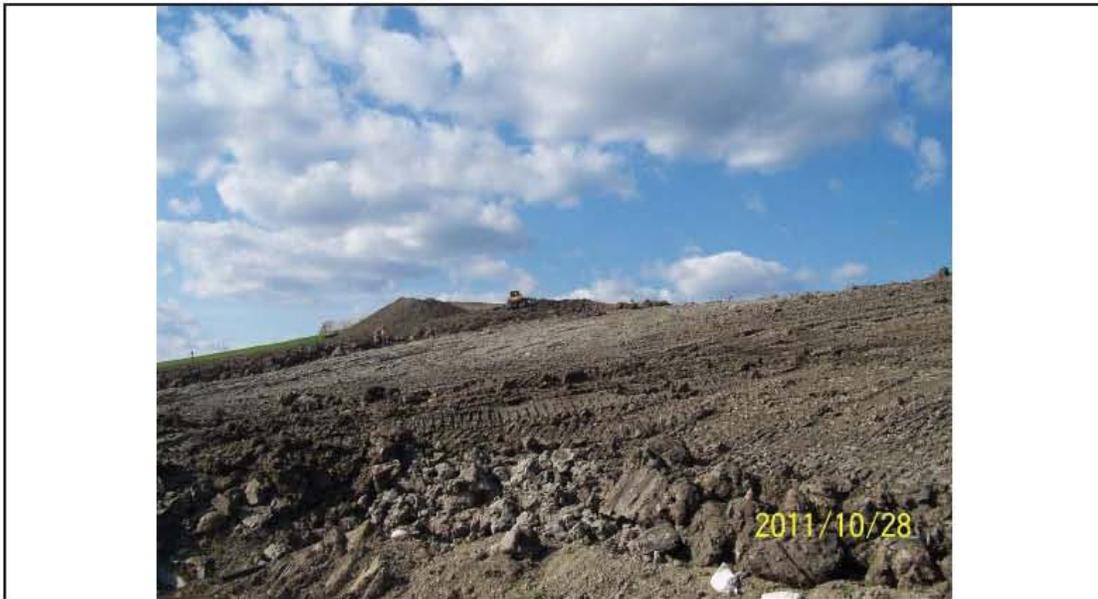
Clay placement for Closure Area III

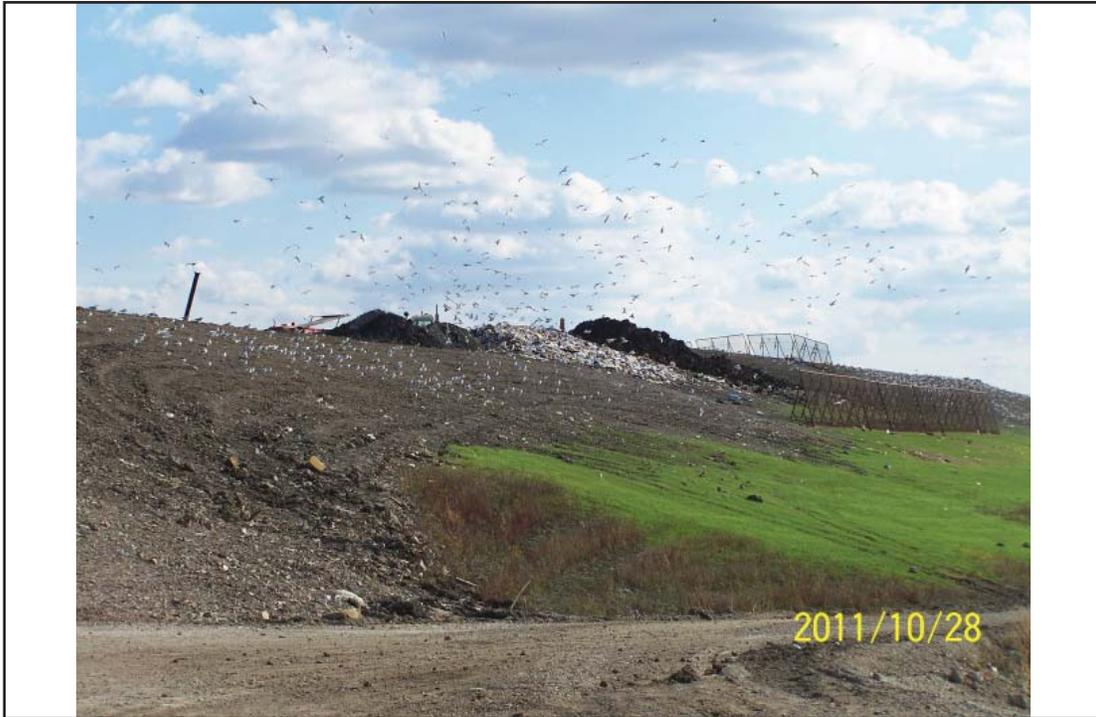
Active area at working face, West slope

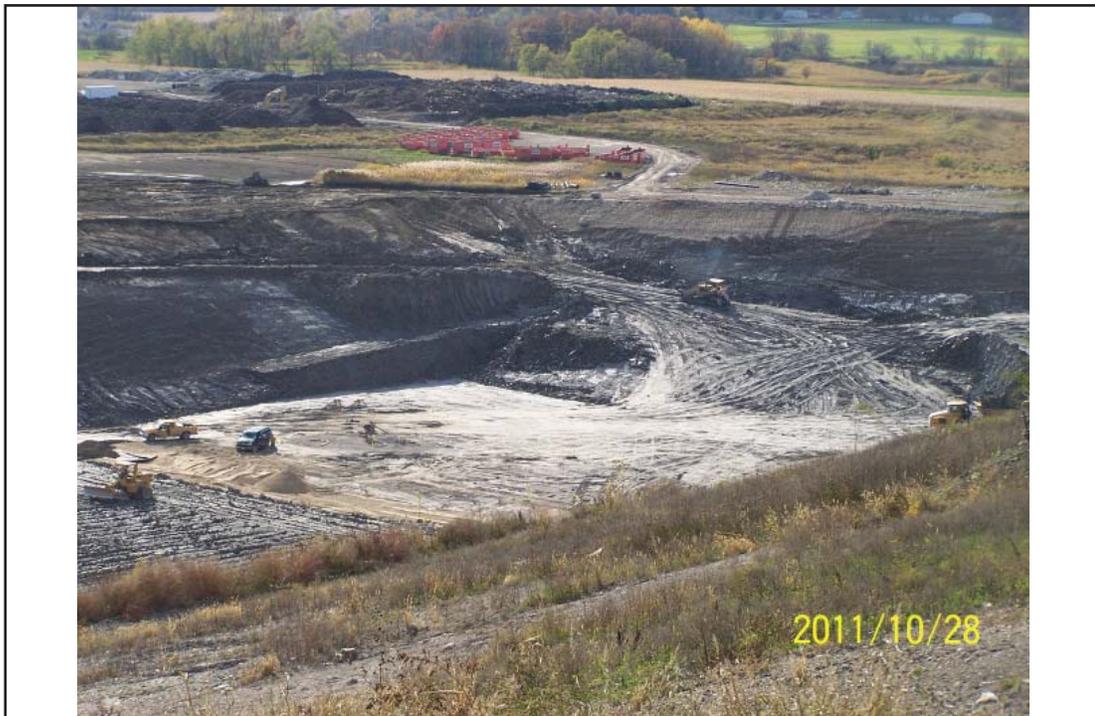
Western edge of excavation

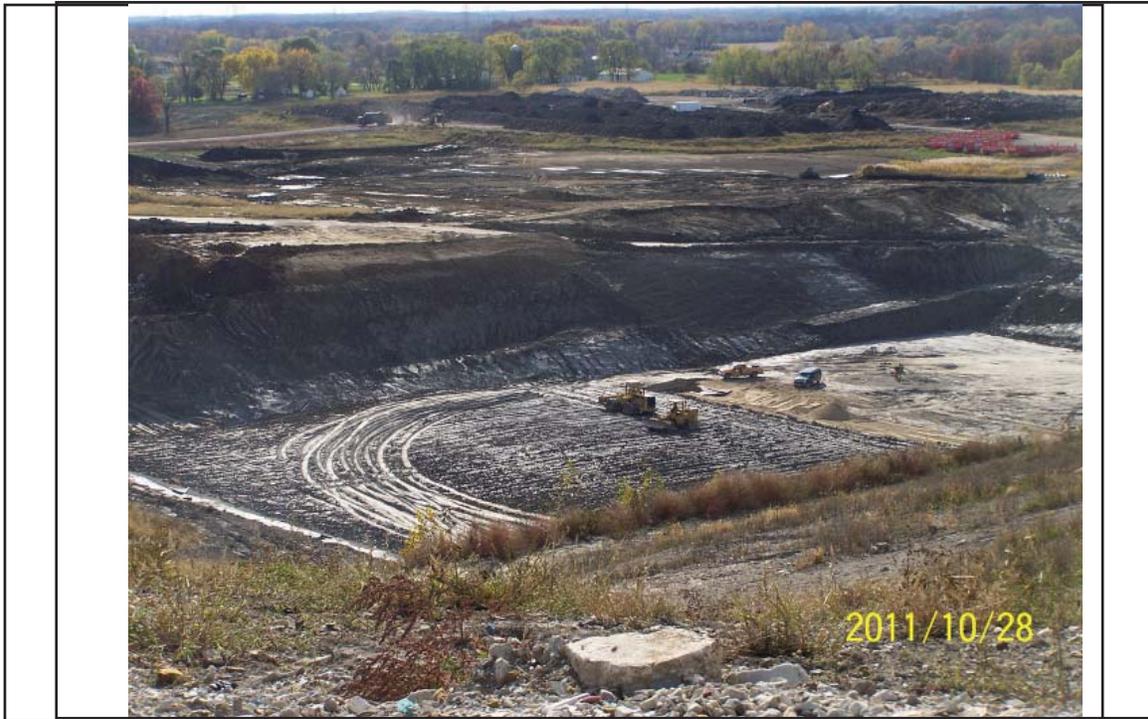
Phase 6/7 junction unexcavated.

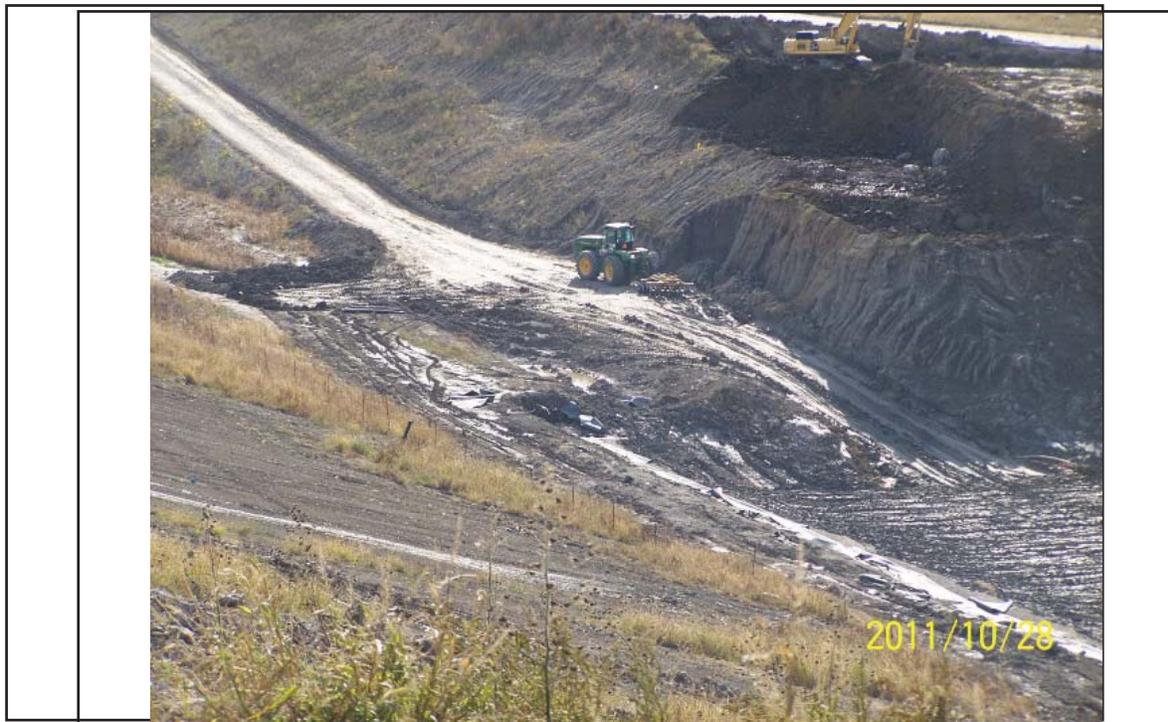
Access road to excavation along Phase 6

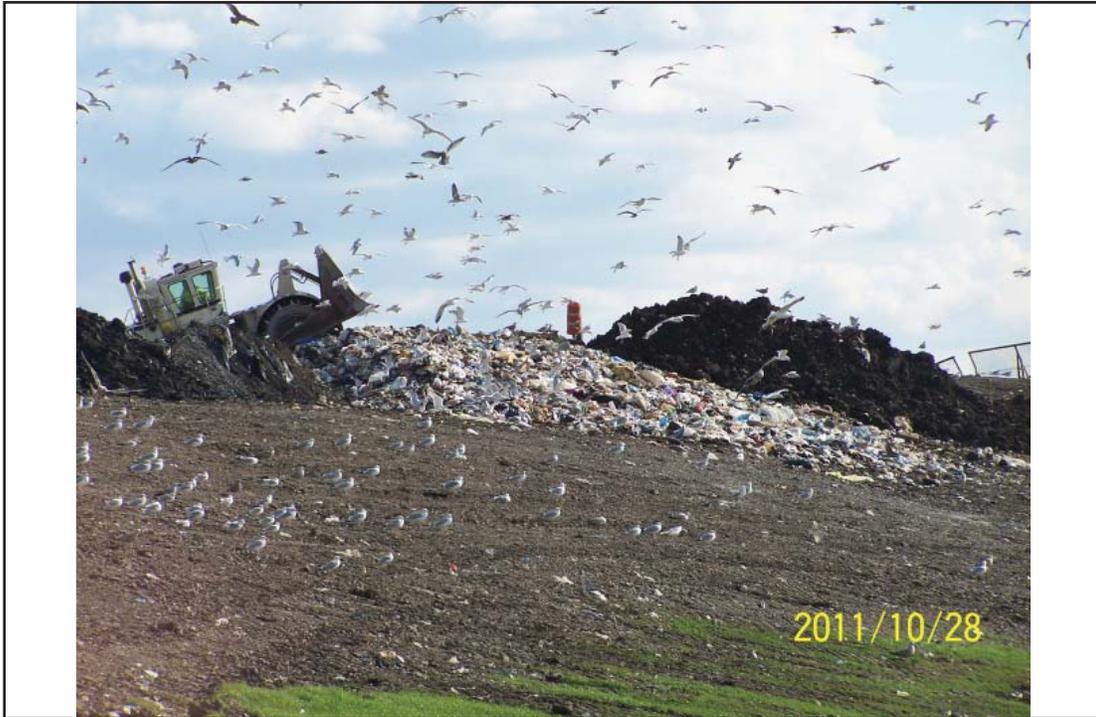
Working face, on slope

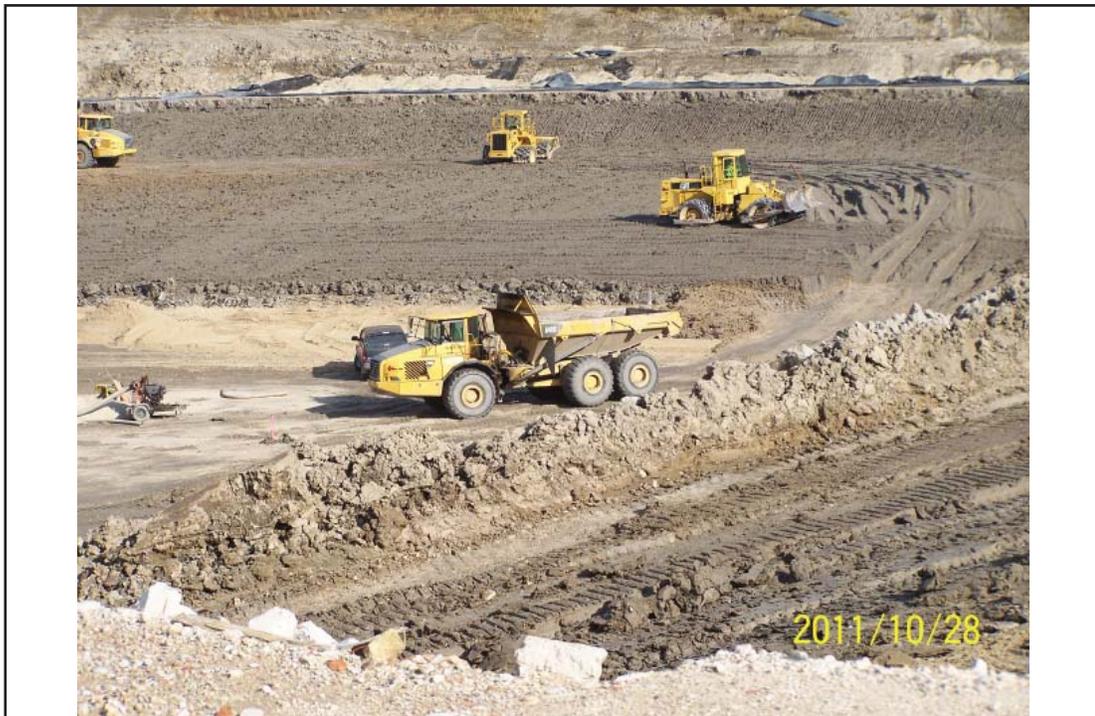
Flipping clay to cover sand layer

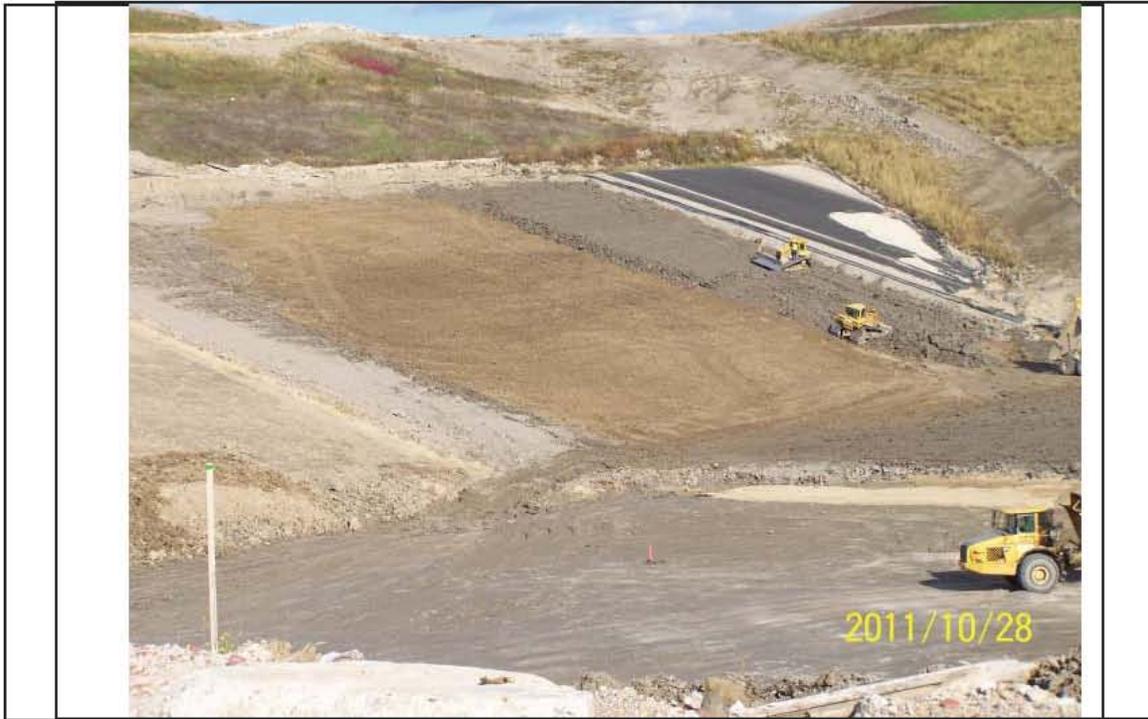
Flipping clay from excavation to cover sand layer

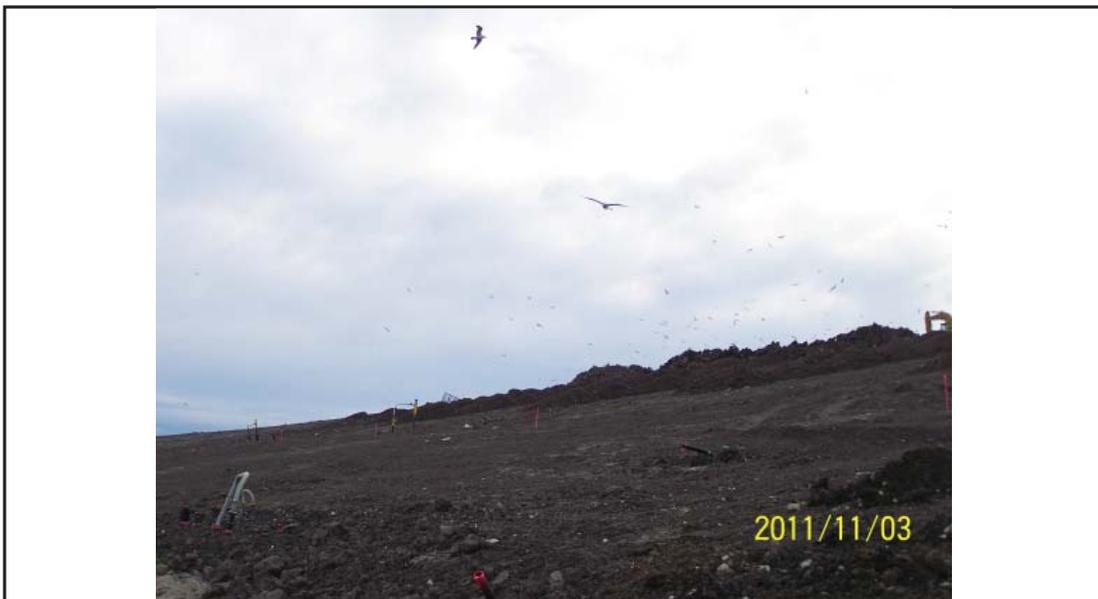
Closure Area III, topsoil stockpiled for spreading on slope

- Construction slowed due to weather
- Construction Audit:
 - Activities reduced due to wet conditions
 - Closure Area III waiting for topsoil, clay too slick for placement after rains

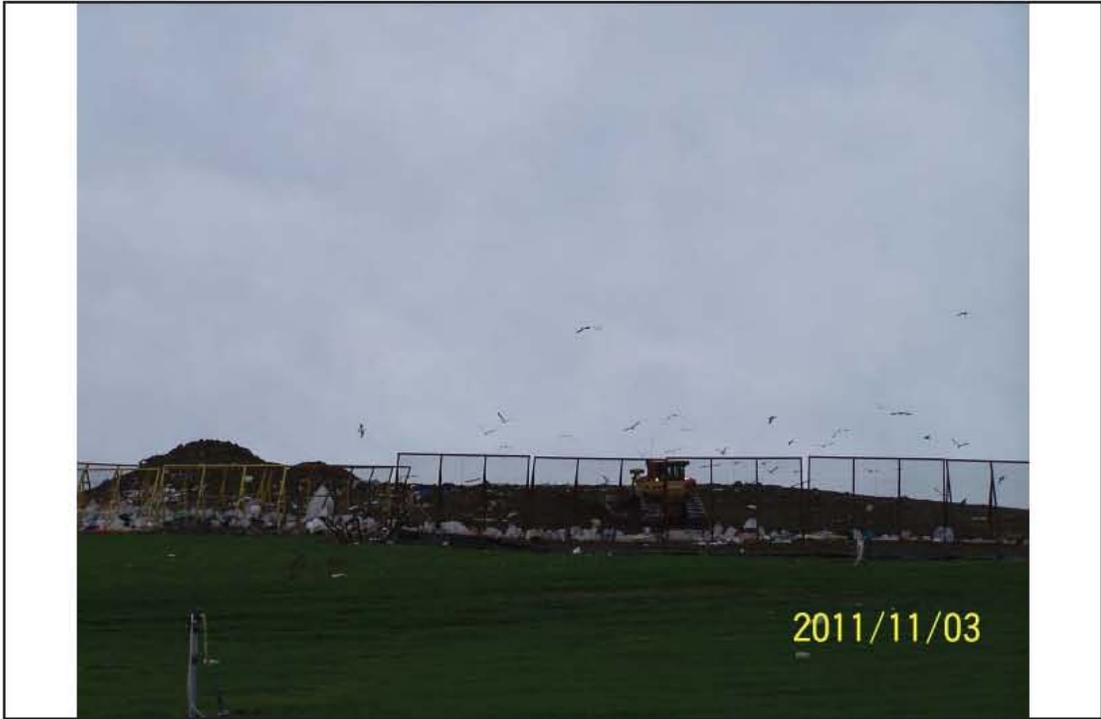
South slope of Phase 5

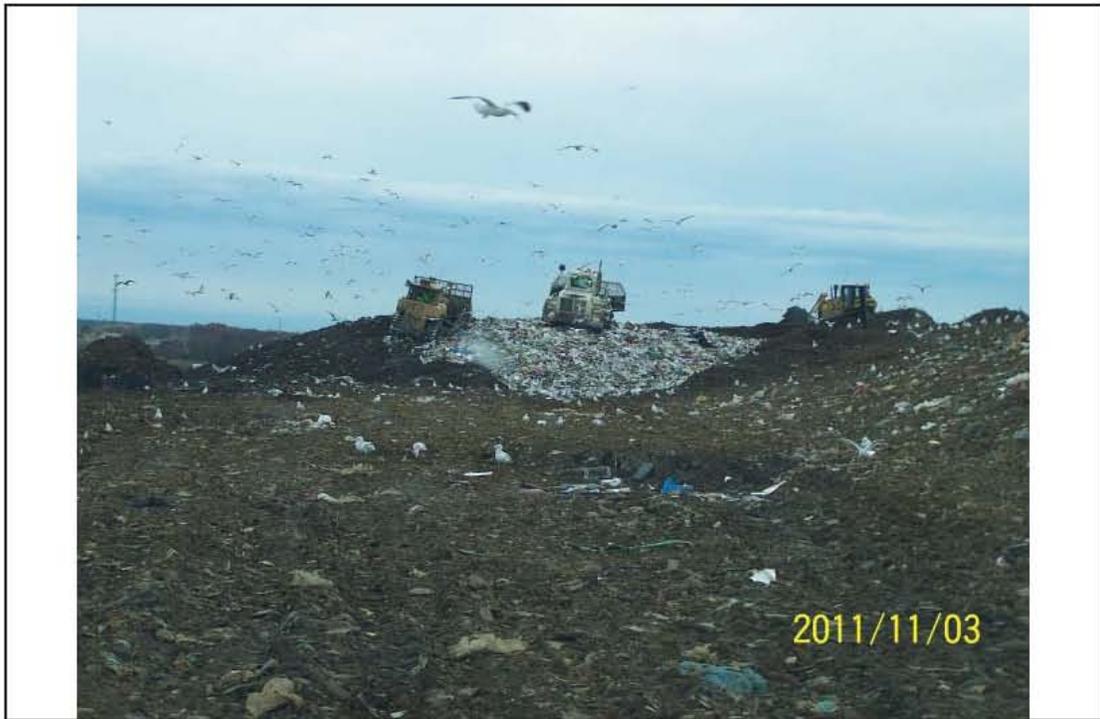
Working face at South end of Active Area

- Working face at south end of Phase 5 between slopes, very tiny and tight
 - Phase 3 receiving landfill direct soils
 - Previous cover in good shape
 - Daily cover in excellent condition

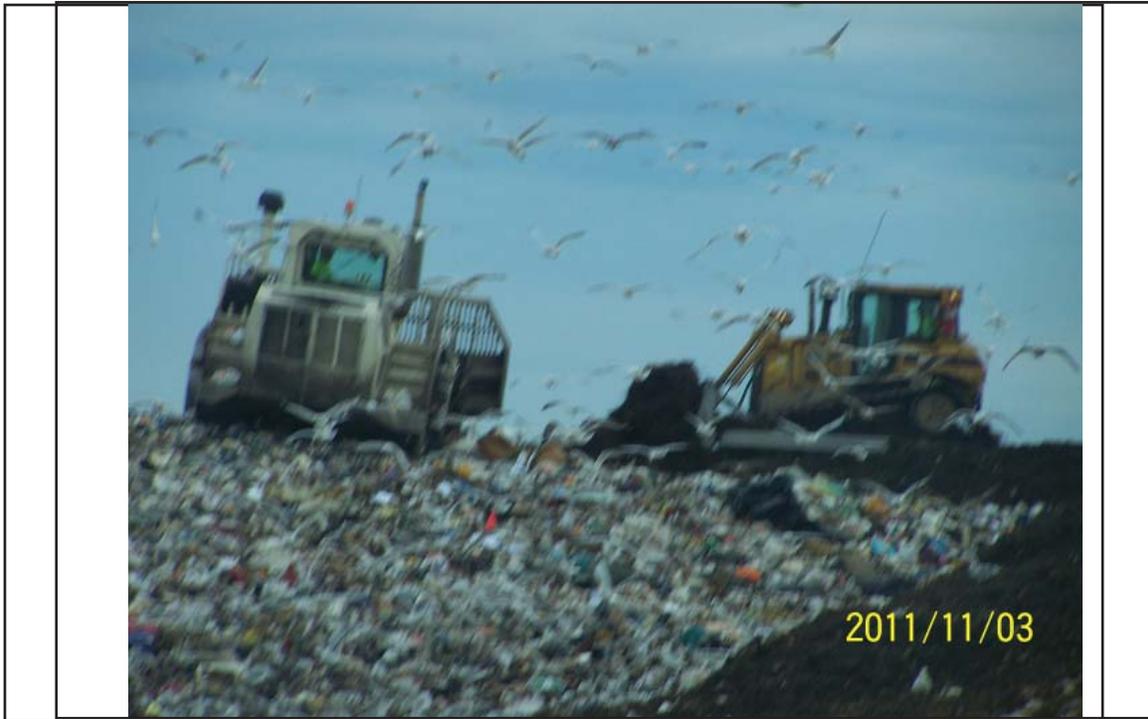
Working face

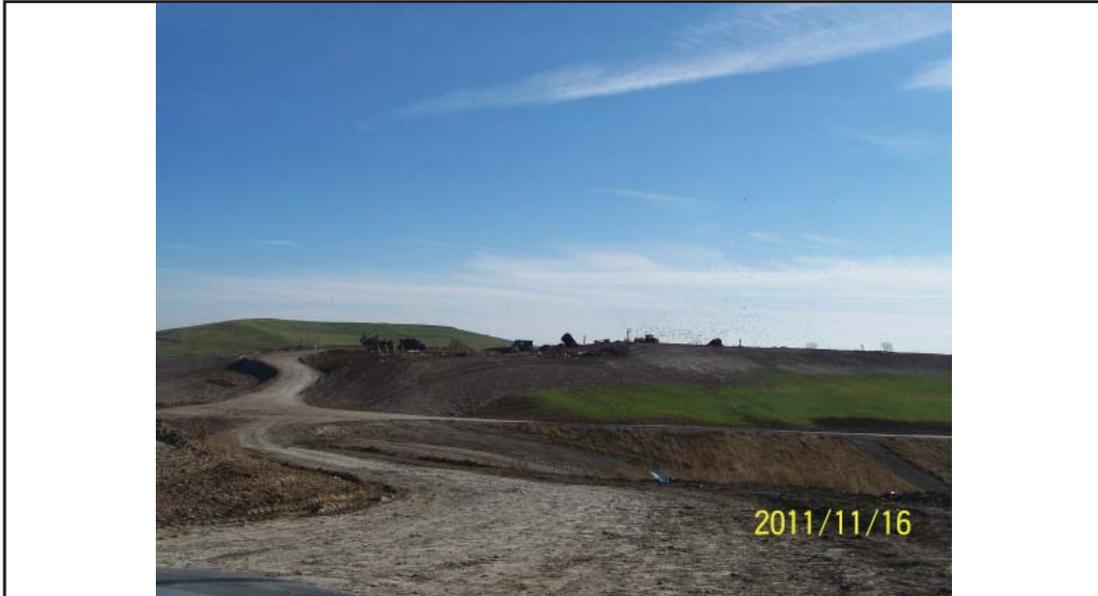
Active area, new road under construction

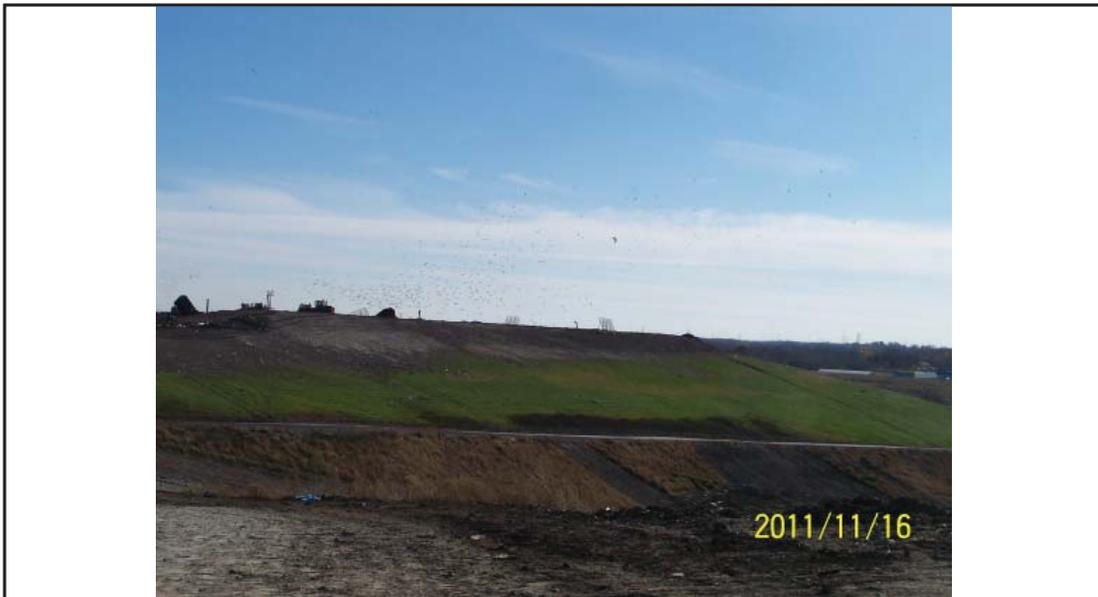
Active area and South slope

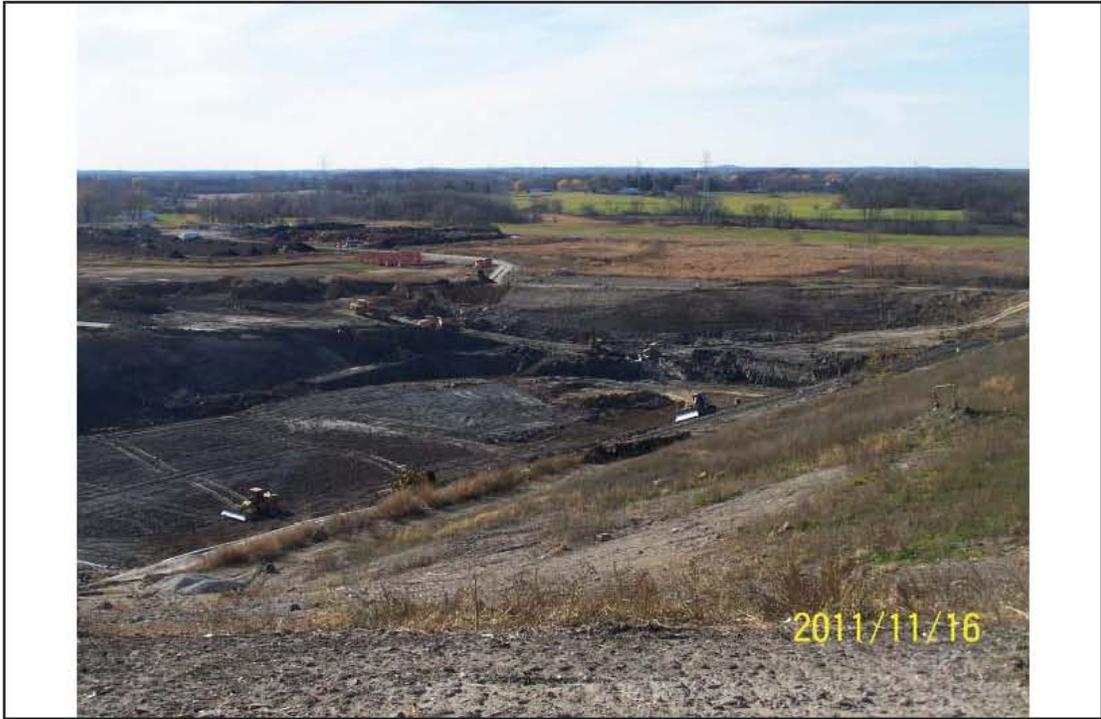
Excavation area, with ongoing clay liner construction

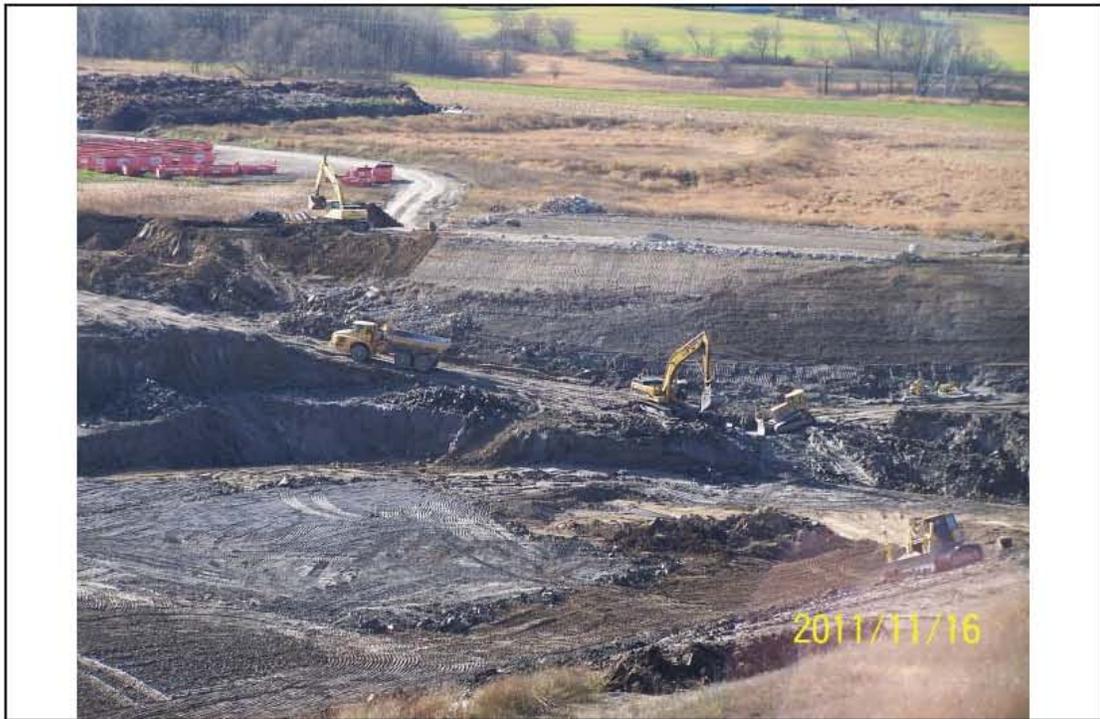
Western edge of excavation
