Veolia Emerald Park Landfill
City of Muskego

2011 Veolia Emerald Park Landfill Year End Compliance Officer Report and Audit Summary

TO: Veolia Emerald Park Standing Committee
FROM: Jo-Walter Spear, Jr., P.E.
COPIES: File
DATE: 04/02/2012
PROJECT NUMBER: 1012.10030

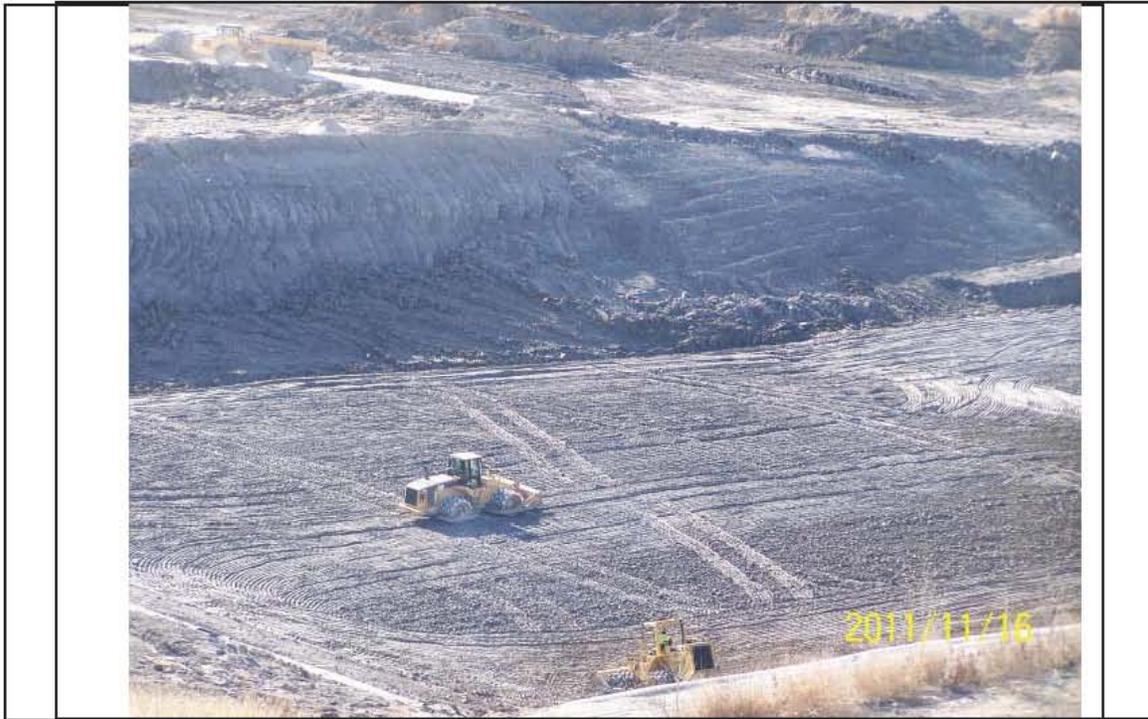
Clay being worked over sand layer

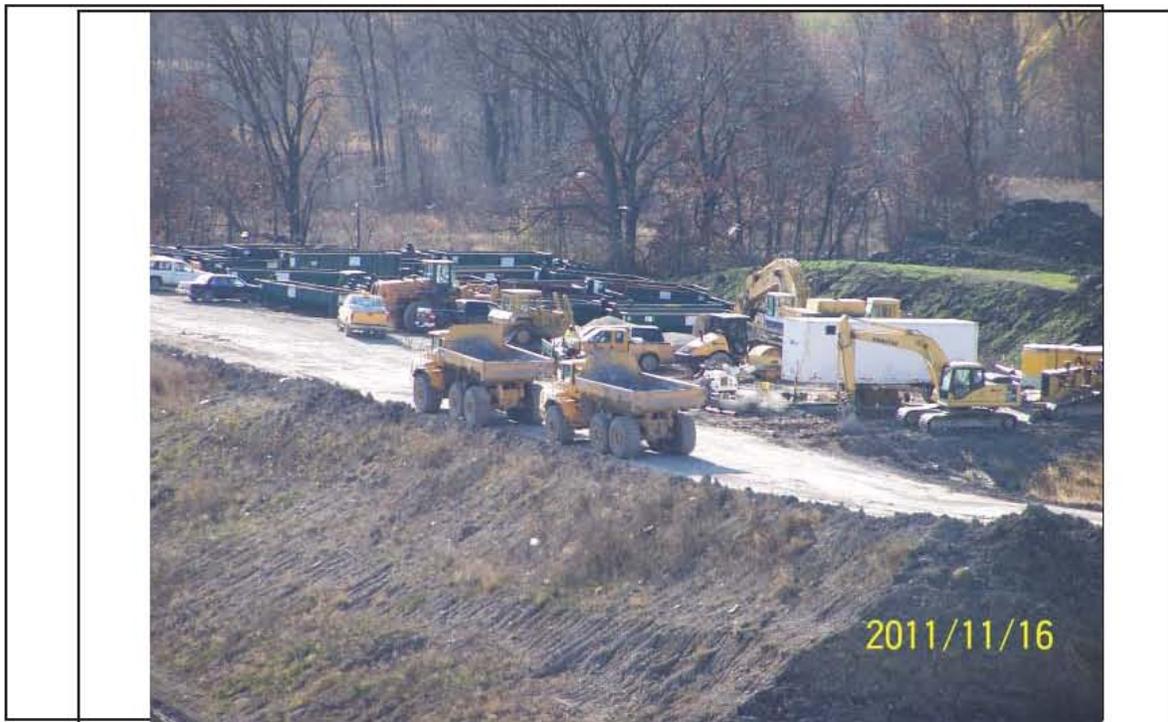
Haul trucks moving clay to Closure Area III, South slope of Phase 5

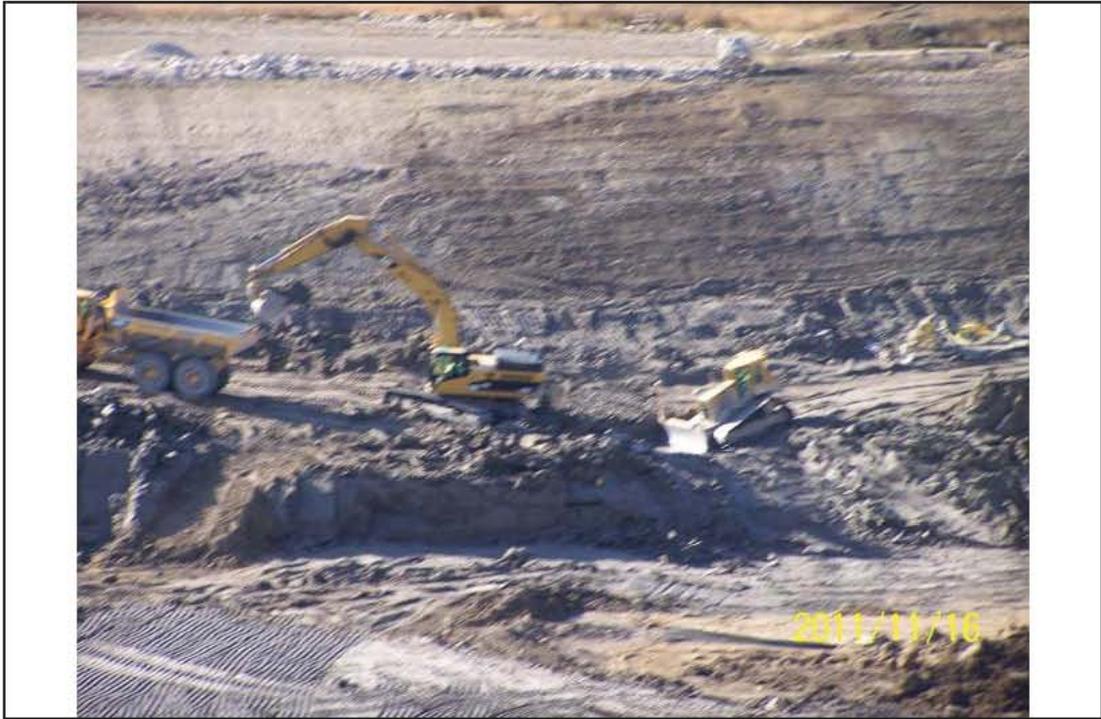
Excavation at Western edge of Phase 7

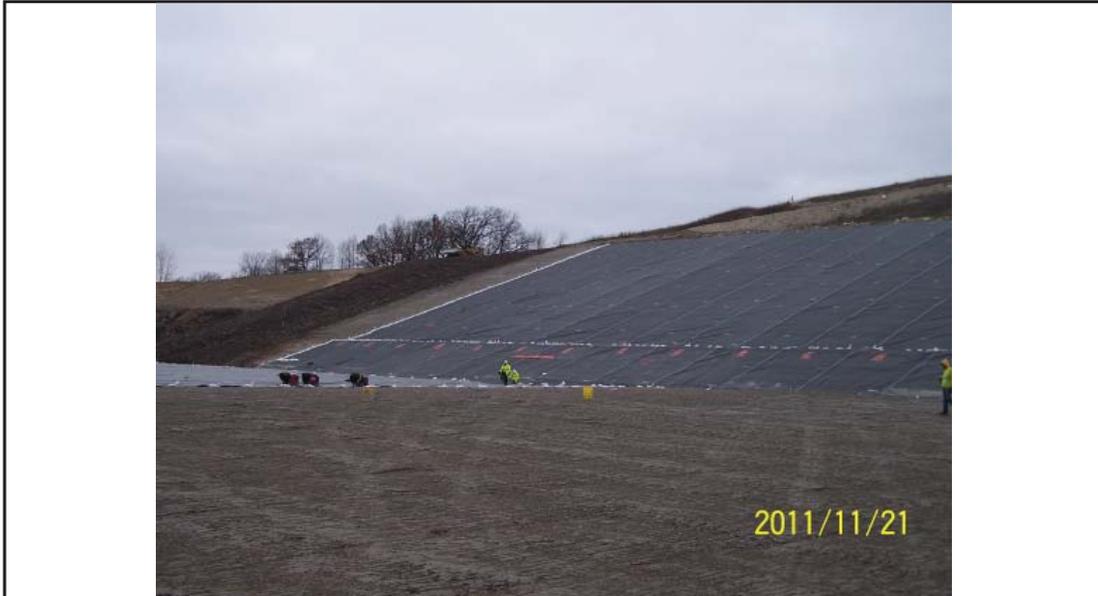
Exposed subgrade at start of Audit.

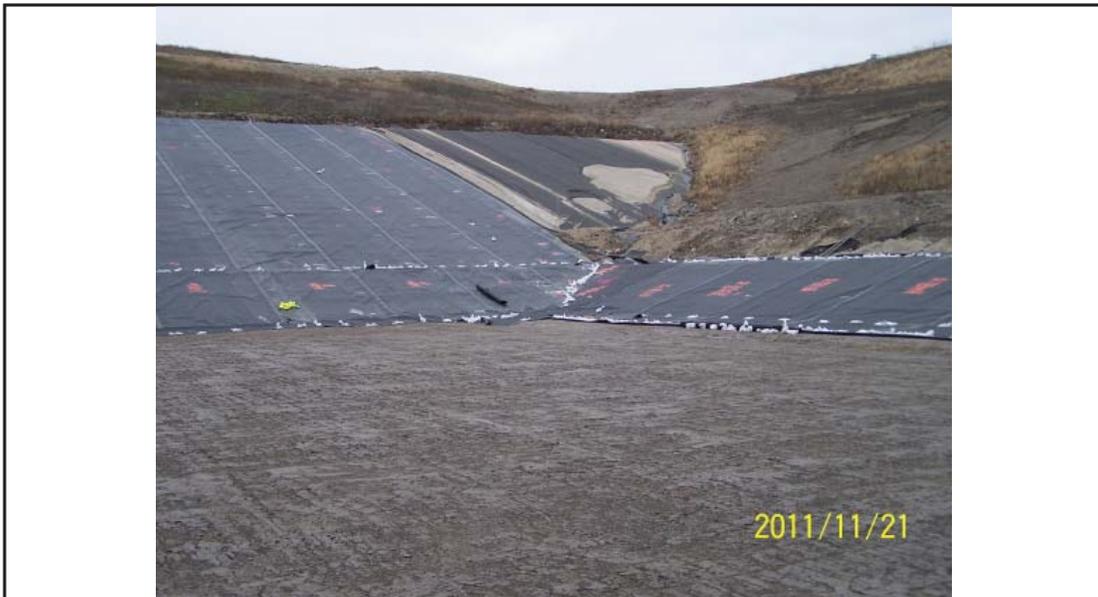
Rough high point of Phase 7 East side to flow to East collection trench.

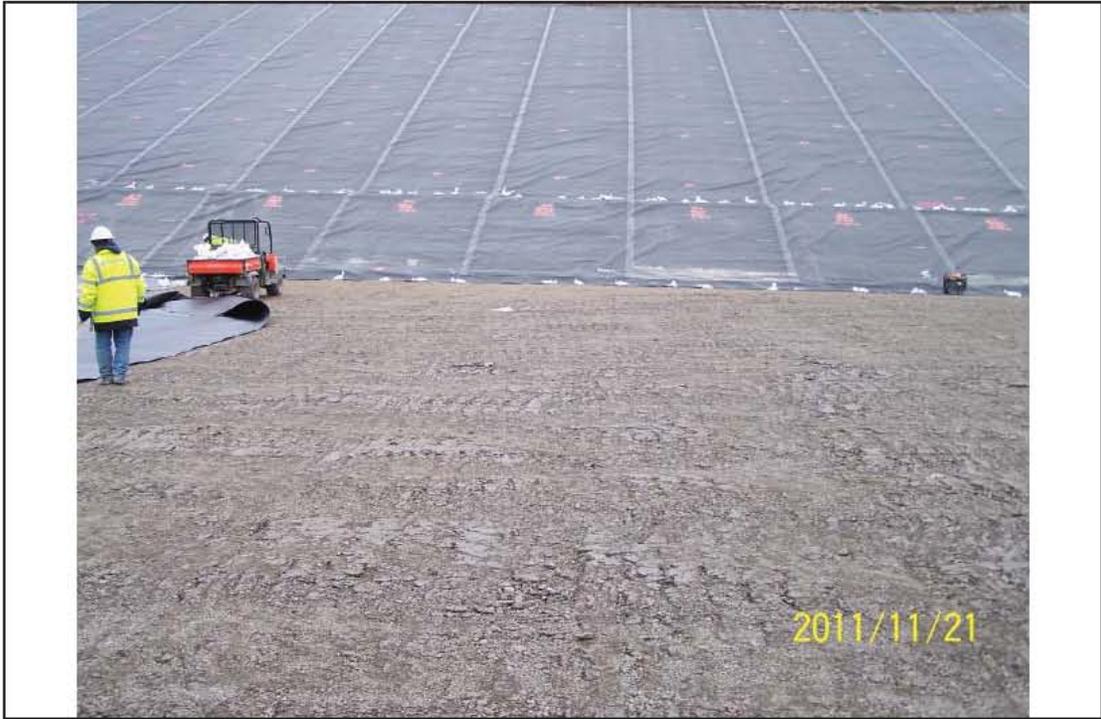
Subgrade of Phase 7

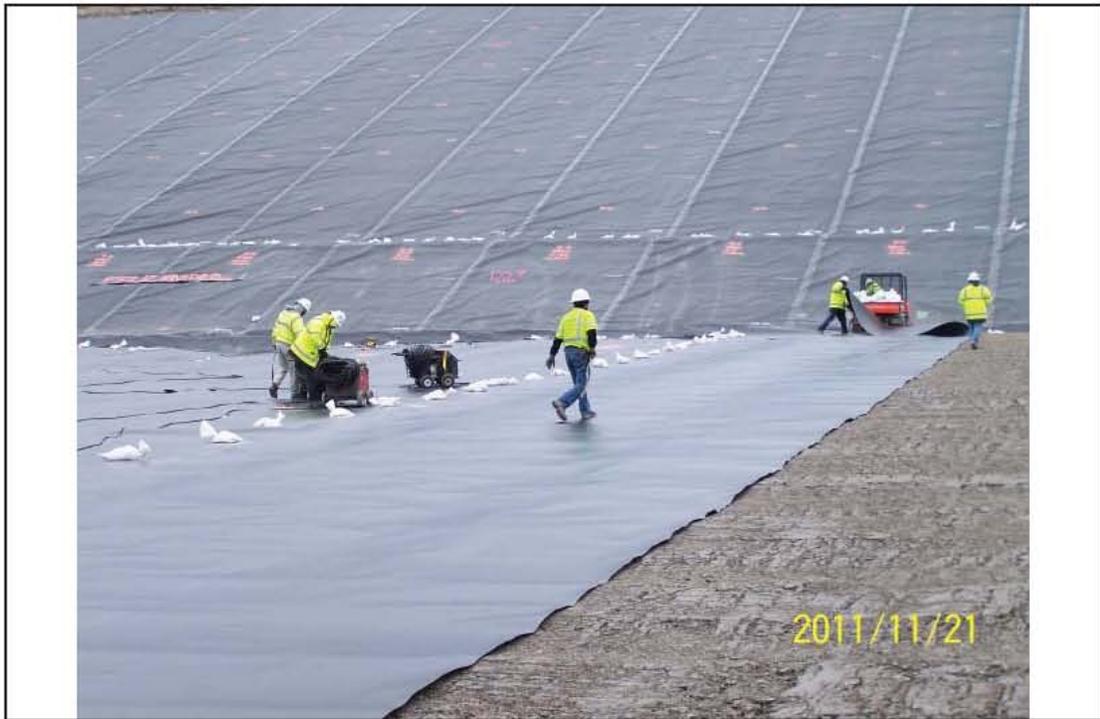
Panel being deployed and prepared for welding

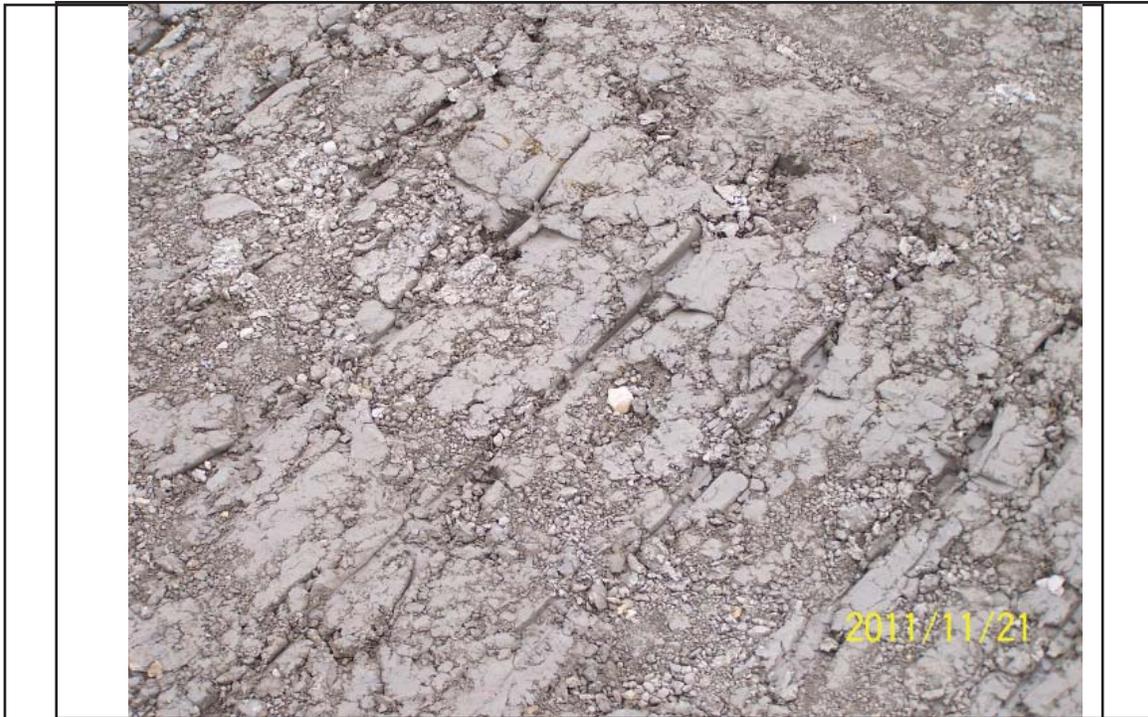
Stone in clay, there are several stones in this photo, but only the center stone shows well.

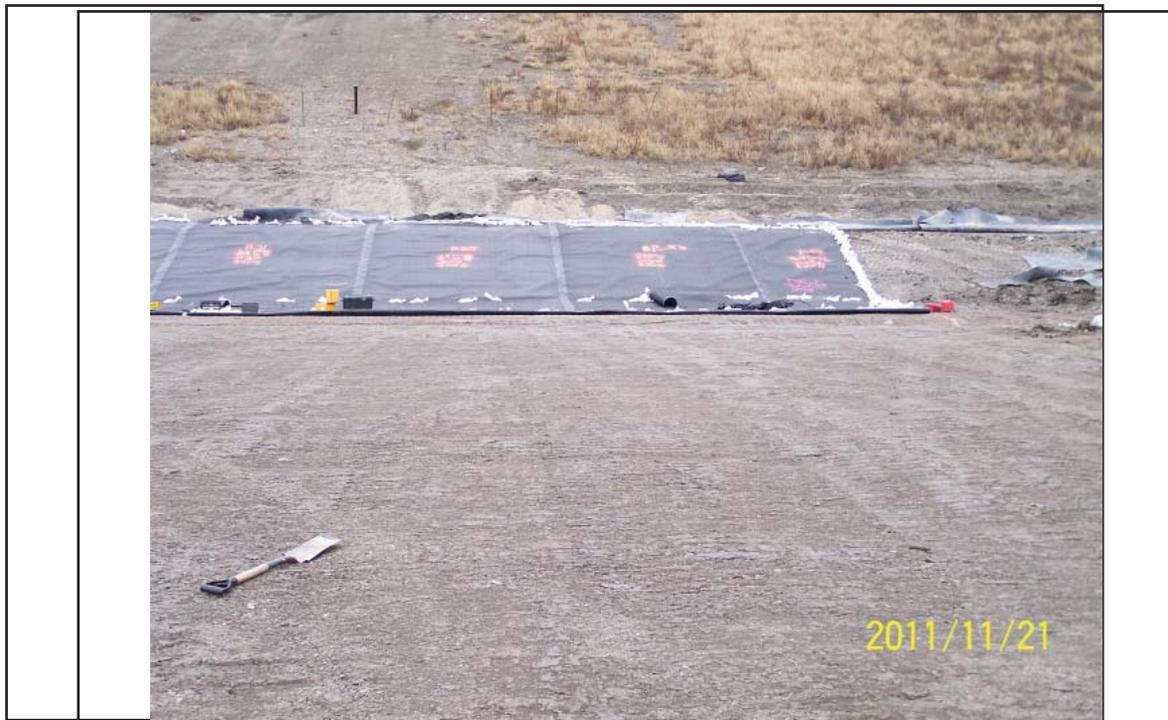
Stone picker removed himself from the picture, no clay or betonite being used to fill holes.

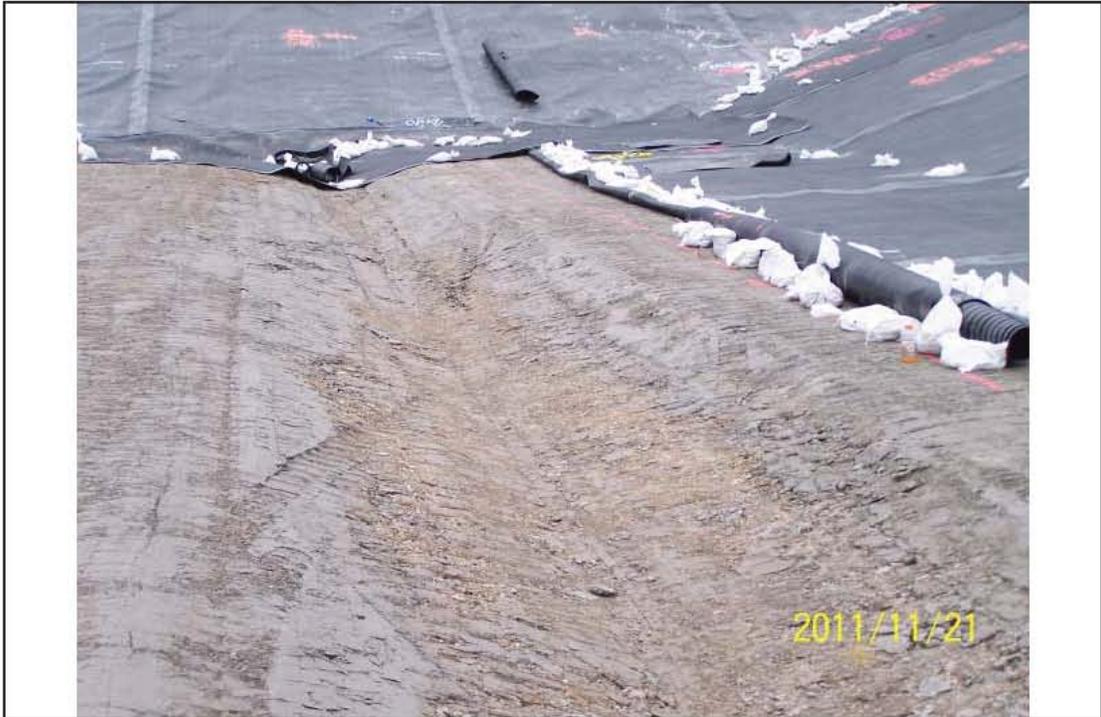
Leachate collection trench, mixed brown and grey clay

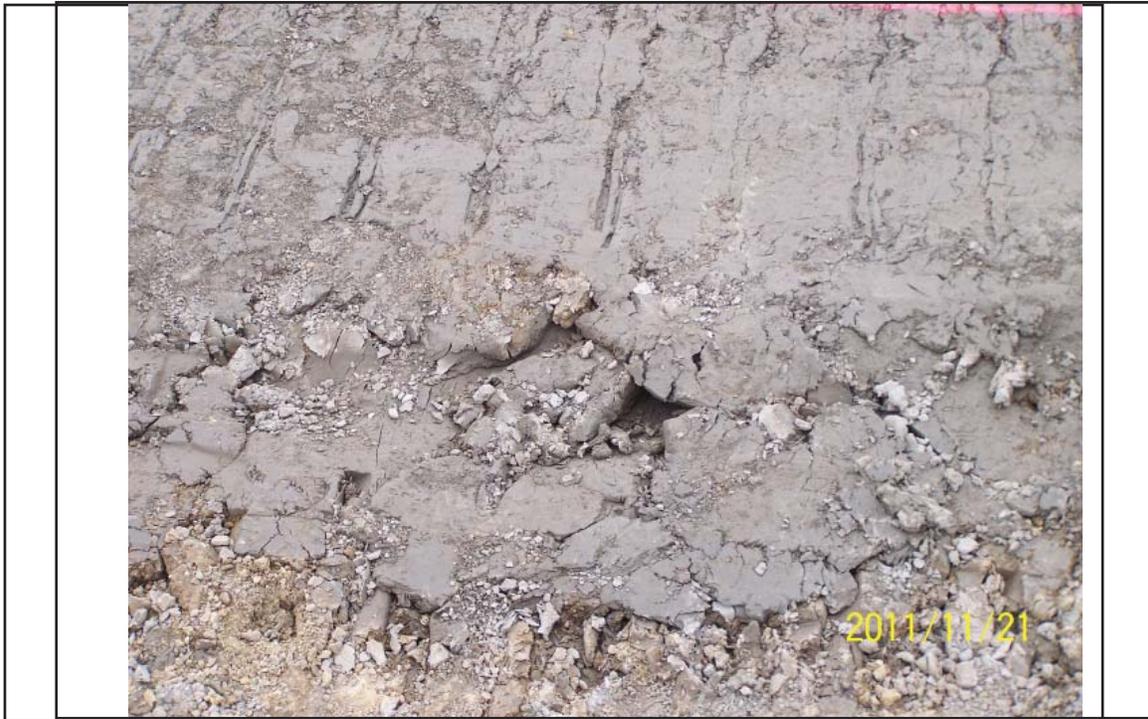
Cleat mark at edge of leachate collection trench. Bulldozer track marks were never rolled

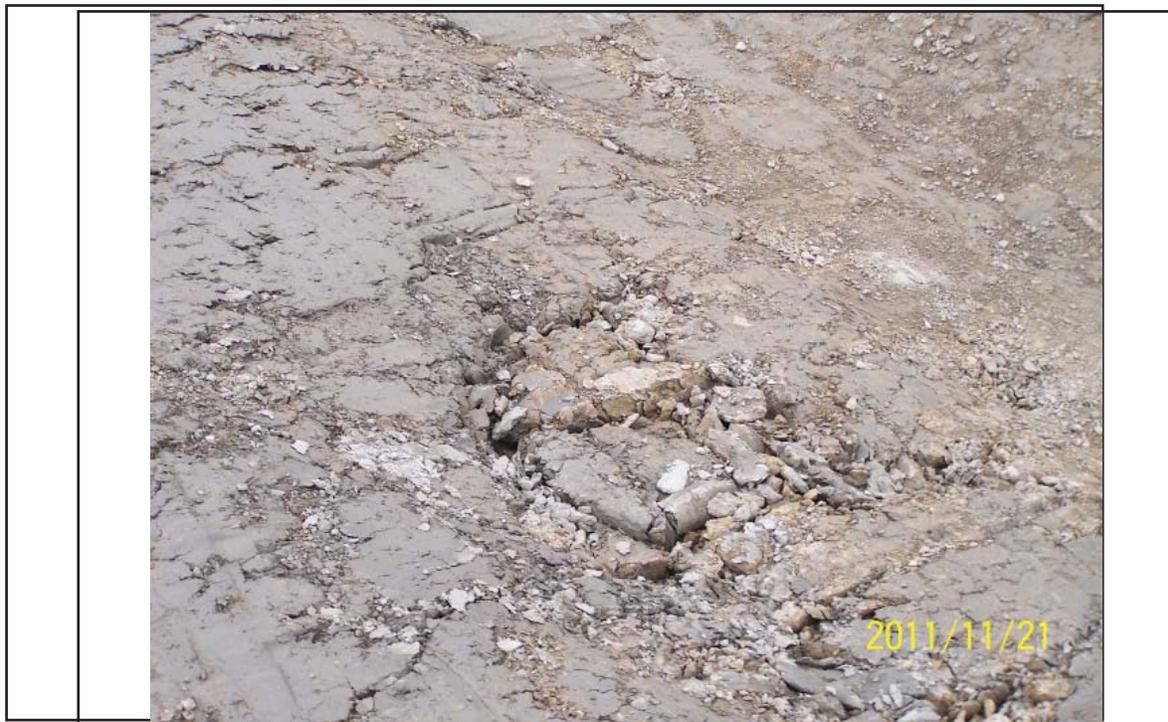
Dry area in the clay

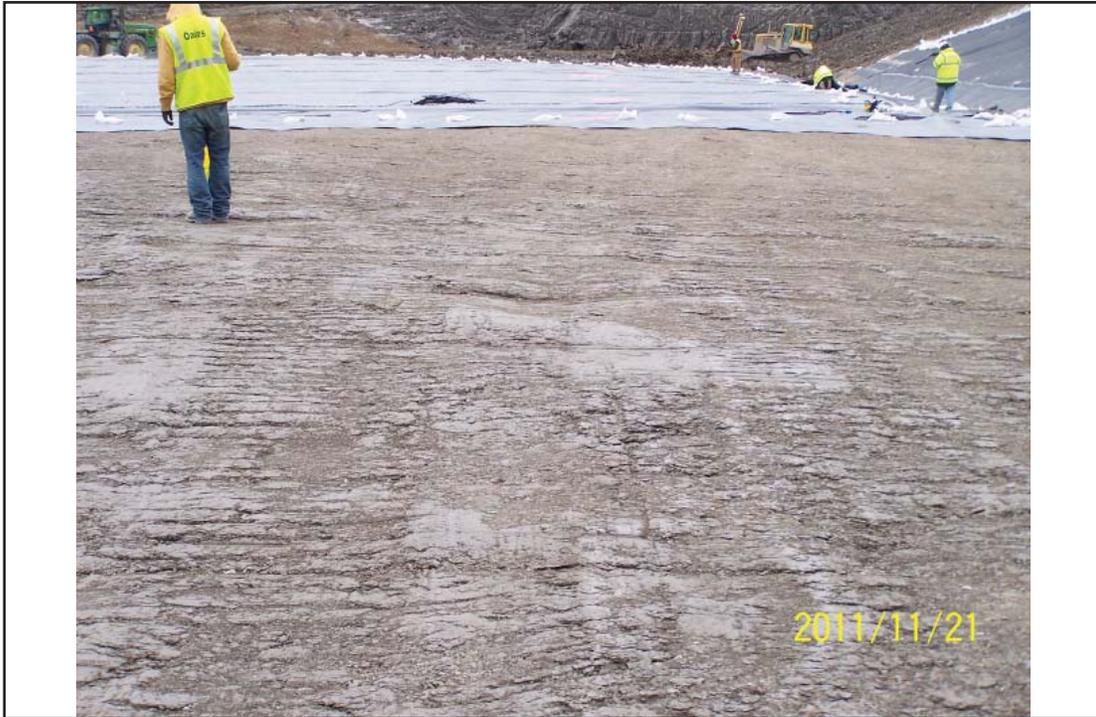
Subgrade undulating with deviations from smooth drum roller edge

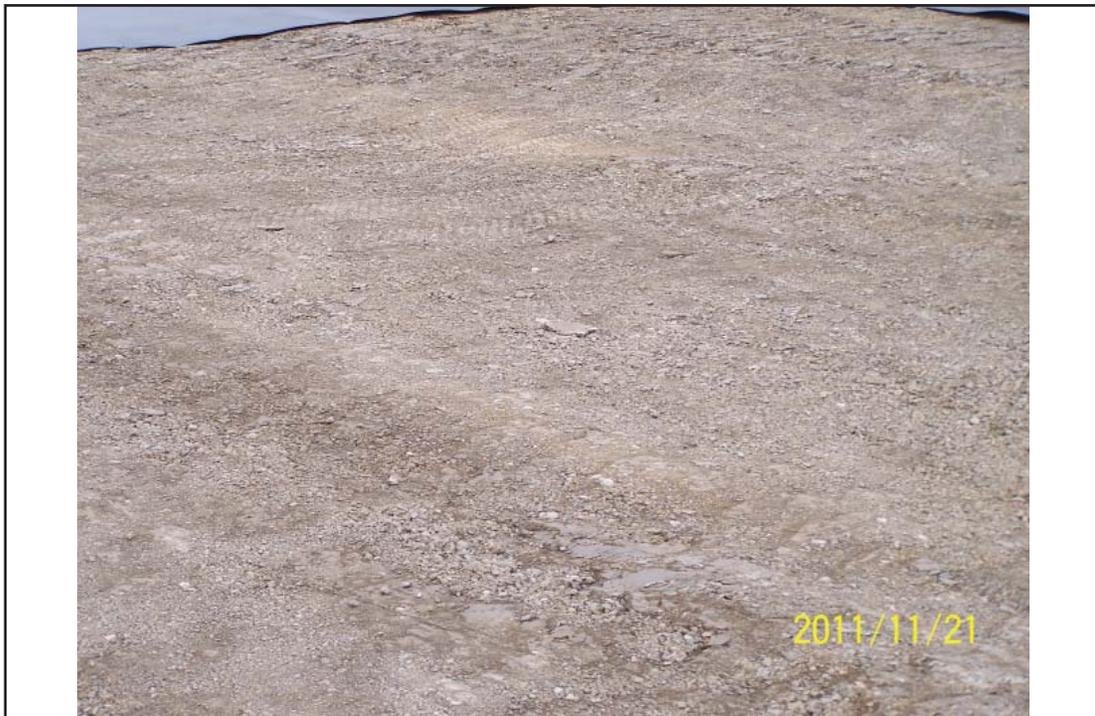
Roughly Northwest corner of subgrade, clay in small balls rather than flat, very dry.

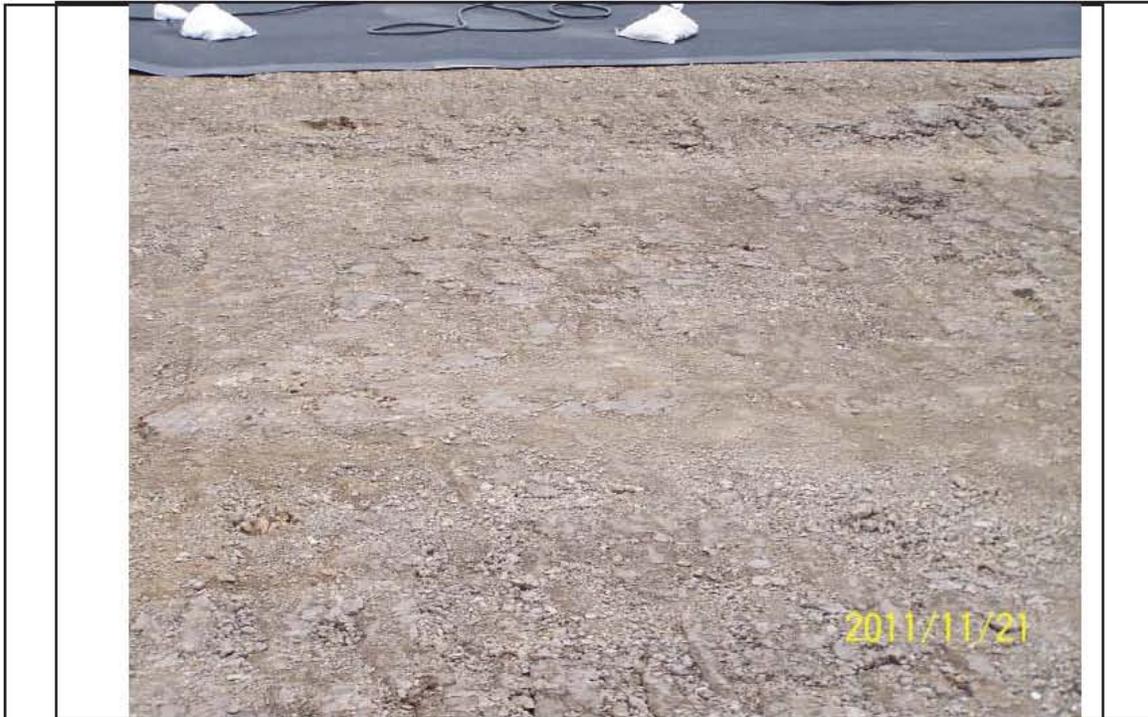
Subgrade clay, appears dry and clumped

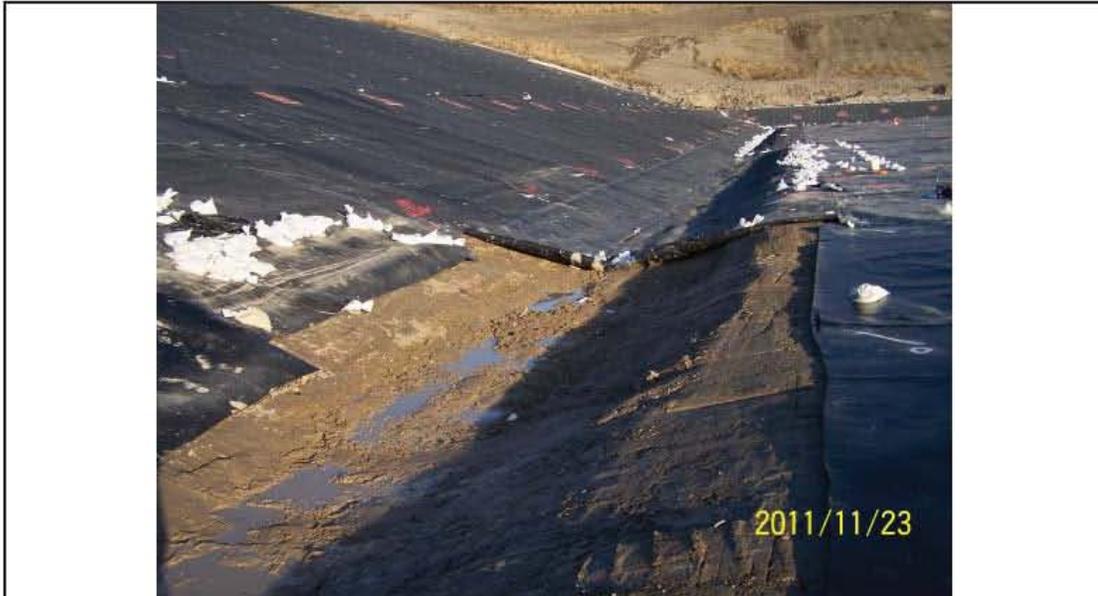
Clay drying before liner placement

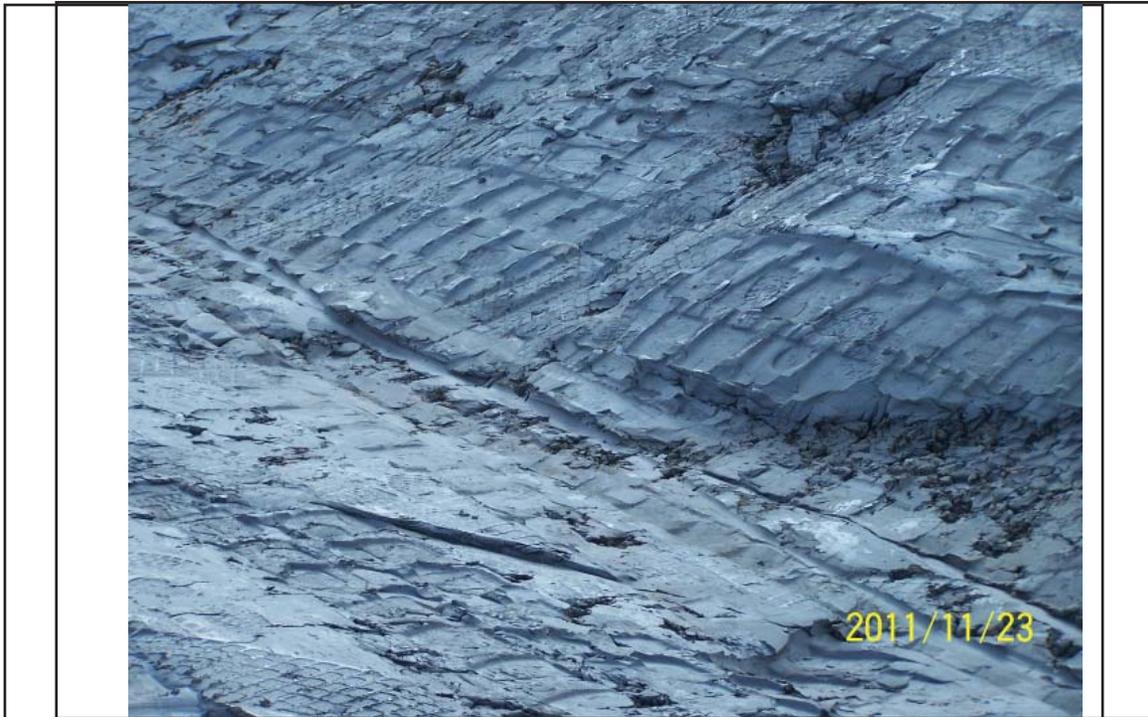
Clay not ready for liner placement

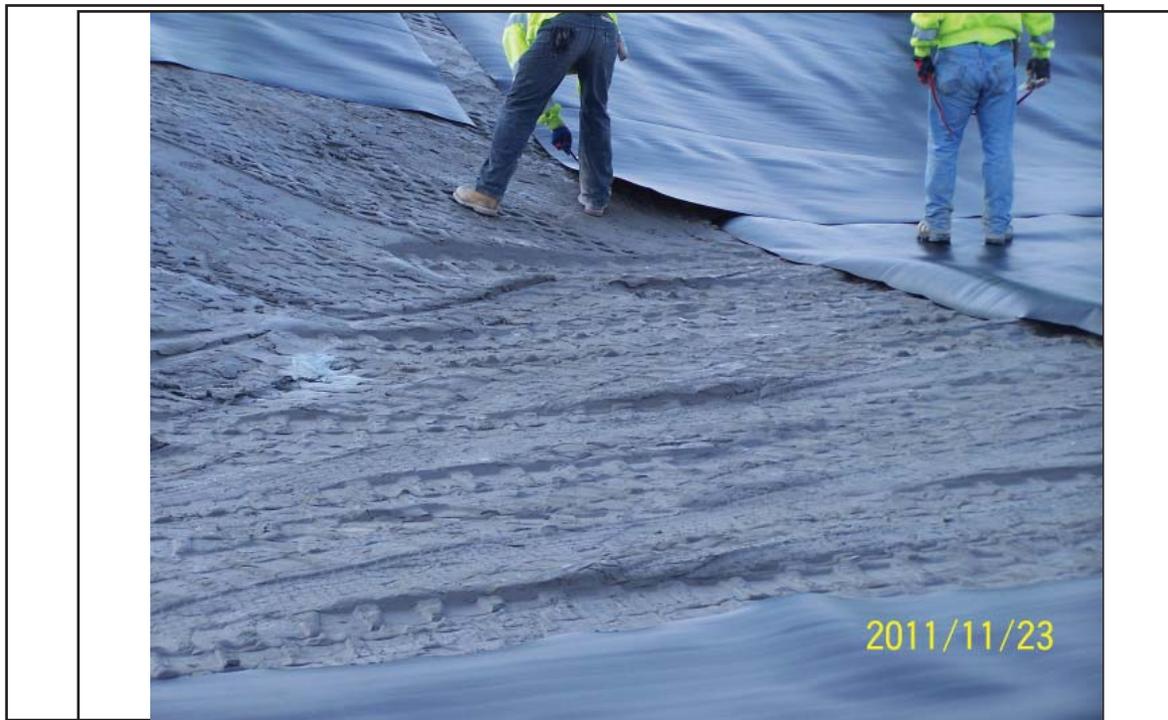
Final placement about the West ed of liner. Clay appears very plastic

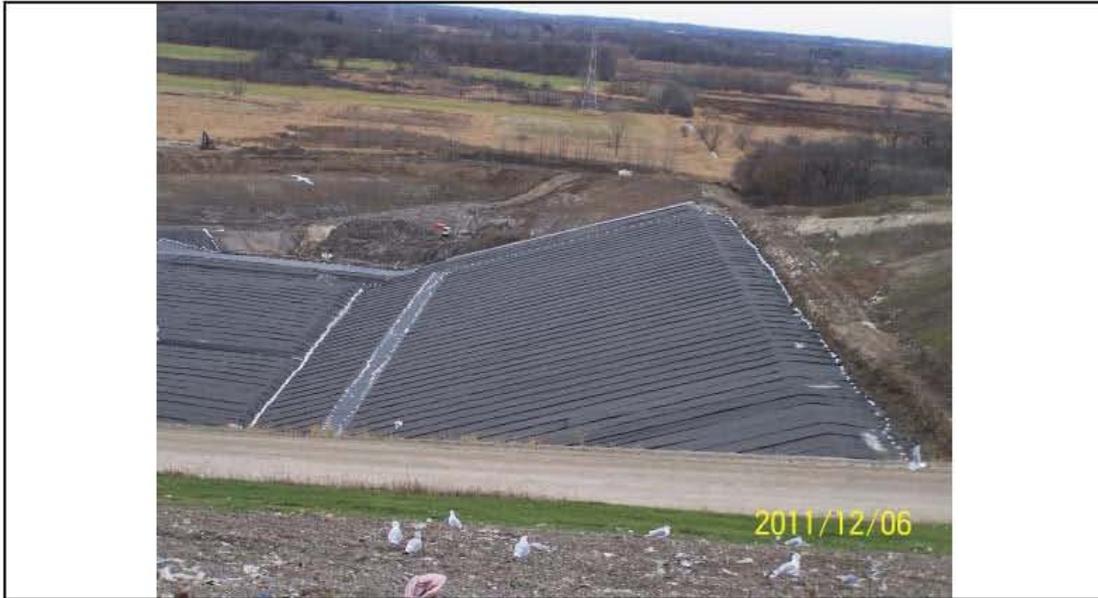
Complete liner and geotextile on side slope

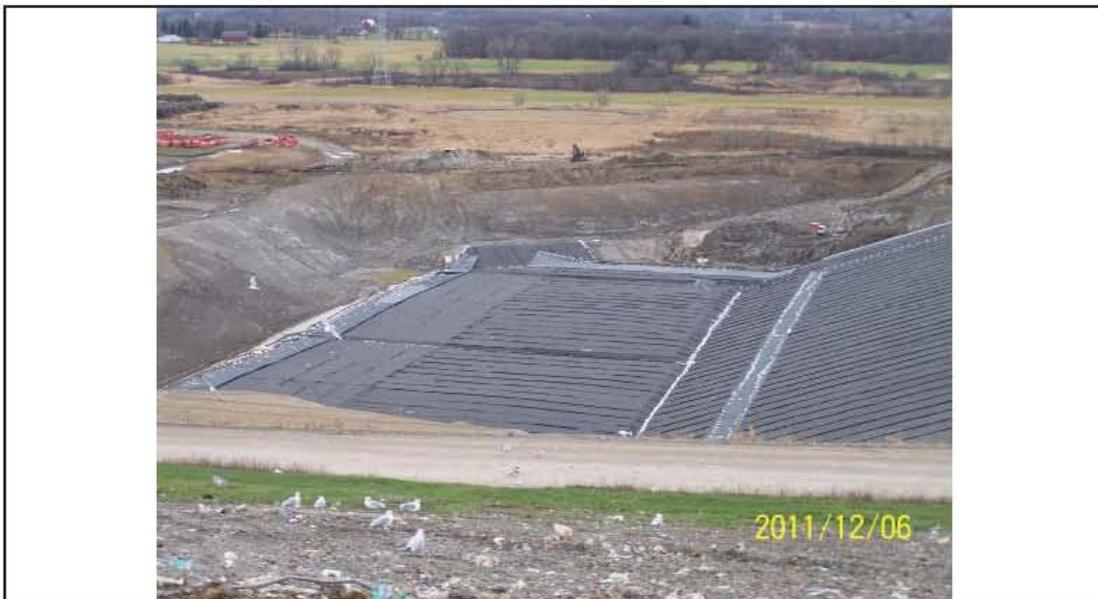
Complete liner and geotextile at base

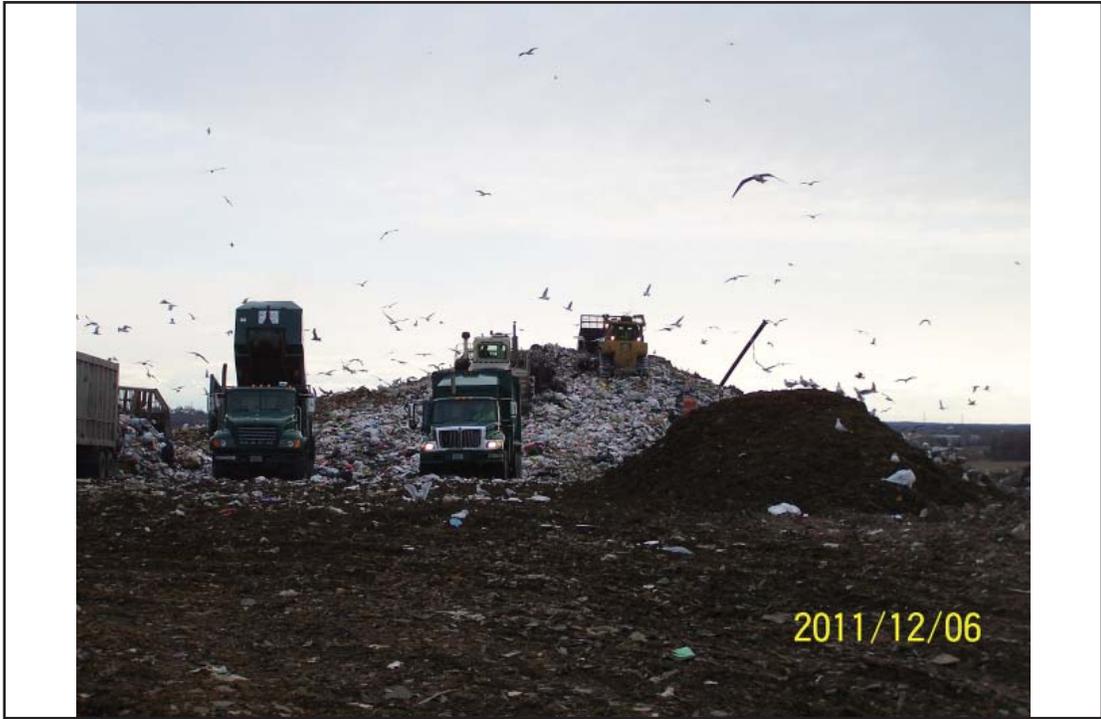
Working face

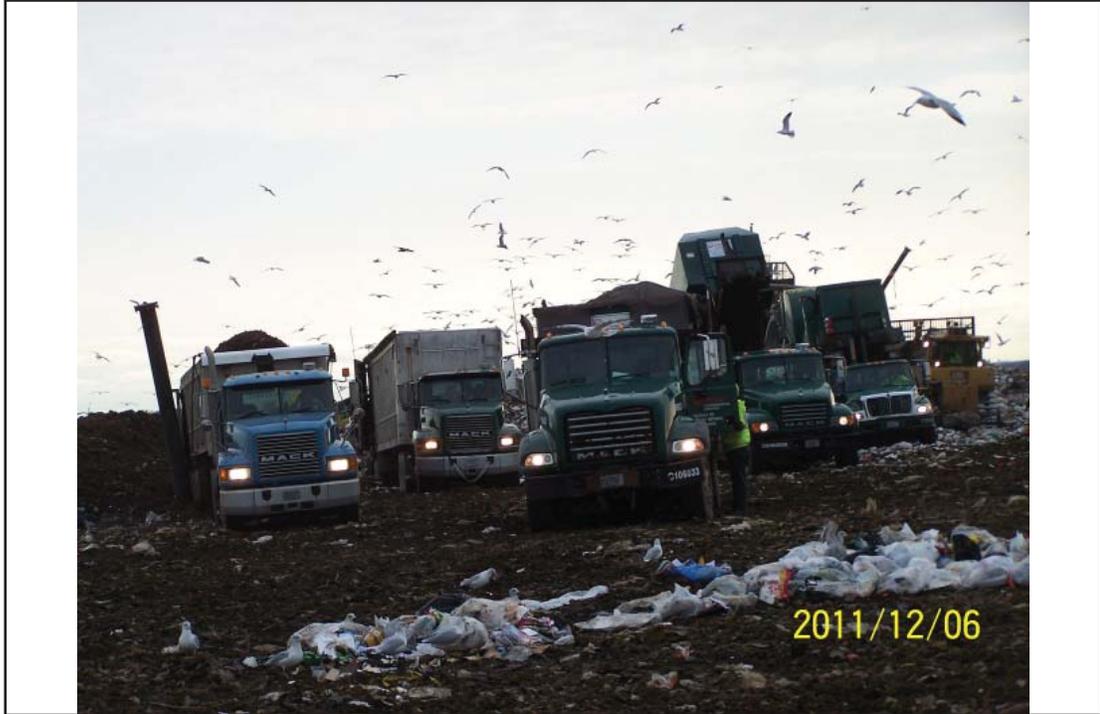
Active area very small and tight on Phase 5

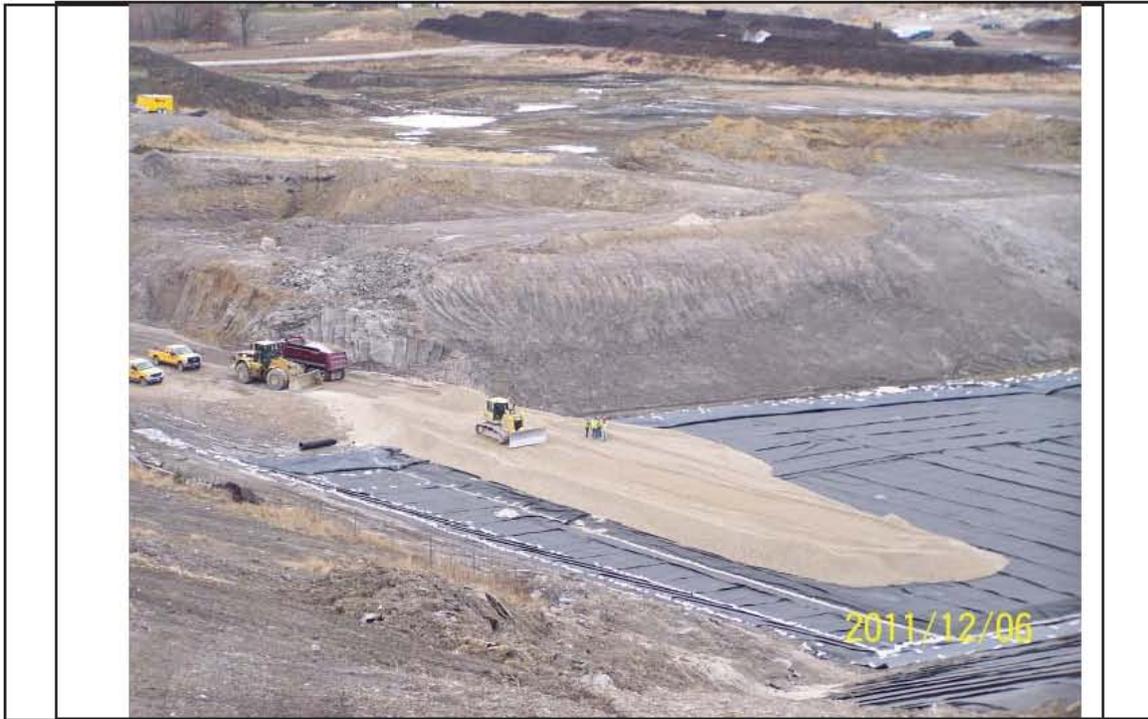
Beginnings of drainage layer placement

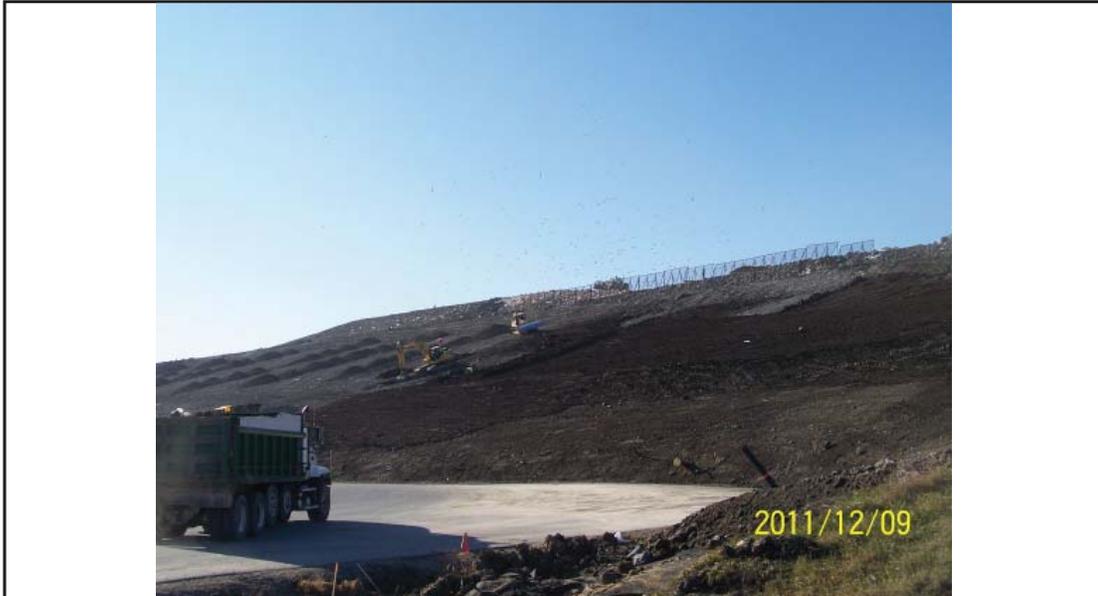
Closure Area III, Phase 5 West slope, top soil being spread out over clay cap

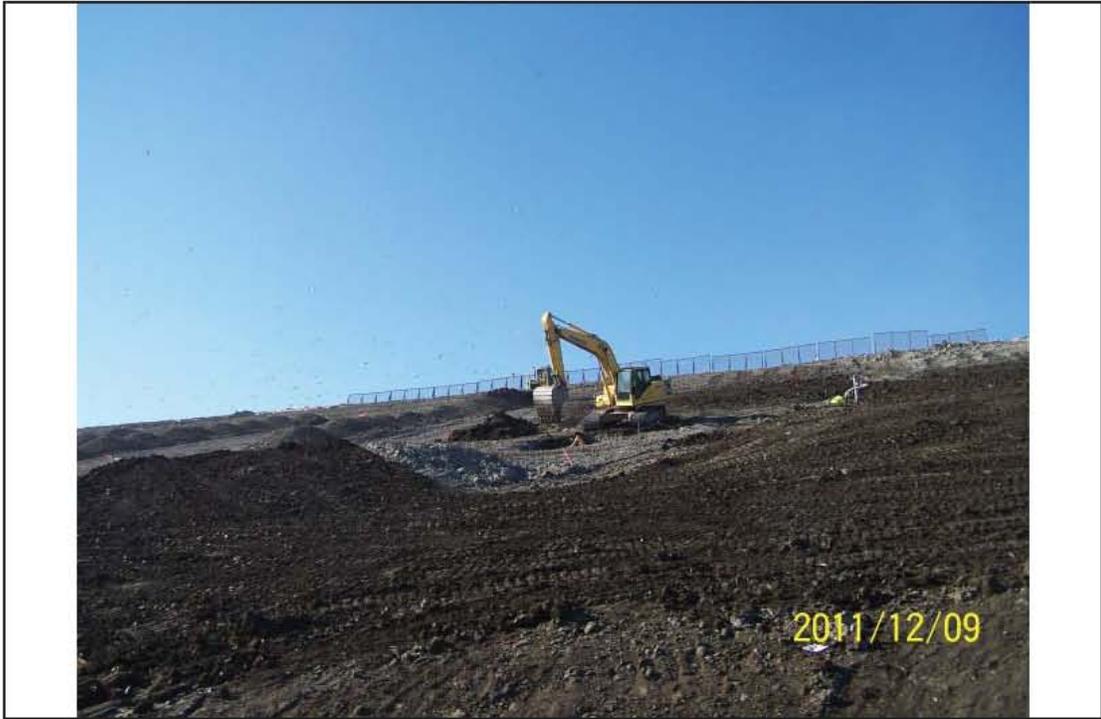
Working face, centered right about future injection well.

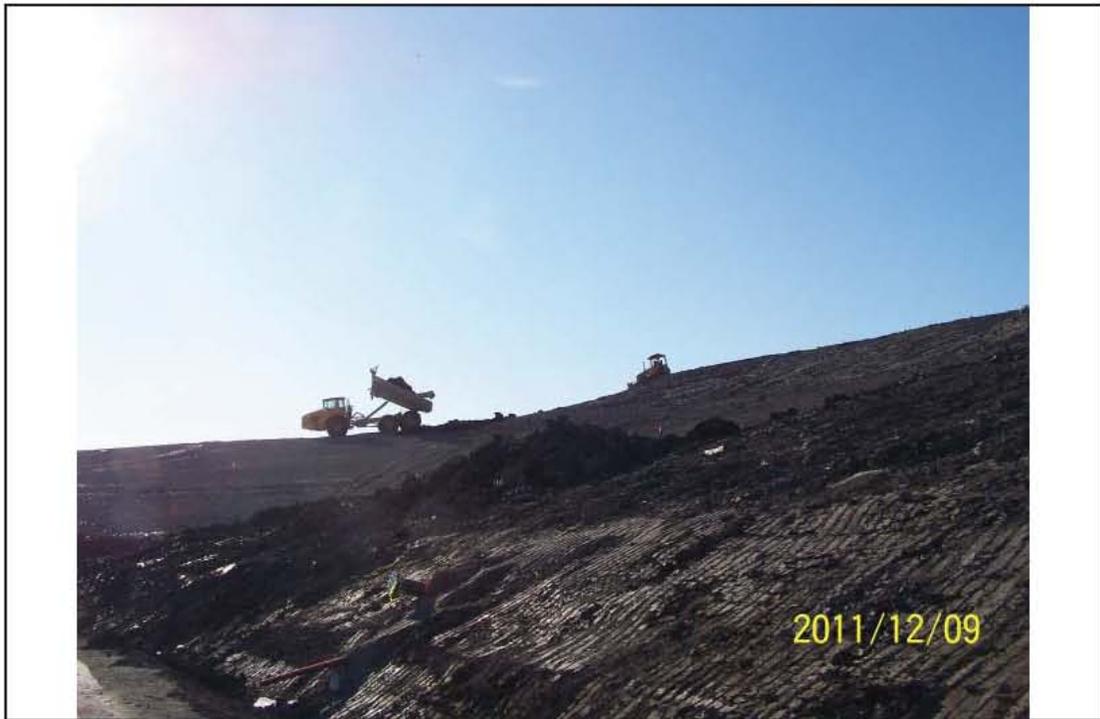
Geotextile deployment in Phase 7

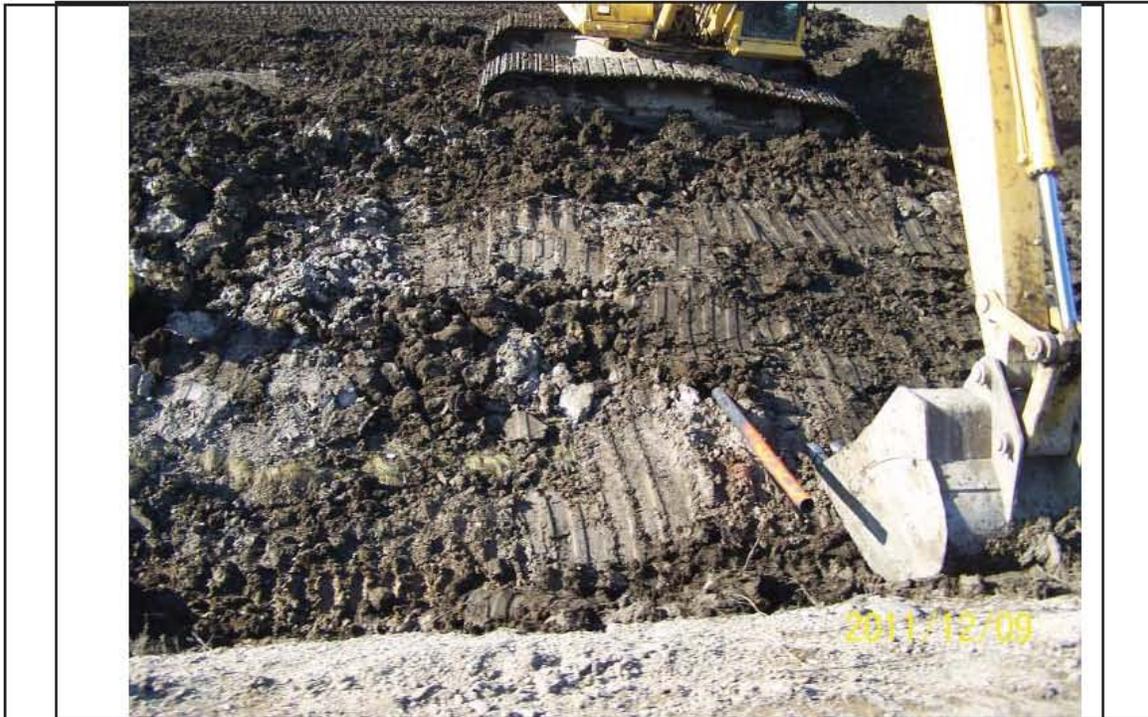
Phase 6 liner exposed for connection to Phase 7 along slope

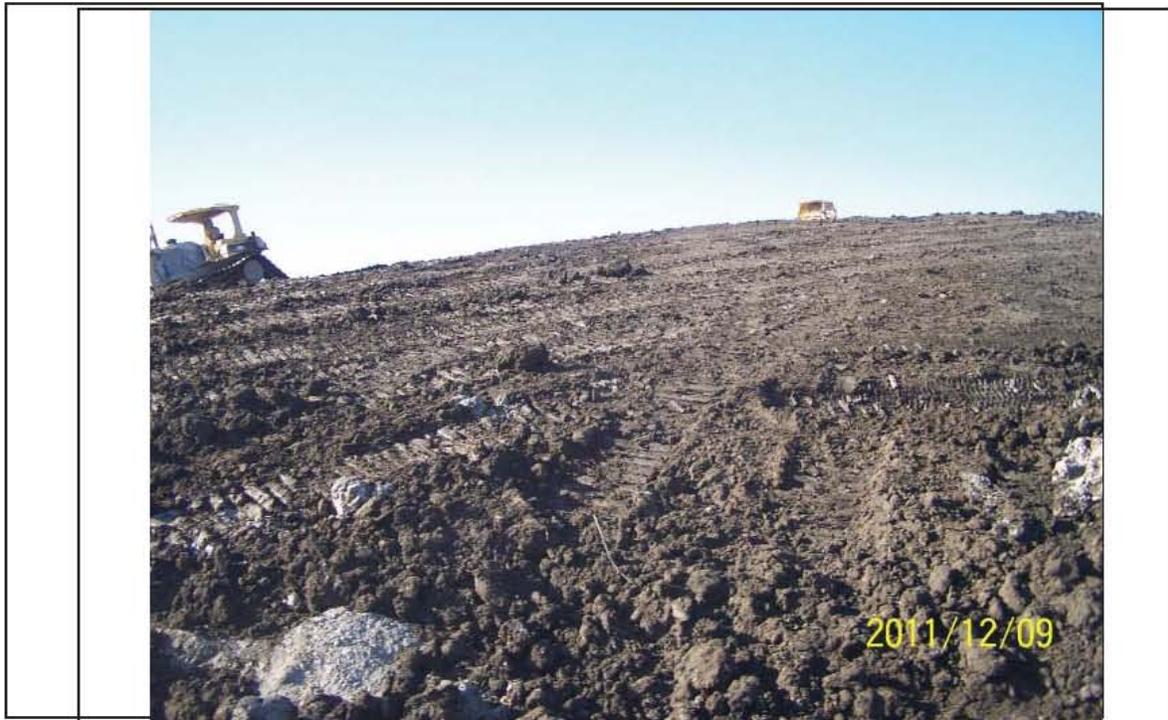
Exposed connection to Phase 3/4 at top

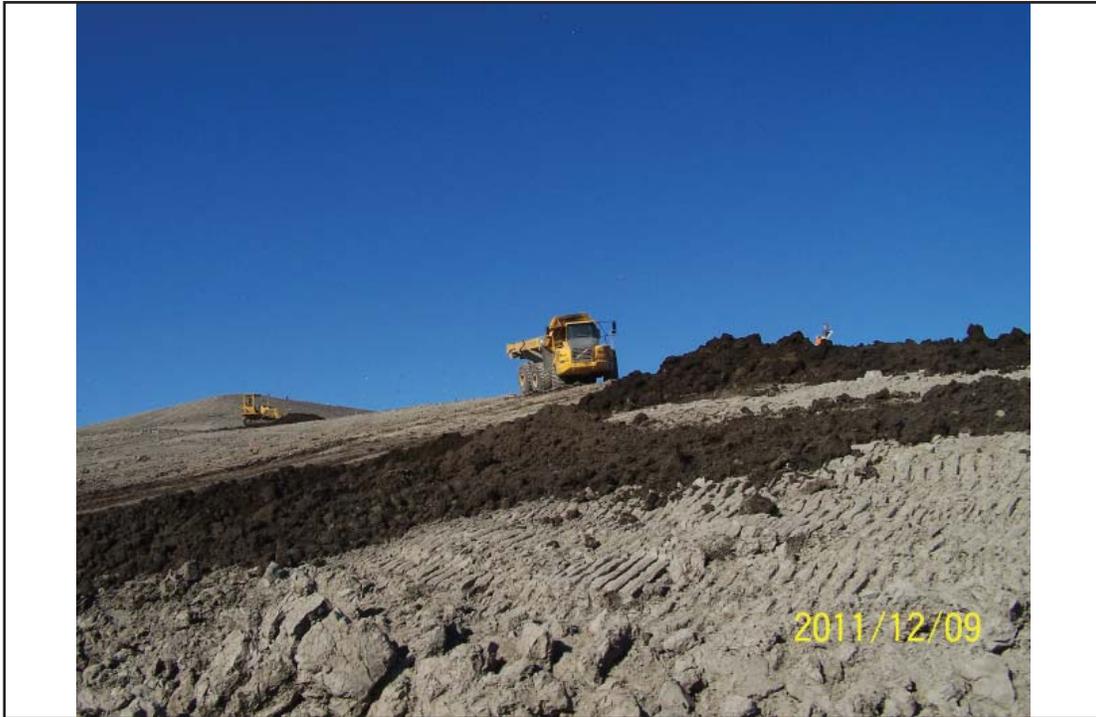
Topsoil being placed on Closure Area III side slopes
