Veolia Emerald Park Landfill
City of Muskego

2011 Veolia Emerald Park Landfill Year End Compliance Officer Report and Audit Summary

TO: Veolia Emerald Park Standing Committee
FROM: Jo-Walter Spear, Jr., P.E.
COPIES: File
DATE: 04/02/2012
PROJECT NUMBER: 1012.10030

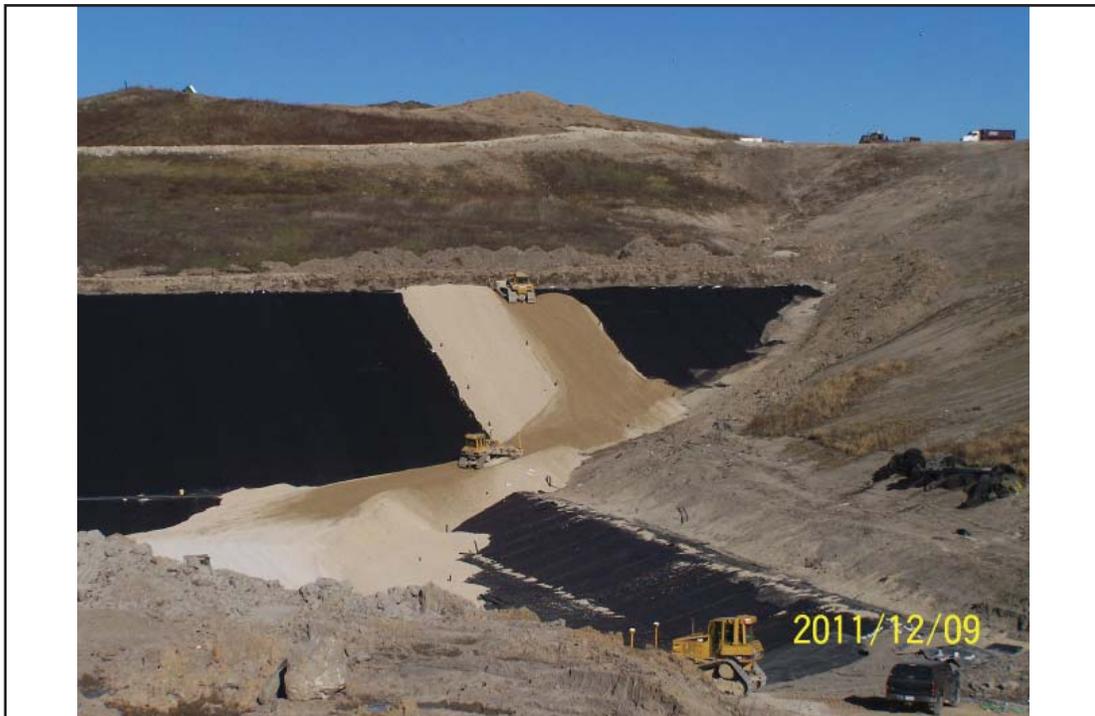
LGP Dozer spreading drainage layer, leachate collection system stone up side slopes

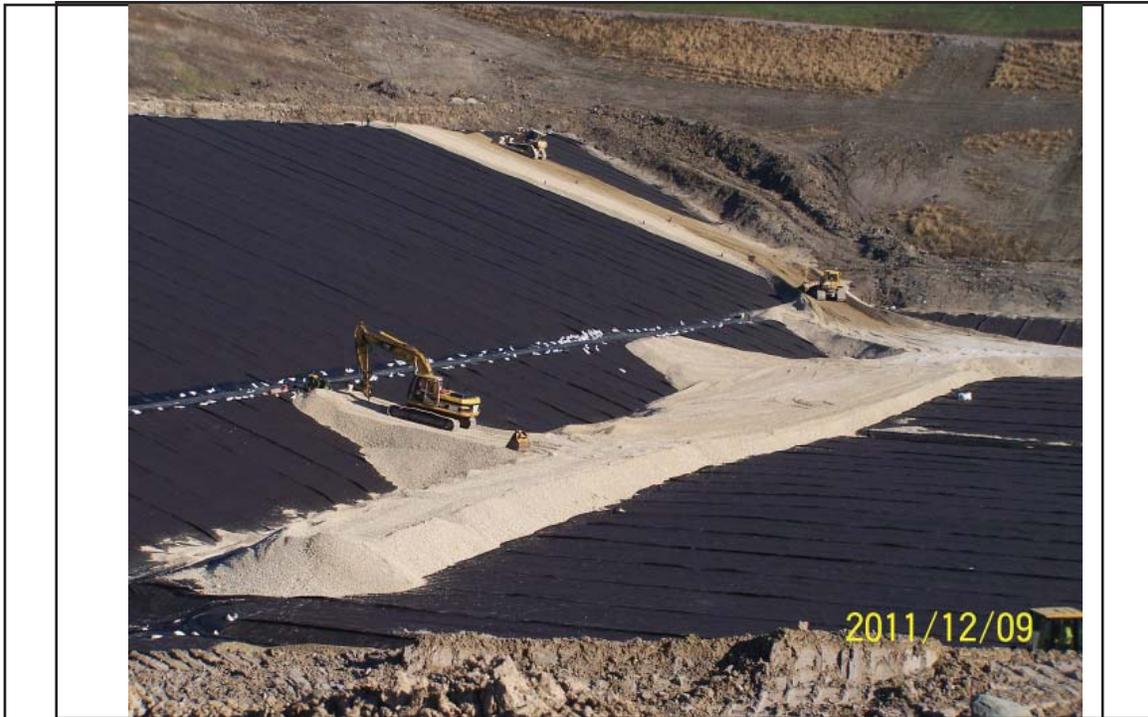
Stone placement for drainage layer being done on side slopes during the day and on base at night.

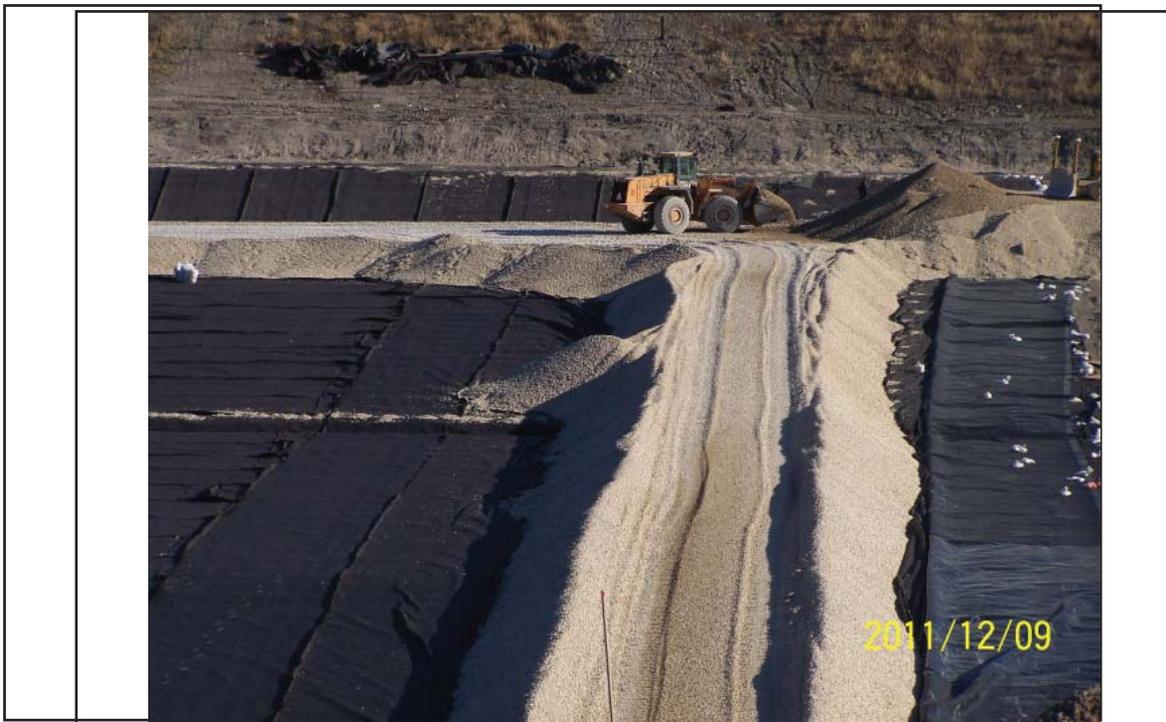
Loader being used to move rock about cell for spreading by LGP dozer

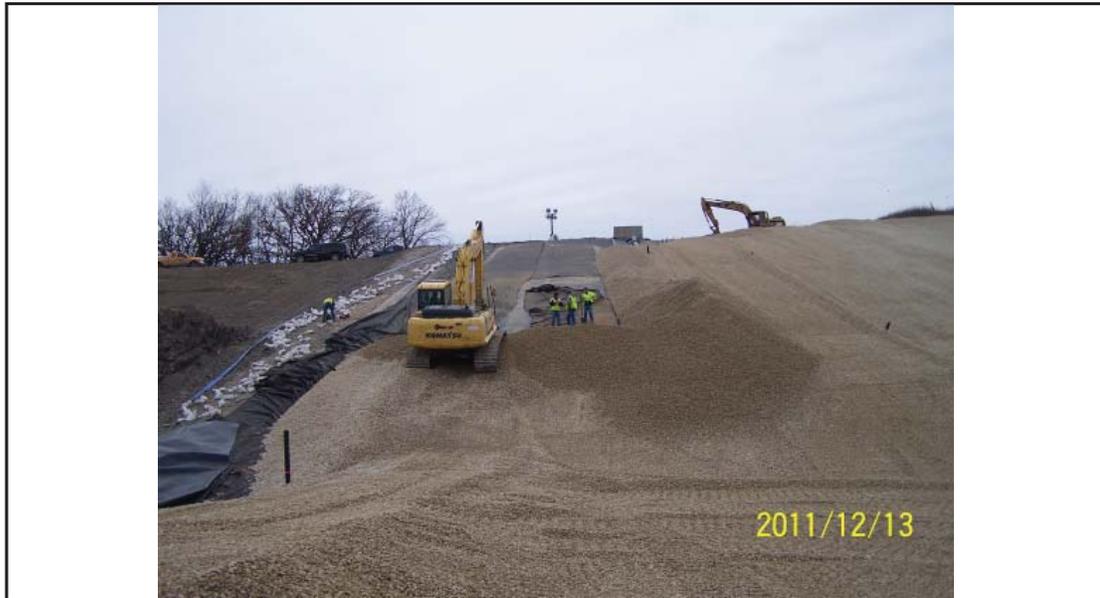
- * Slide of drainage material occurred on 12/12/2011 in the late afternoon. Contractor pulling back stone on 12/12 PM & 12/13 AM. Ann Beckta onsite to inspect
- * Topsoil Placement on Closure Area. ~~OTC~~ Ongoing. Excavated on sight & hauled to closure area.
- * Slide area west of sump & sideslope riser with no impact apparent to either. Stone removal ongoing until toe of slope cleared. Current plan is to not replace stone until liner work in Spring completed.
- * Liner testing will be for all HDPE Placed.

Area of liner that stone slid.

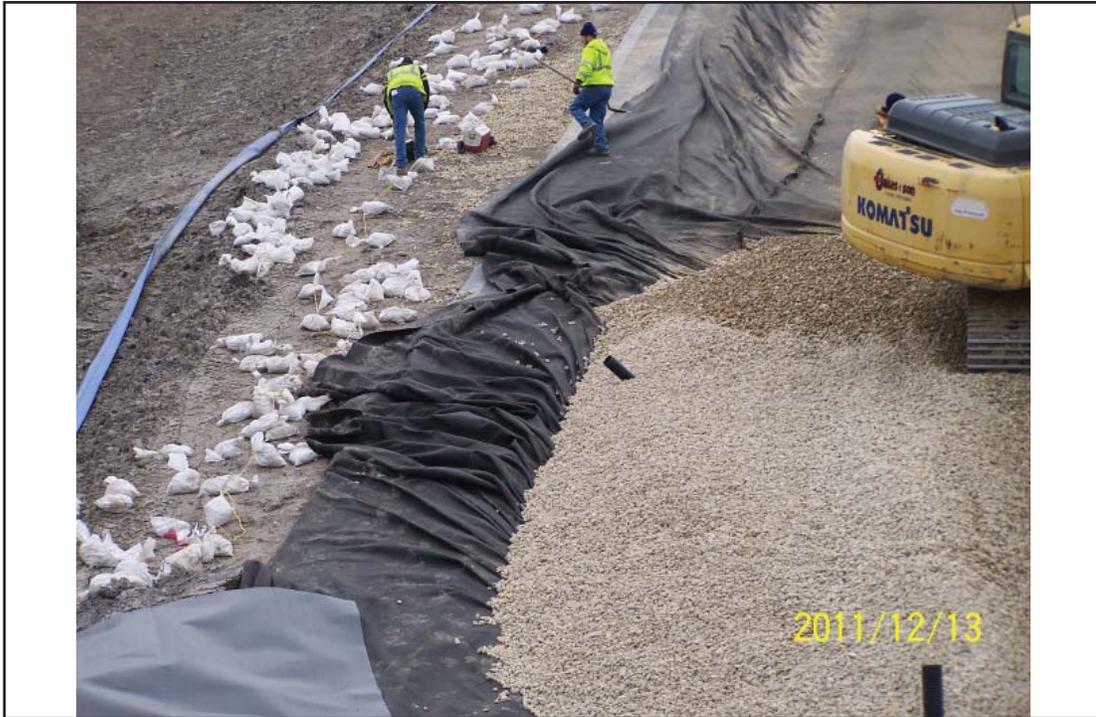
Geo-textile dragged and wrinkled by sliding stone

Crews removing stone and preparing to repair geo-textile

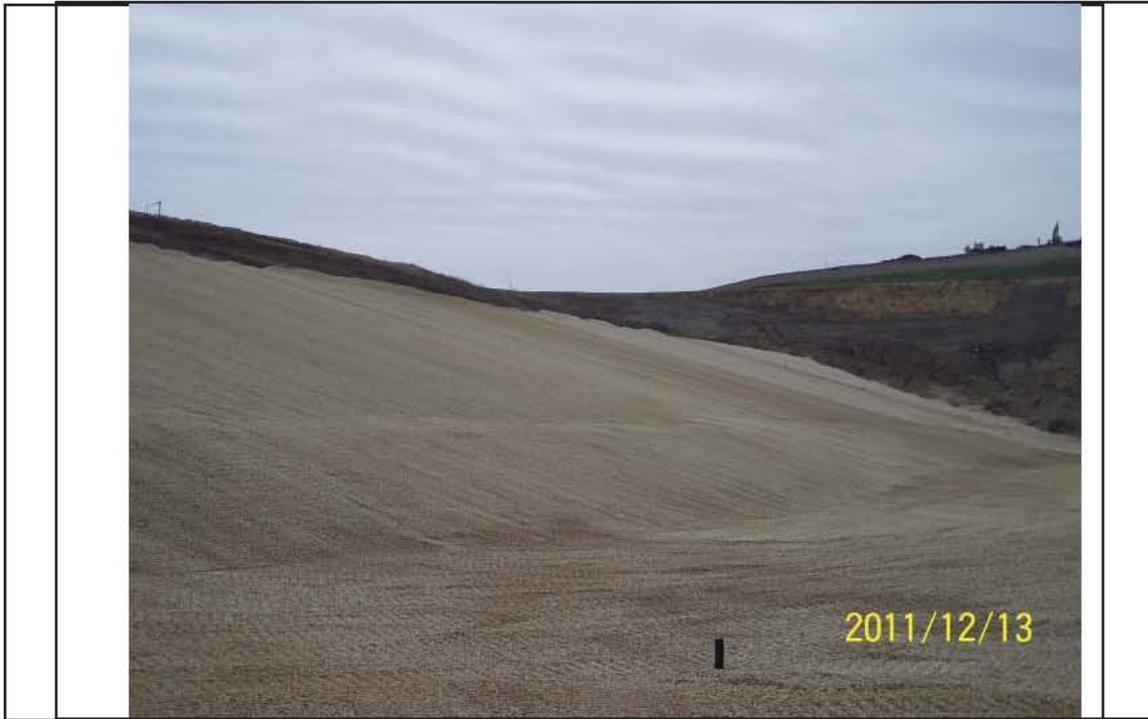
Complete drainage layer, leachate collection system on side slope

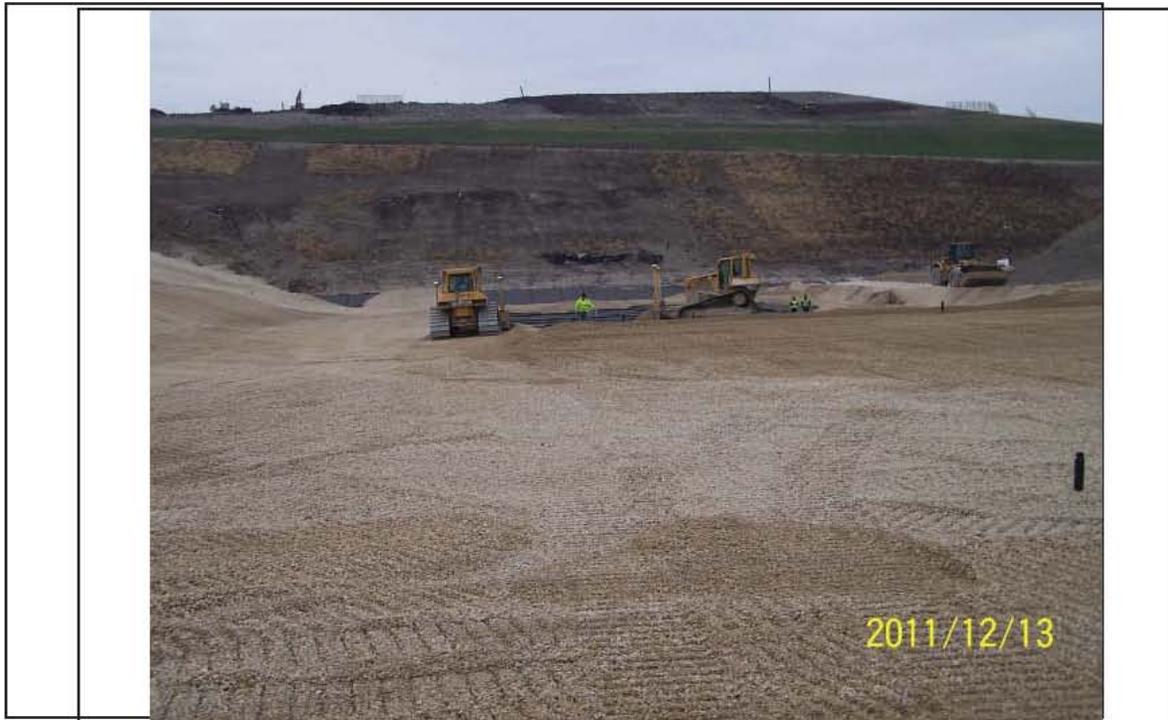
Drainage layer, Leachate collection on bottom of phase

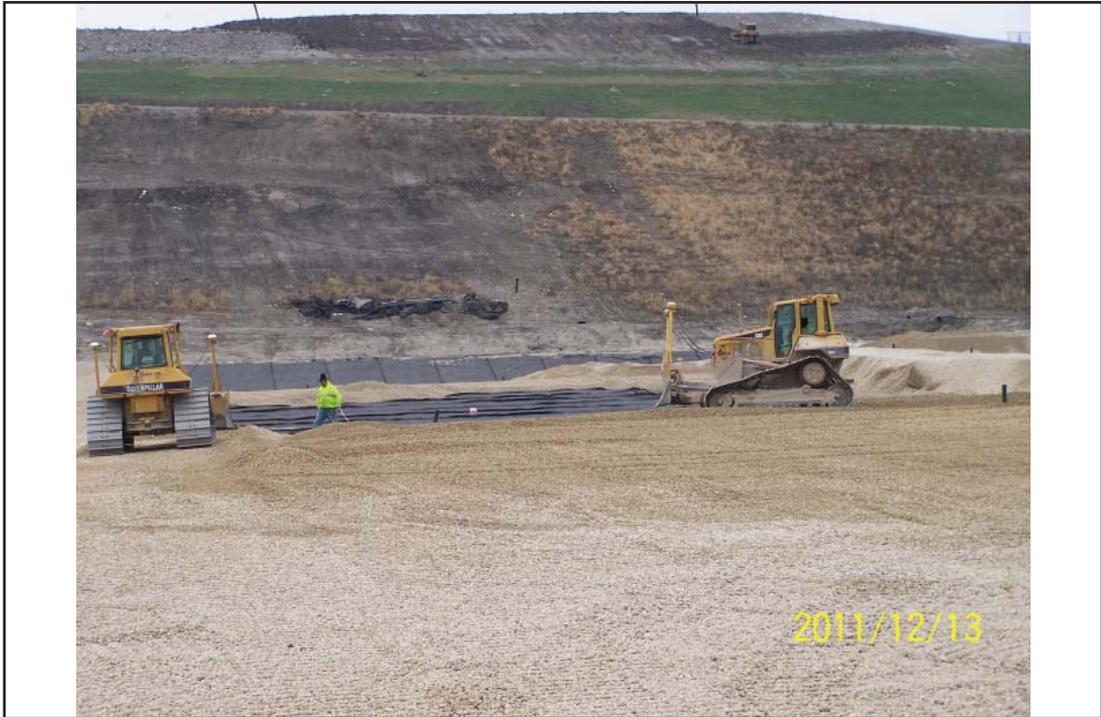
Stone placed to date.

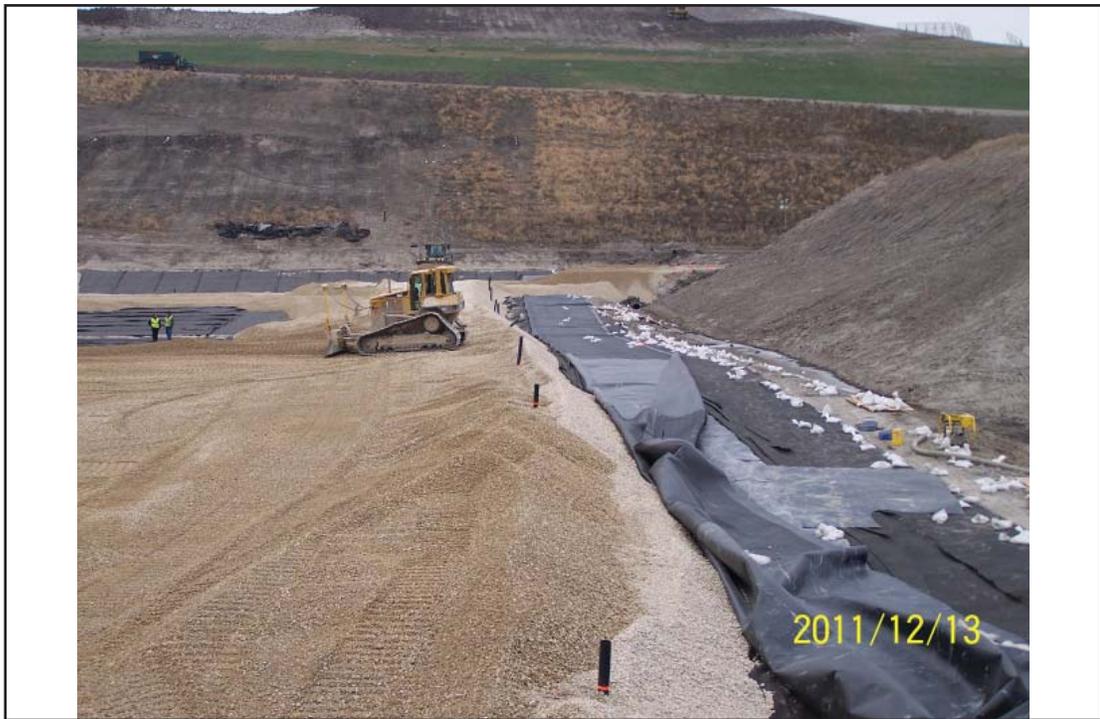
HDPE pipe used to mark stone depth

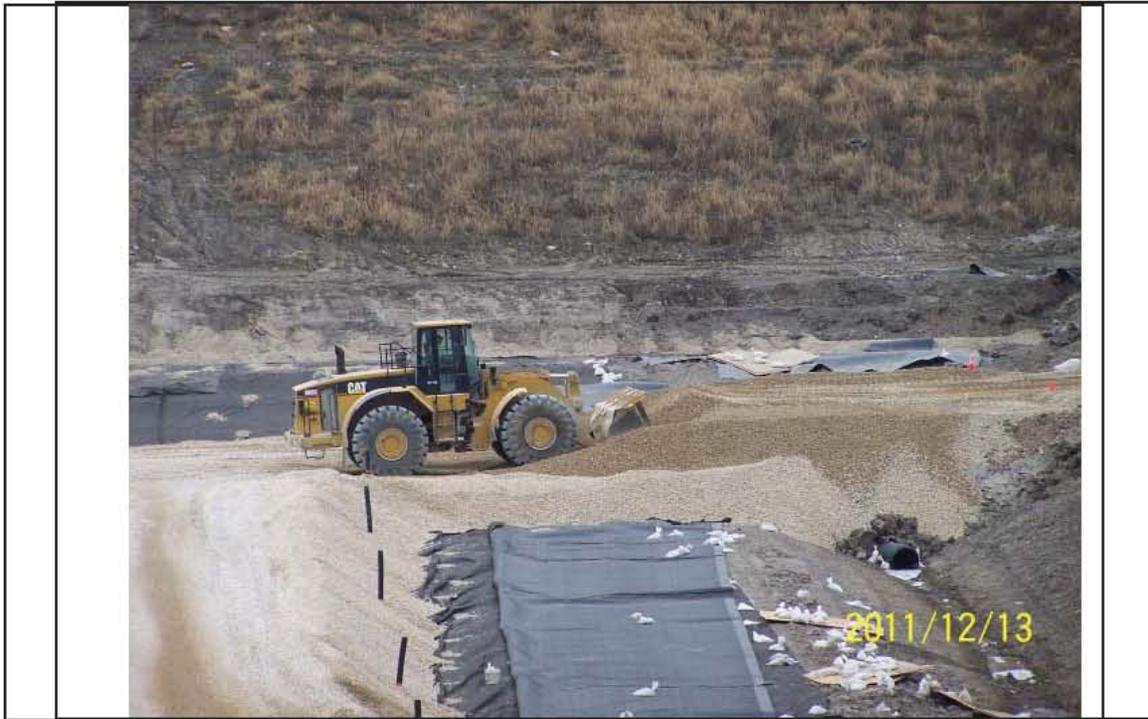
Front end loader delivering stock piled stone about phase

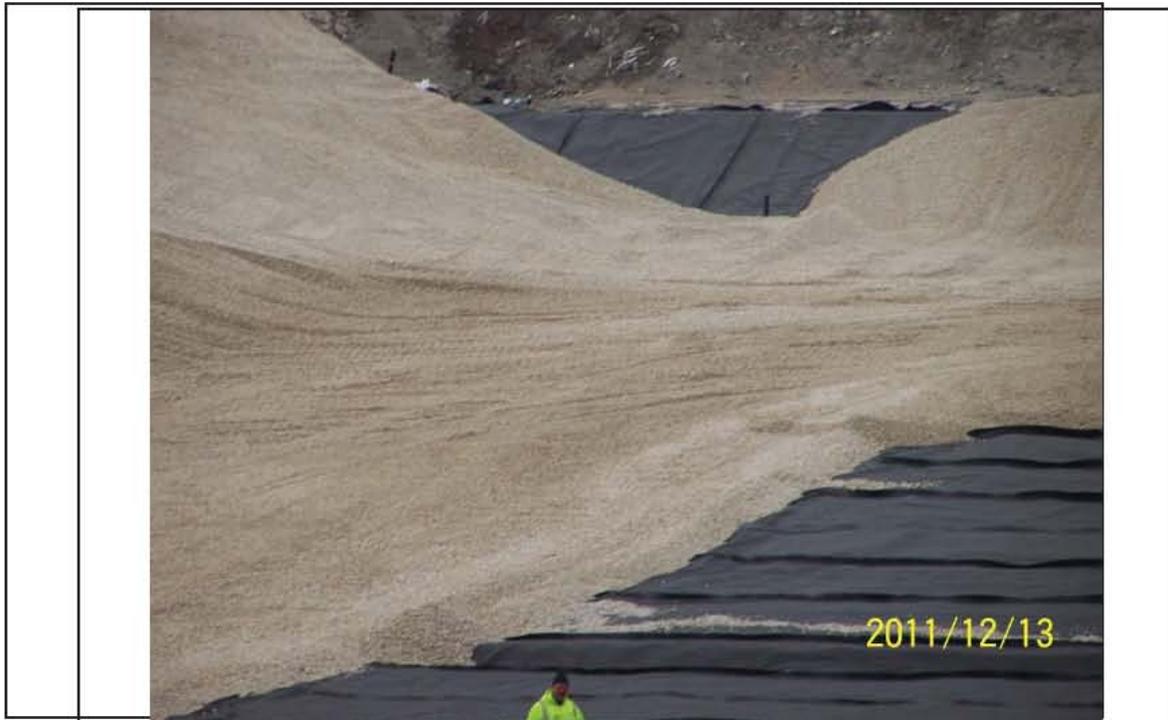
Placed drainage layer, leachate collection

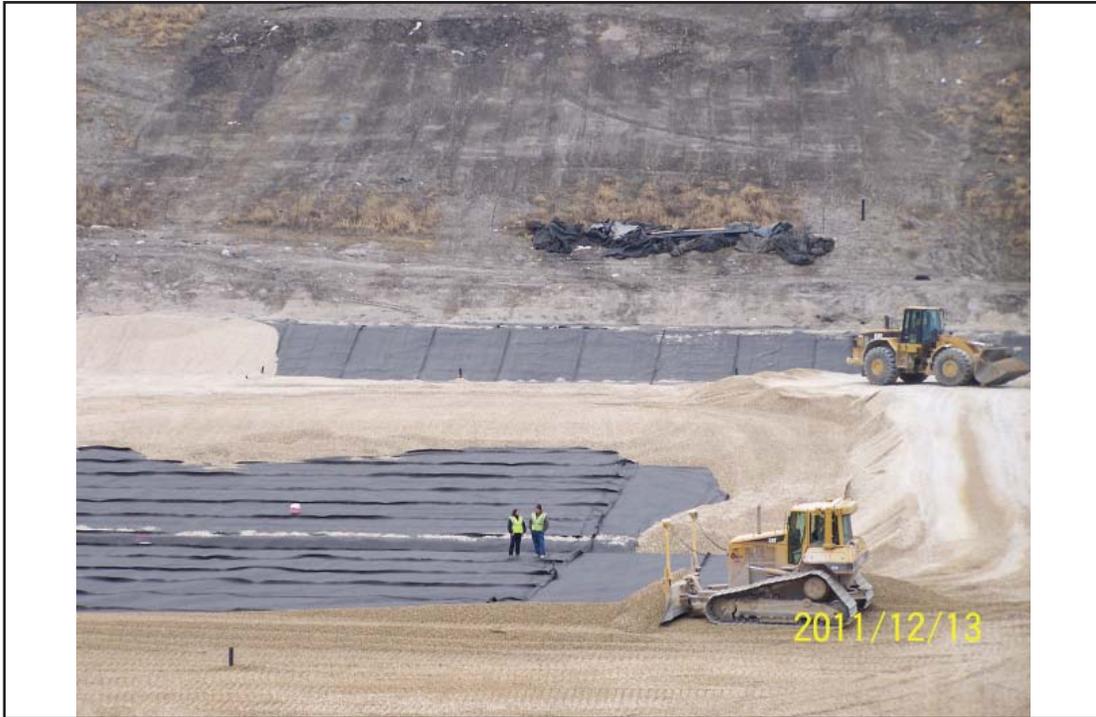
LGP Dozer spreading drainage layer, leachate collection system across bottom of cell

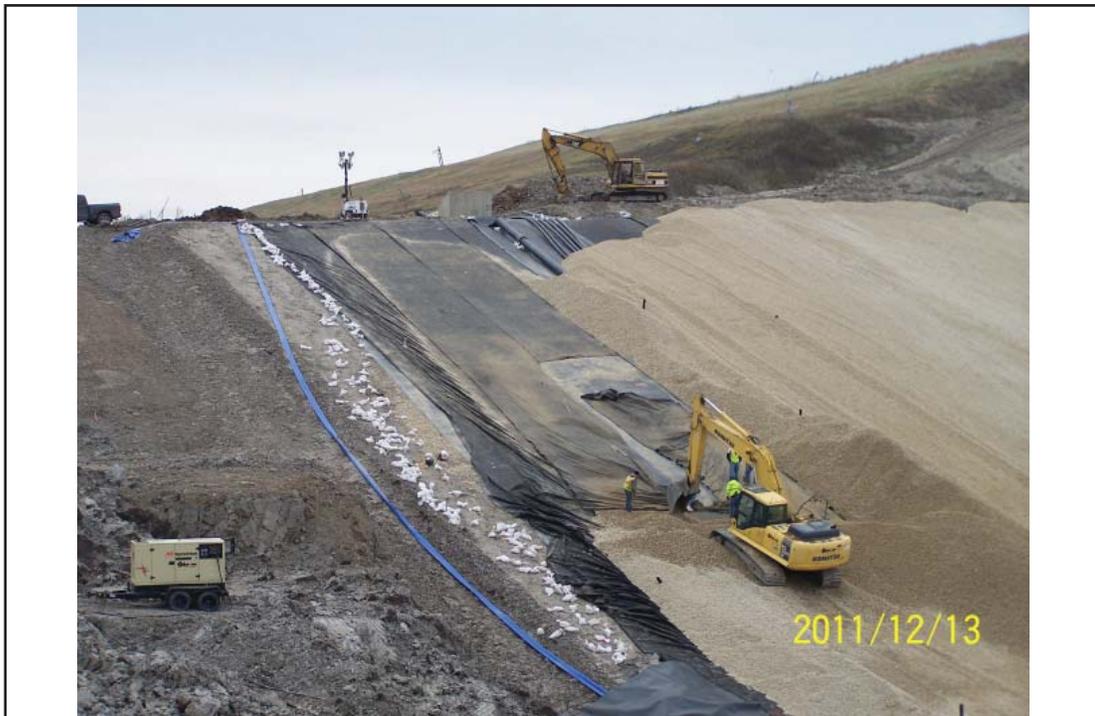
Sliding stone only appeared to impact geo-textile

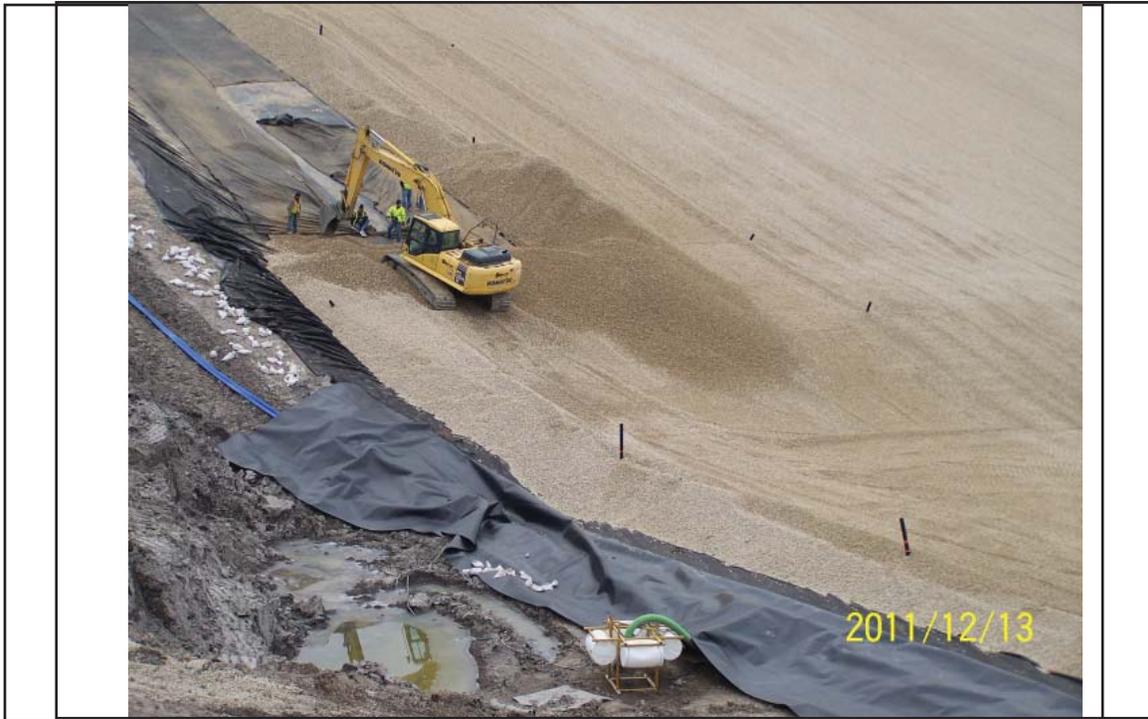
Area below slide

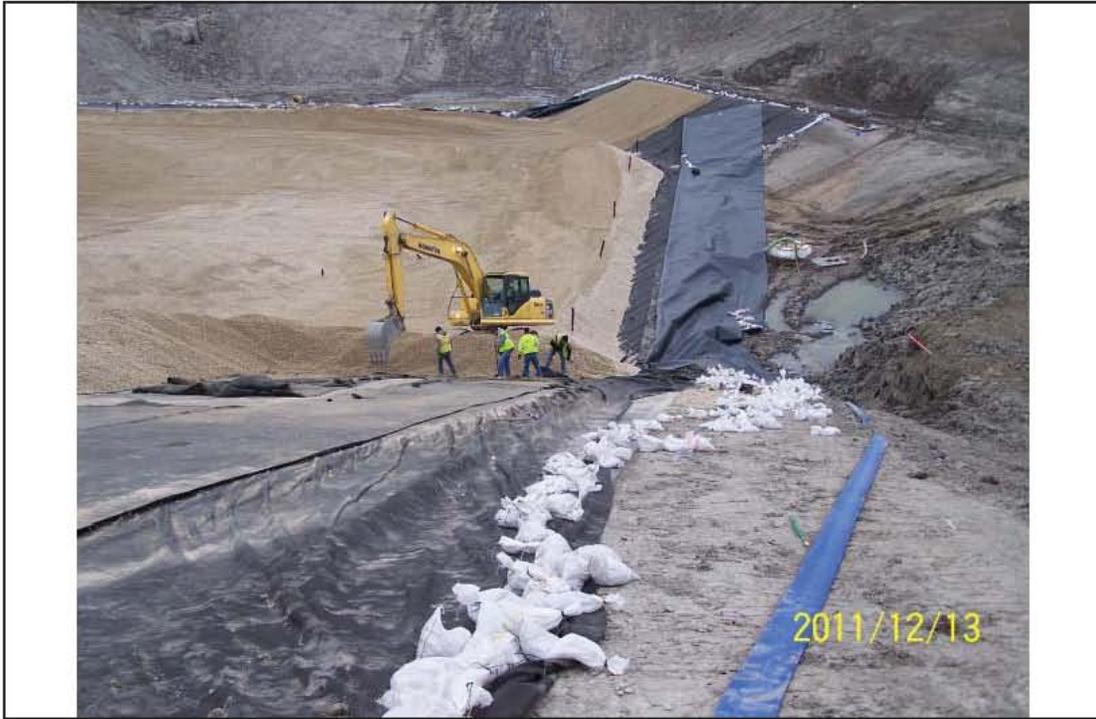
View from above of area adjacent to slide

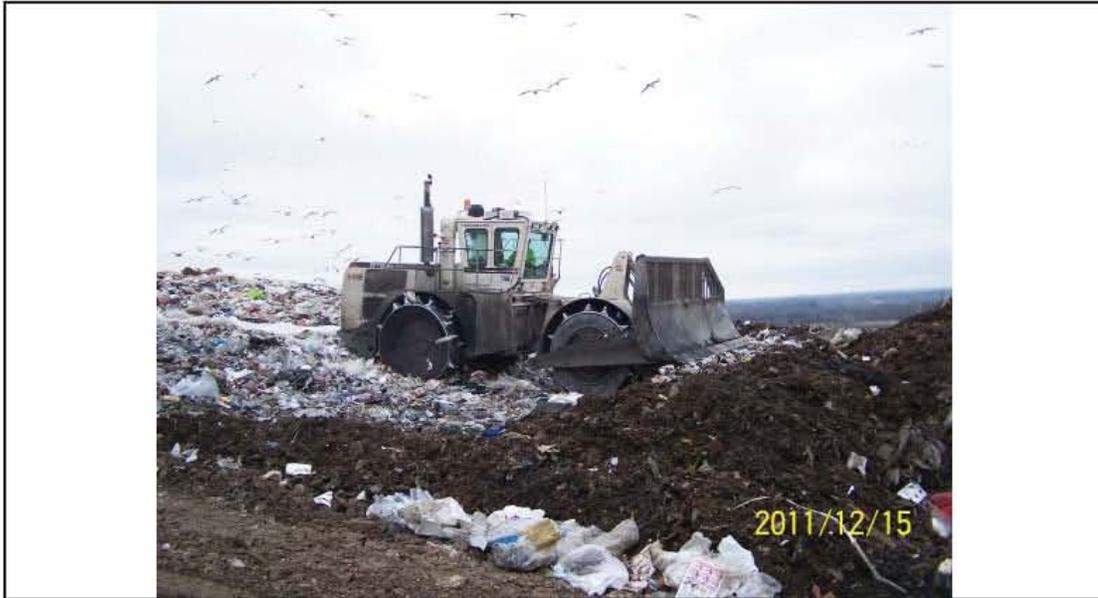
Compactor in working face

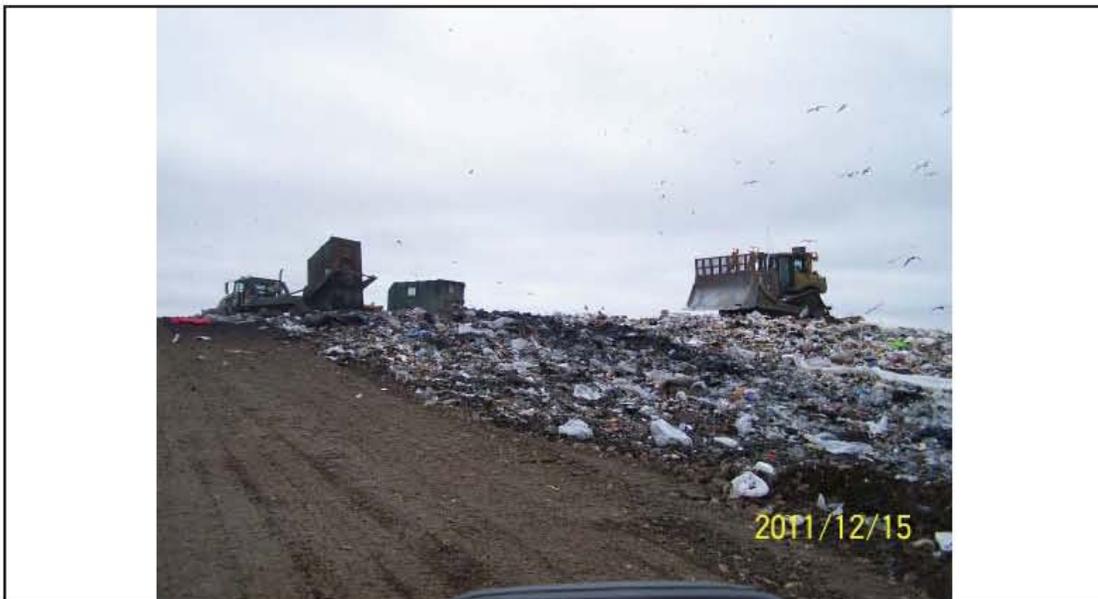
Active area

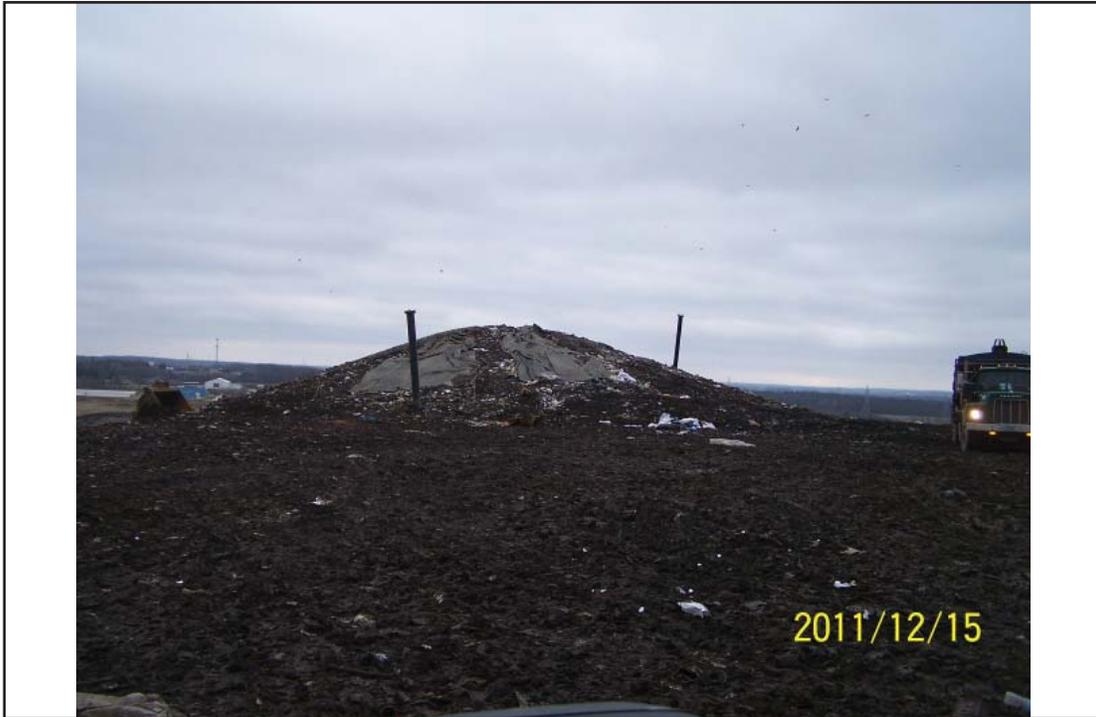
Previous working face covered in tarps

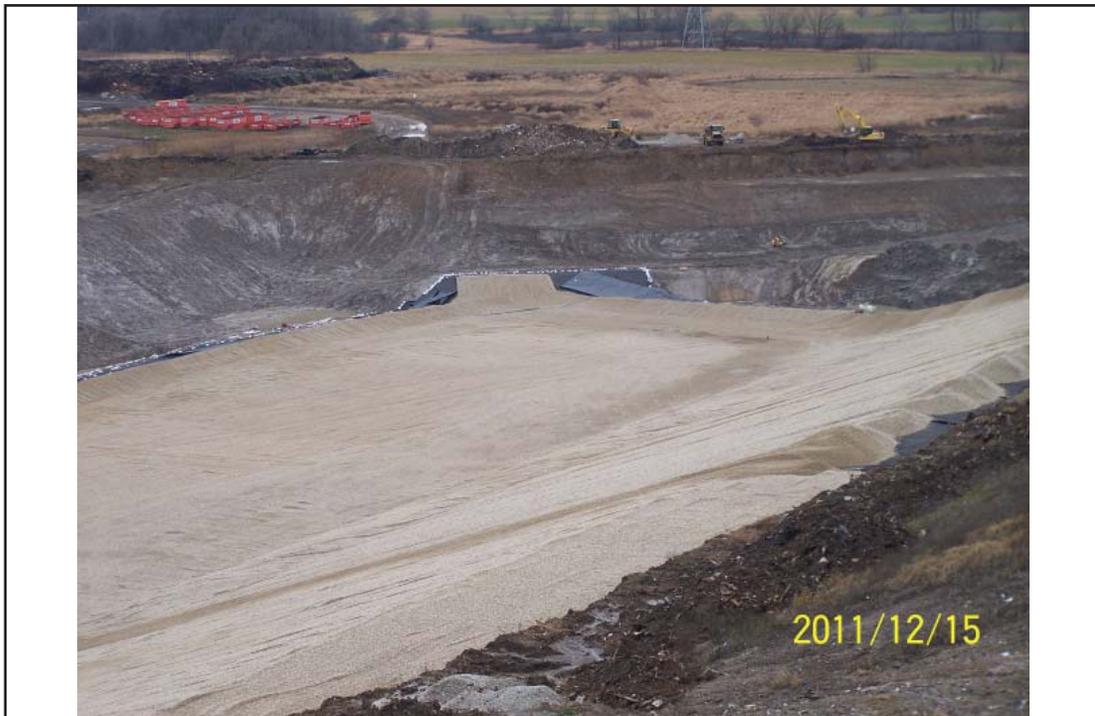
Phase 7 viewed from Northeast

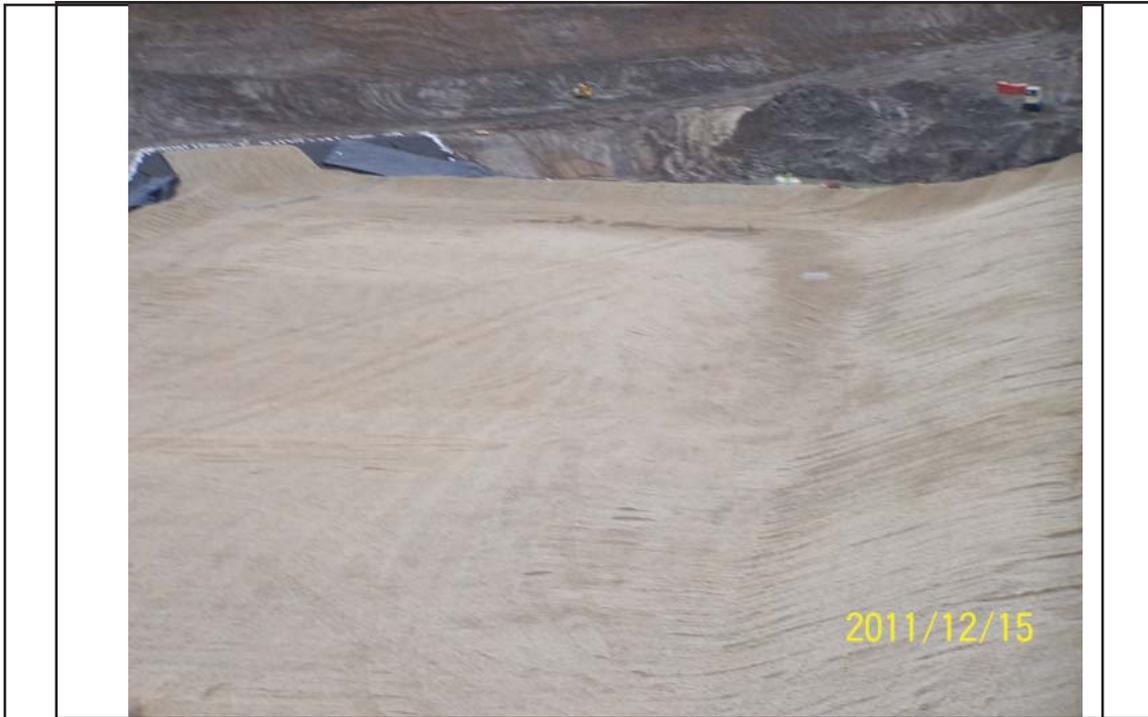
Bottom of phase completed

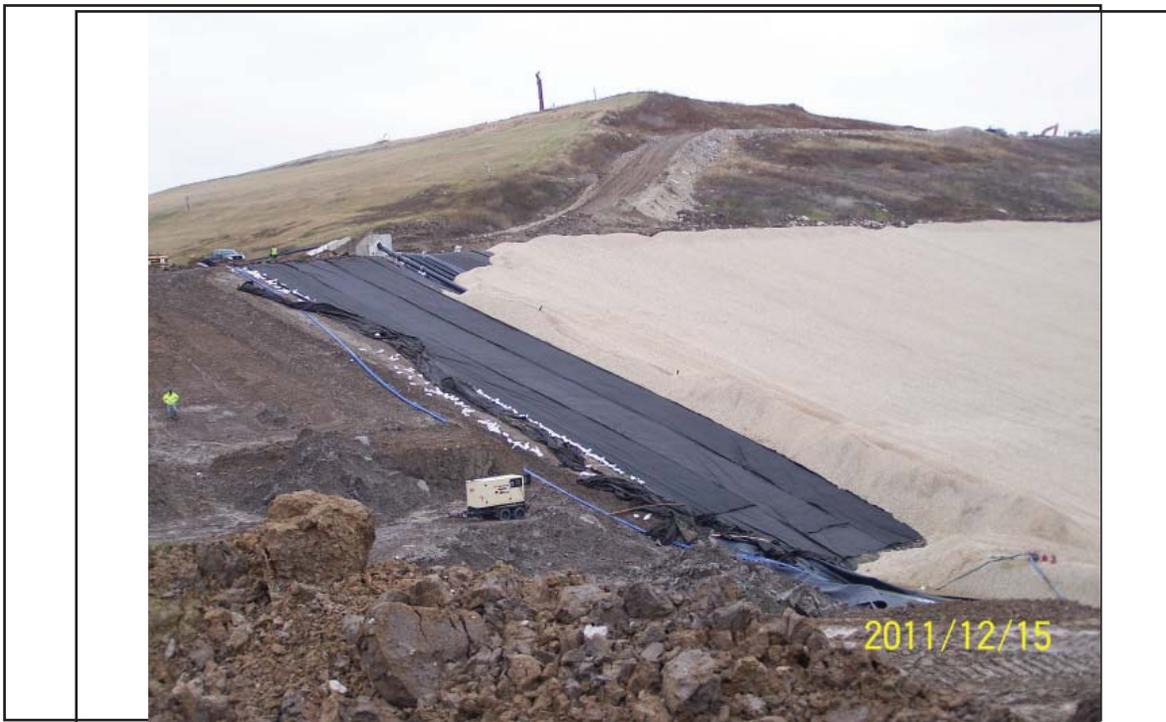
Drainage layer, leachate collection placed over sump side slope riser only, not near edge of geo-textile and liner

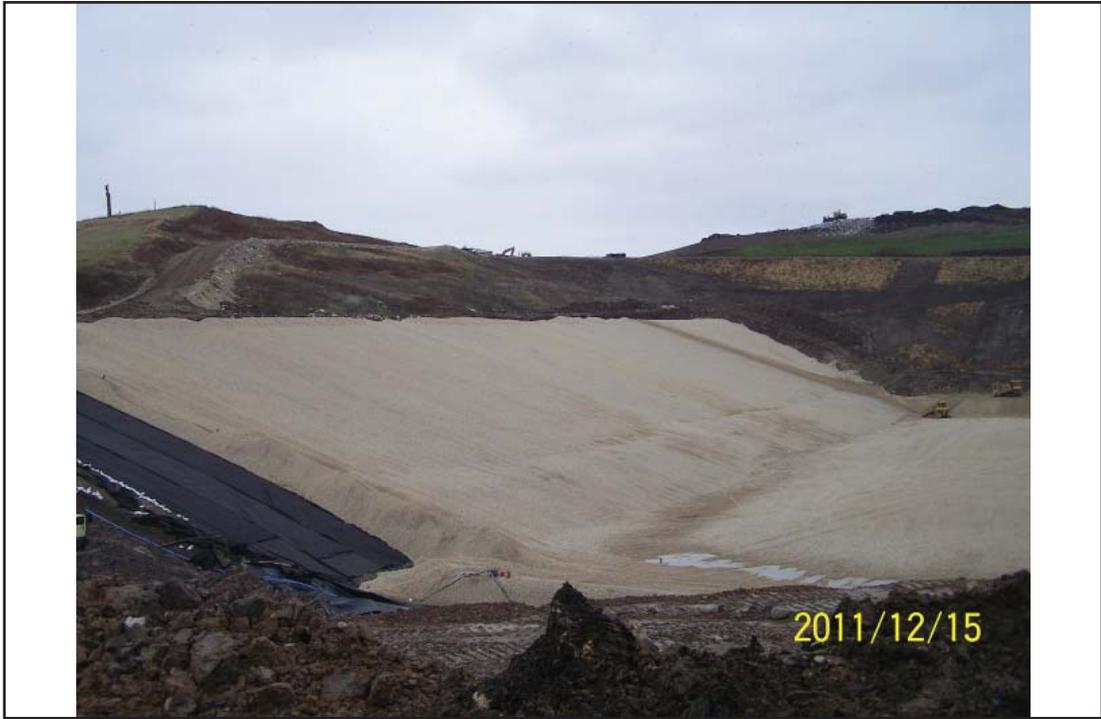
Completed drainage layer, leachate collection until cell is finished in spring of 2012

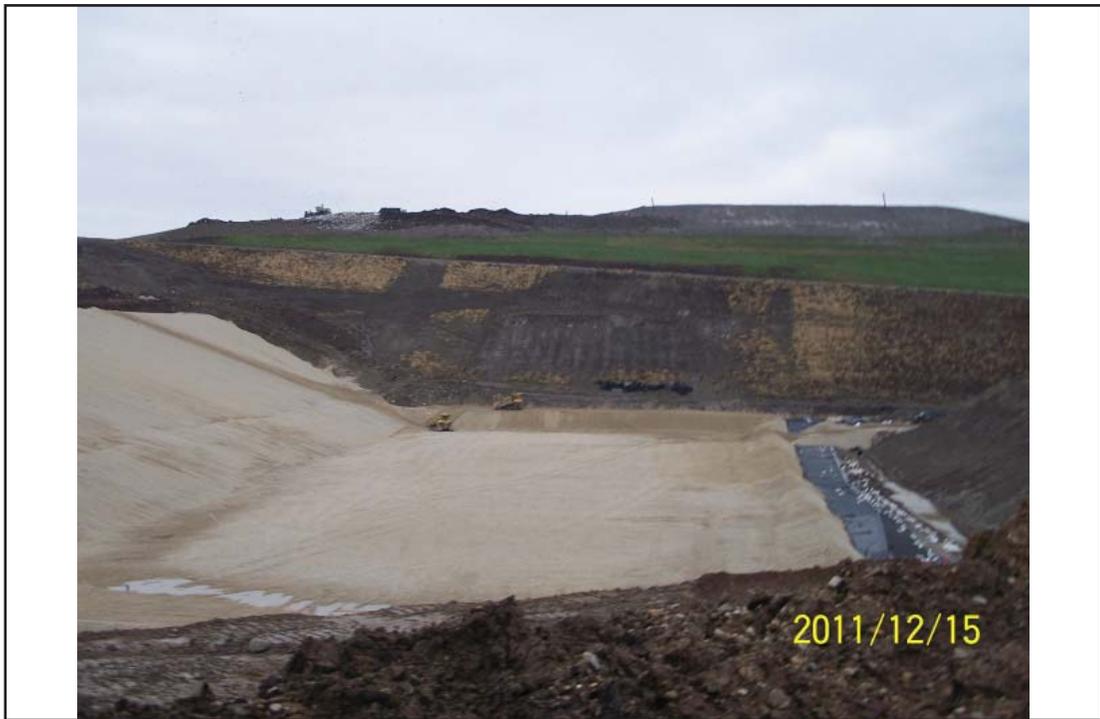
Phase 7 viewed from the West

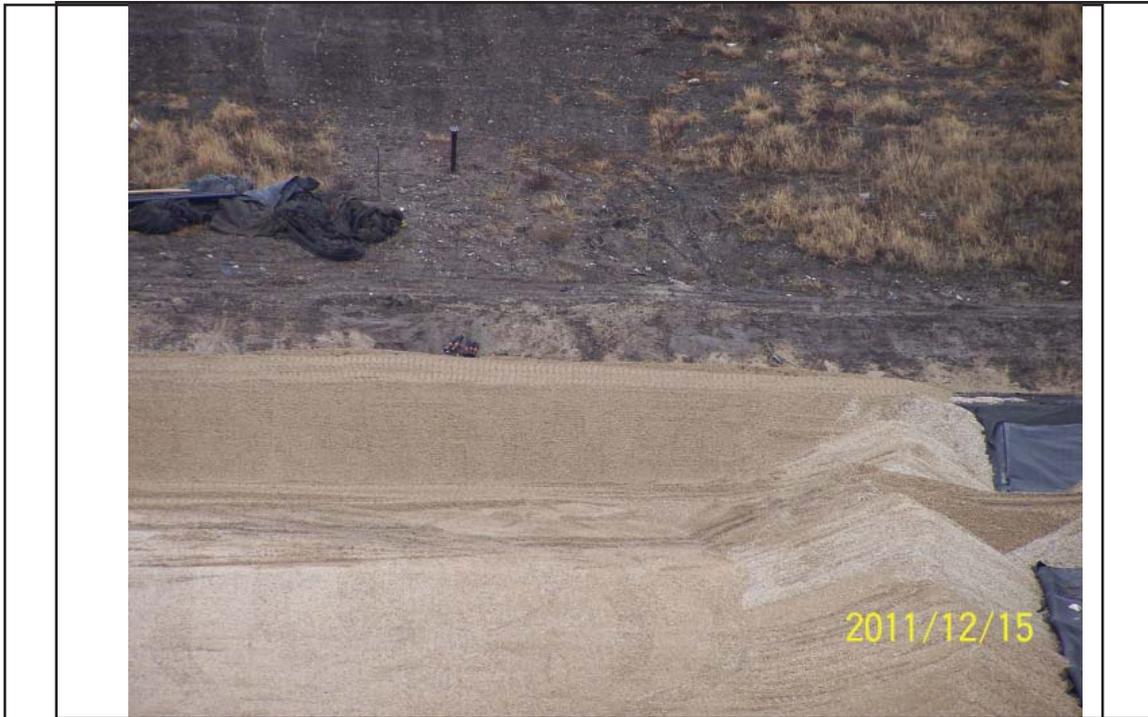
Completed areas of drainage layer, leachate collection

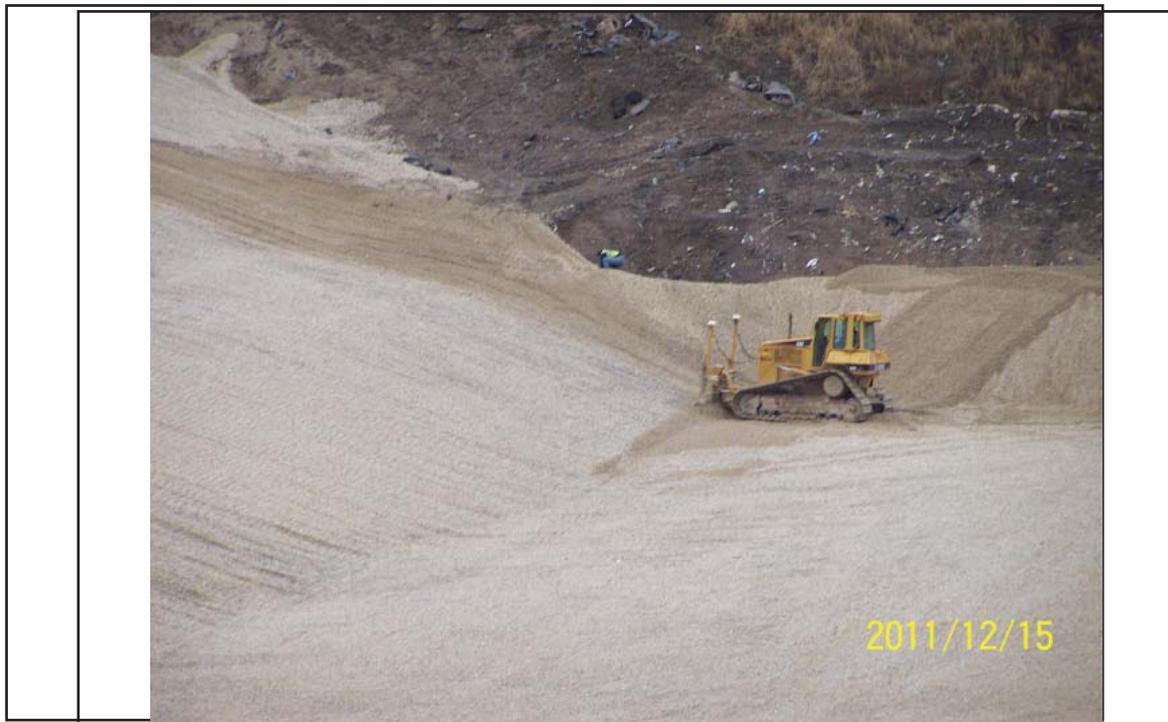
Ongoing stone spreading, depth nearly reached

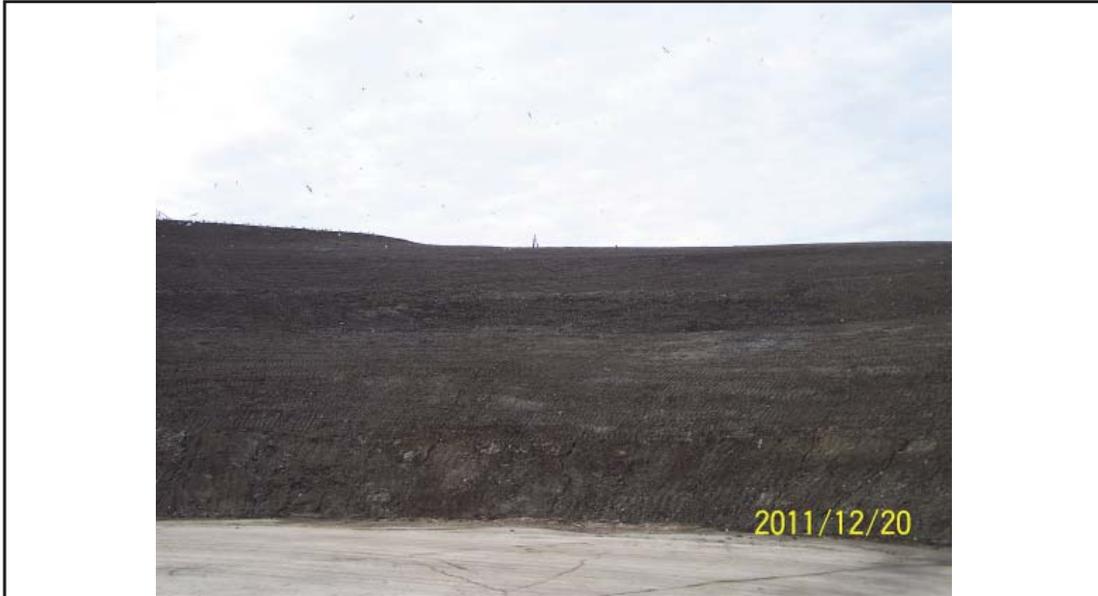
Closure Area III at Phase 4/5 juncture, berm and top soil in place.

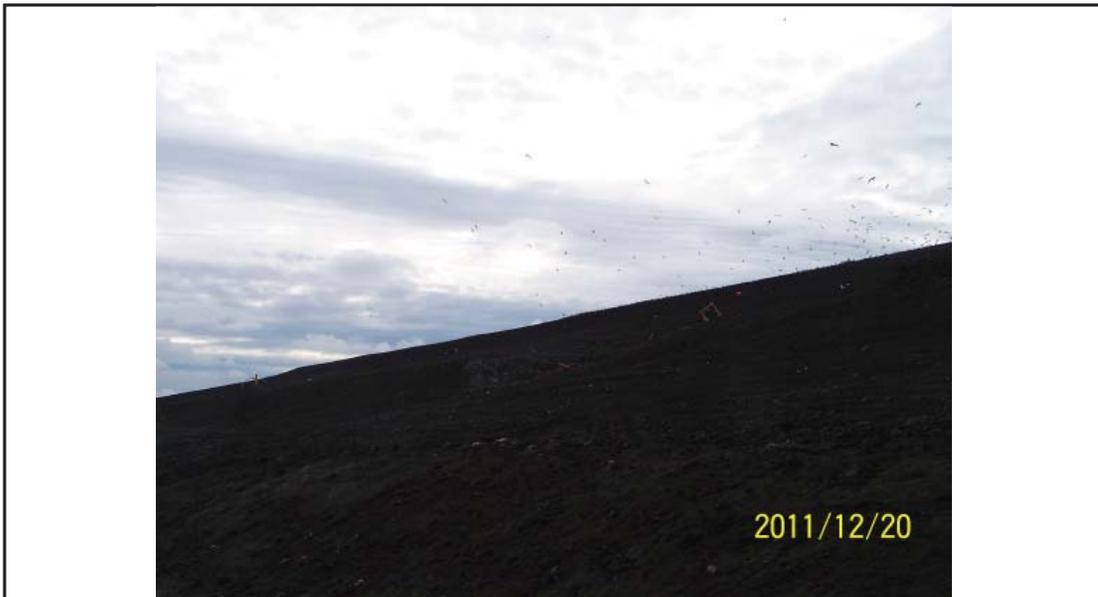
Closure Area III at Phase 5, Southwest corner, top soil placed

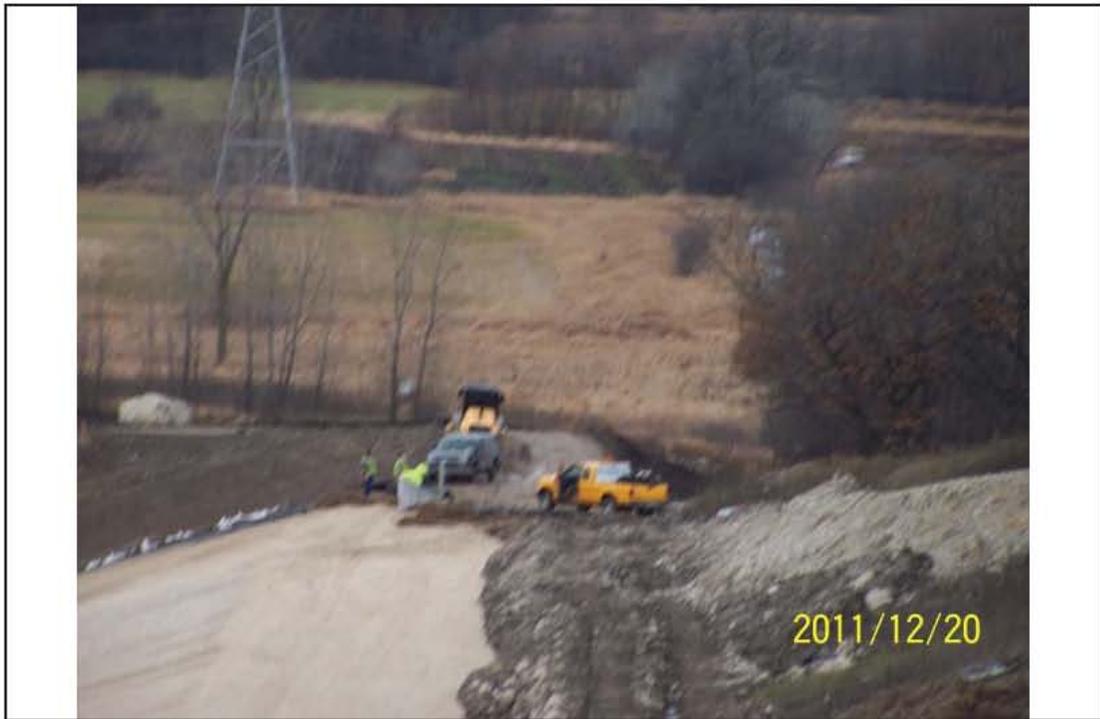
Stone drainage layer, leachate collection system at junction with Phase 3

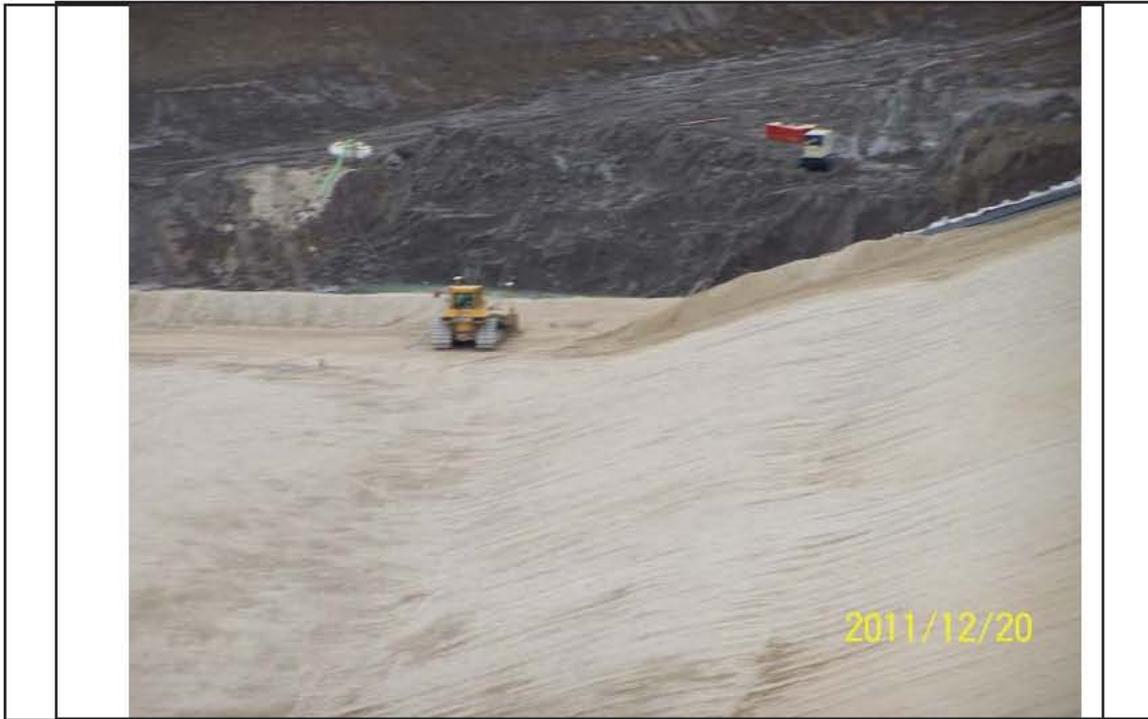
LGP dozer establishing berm at edge of liner
