Veolia Emerald Park Landfill
City of Muskego

2011 Veolia Emerald Park Landfill Year End Compliance Officer Report and Audit Summary

TO: Veolia Emerald Park Standing Committee
FROM: Jo-Walter Spear, Jr., P.E.
COPIES: File
DATE: 04/02/2012
PROJECT NUMBER: 1012.10030

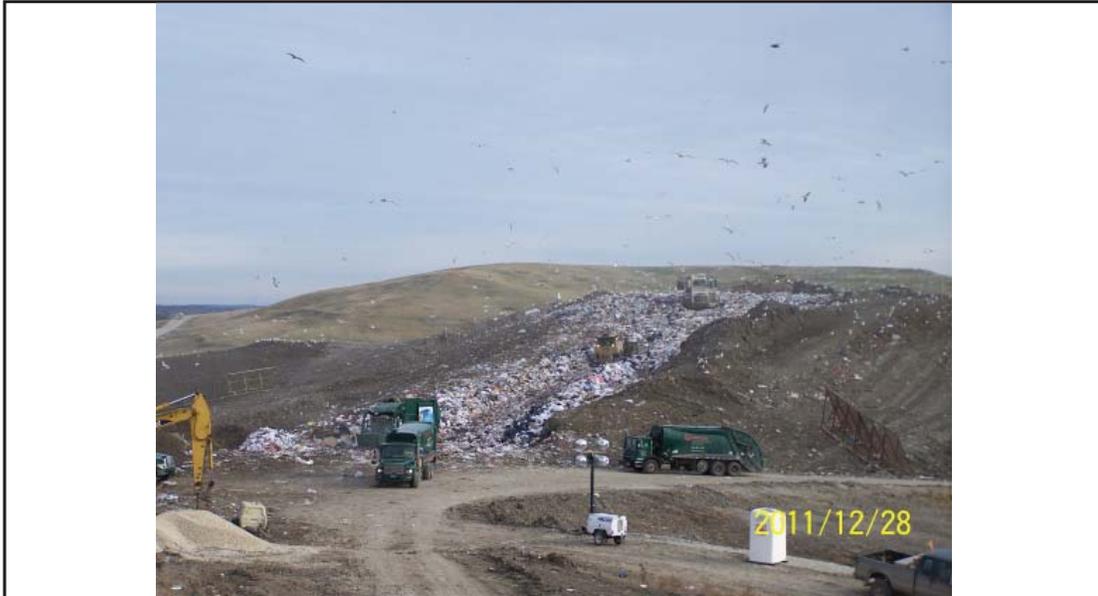
Active Area, with working face at Northwest corner.

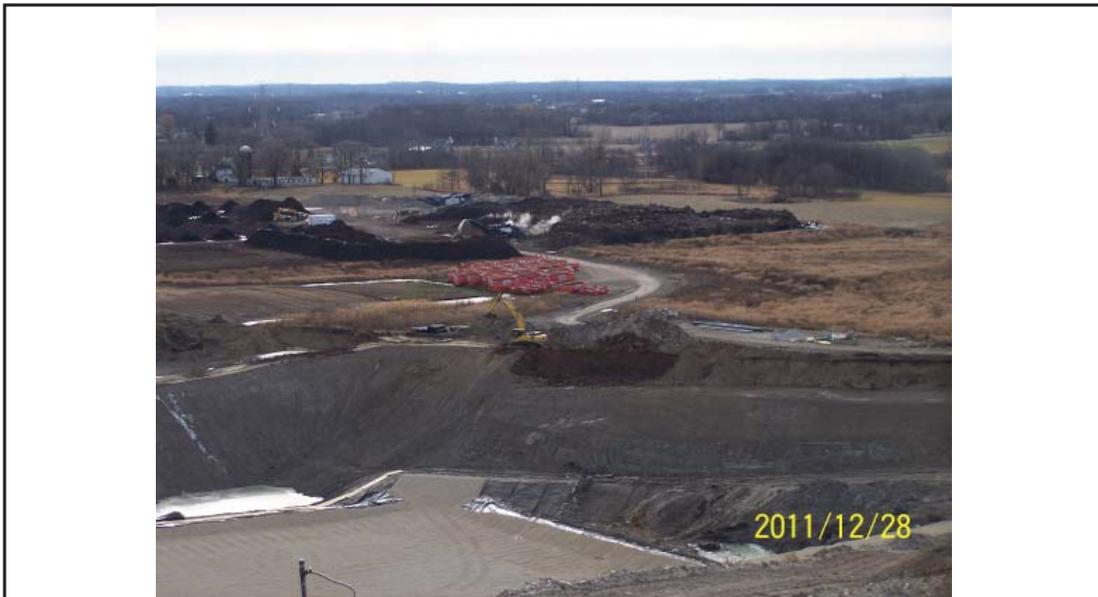
Final excavation and earth moving until spring

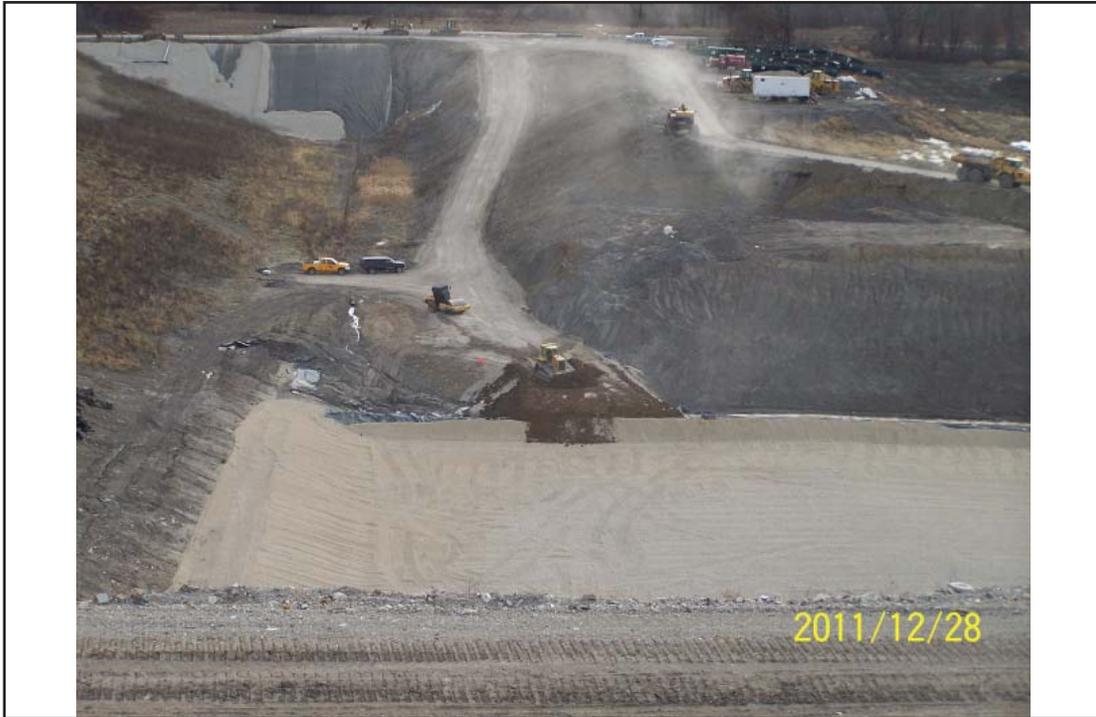
Access road construction nearly complete

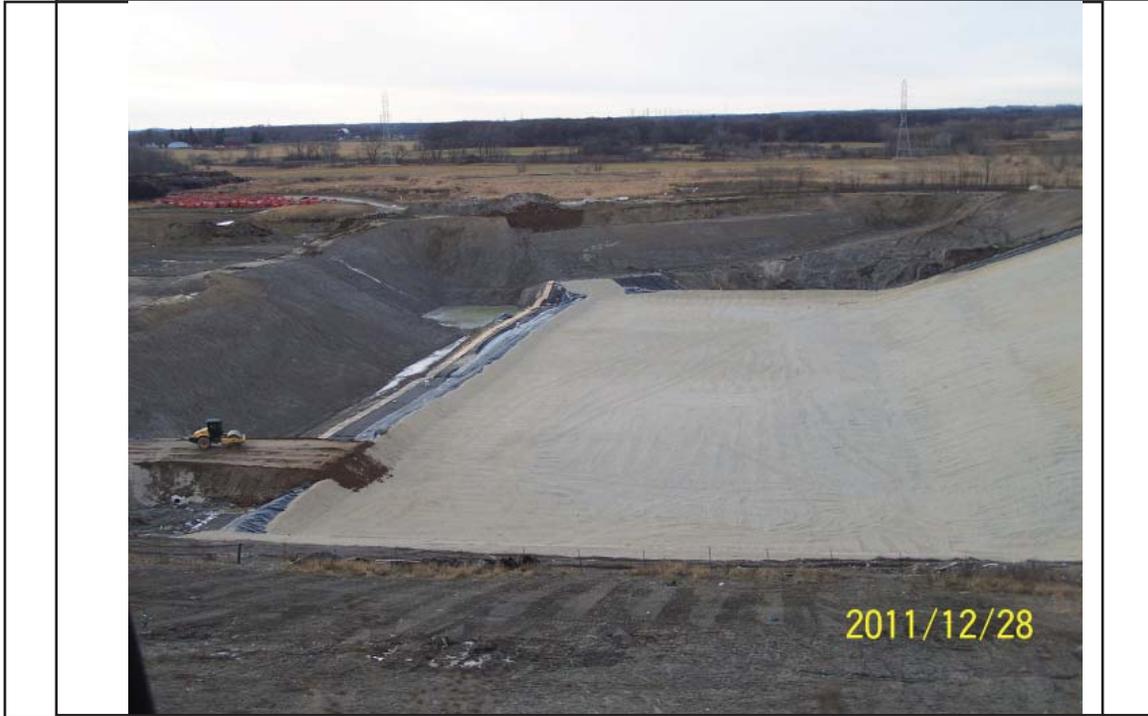
Stone drainage layer, leachate collection, completed
