2012 Advanced Disposal Services Emerald Park Landfill Year End Compliance Officer Report and Audit Summary

TO: Veolia Emerald Park Standing Committee
FROM: Jo-Walter Spear, Jr., P.E.
COPIES: File
DATE: 04/04/13
PROJECT NUMBER: 1012.10030

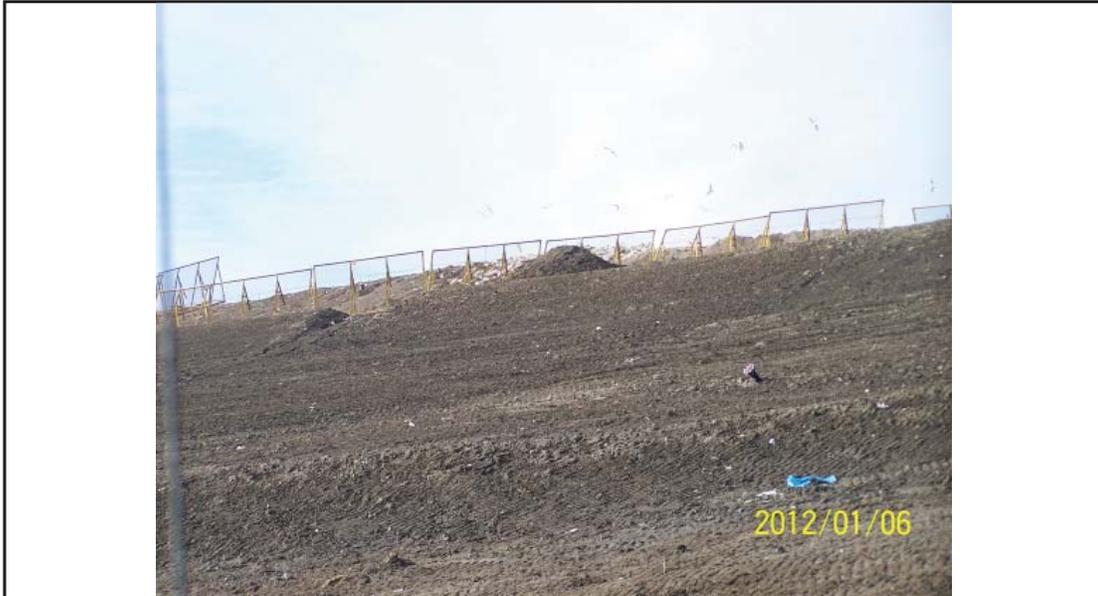
Phase 5, East slope, waste limits can be seen at top. Closure area completed

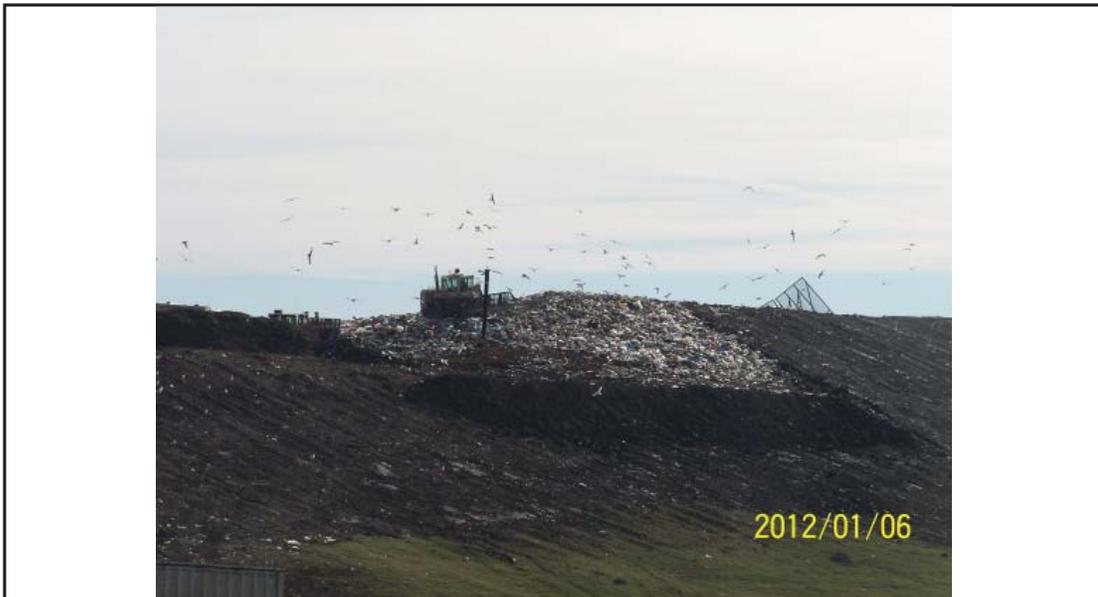
Active area

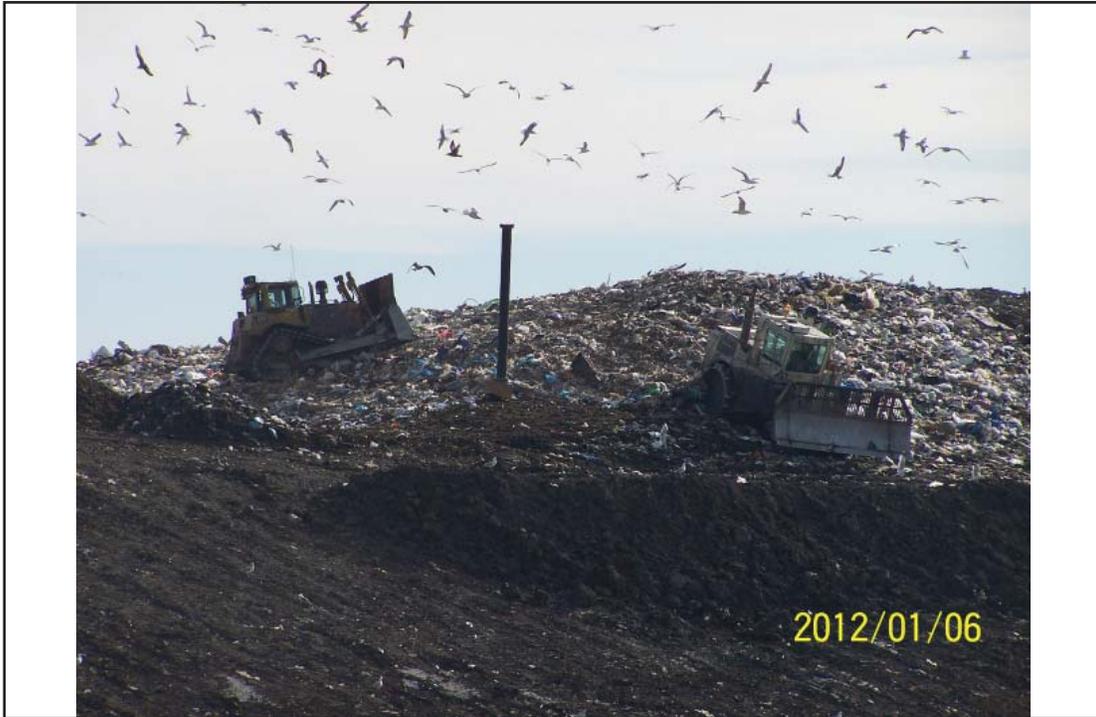
Working face shaping about extended injection well

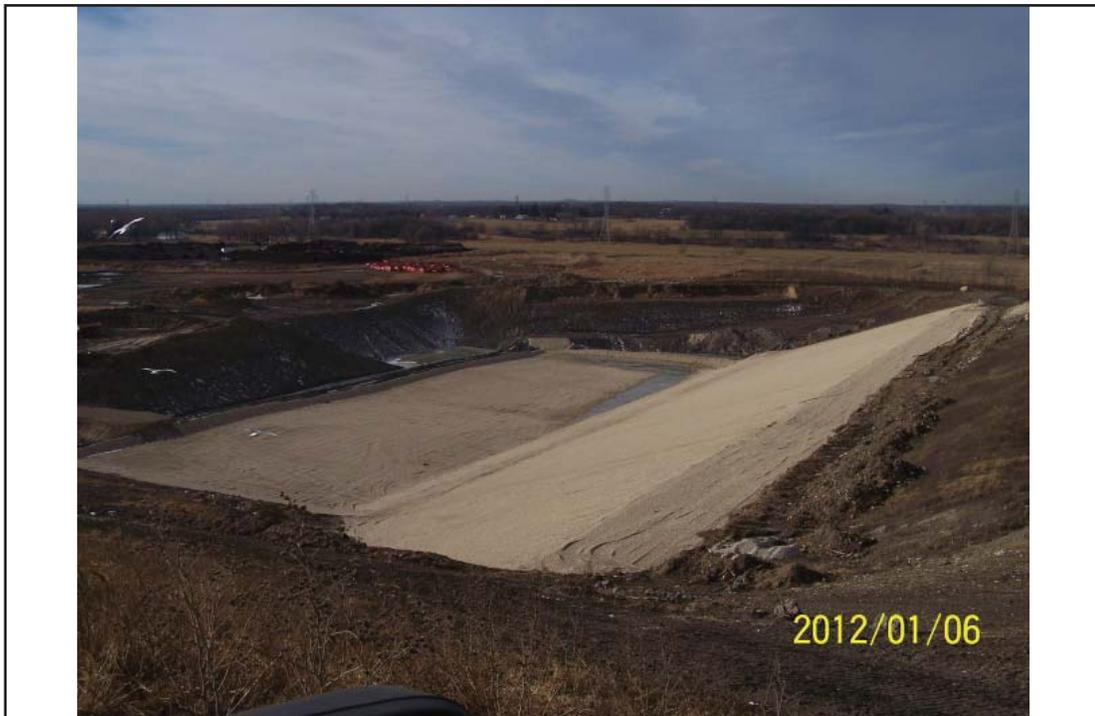
Phase 7, completely prepared for waste tipping. Northwest corner will be pumped dry when

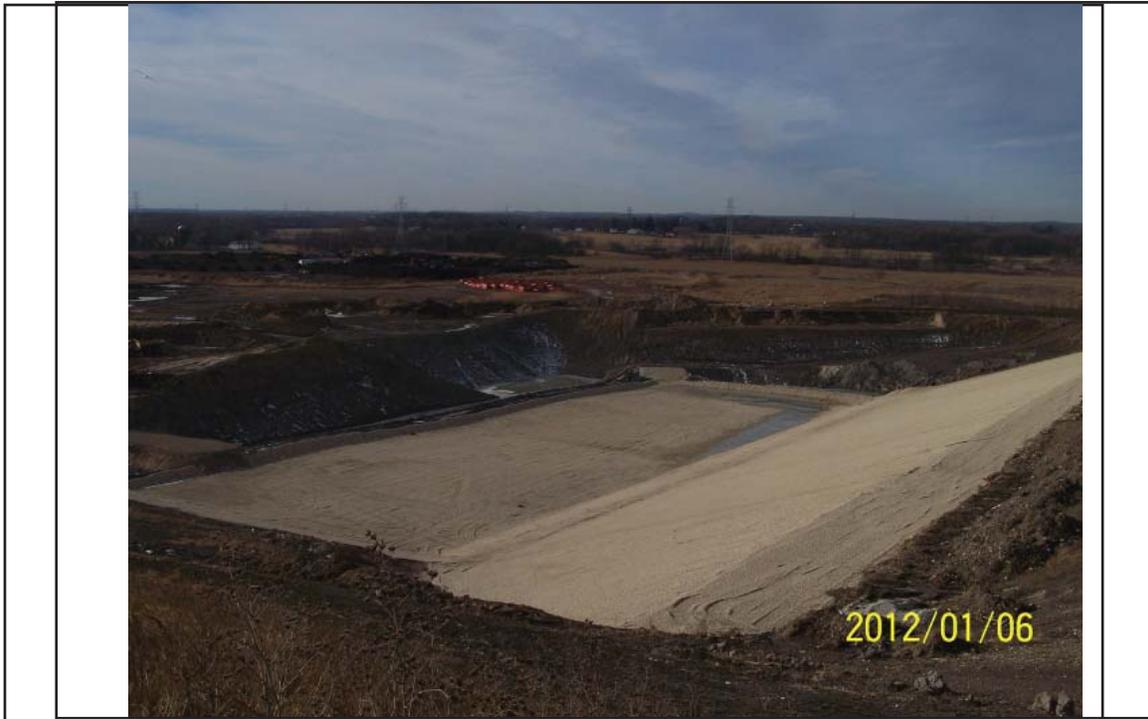
Phase 7 awaiting approval

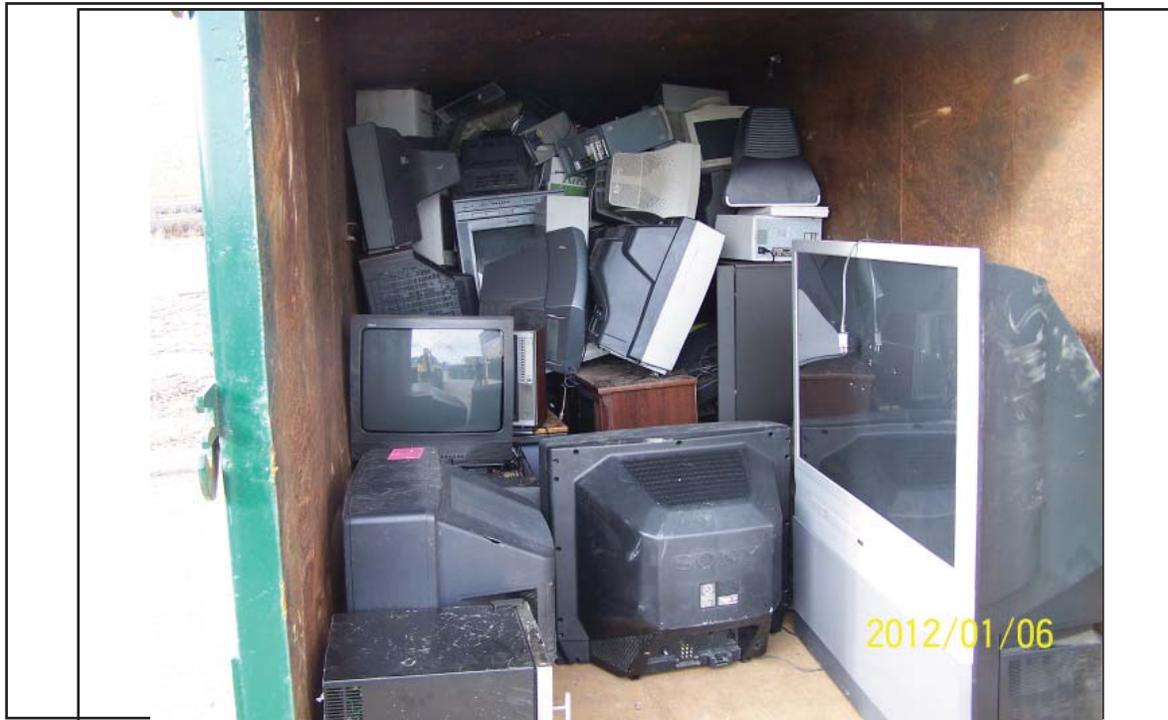
E-Waste Collection box

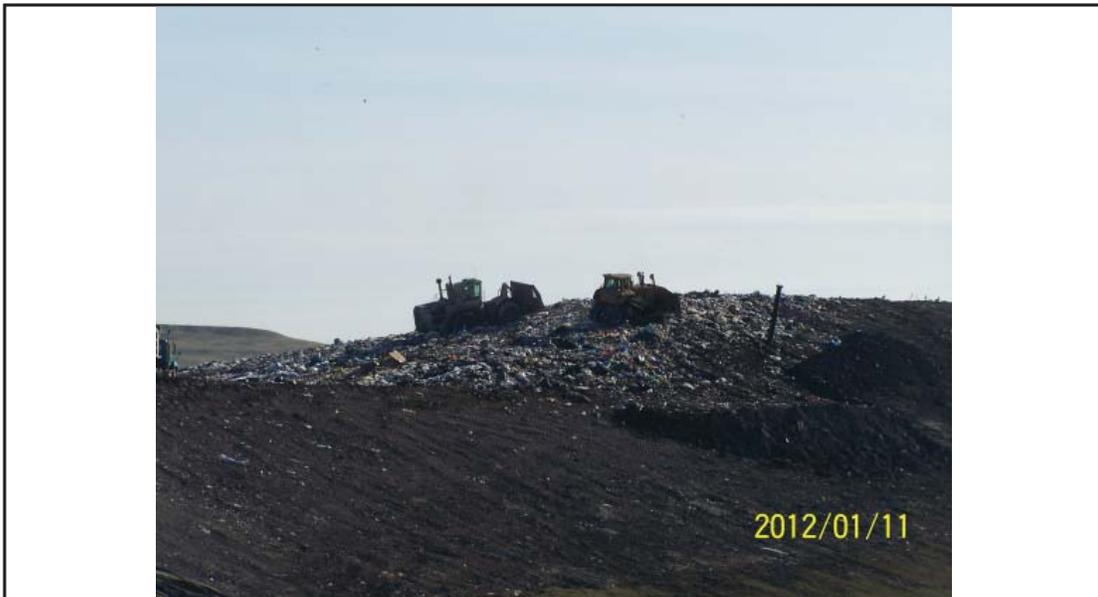
Active area

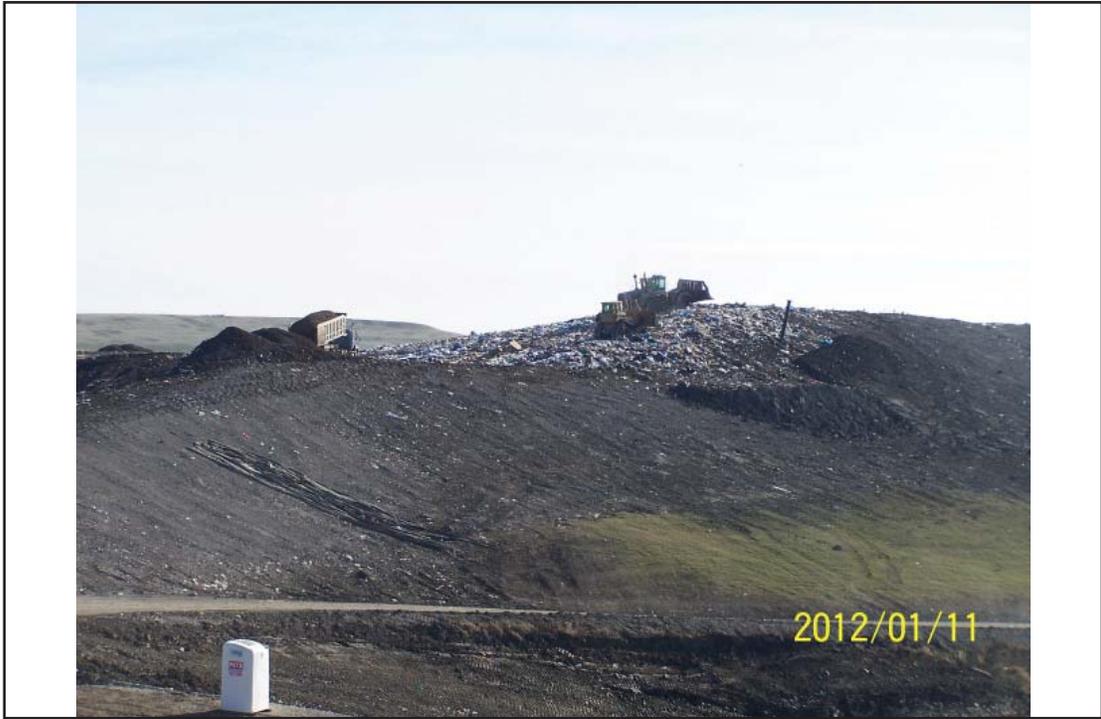
Working face at top of Phase 5/6

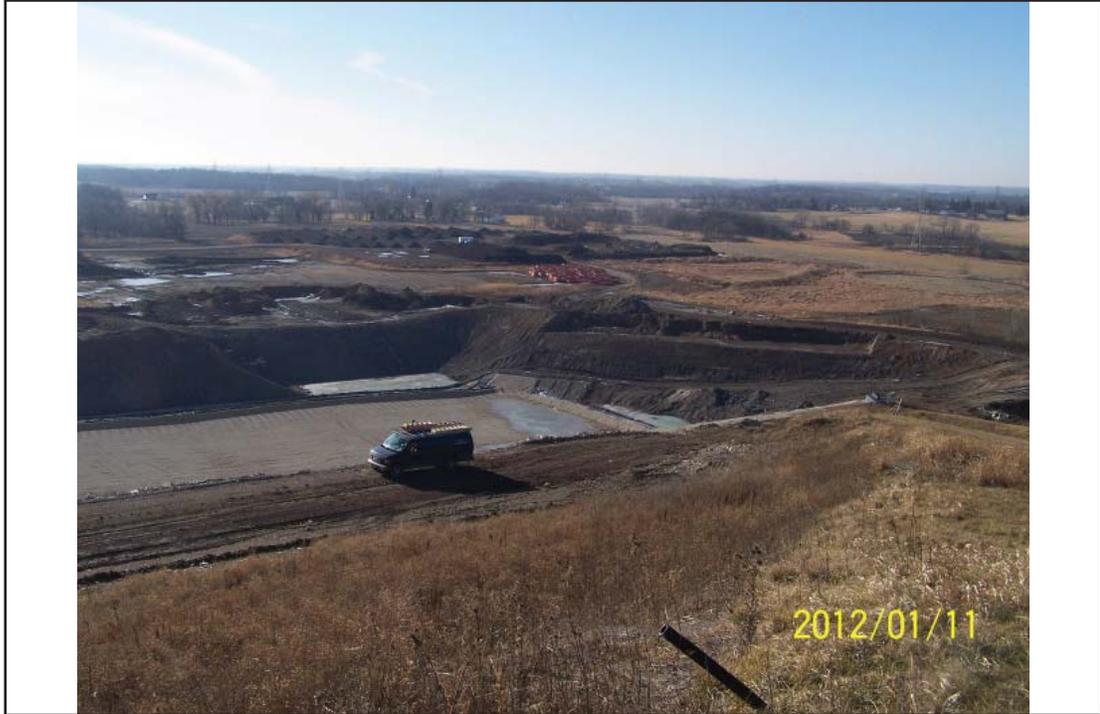
Phase 7 and compost area

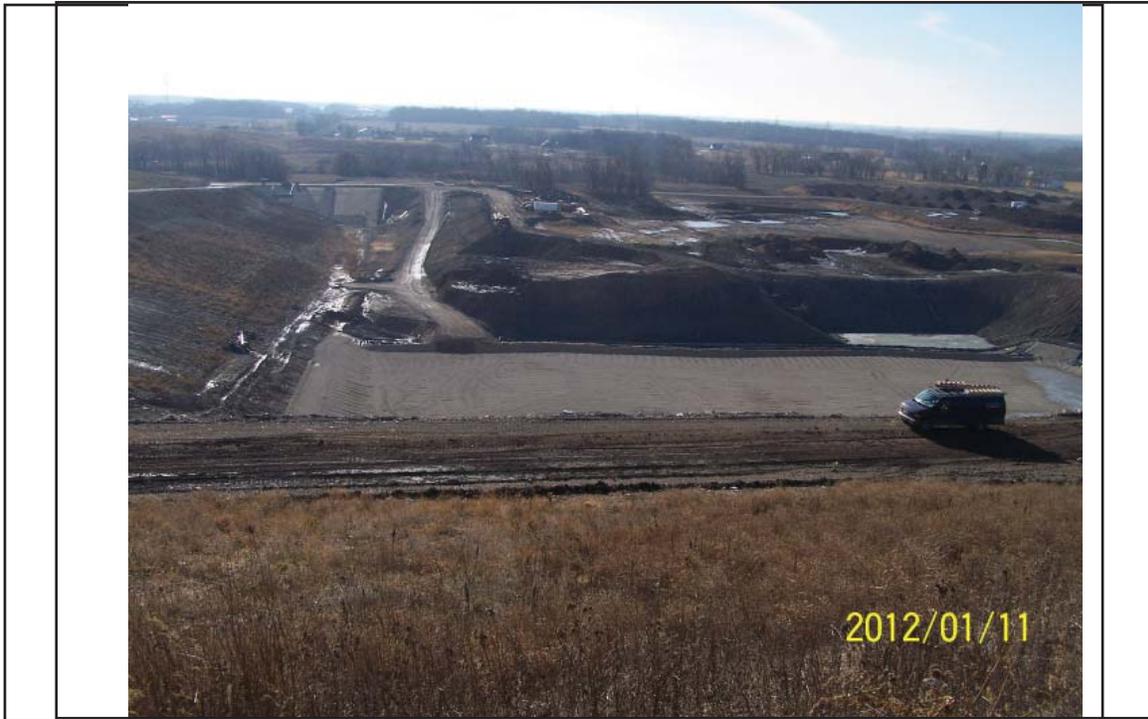
Phase 7 awaiting approval

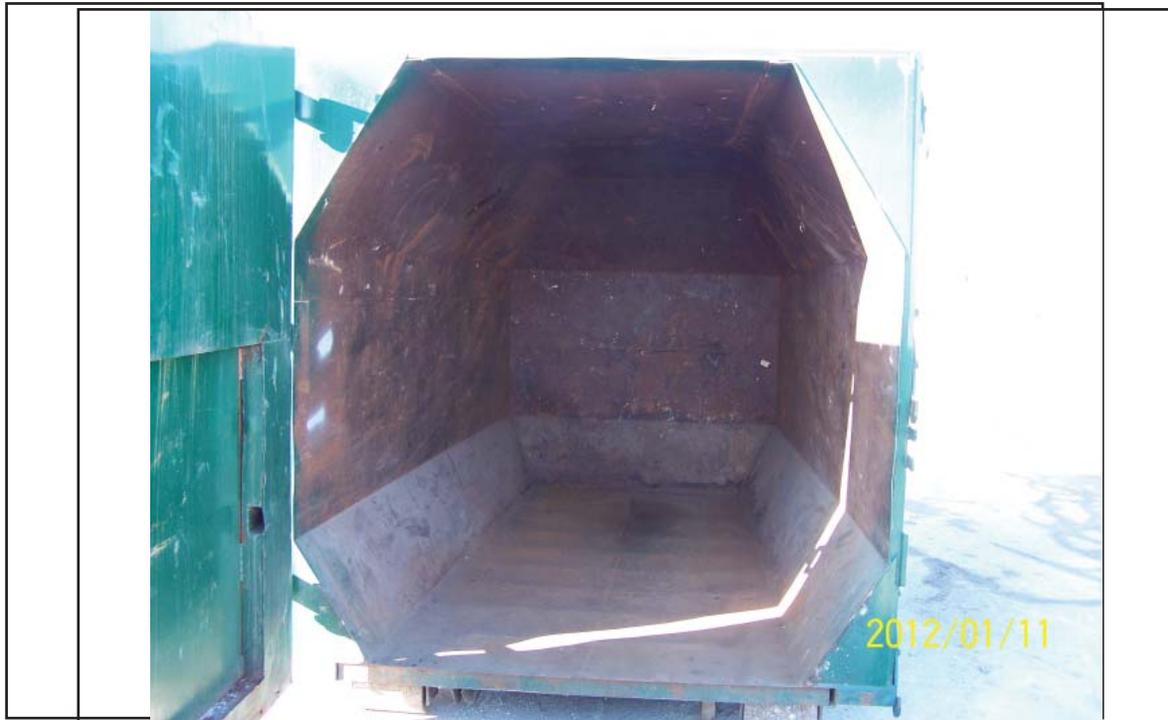
E-waste collection container read

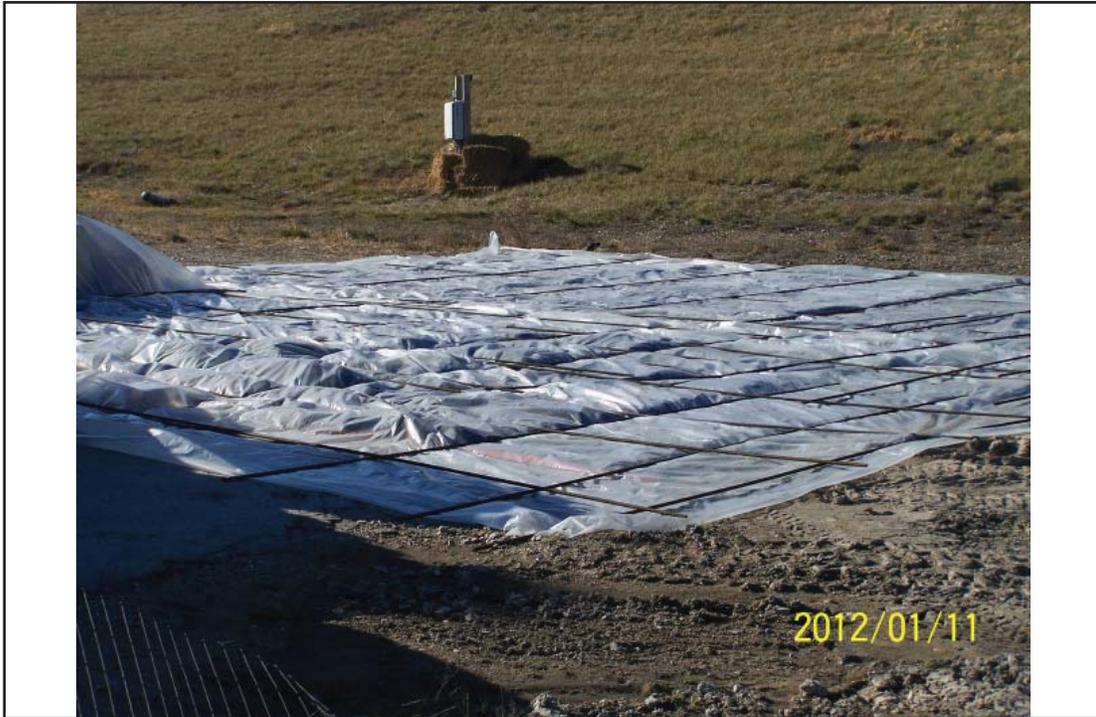
Preparing an area for future construction

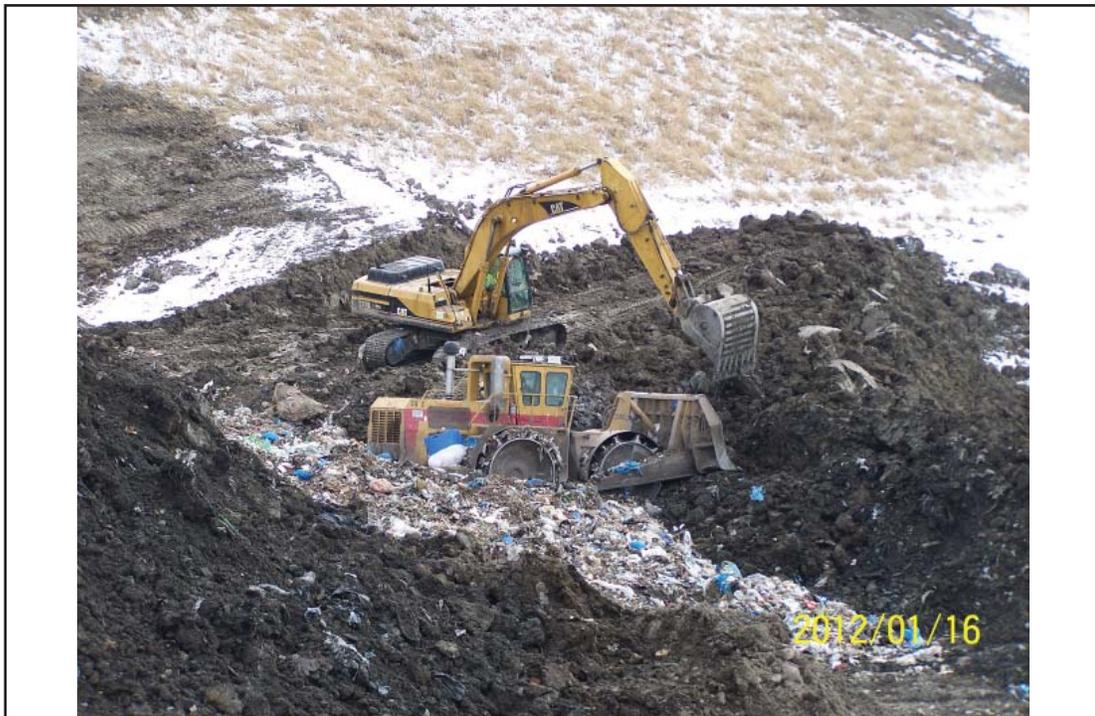
On January 16, 2012; waste receipt in Phase 7 was permitted, the process is called a fluff layer, photos only were taken on 1/16/2012

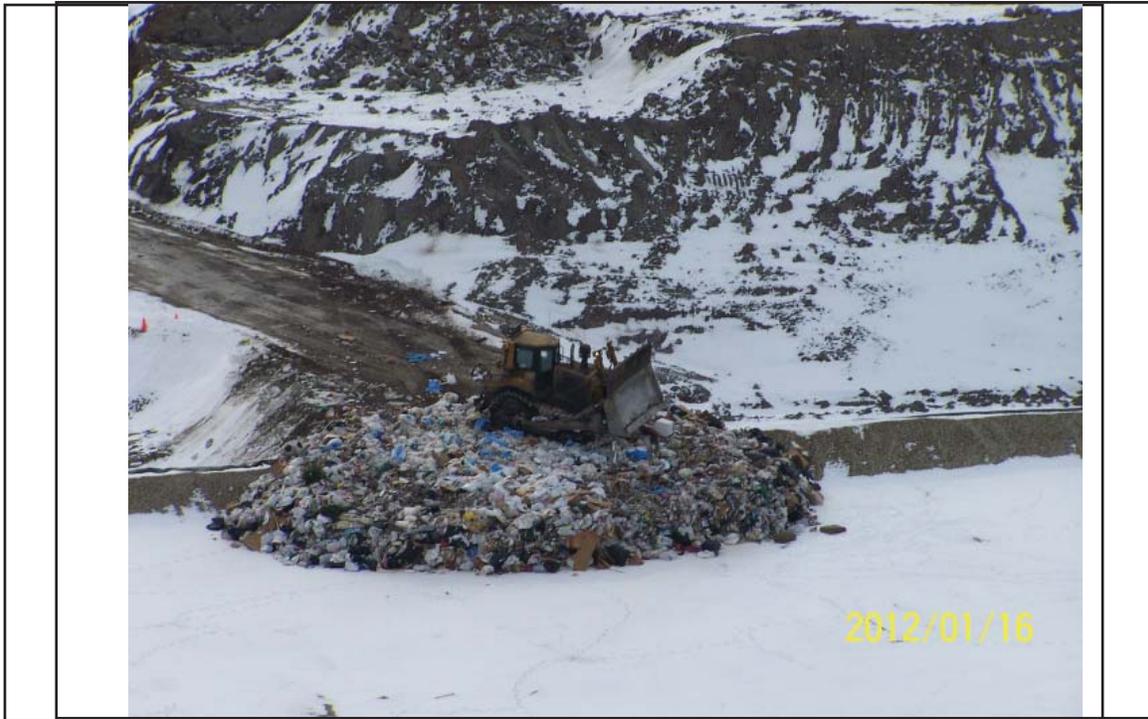
Fluff Layer

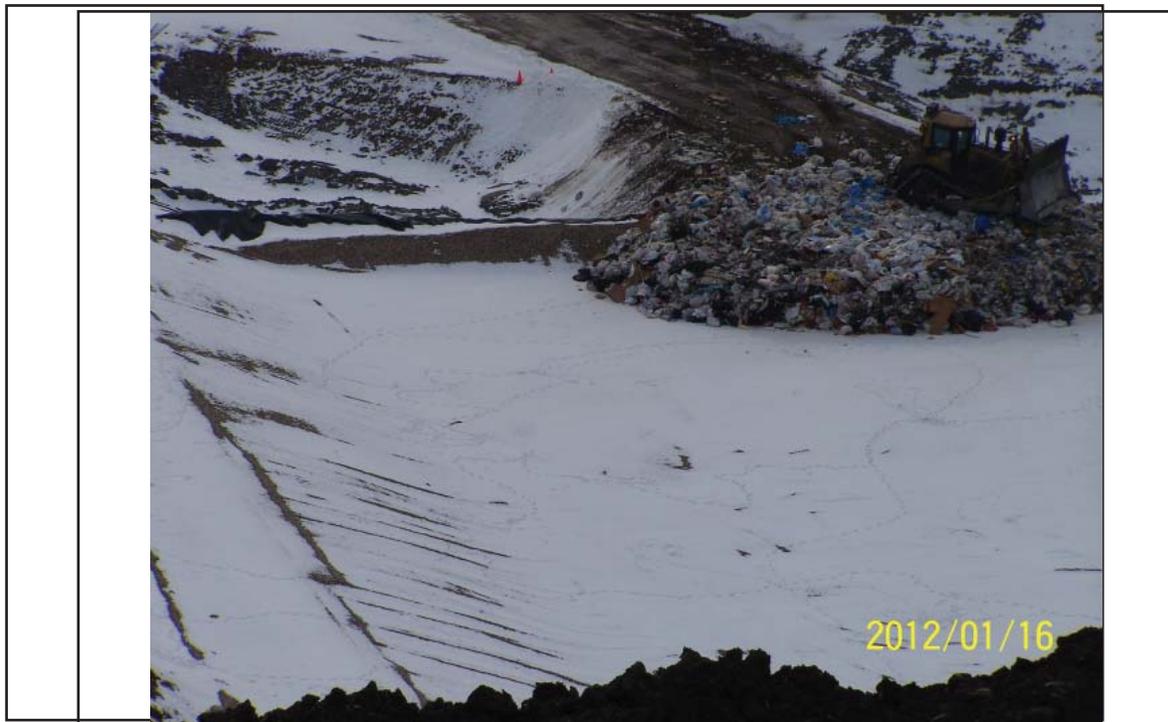
Fluff layer being spread out from access road

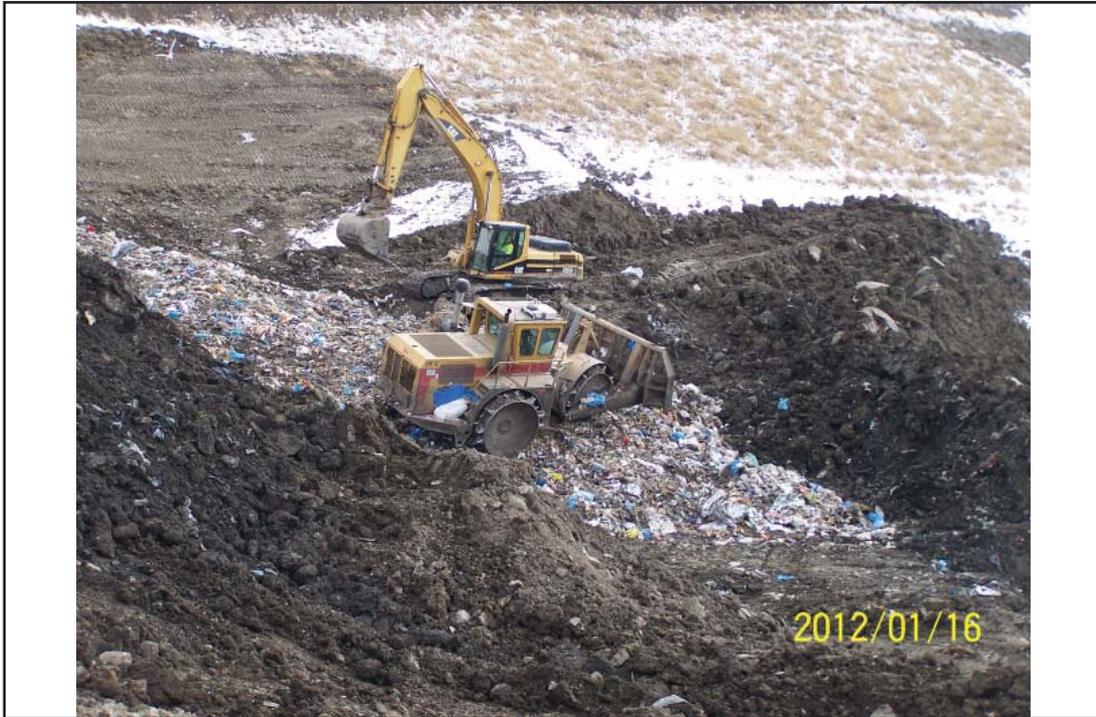
Current working face in side slope of Phase 3

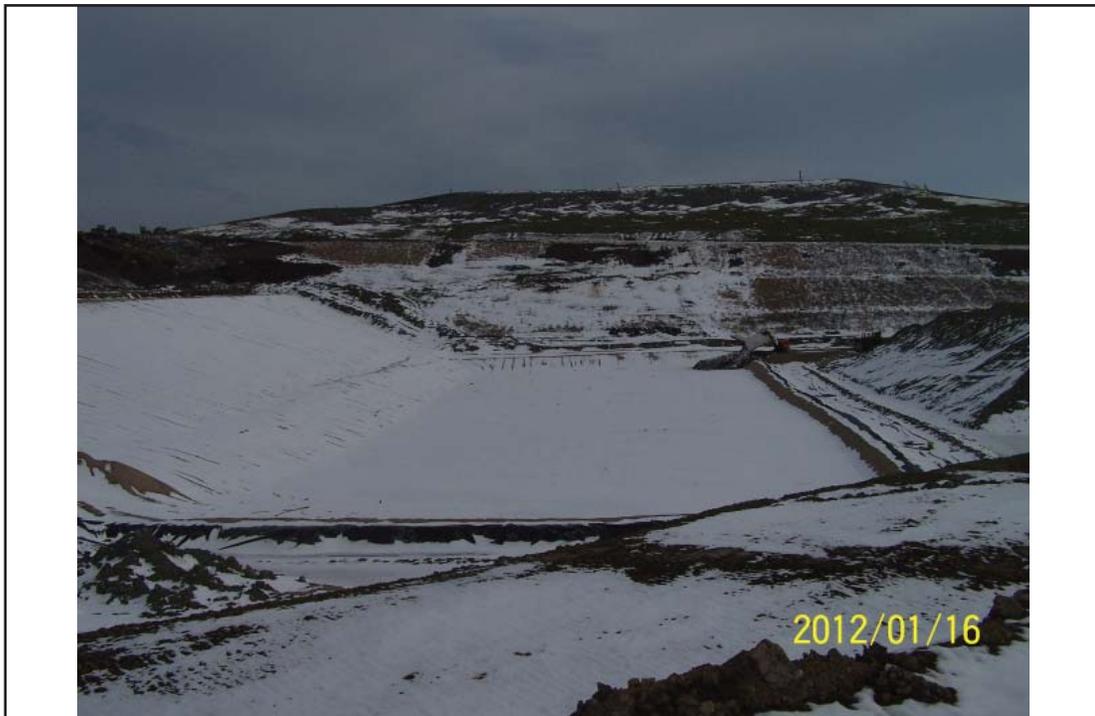
Phase 7 overview on first day receiving waste, in a fluff layer

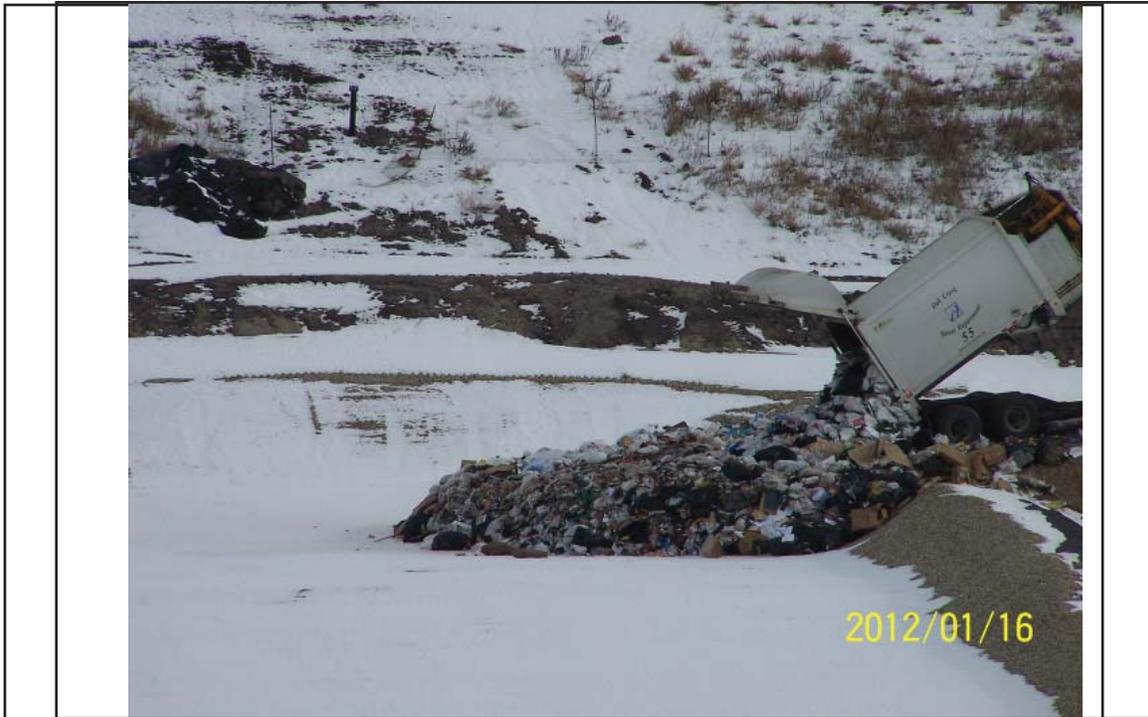
Fluff layer being added, and then will be pushed out into the cell

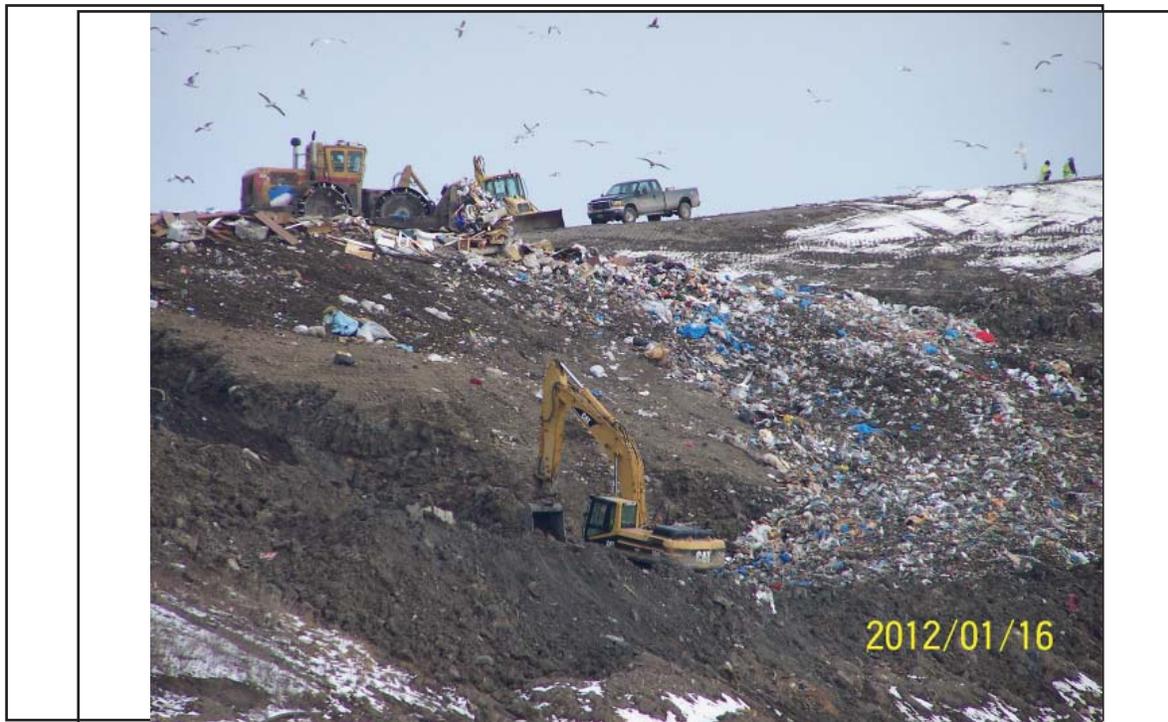
Excavator preparing future waste placement location

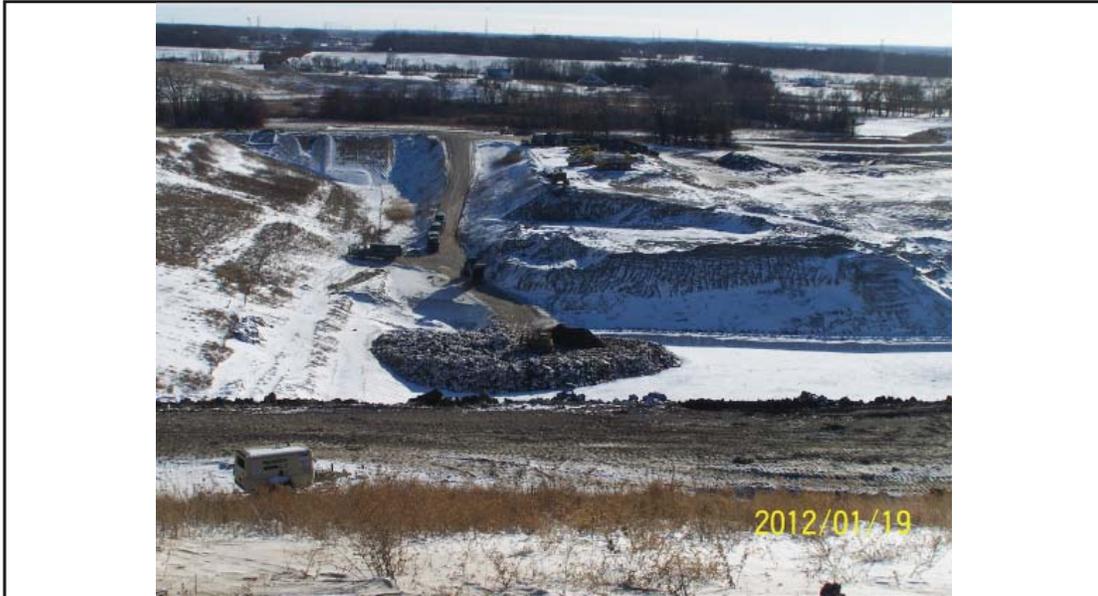
Phase 7 overall

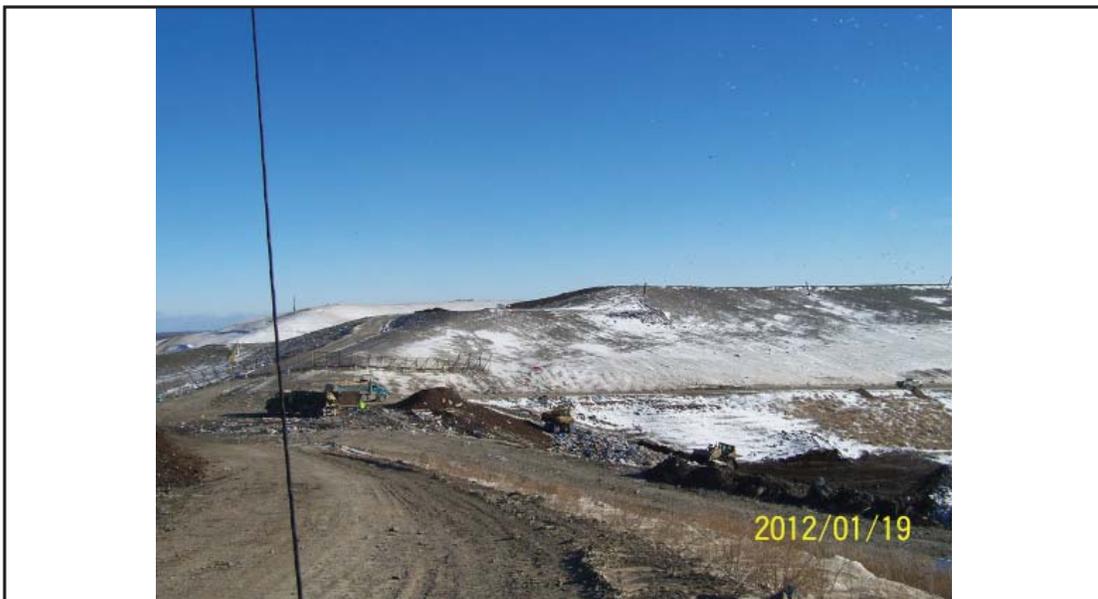
Active area

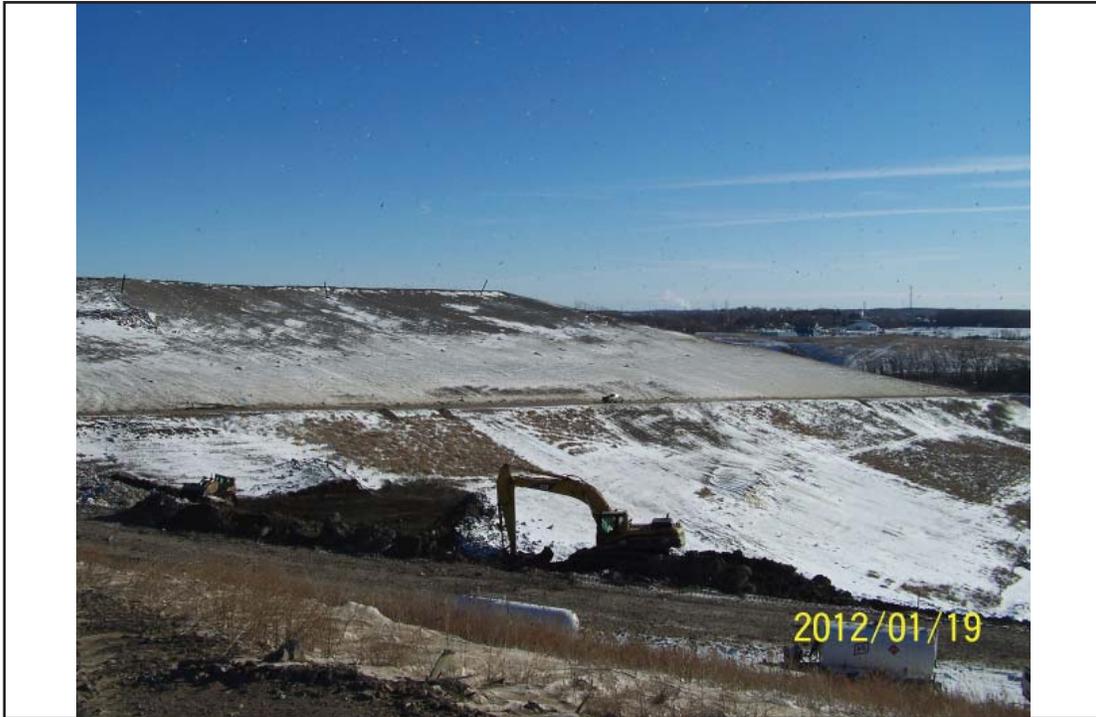
Excavation of slope soils for future waste placement

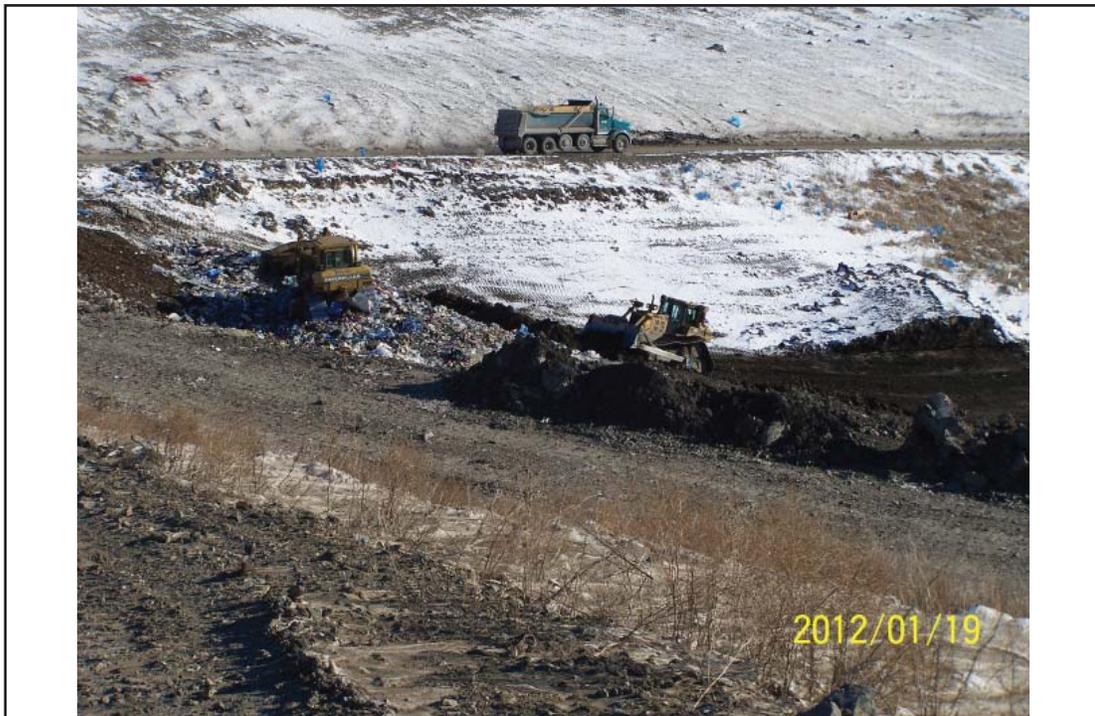
Working face viewed from top of Phase 2

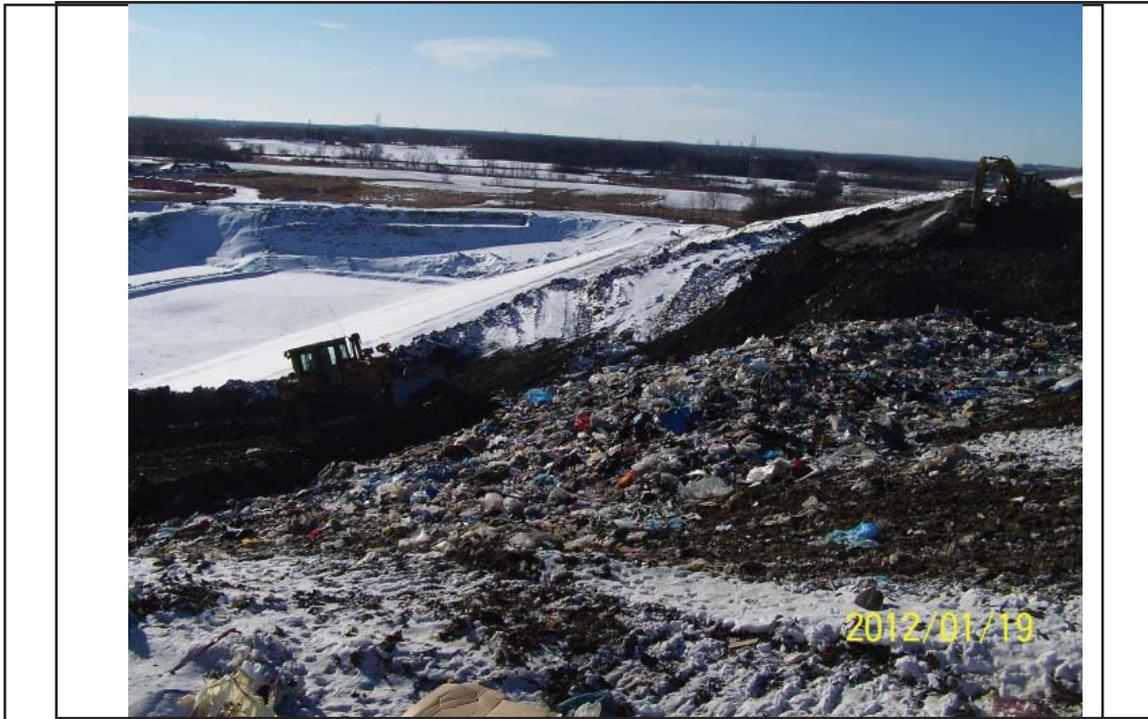
Working face

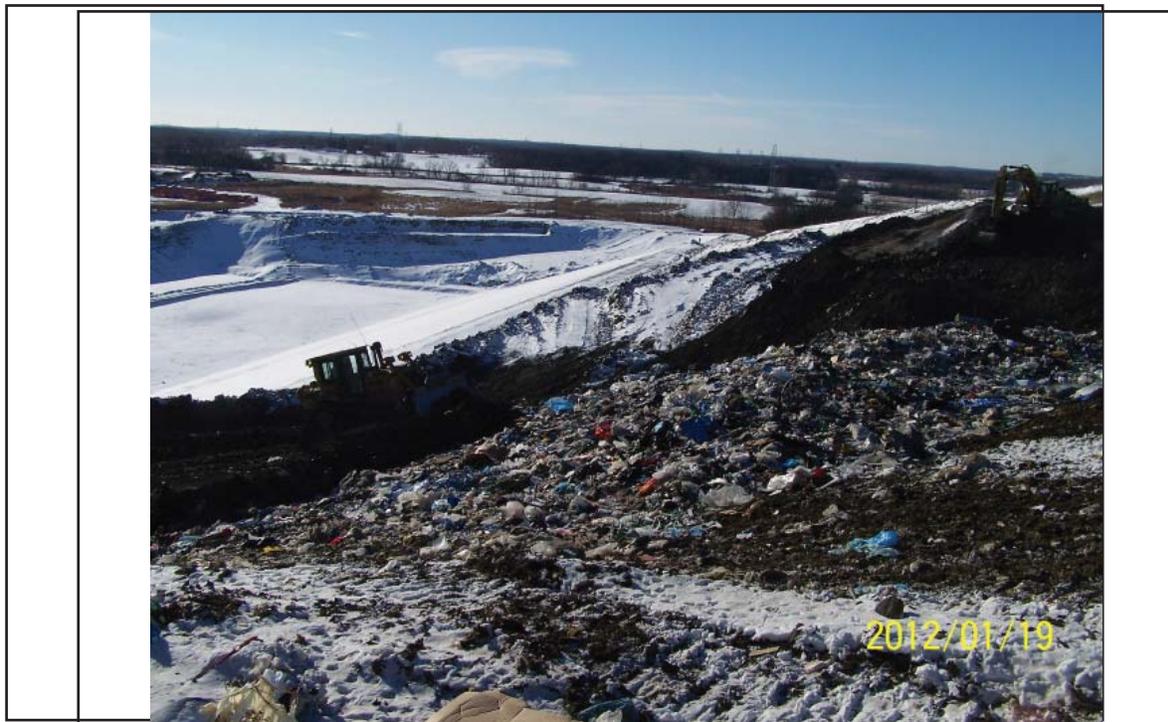
Working face

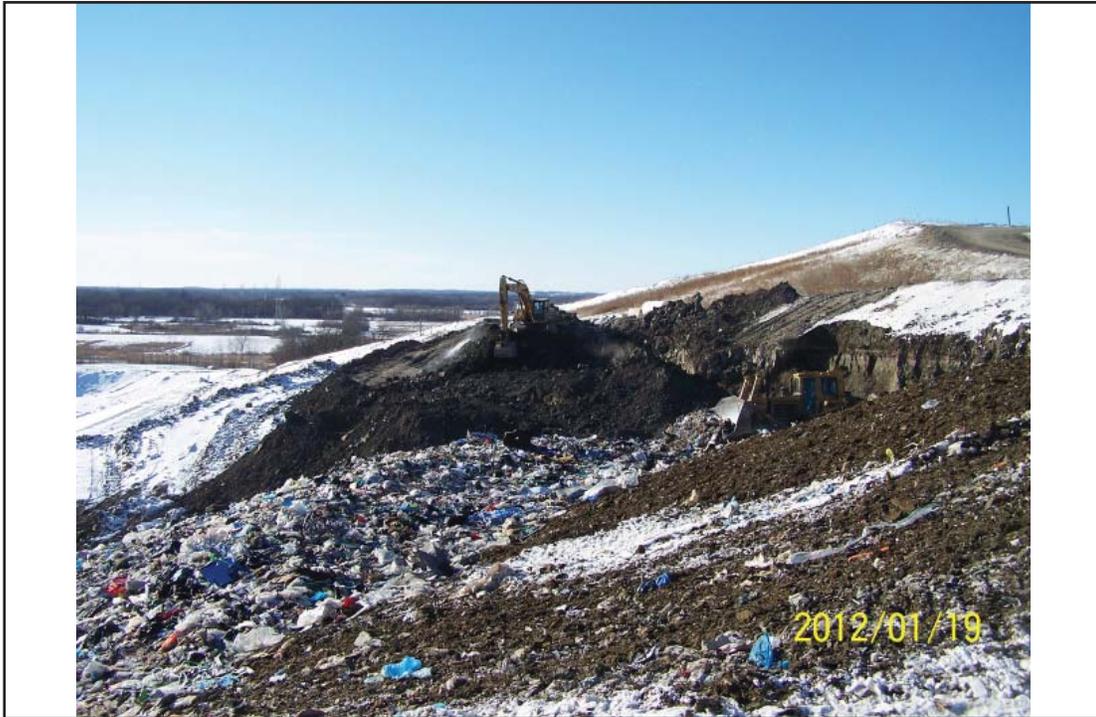
Working face notched into slope

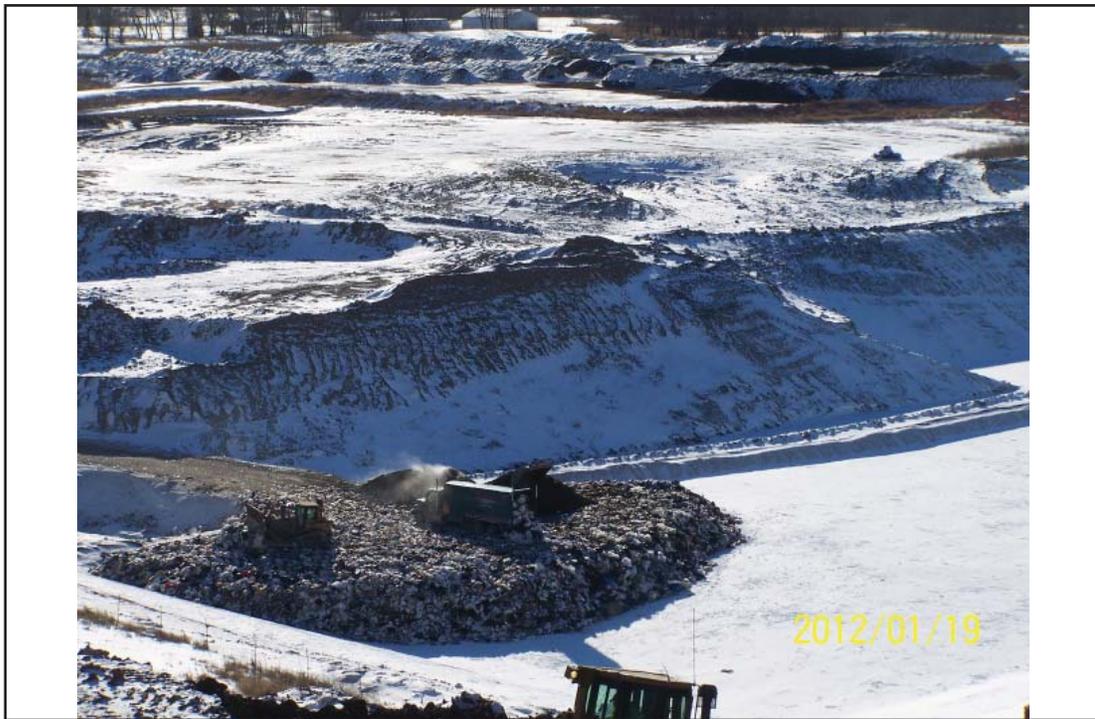
Phase 7 fluff layer spreading

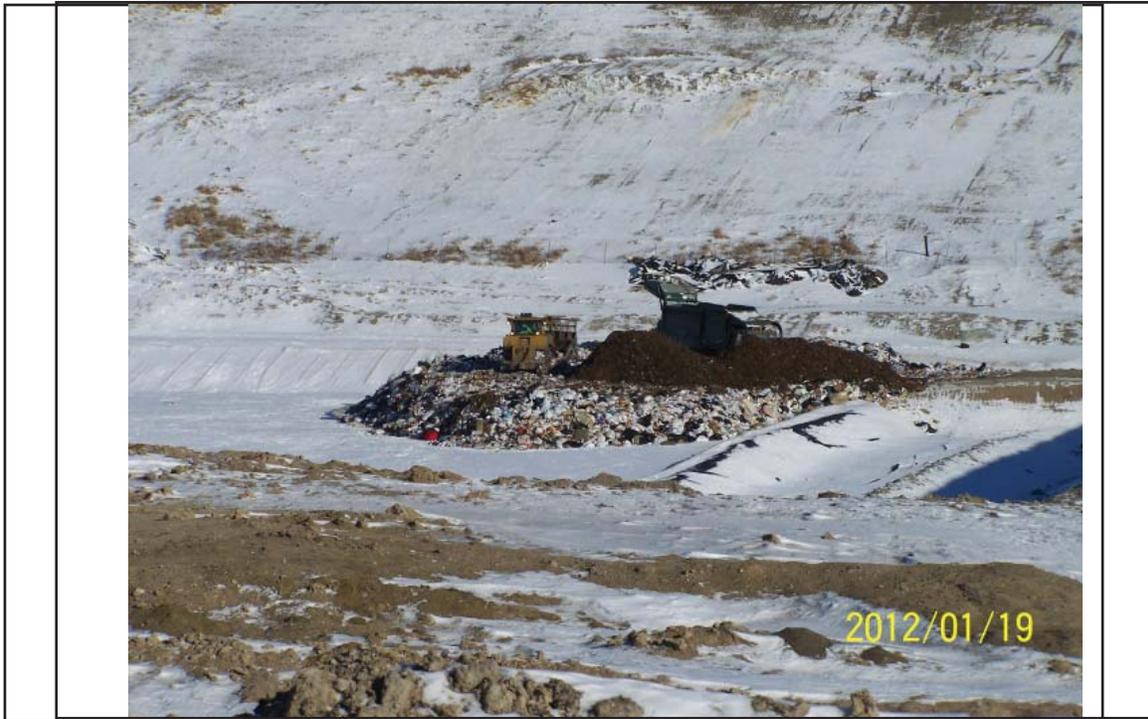
Phase 7 fluff layer with autofluff stockpiled for cover

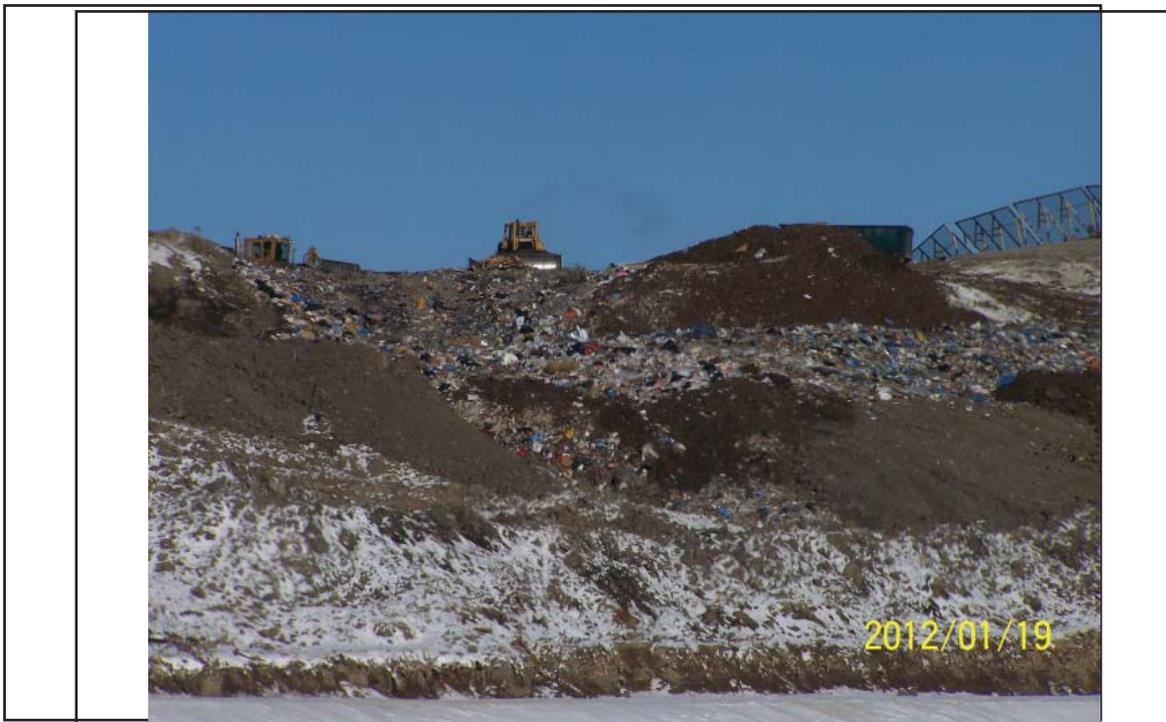
Active area on South slope of Phase 3
