2012 Advanced Disposal Services Emerald Park Landfill Year End Compliance Officer Report and Audit Summary

TO: Veolia Emerald Park Standing Committee
FROM: Jo-Walter Spear, Jr., P.E.
COPIES: File
DATE: 04/04/13
PROJECT NUMBER: 1012.10030

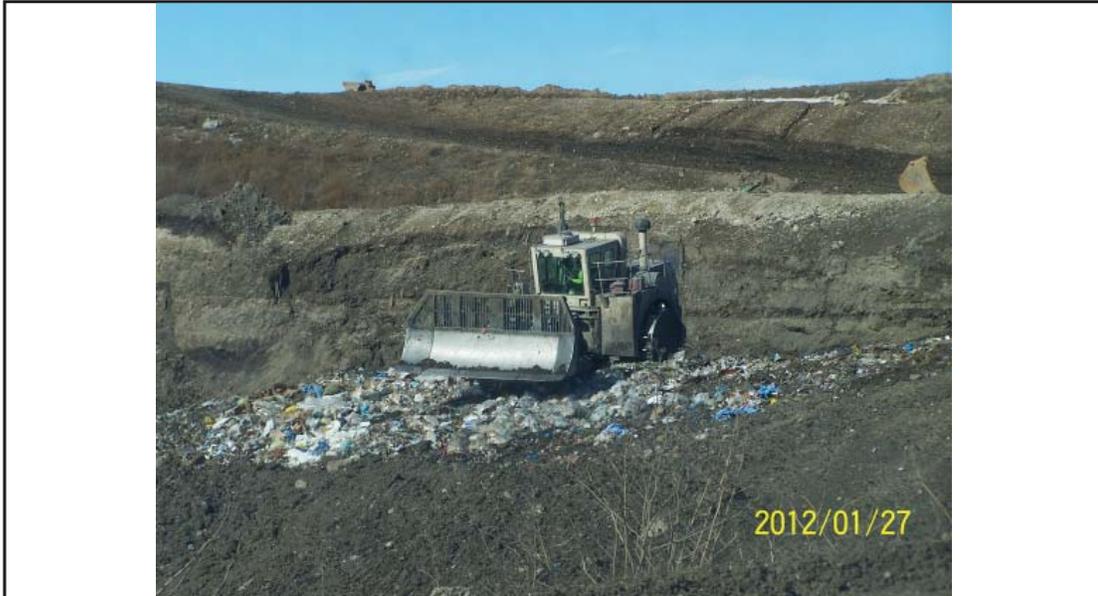
Working face in Phase 3 South Slope

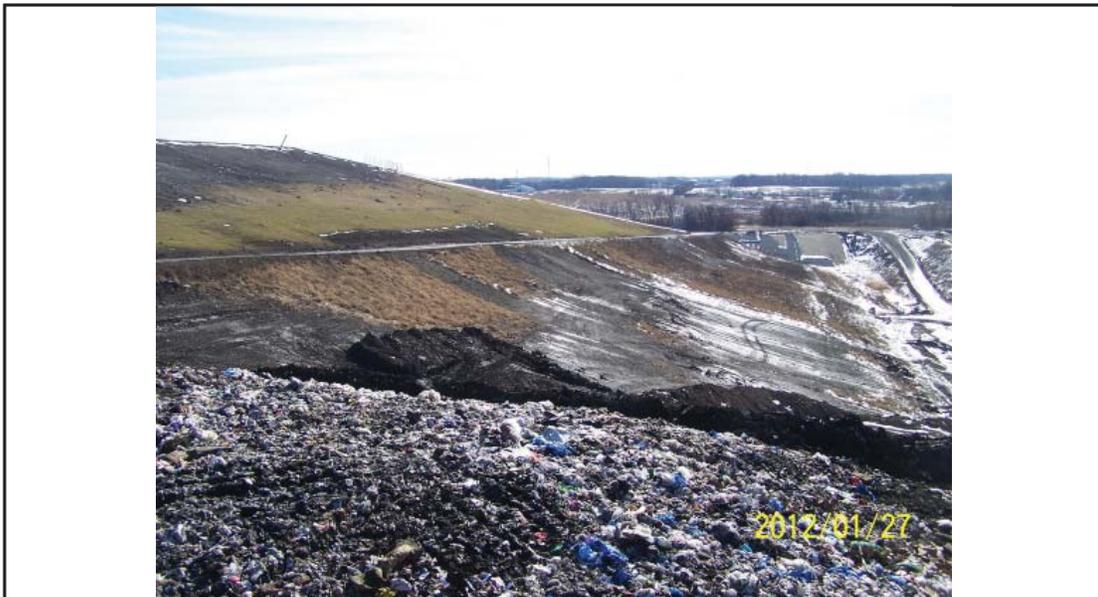
Working face

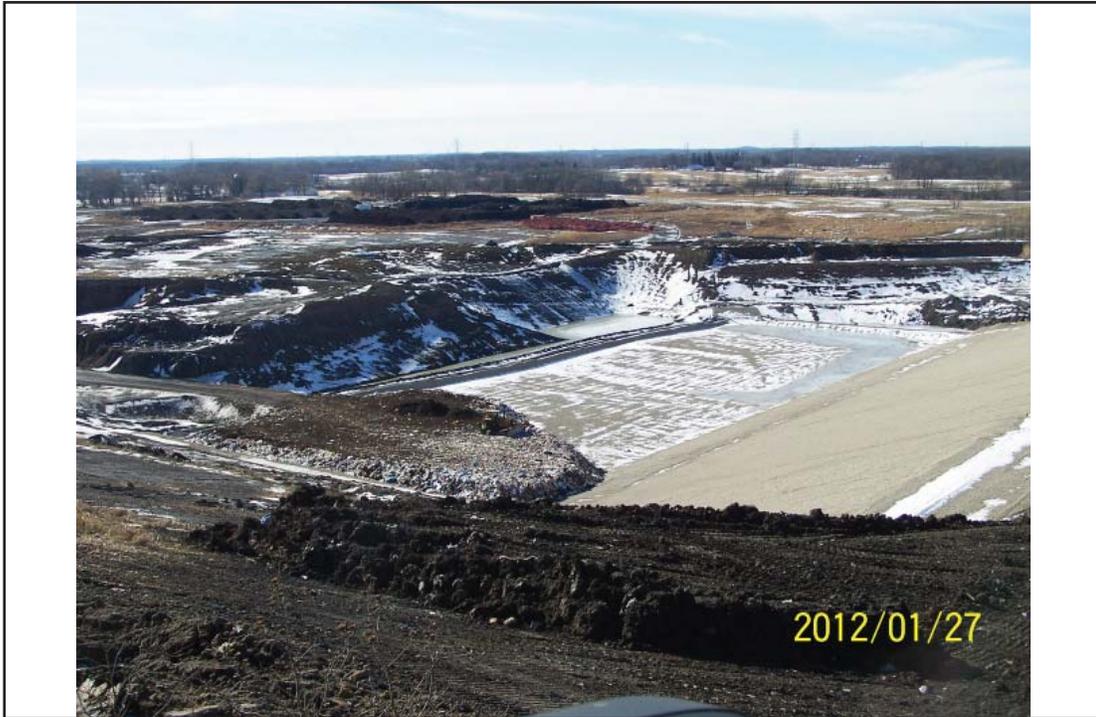
Fluff layer progression across Phase 7

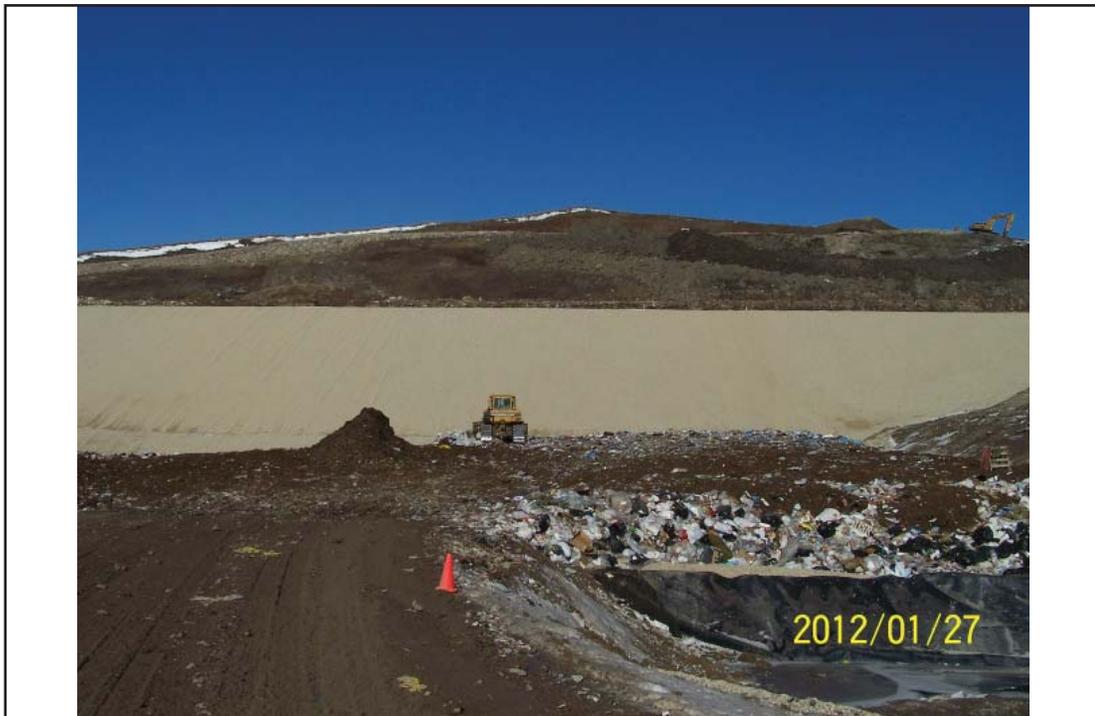
Fluff layer at grade

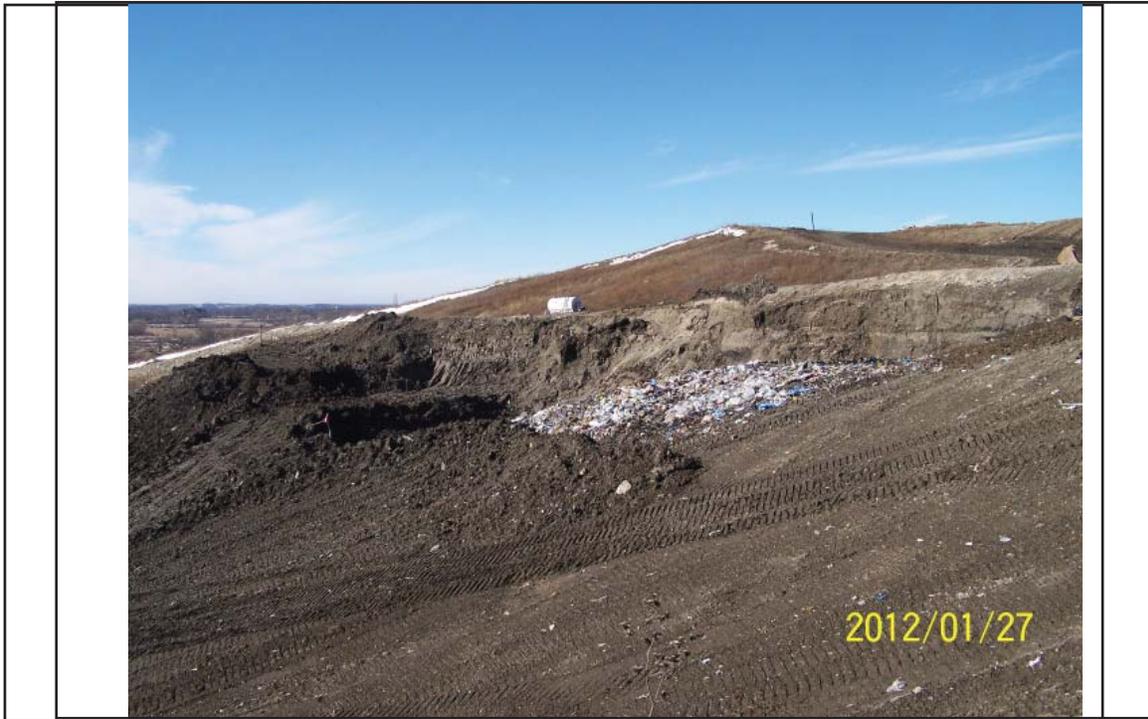
Working face in side slope

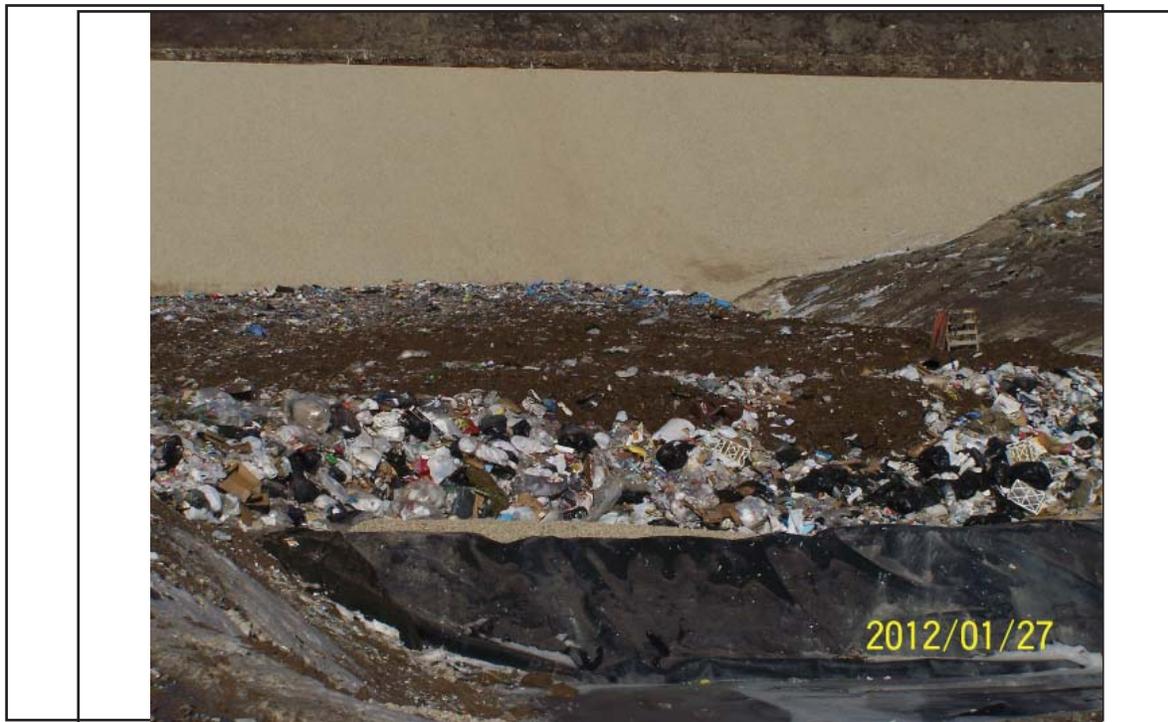
Fluff layer, approxiamately 10 feet thick

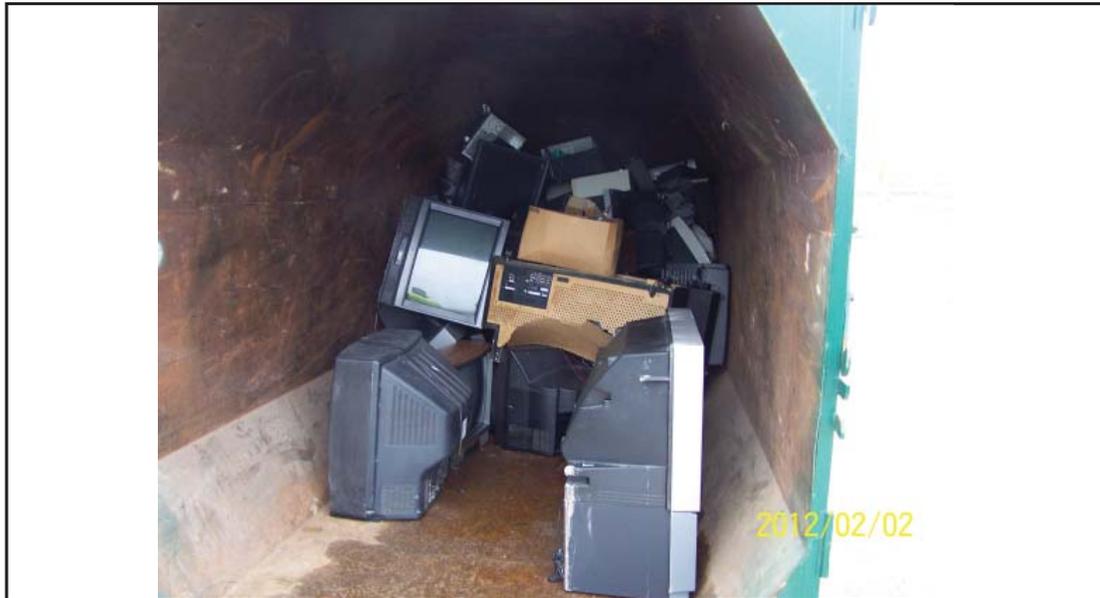
E-waste box 1/2 full

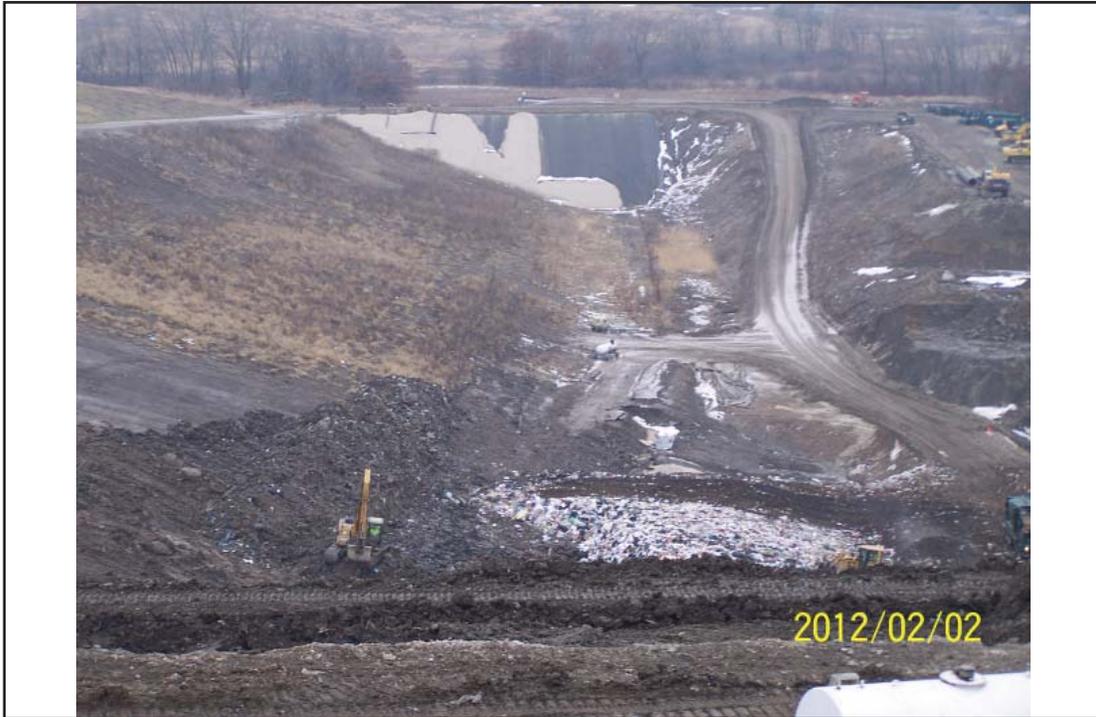
Phase 6/7 junction

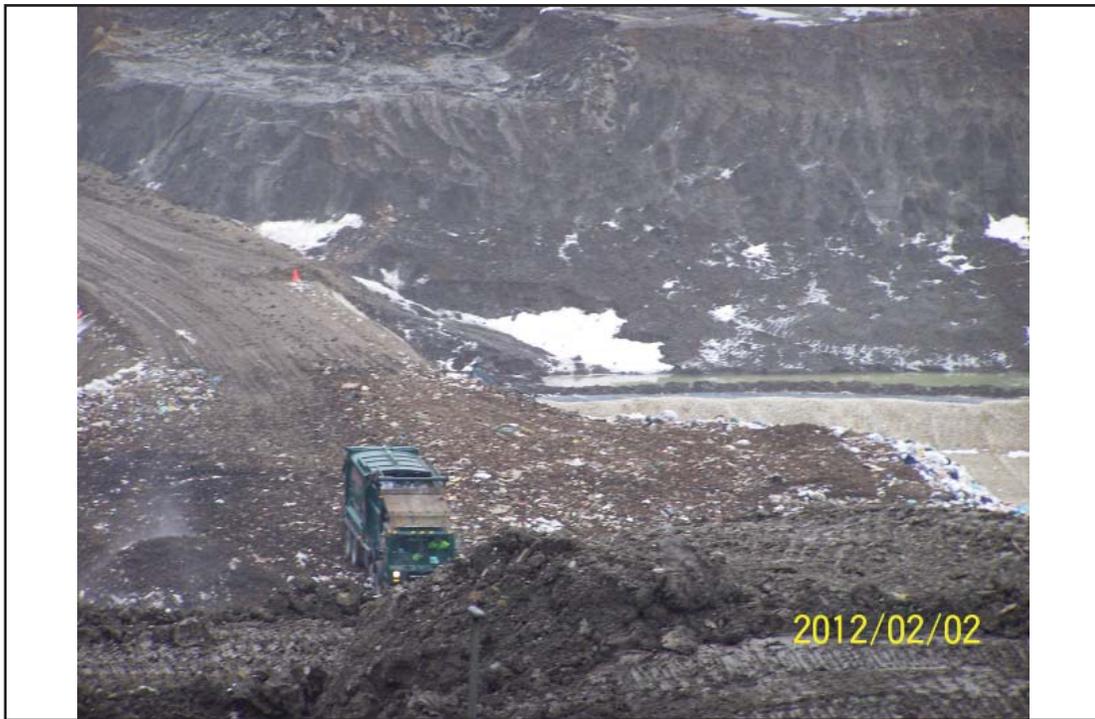
Fluff layer receiving waste

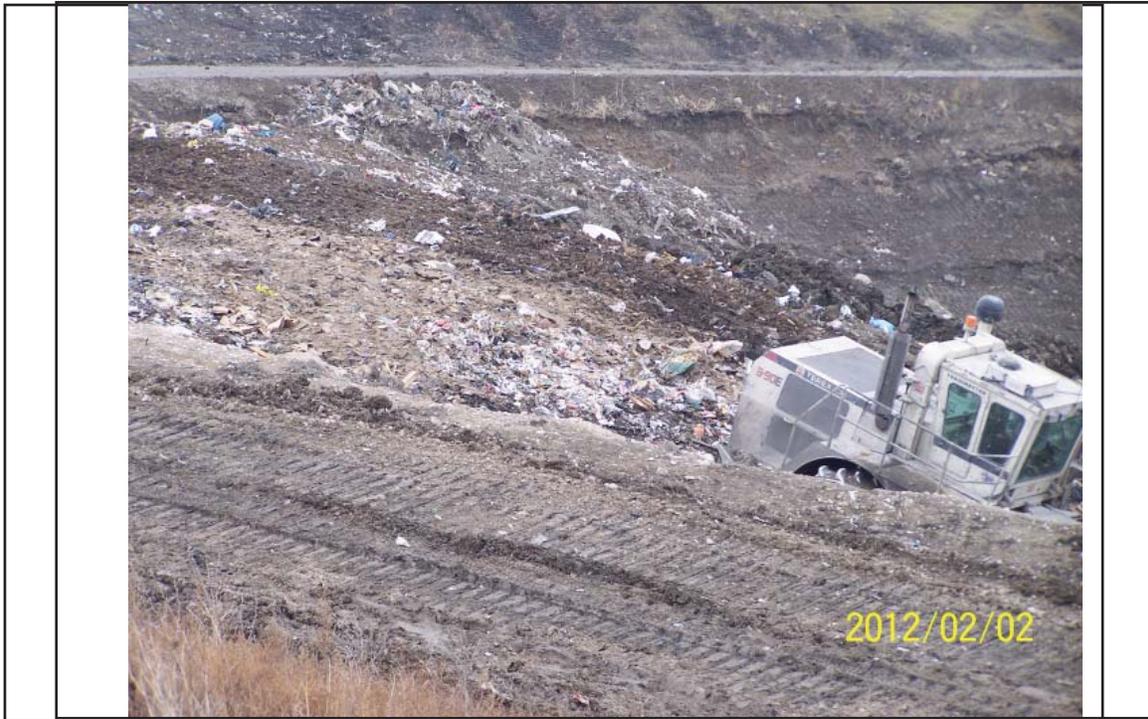
Working face in side slope

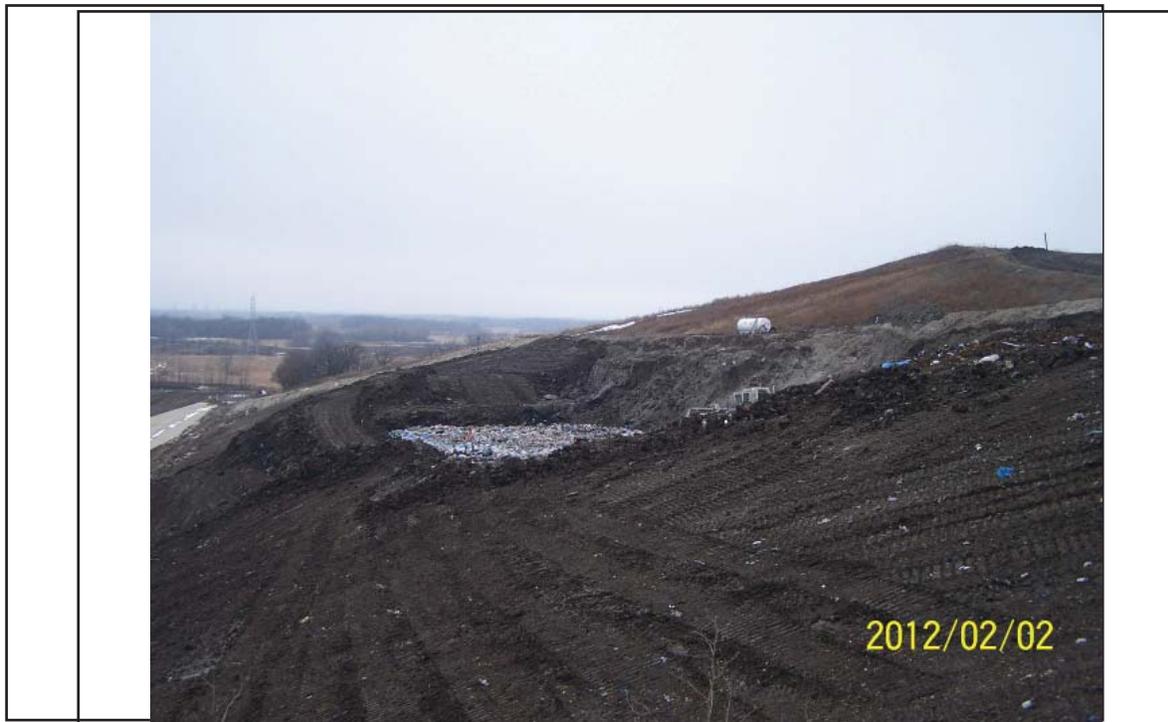
Working face in side slope of Phase 3

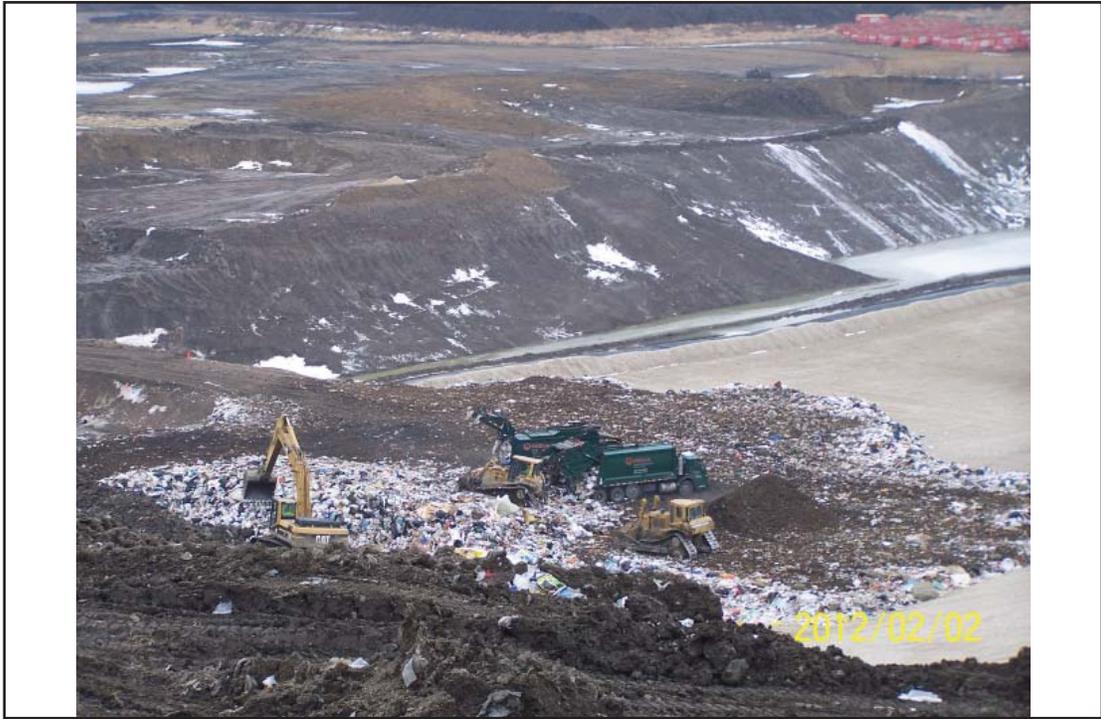
Phase 7, with working face in side slope of Phase 3 above

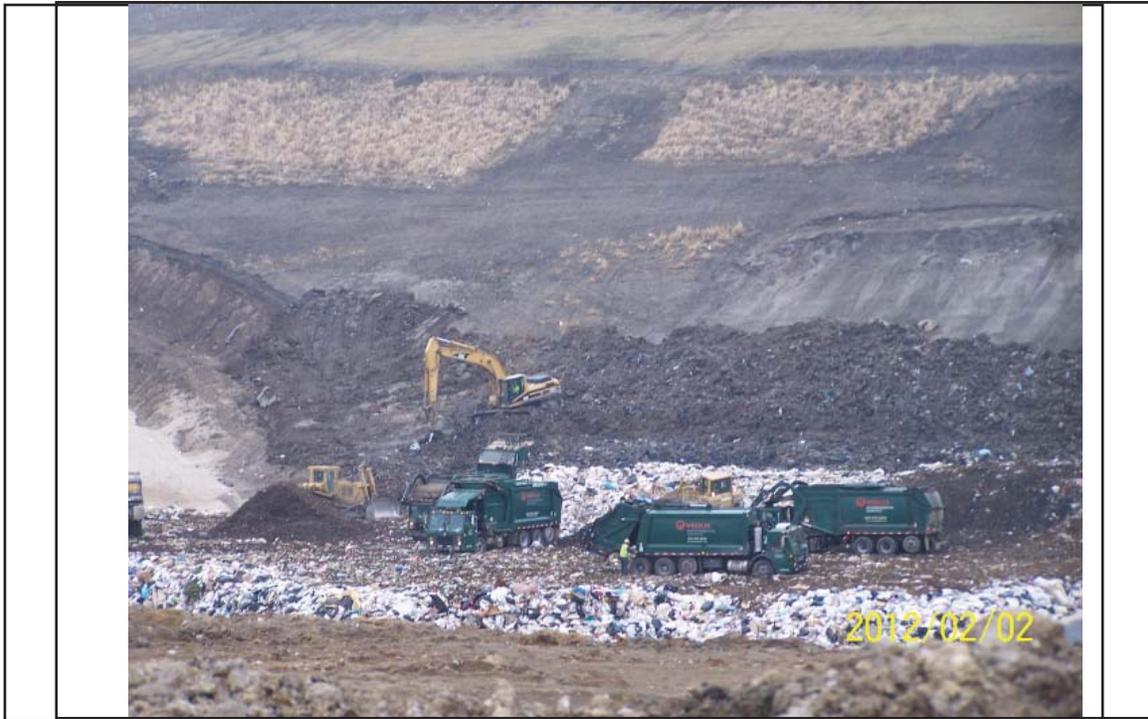
Fluff layer large enough to allow trucks to tip in Phase 7

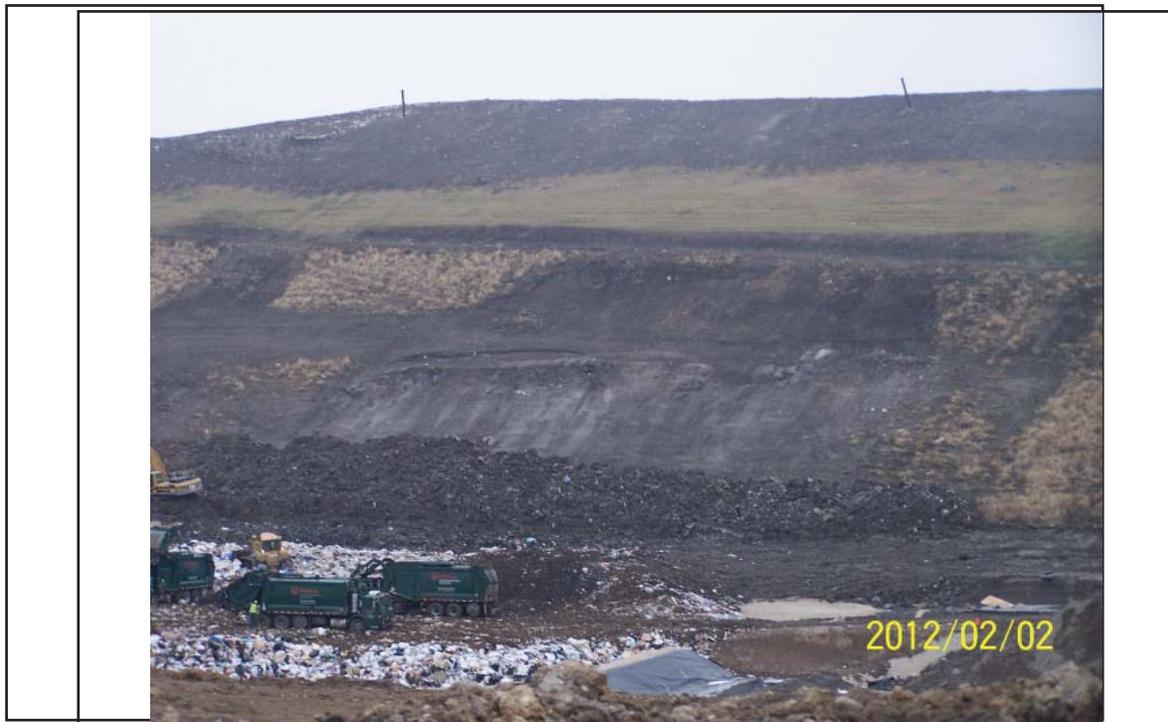
Phase 7 and Phase 6 West slope, future waste placement location

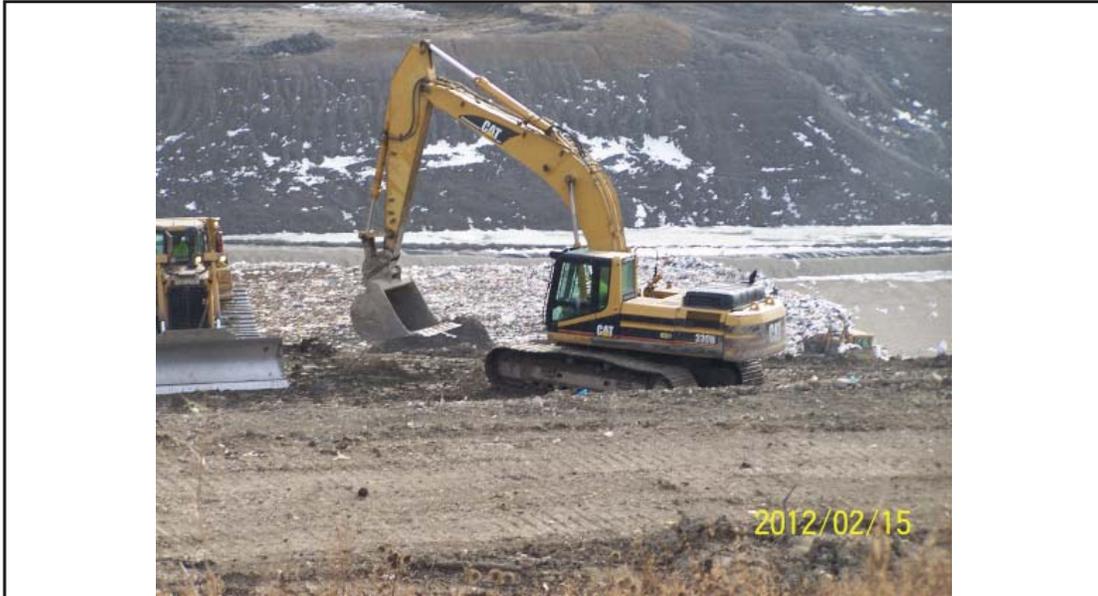
Excavator helping with fluff layer spreading

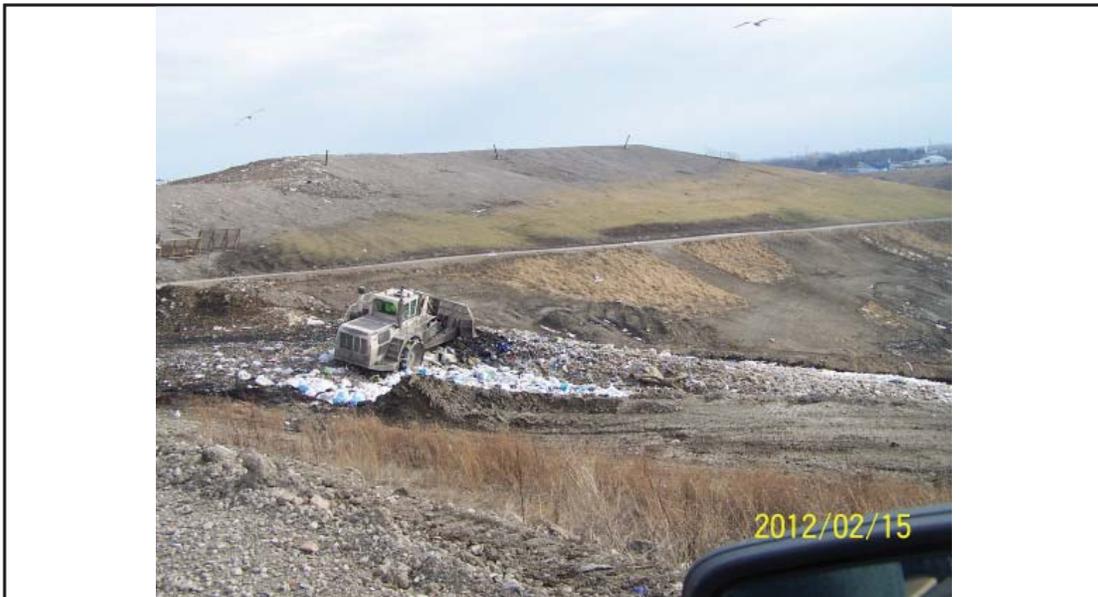
Compactor active above fluff layer

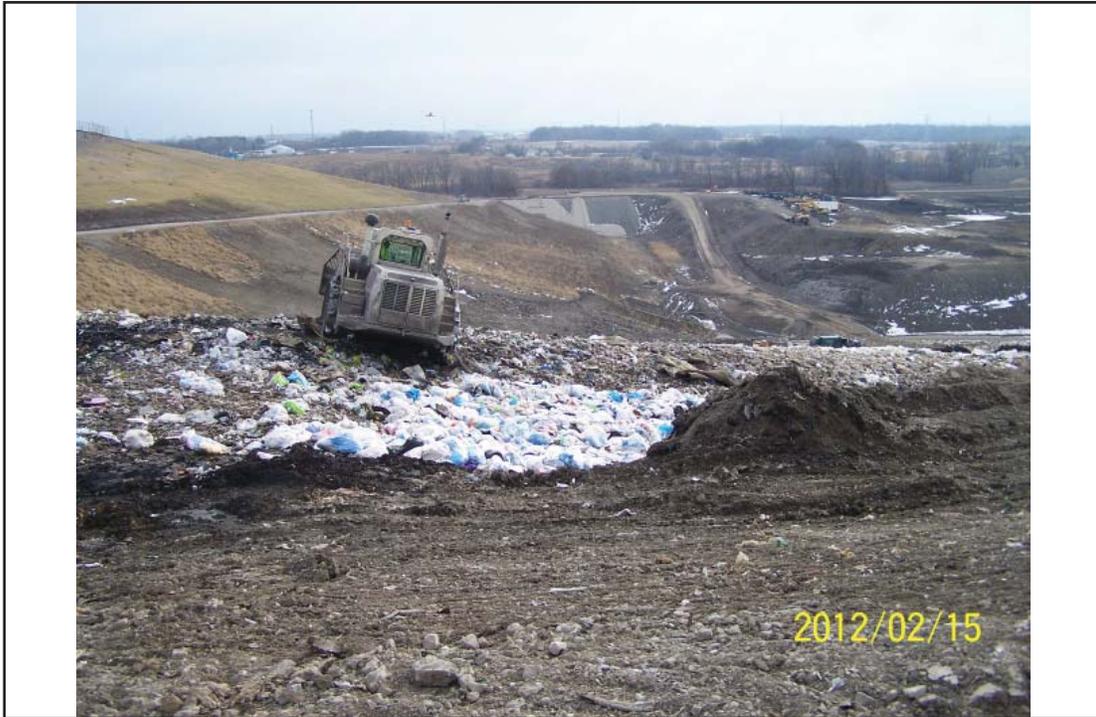
Working face in South slow of Phase 3

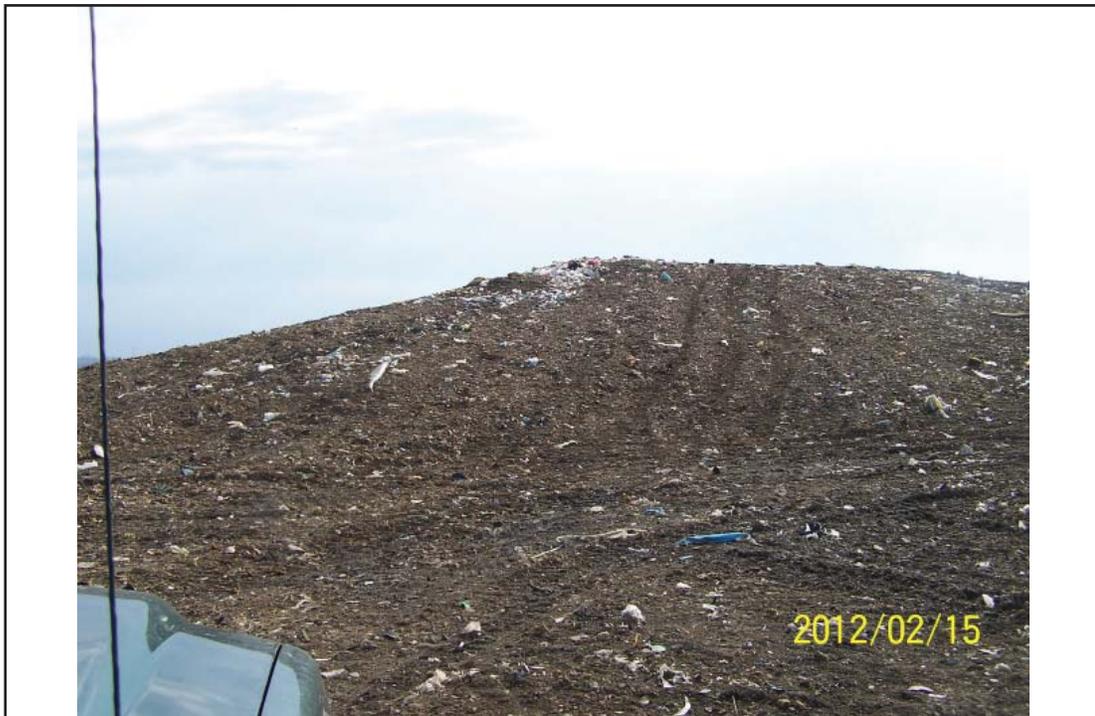
Site's highest point on Phase 5

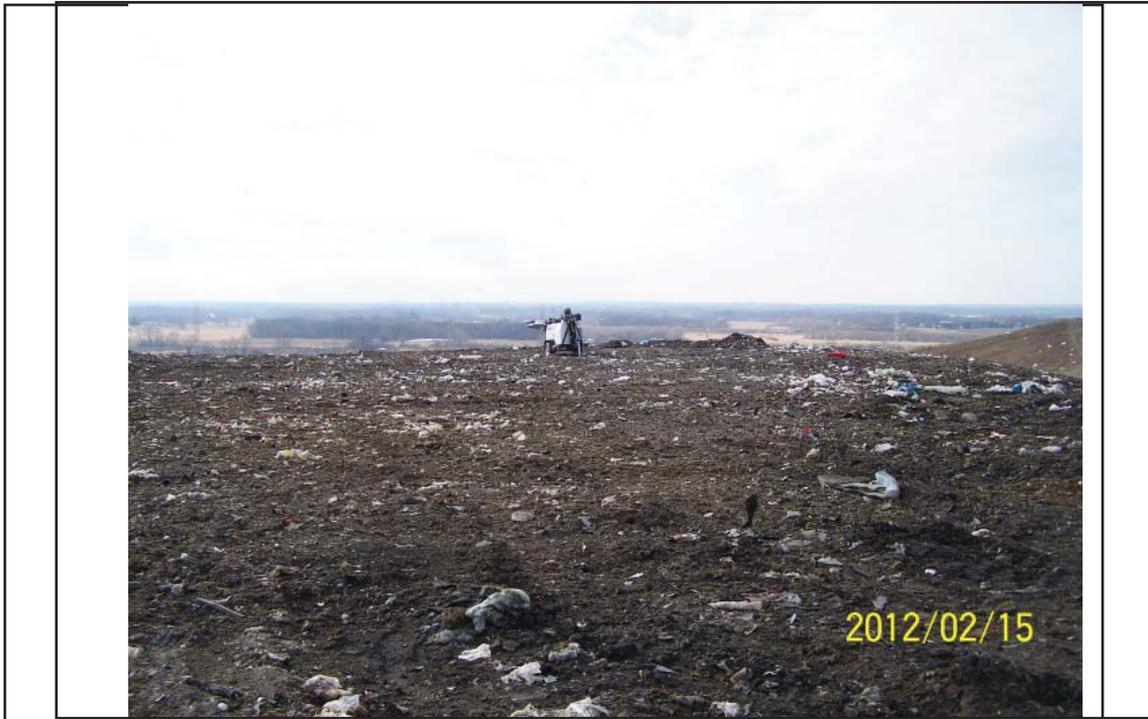
Landfill direct soils

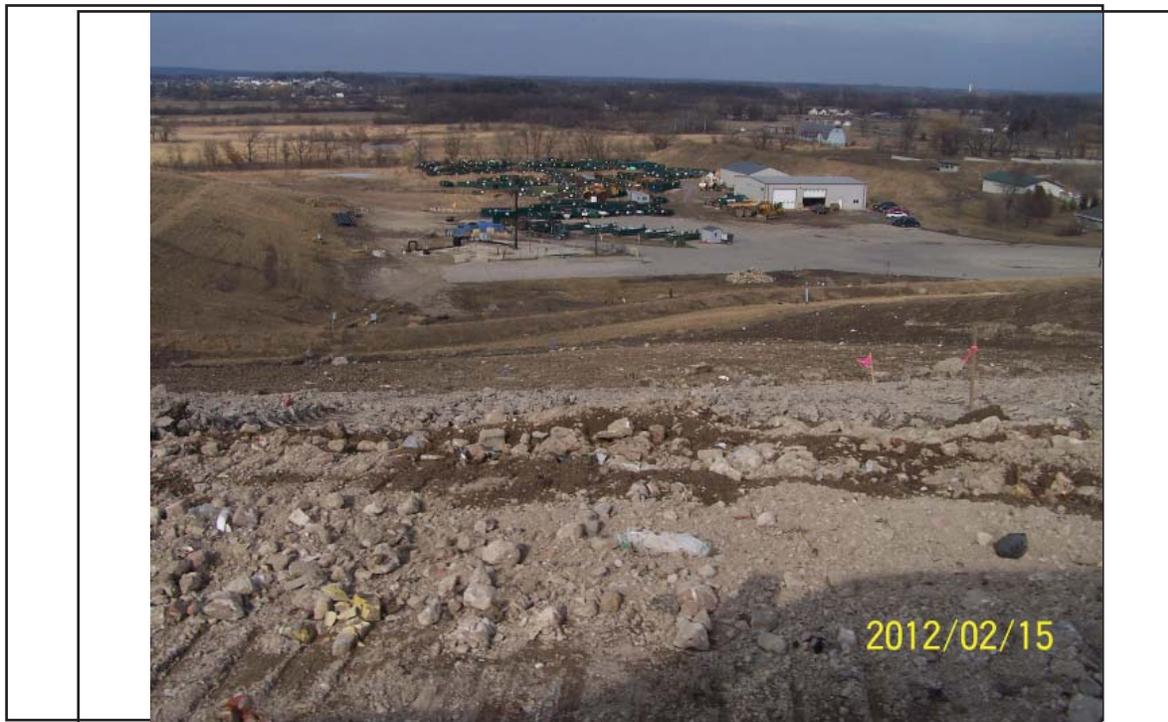
North slope of Phase 4, additional clay to be added prior to top soil and planting

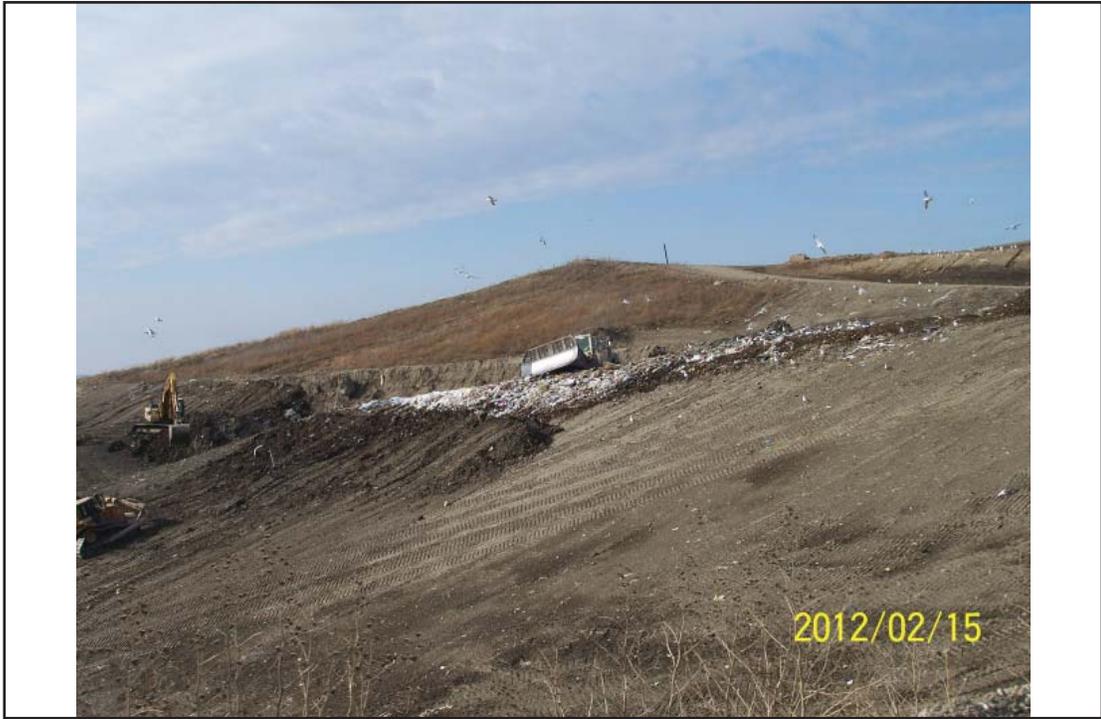
Working face in South slope of Phase 3

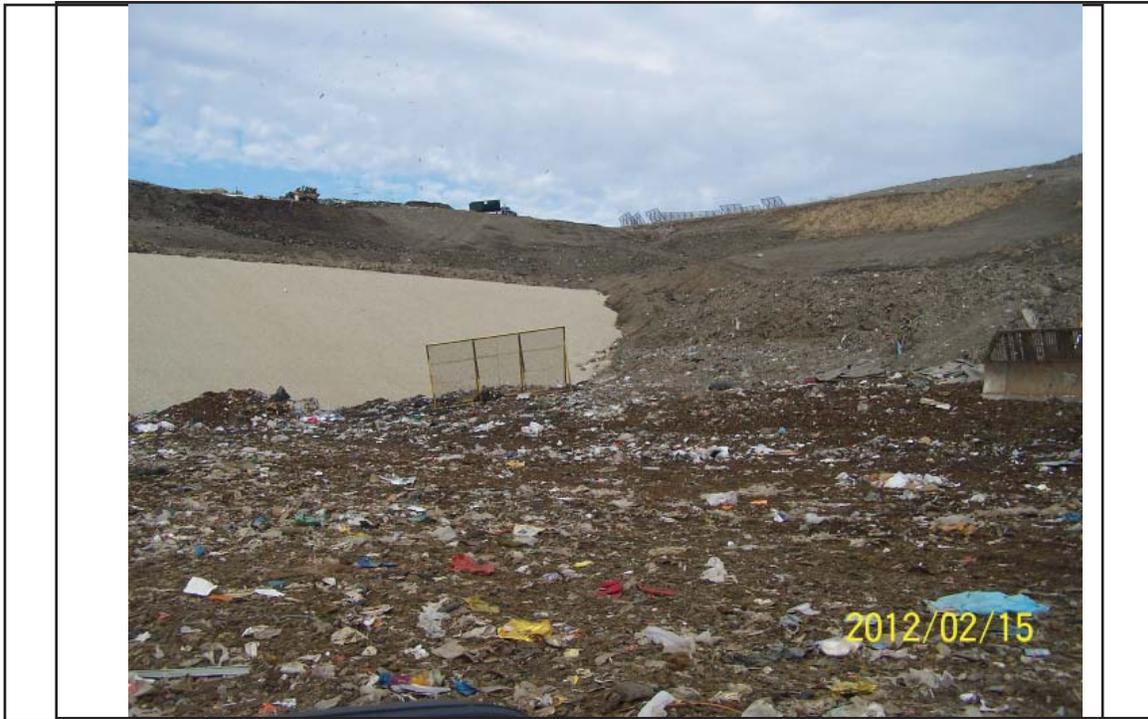
Fluff layer after placement and use

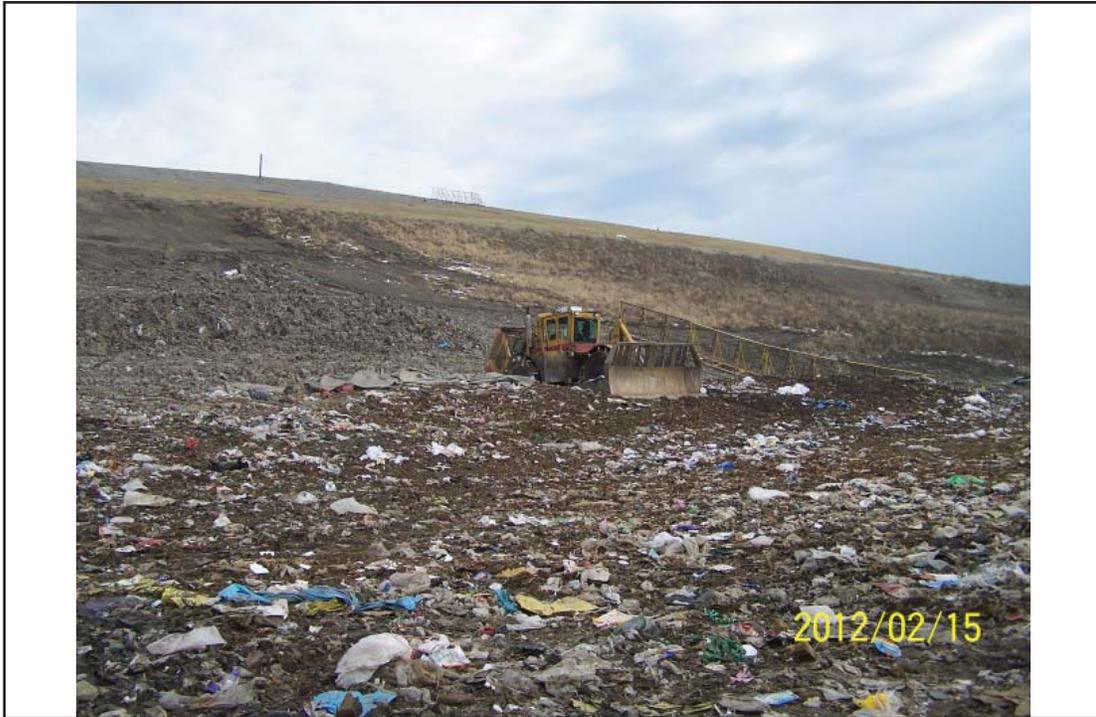
Dozer active in new Cell

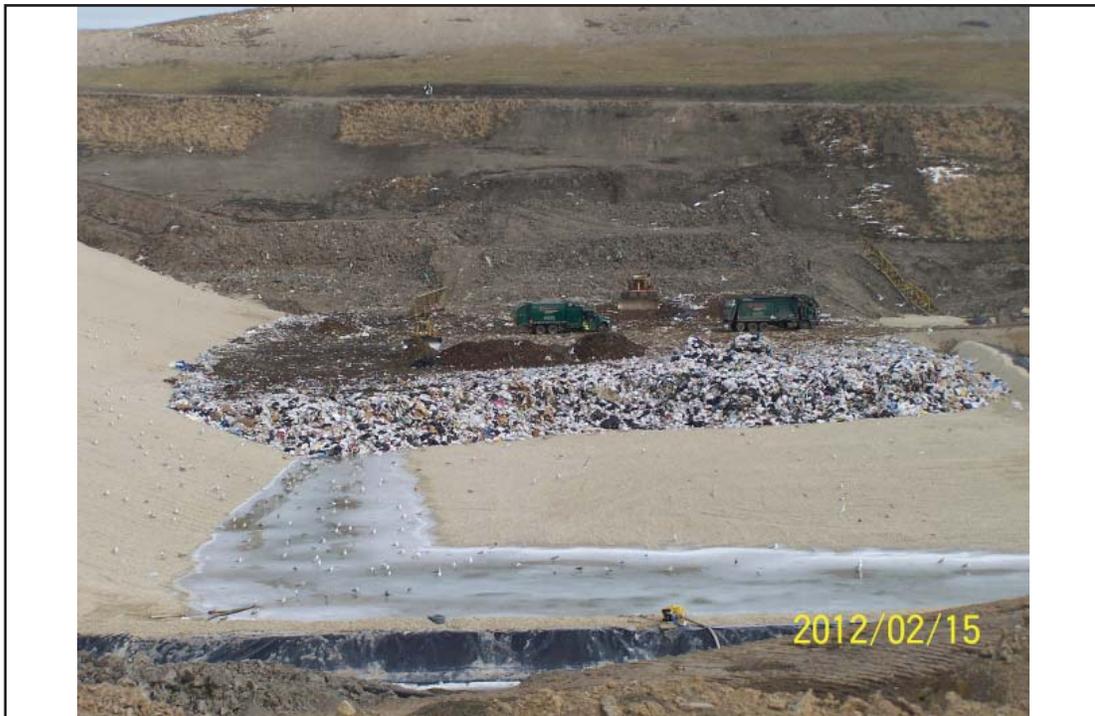
Phase 7 recieving waste for Fluff layer and some placement to the East

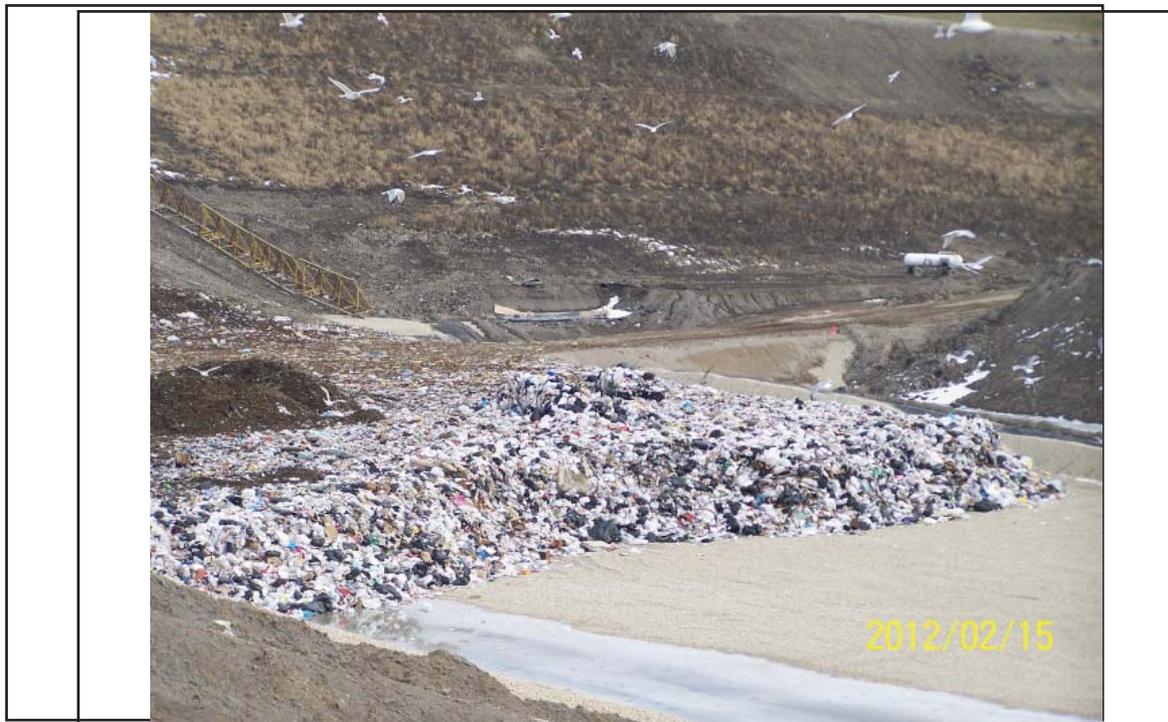
Fluff layer progress

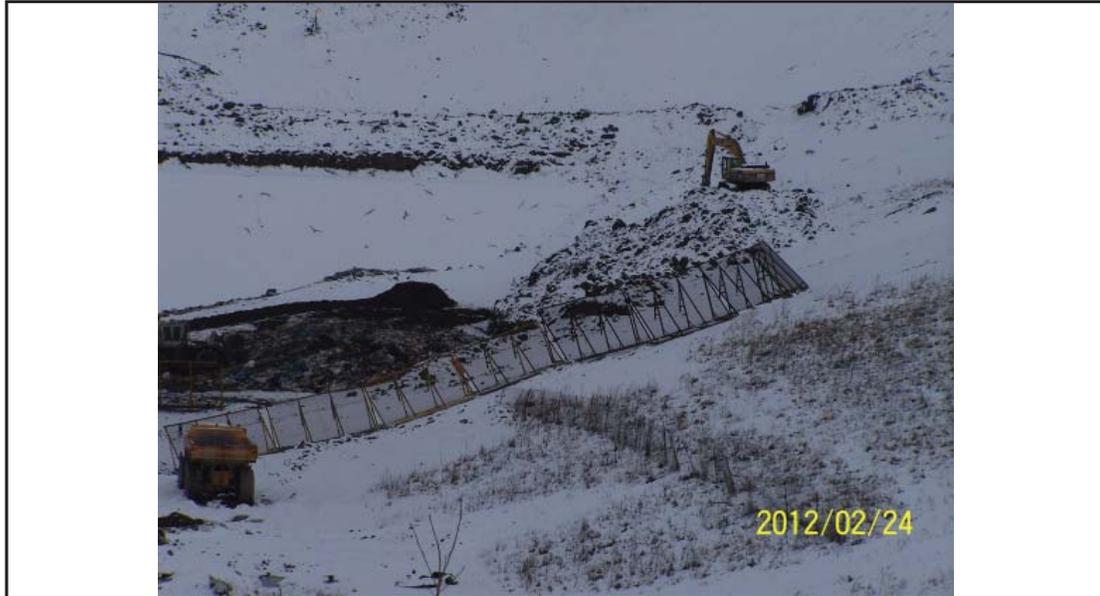
Working face

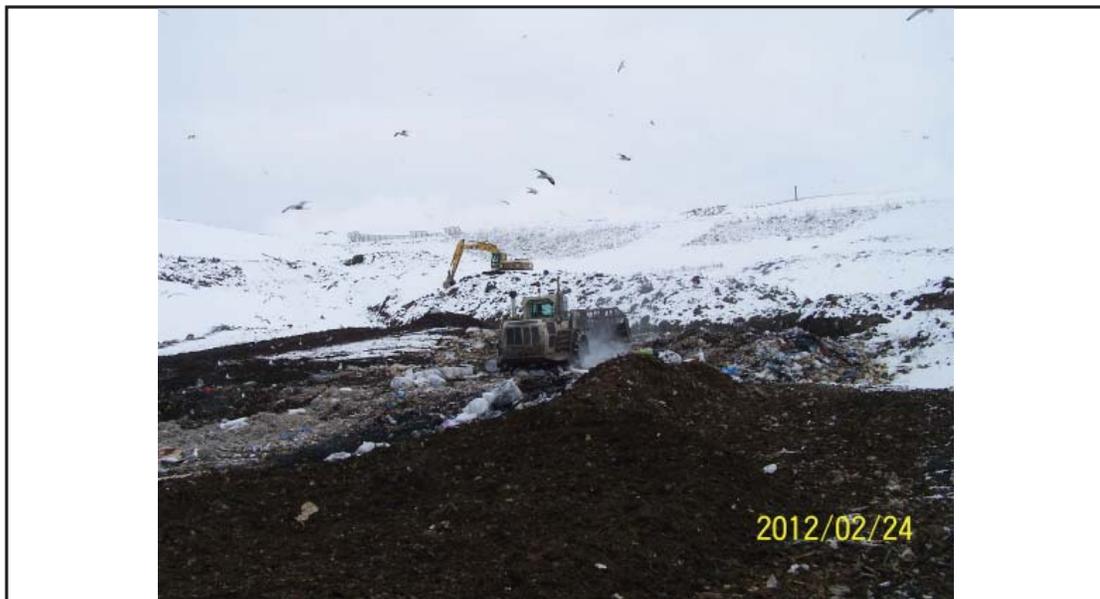
Compactor in up slop working face above Phase 7

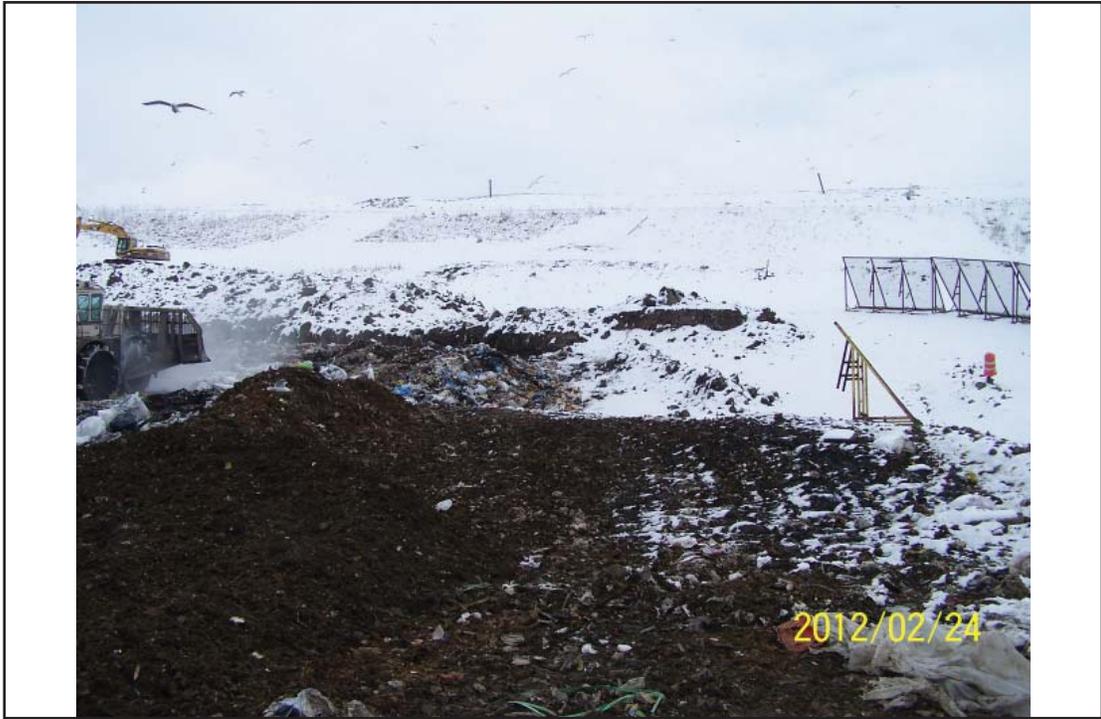
Working face in Phase 7

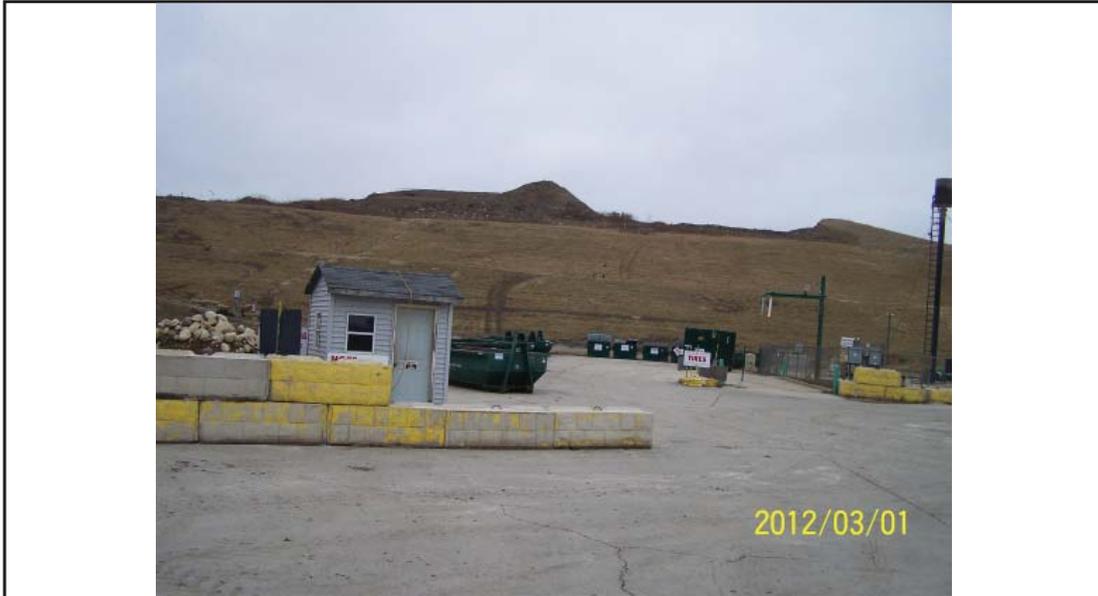
Residential drop off relocated for placement of gas building

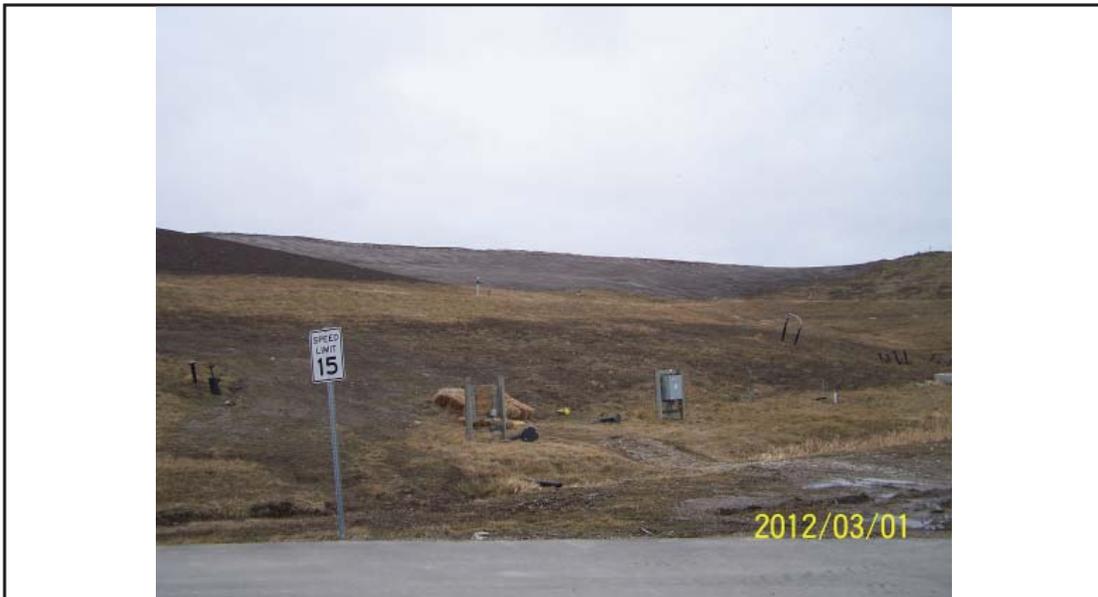
Future location of gas building
