2012 Advanced Disposal Services Emerald Park Landfill Year End Compliance Officer Report and Audit Summary

TO: Veolia Emerald Park Standing Committee
FROM: Jo-Walter Spear, Jr., P.E.
COPIES: File
DATE: 04/04/13
PROJECT NUMBER: 1012.10030

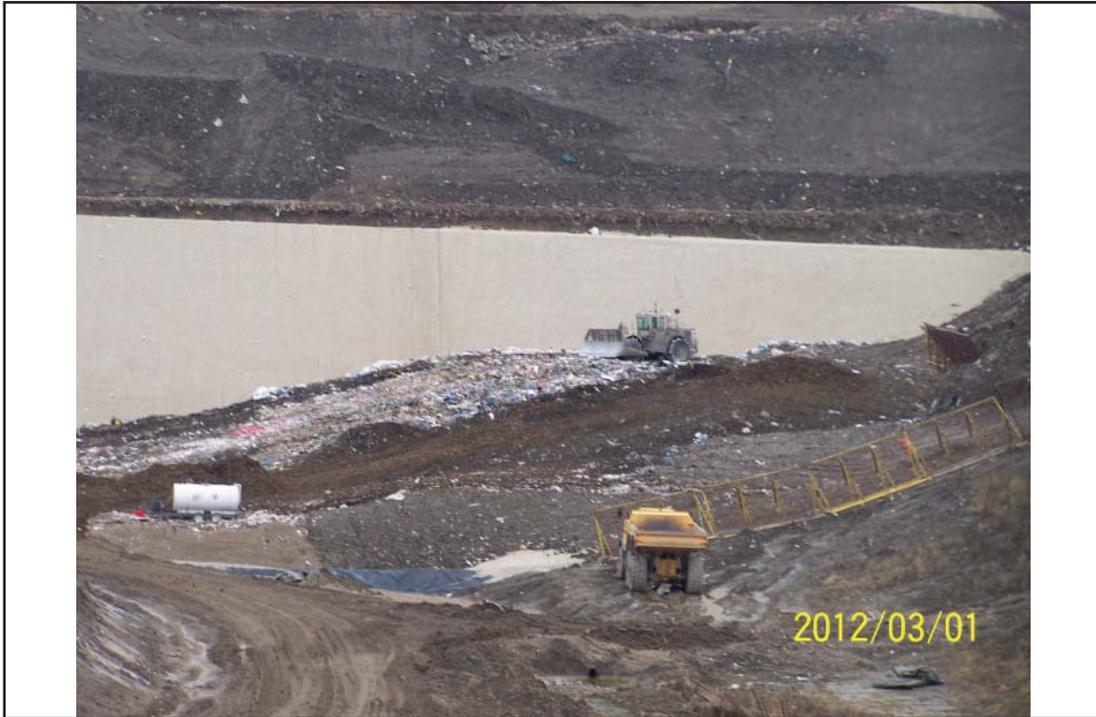
Working face in Phase 7, against Phase 6&7

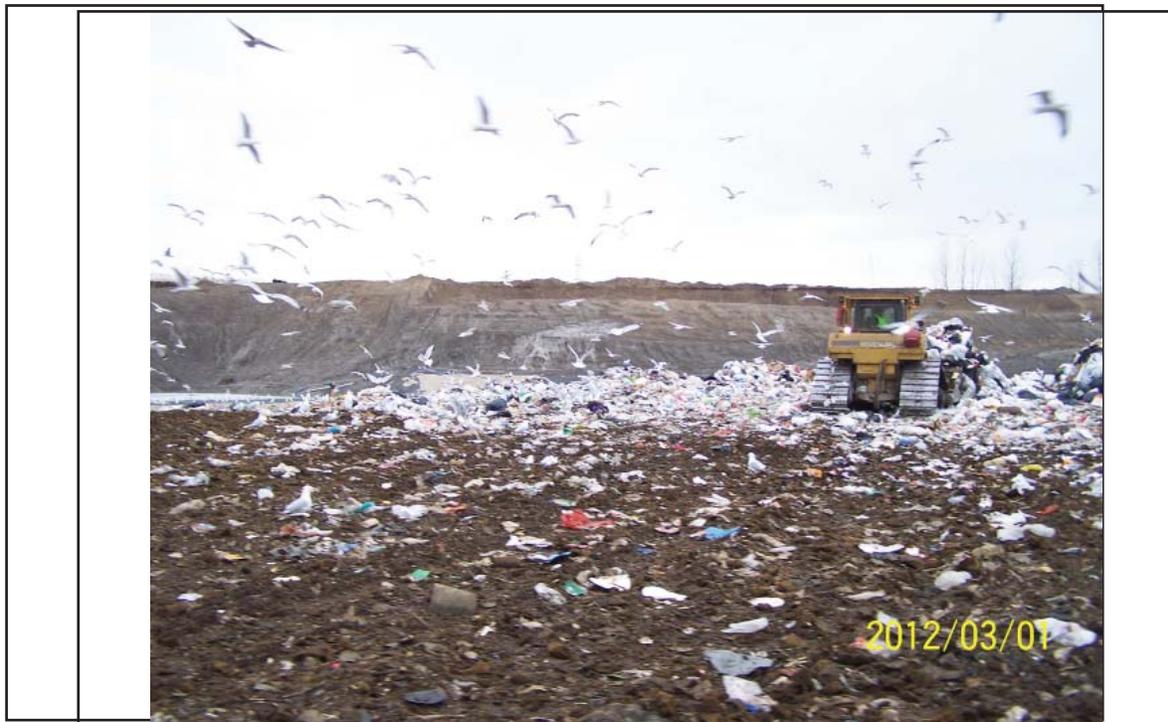
Dozer spreading end of fluff layer

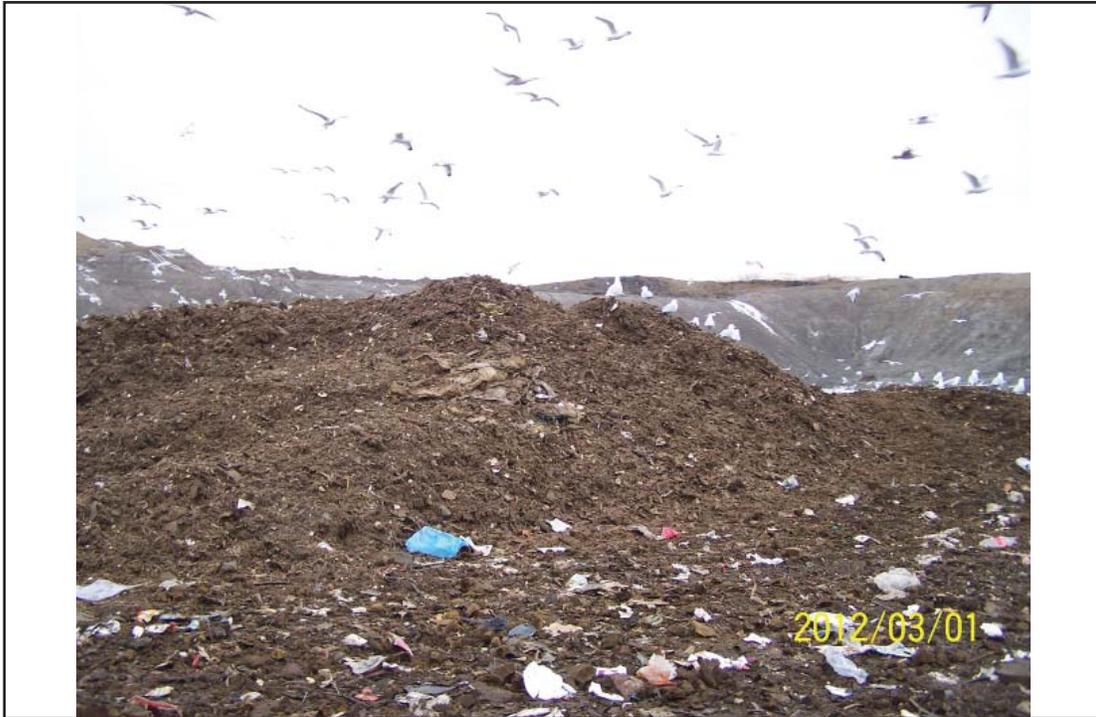
Ample autofluff stockpiled

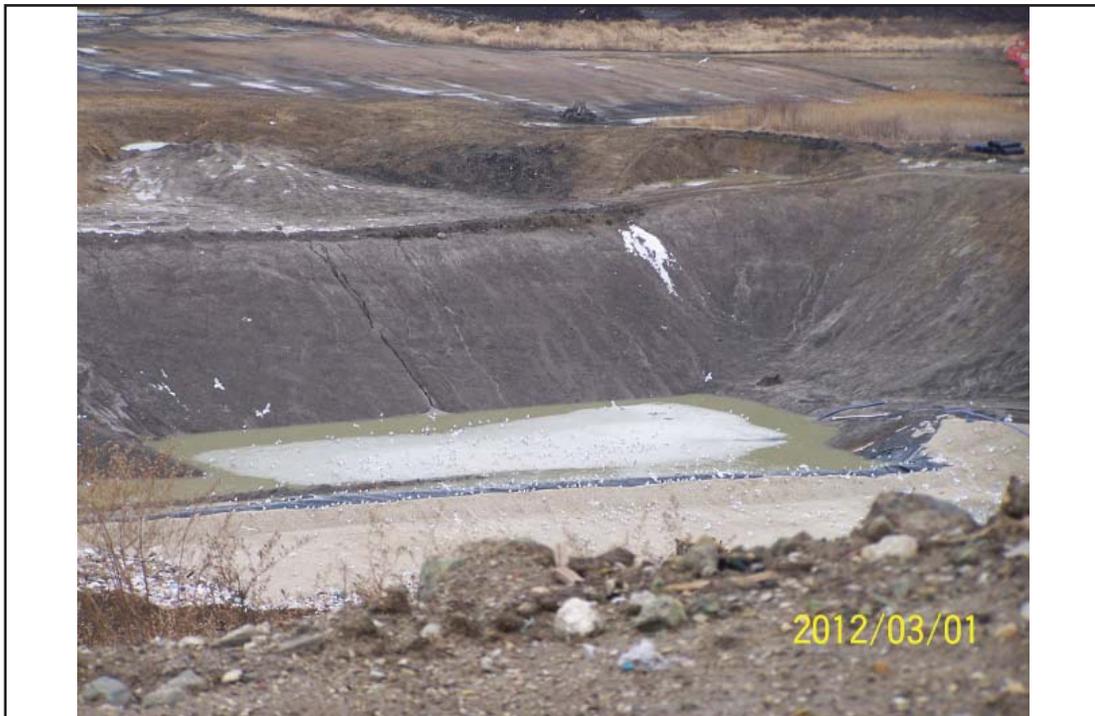
Stormwater basin adjacent to Phase 7

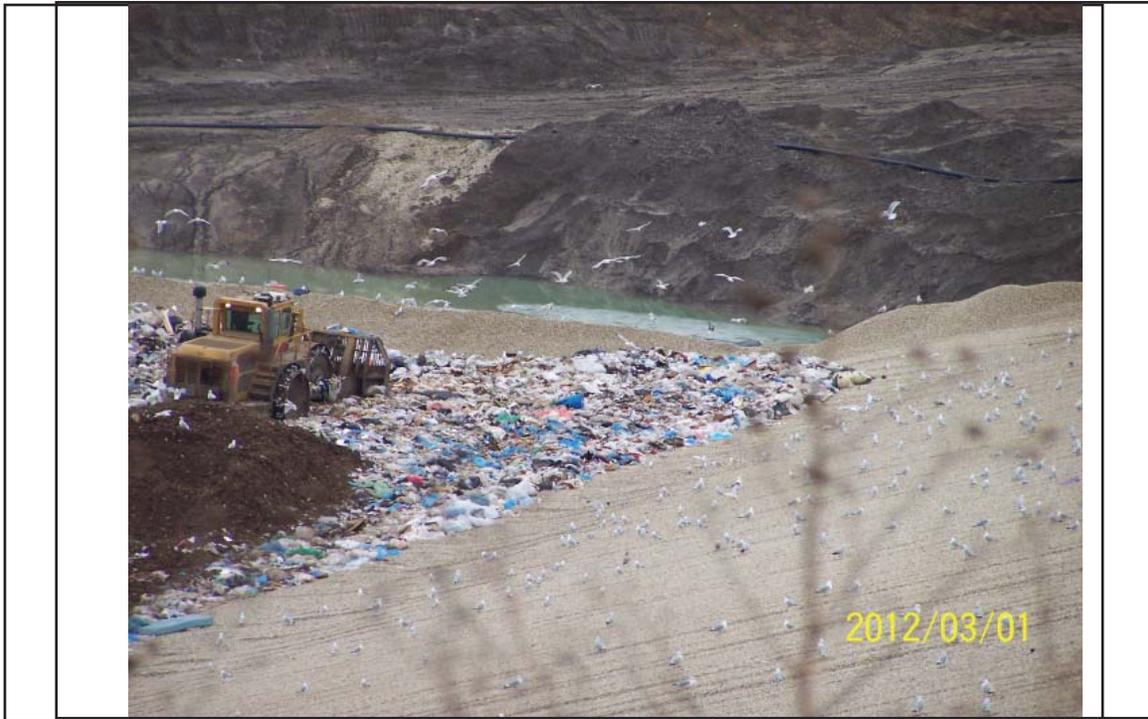
Limits of wast placement until cell construction is finished

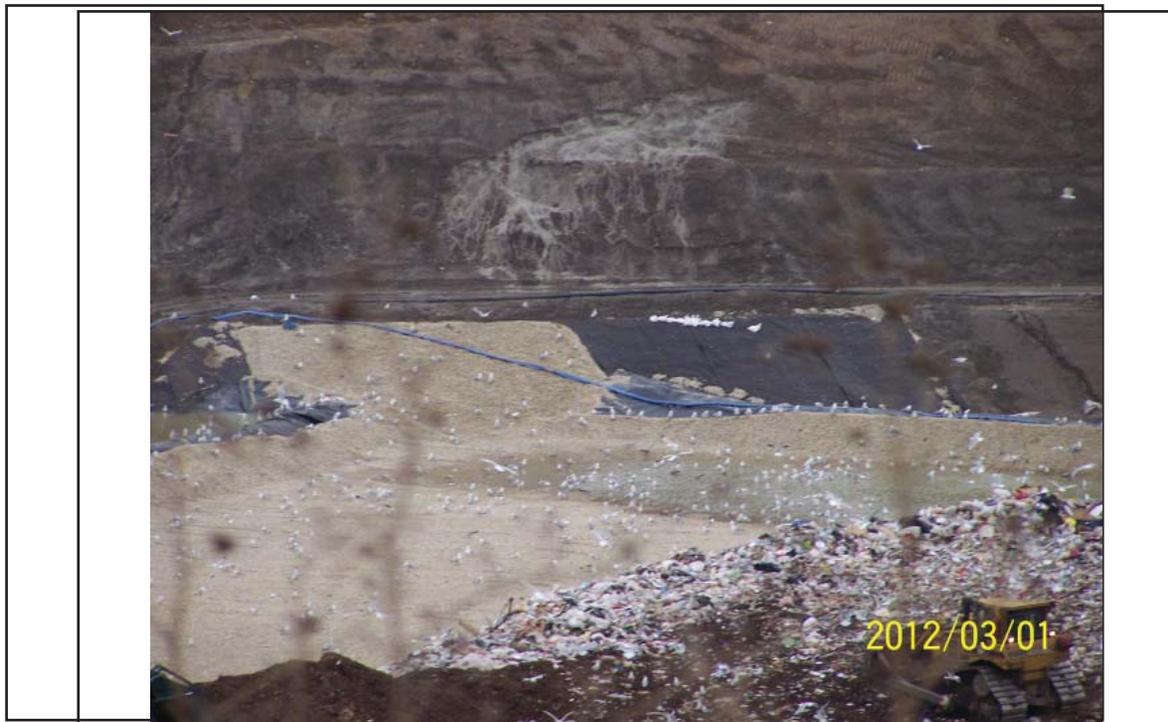
Leachate ponding before sump

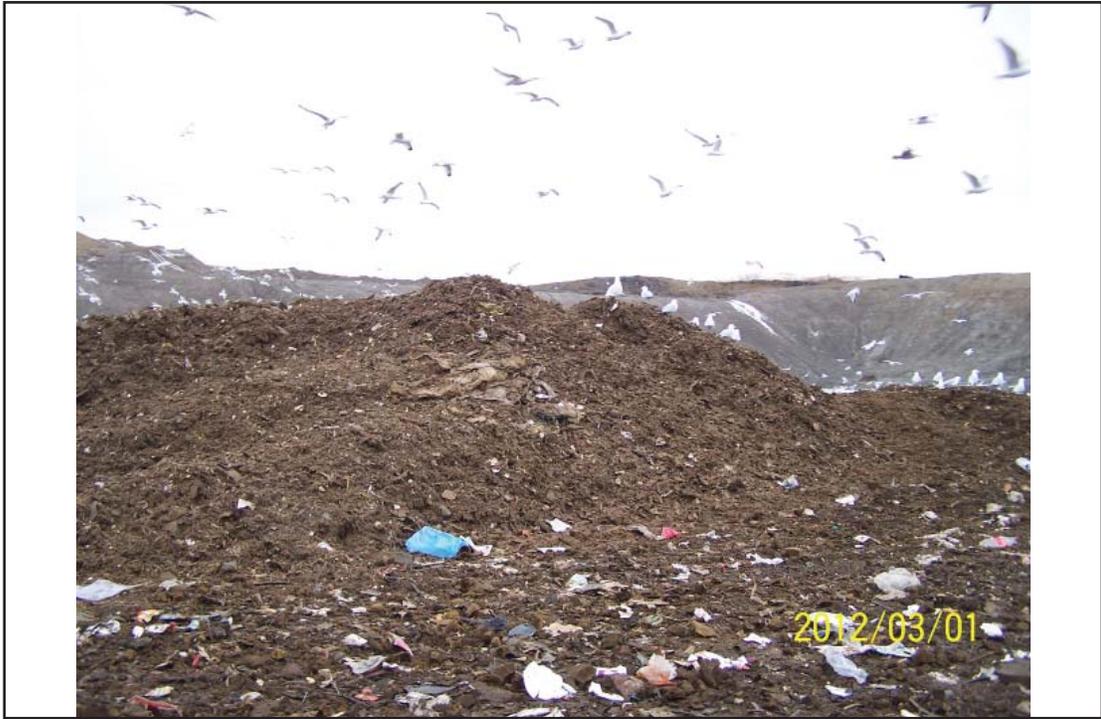
Ample autofluff stockpiled

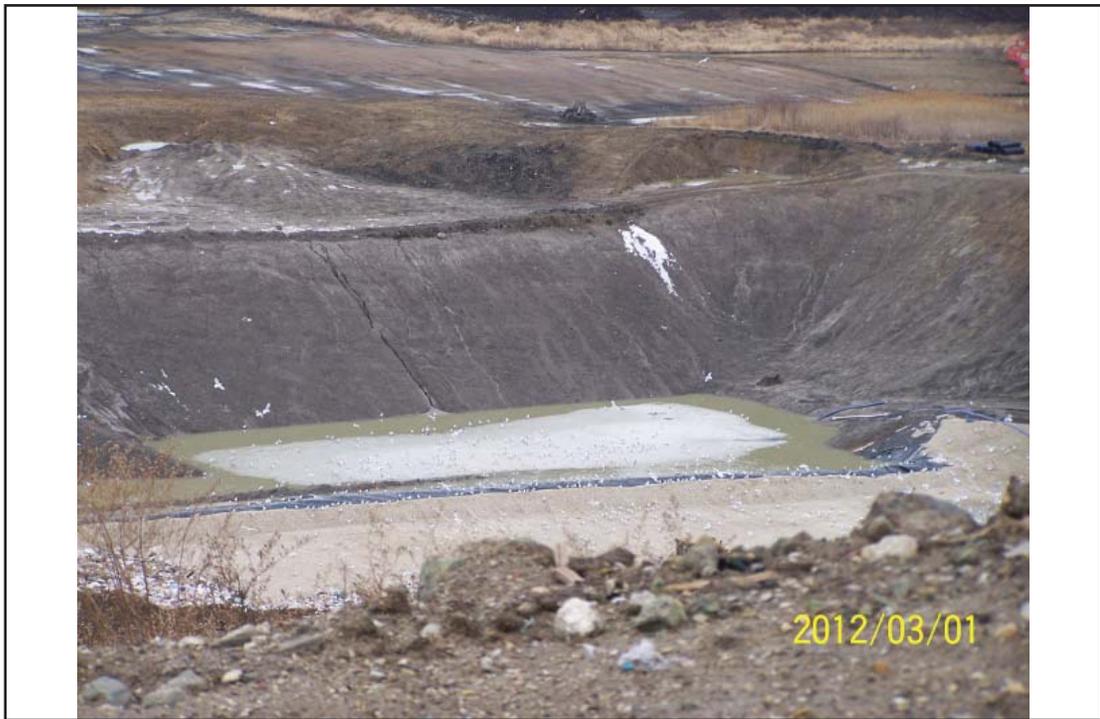
Stormwater basin adjacent to Phase 7

- Three foundations require additional excavation
- Ponds about Phase 7 should be pumped down starting tomorrow
 - Freeboard may be an issue
 - Seeding to be done in May as weather permits

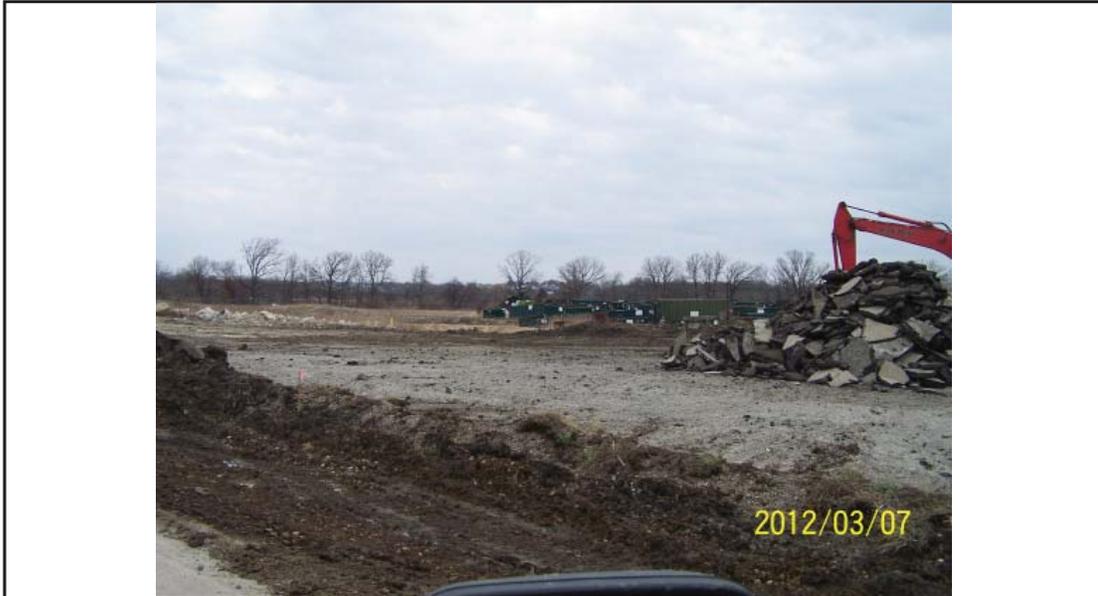
- Tipping scale camera and equipment operators inspecting waste
 - Random Load inspection date was 3/1/12, same noted last week
- Gas building construction started today removing asphalt and soil for construction location

Gas Building construction

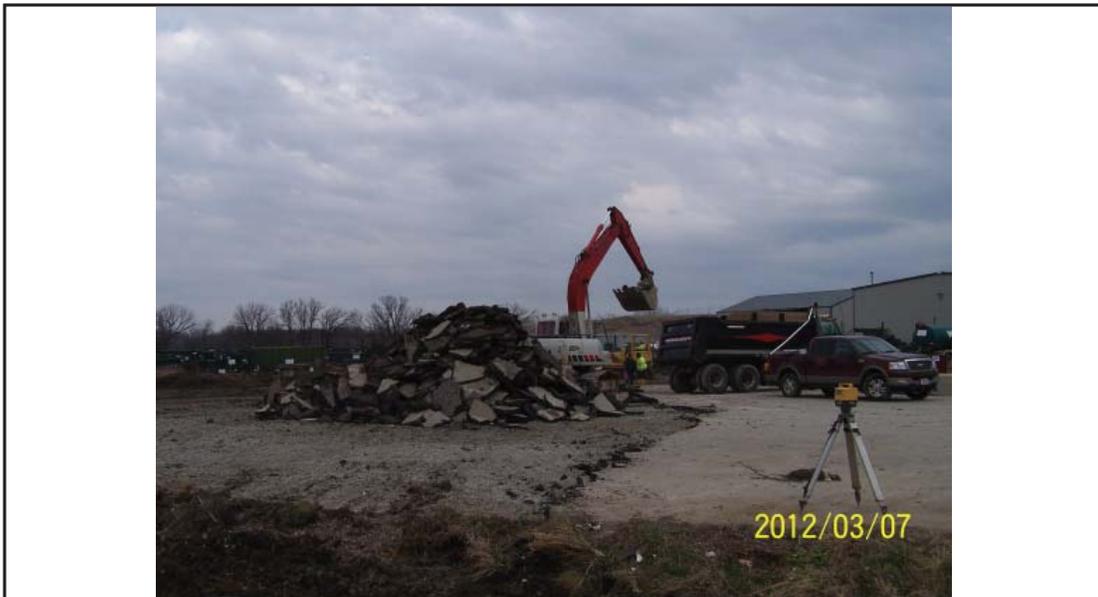
Gas building construction

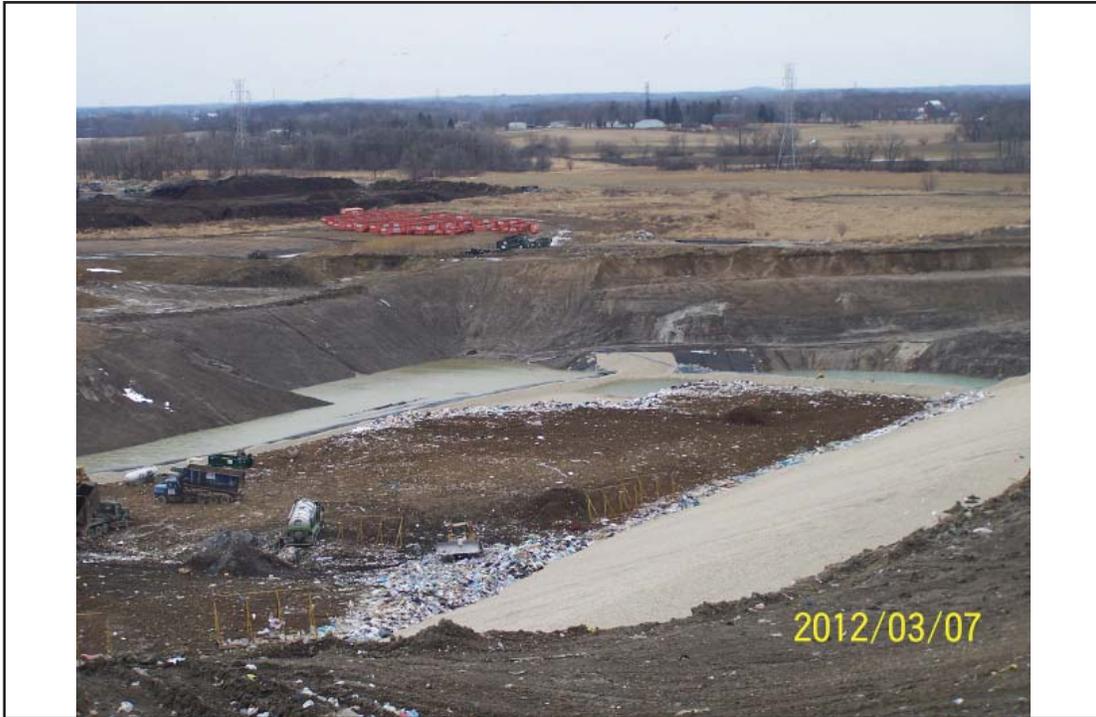
Phase 7, note liquid levels in stormwater basins and in Cell

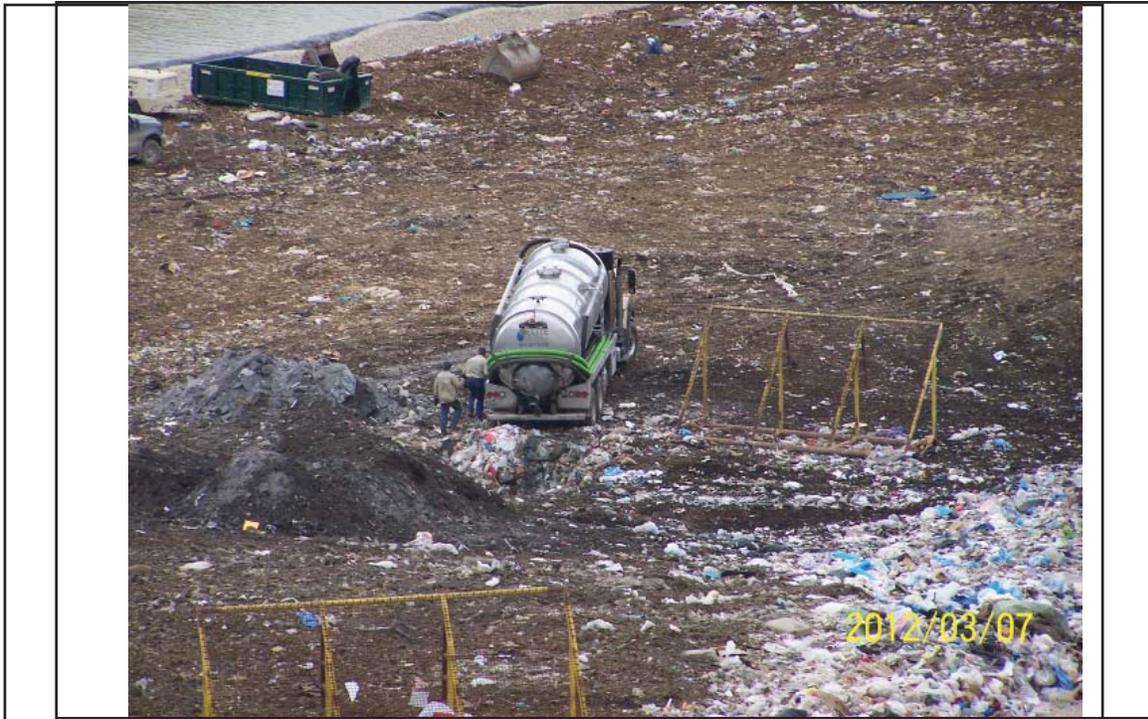
Liquid load tipped in Phase 7

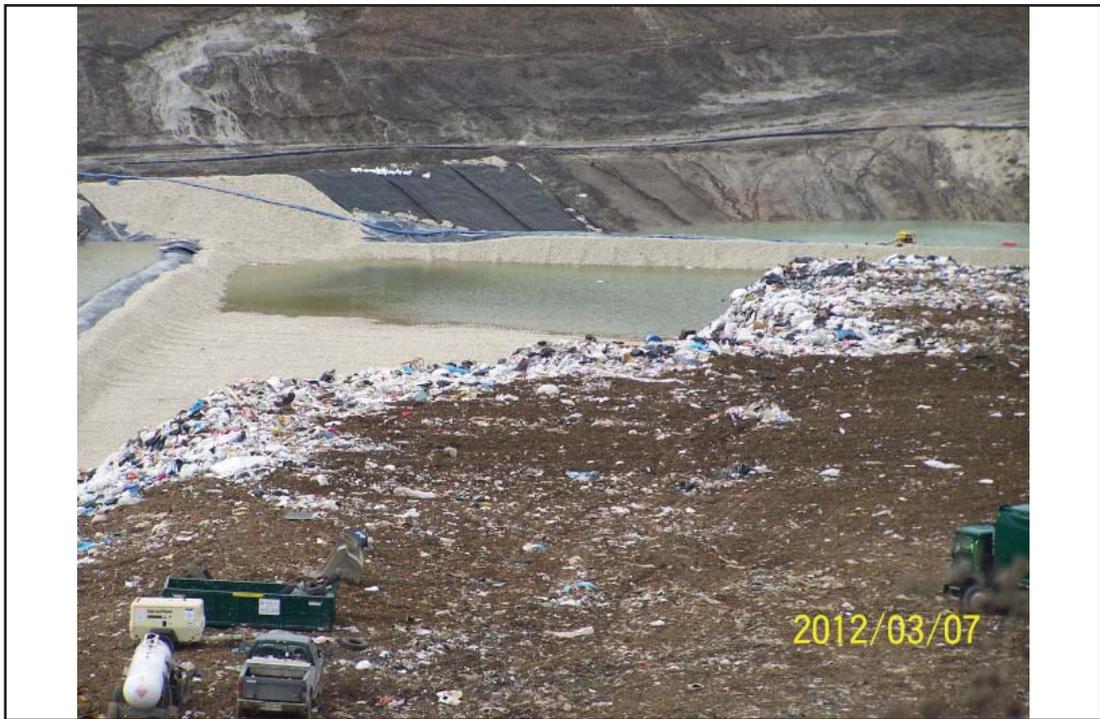
Leachate being pumped, via sump, to MMSD

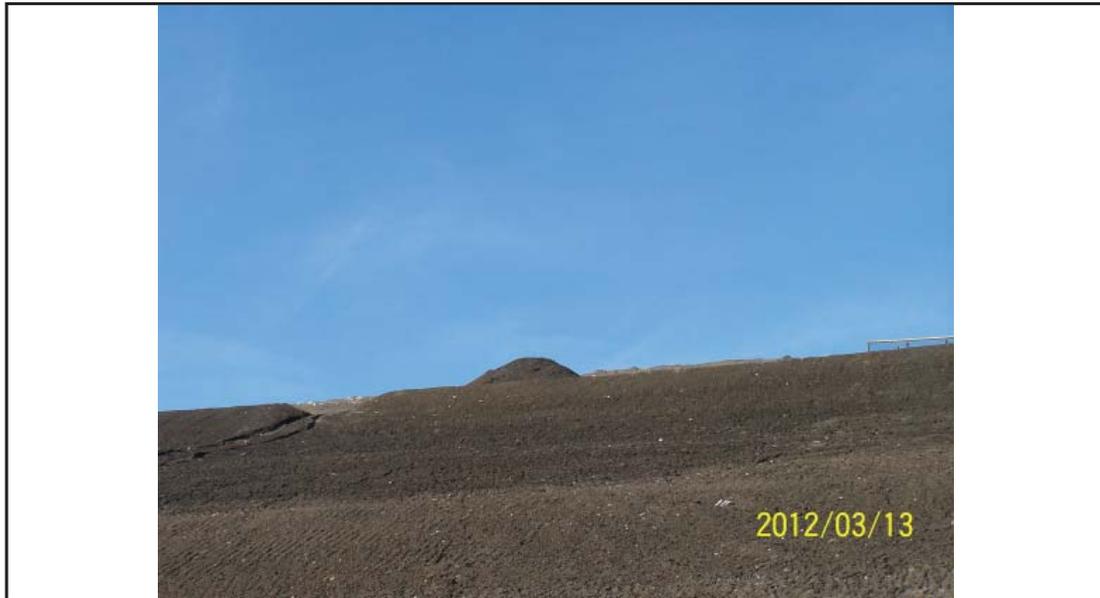
Closure Area III suffering from erosion after storms, stockpiled soils prepared for restoration

- Erosion on Closure Area III; rain expected on 3/21-25
- No odors noted
- No special waste handling noted
- Litter present on site only due to high winds, 2 pickers active

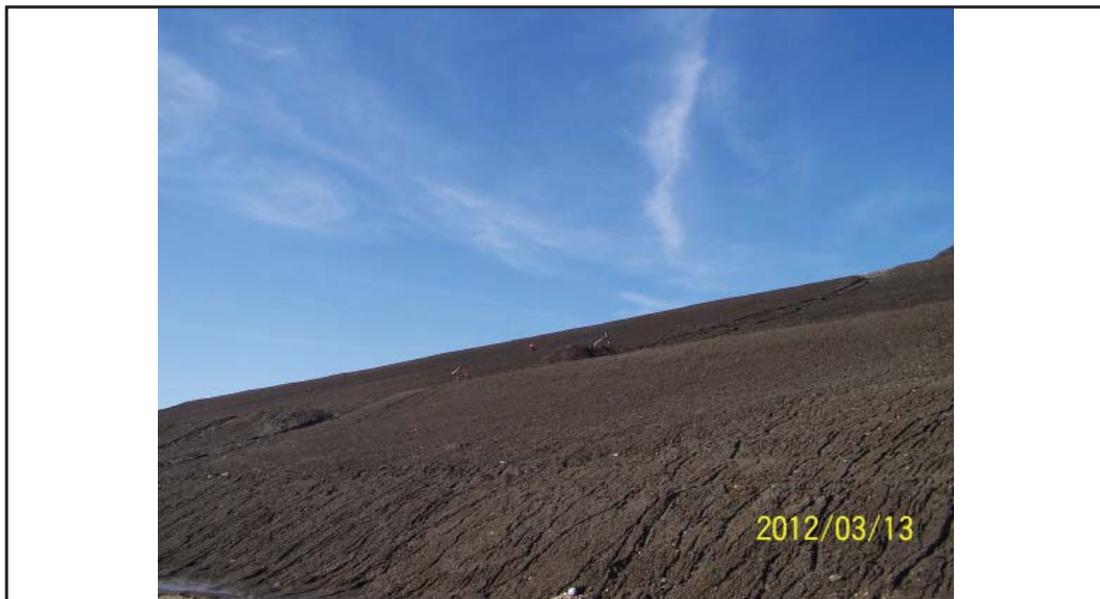
Rills in East slope of Phase 5

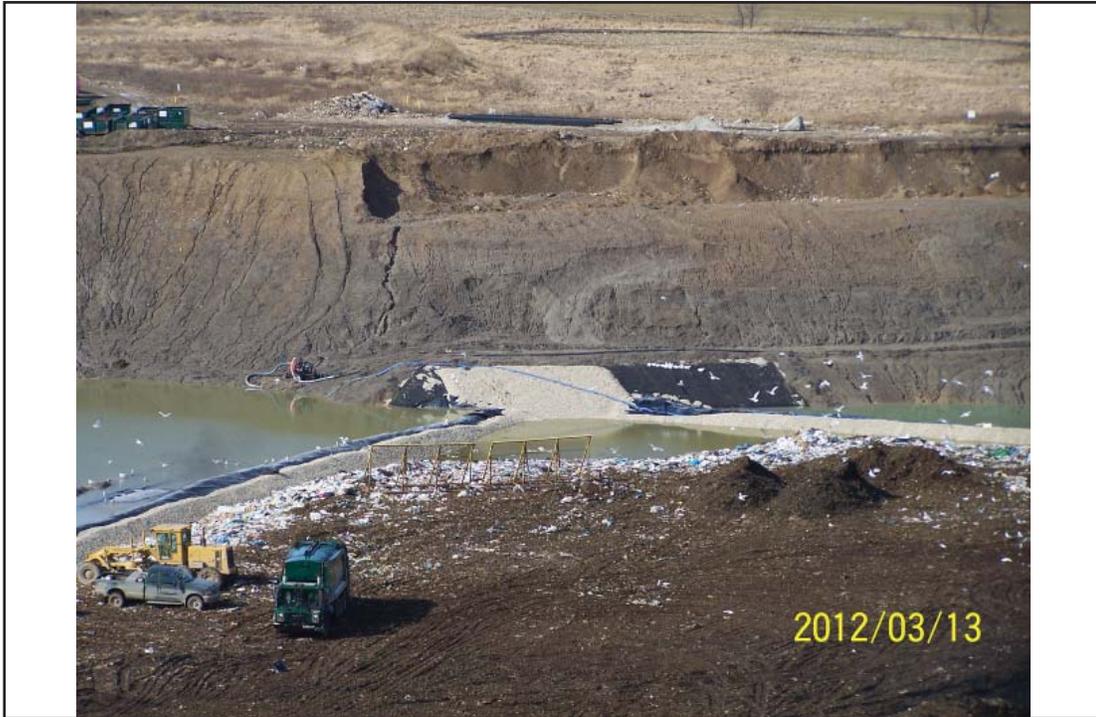
Stormwater and leachate separated by berm

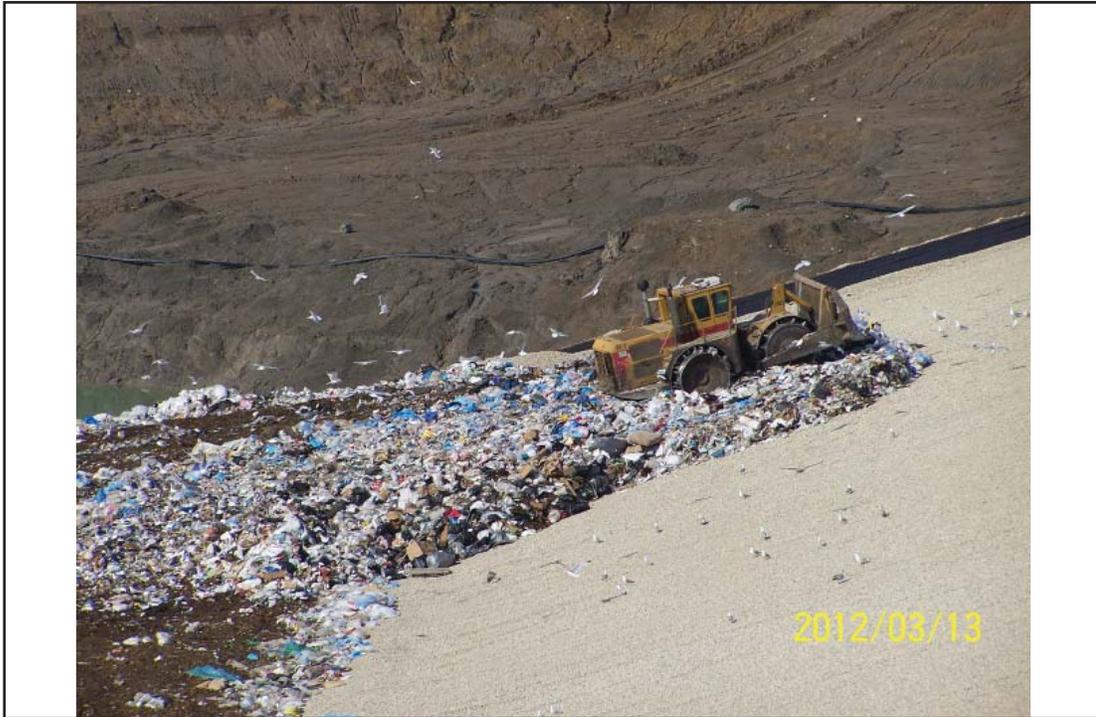
Not a suggested practice, compactor pushing was across drainage layer

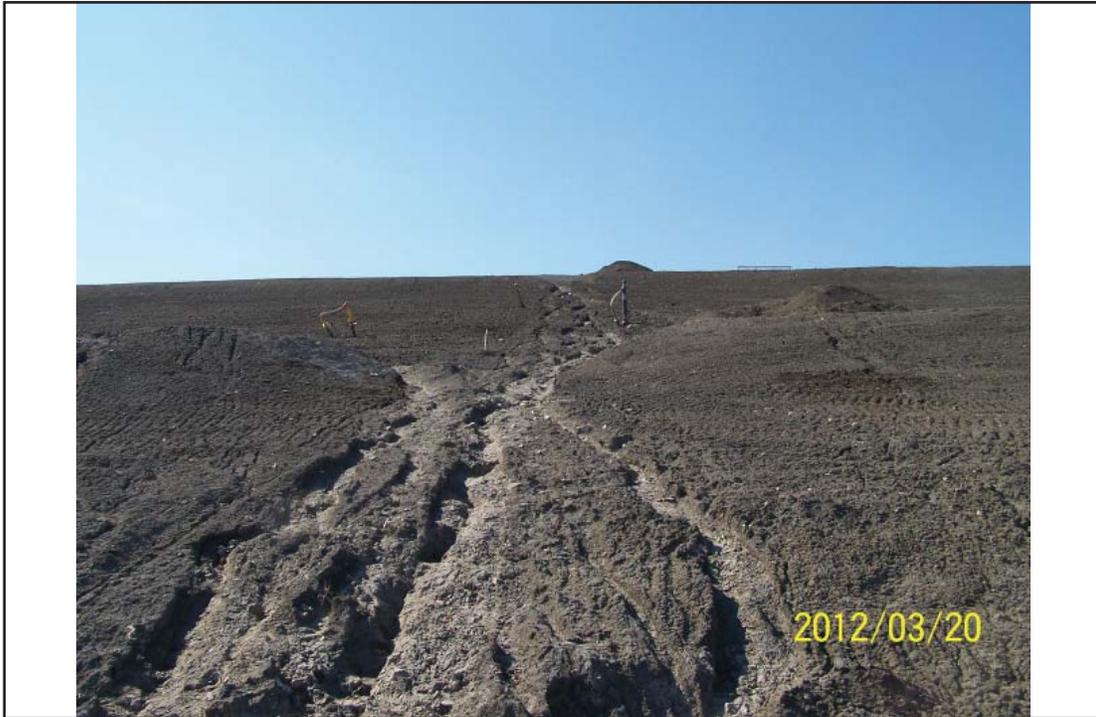
East slope of closure area III, future location of downslope flume

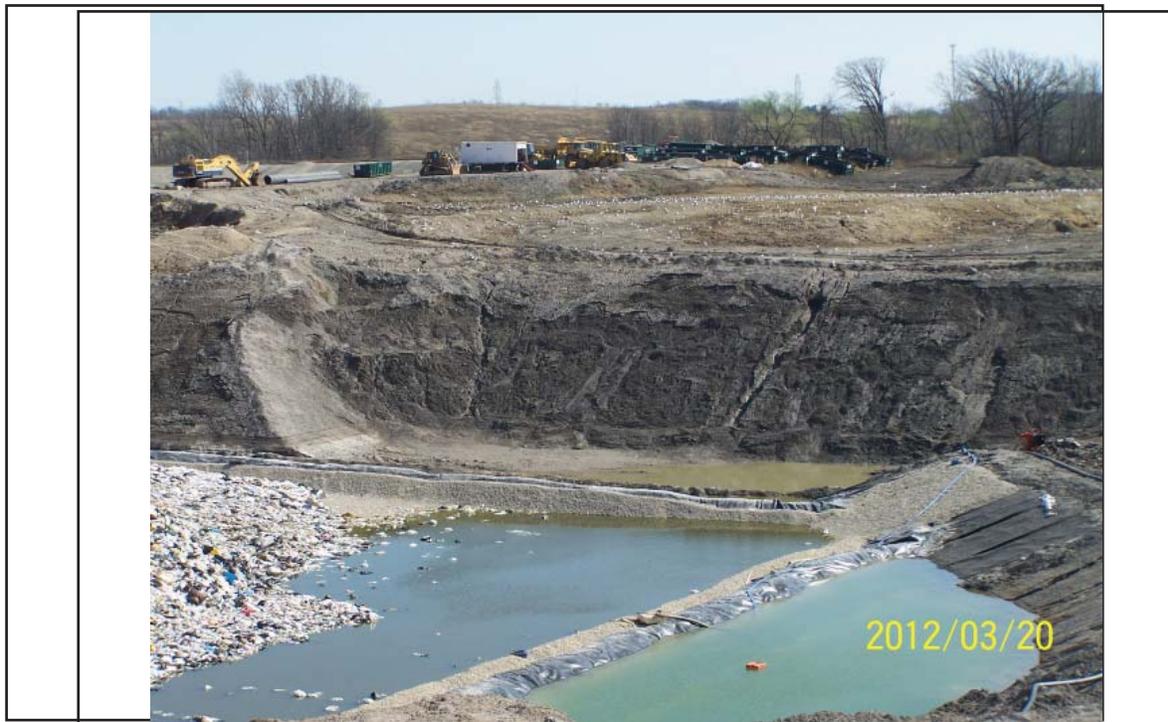
Southern most temp sed basin to be drained by pump

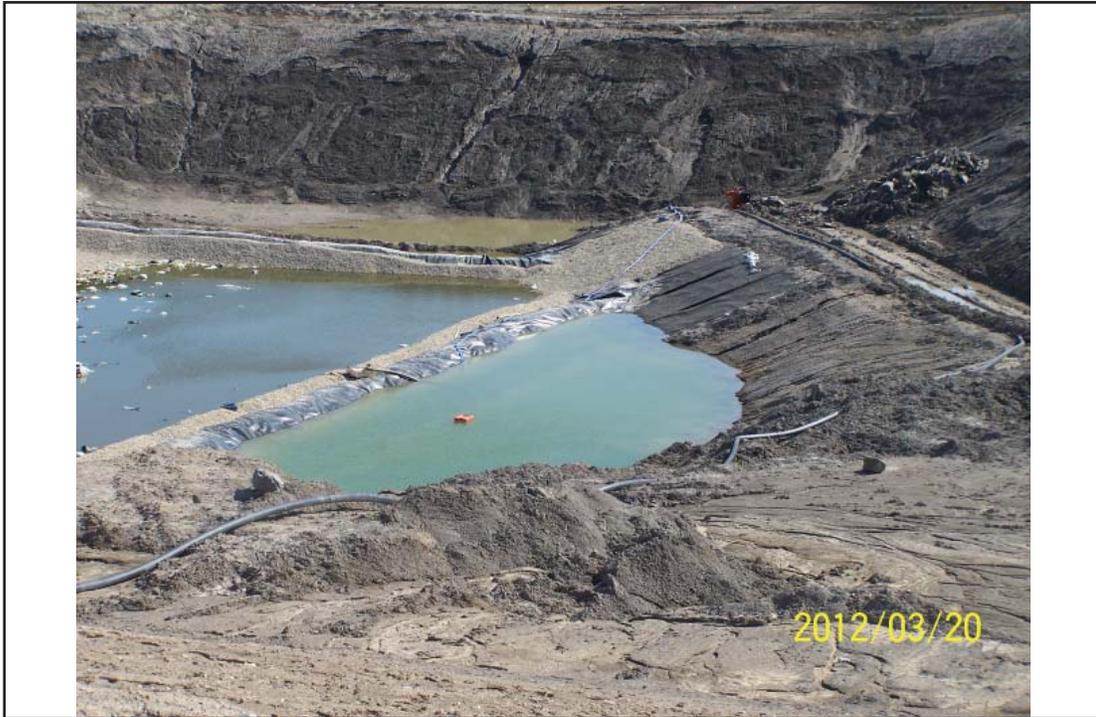
Temp sed basin being drained by pump

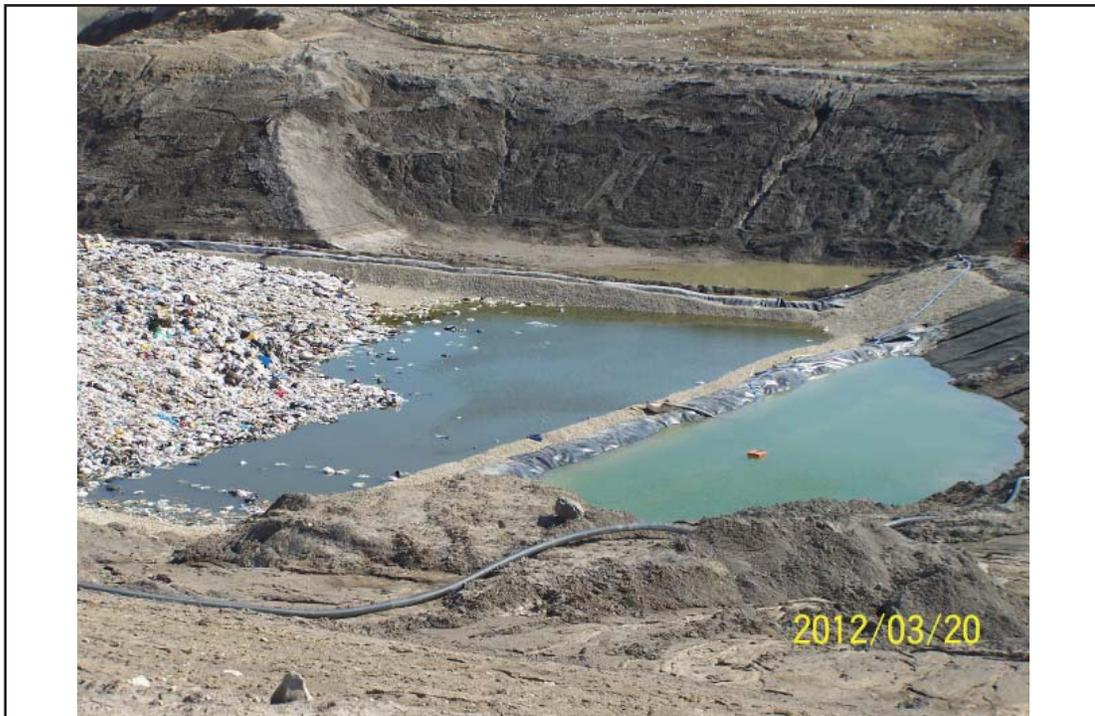
Leachate pool and surface water temp. basin

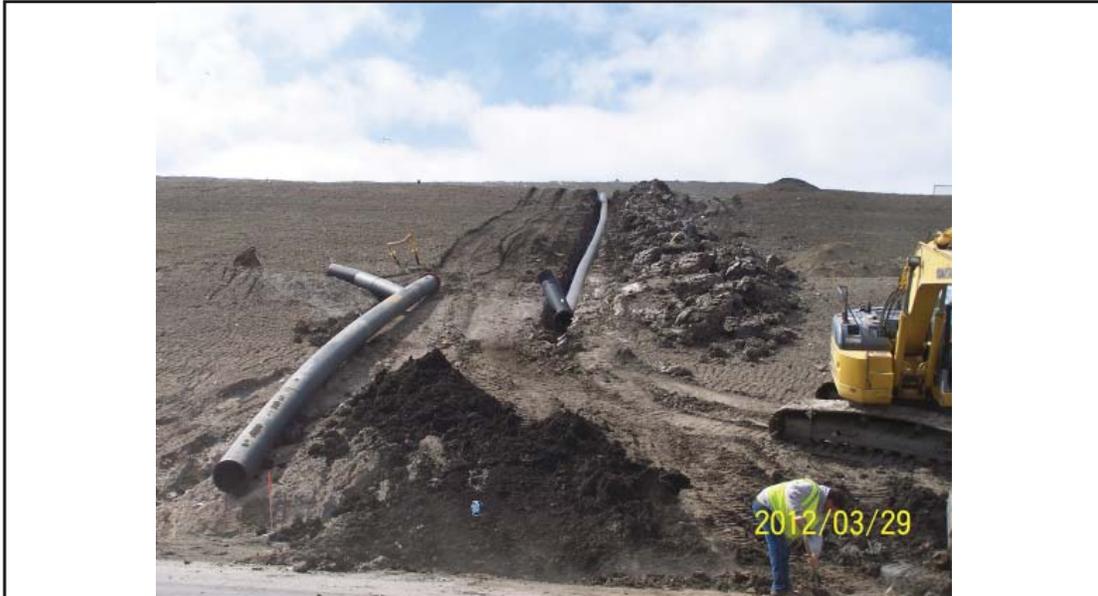
Downslope flume installation

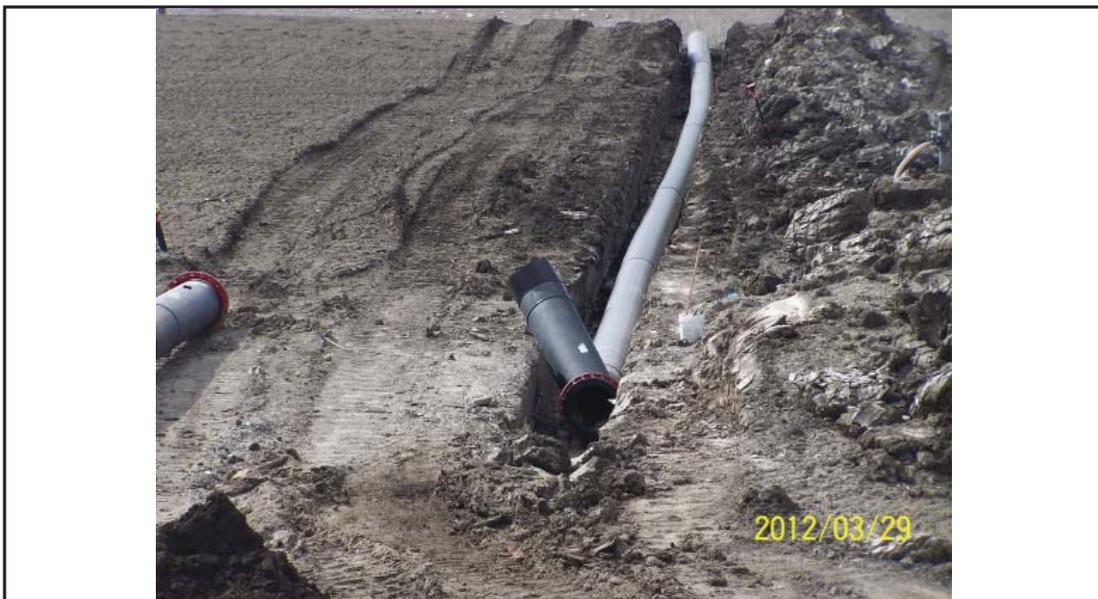
Downslope flume installation

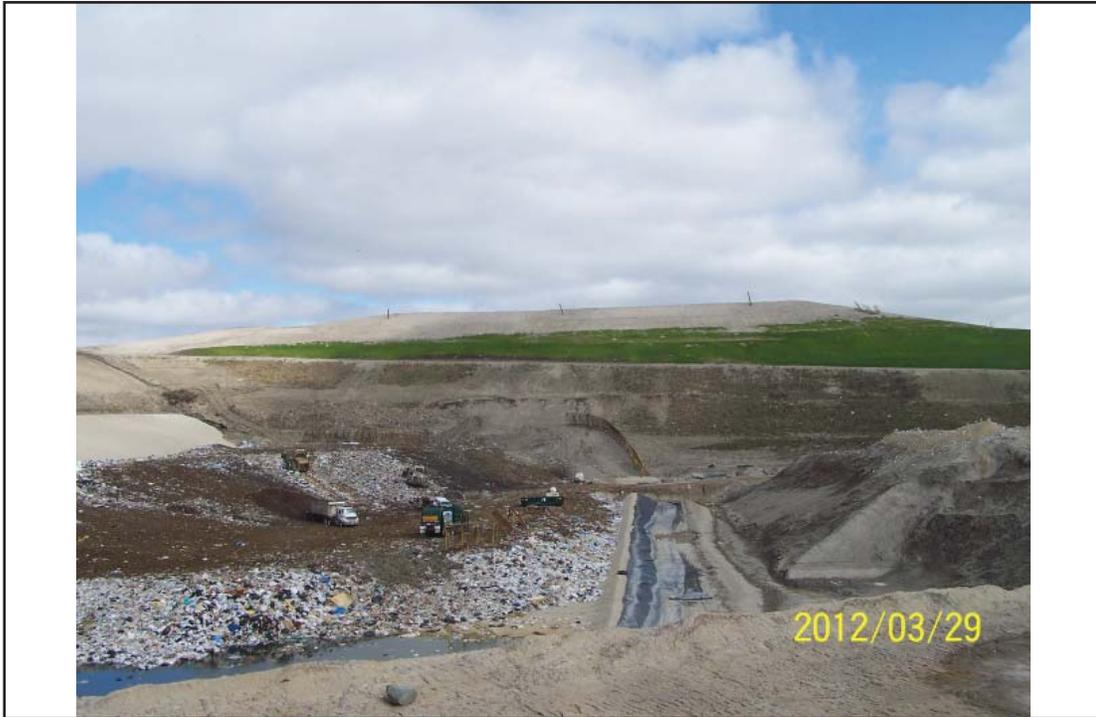
South end of active area, temp basin drained completely, leachate still visible in Phase 7

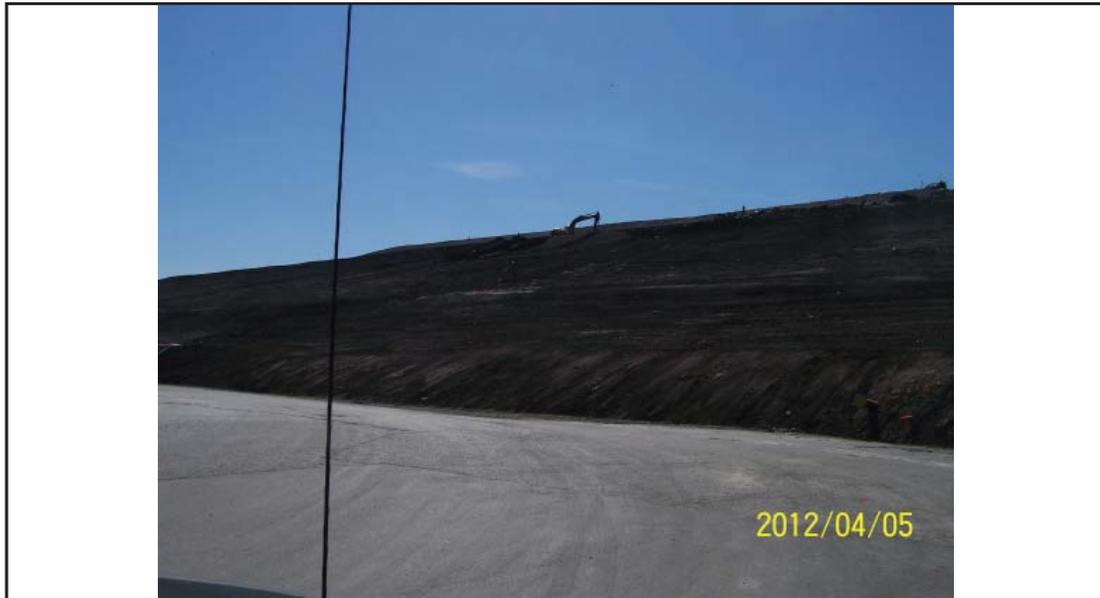
West slope of phase 5

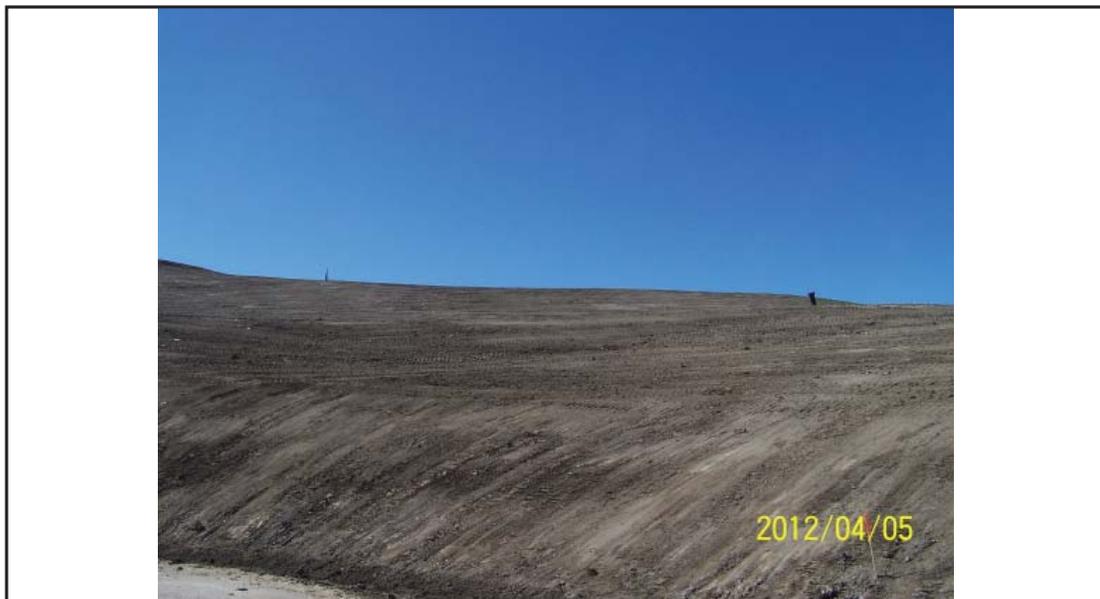
Slope junction of Phase 5 & 6

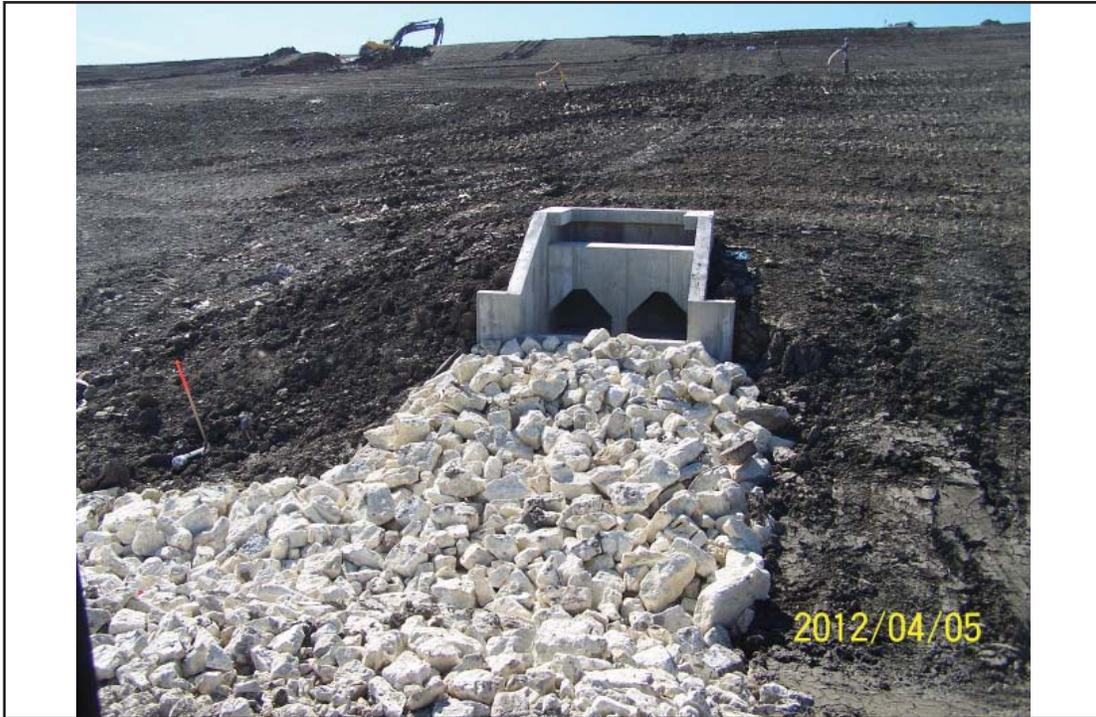
East slope discharge and energy diverter

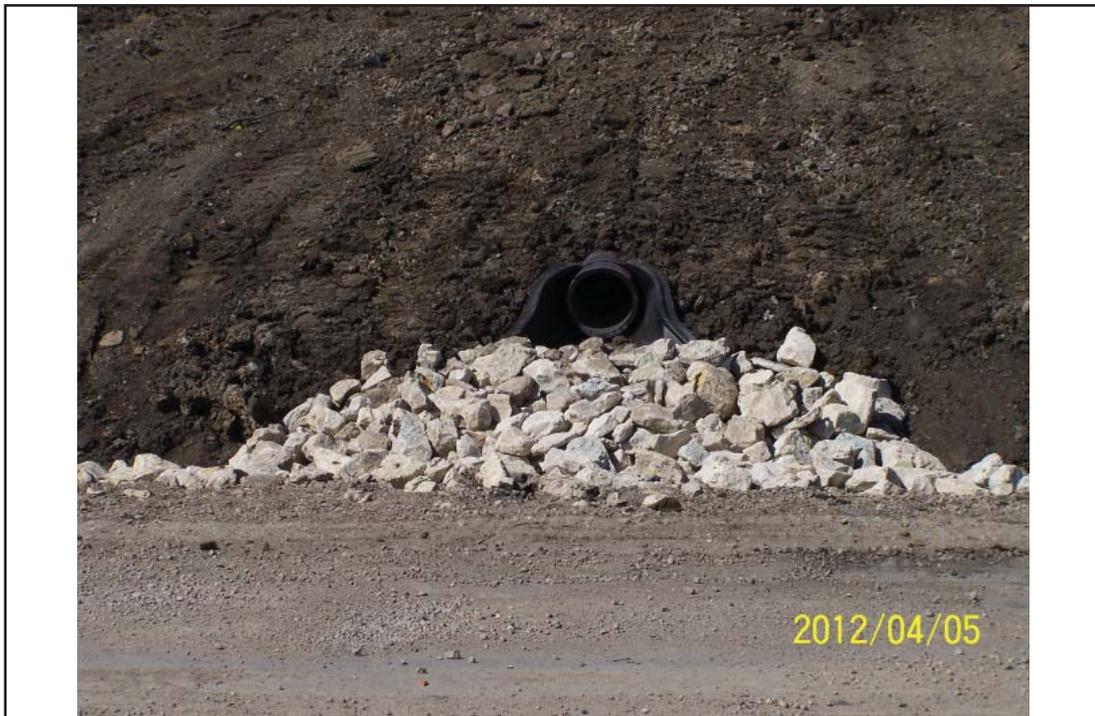
South slope discharge

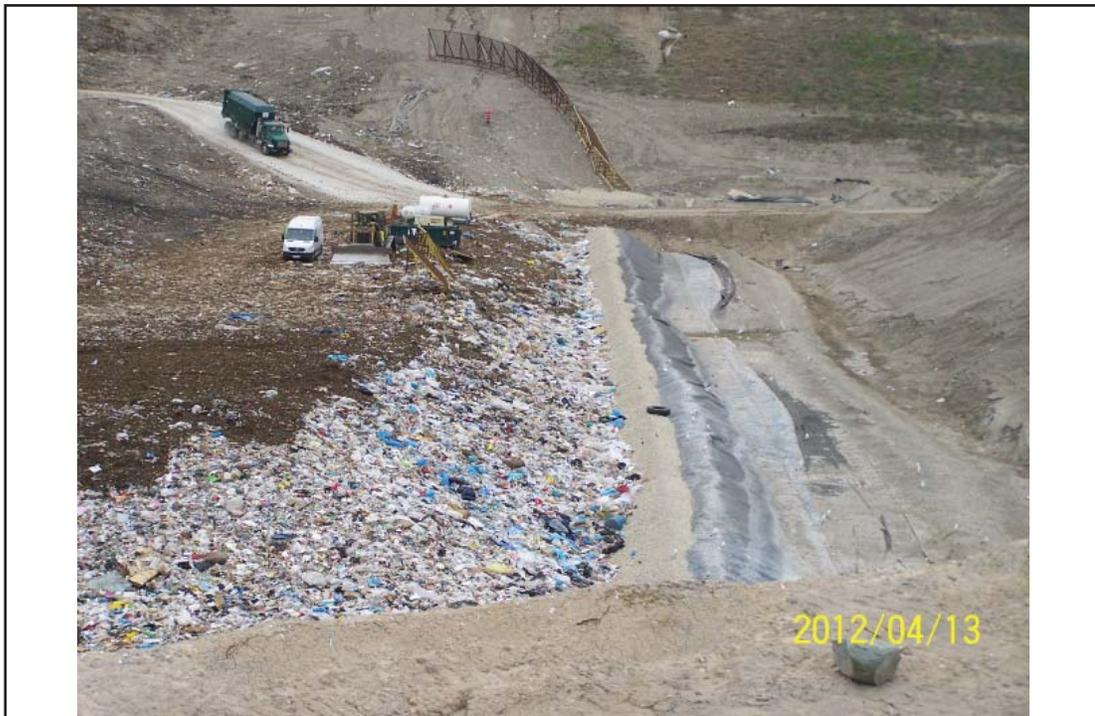
Southern edge of Phase 7, no apparent leachate

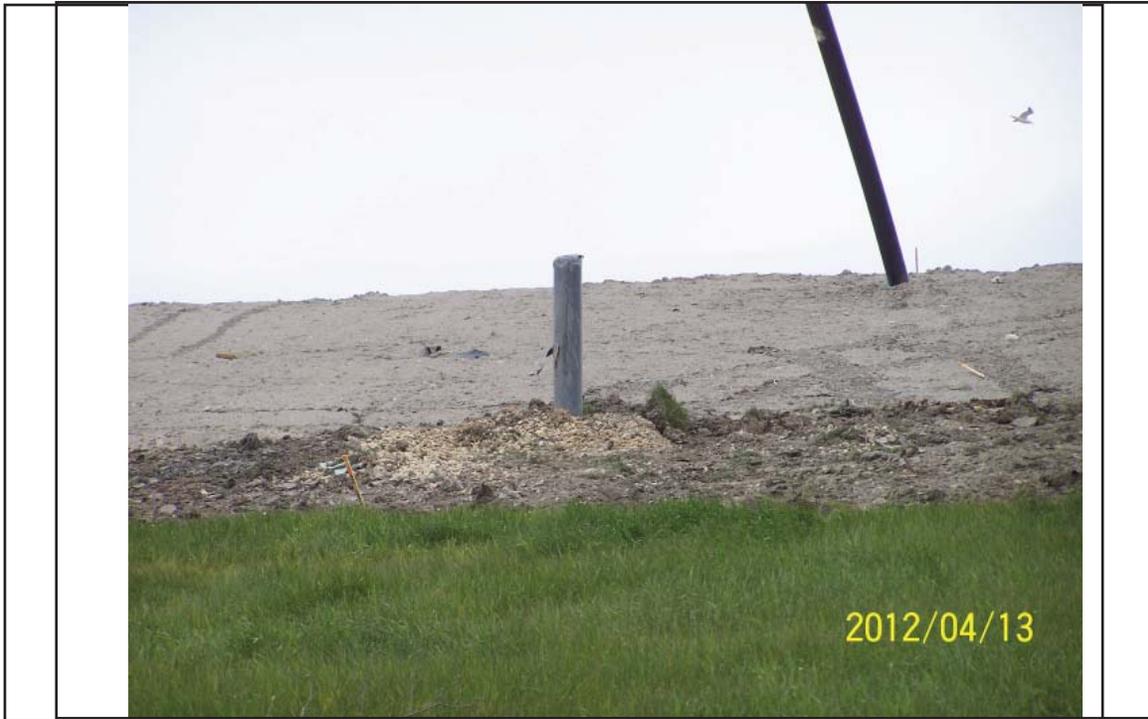
New gas extraction well awaiting header
