2012 Advanced Disposal Services Emerald Park Landfill Year End Compliance Officer Report and Audit Summary

TO: Veolia Emerald Park Standing Committee
FROM: Jo-Walter Spear, Jr., P.E.
COPIES: File
DATE: 04/04/13
PROJECT NUMBER: 1012.10030

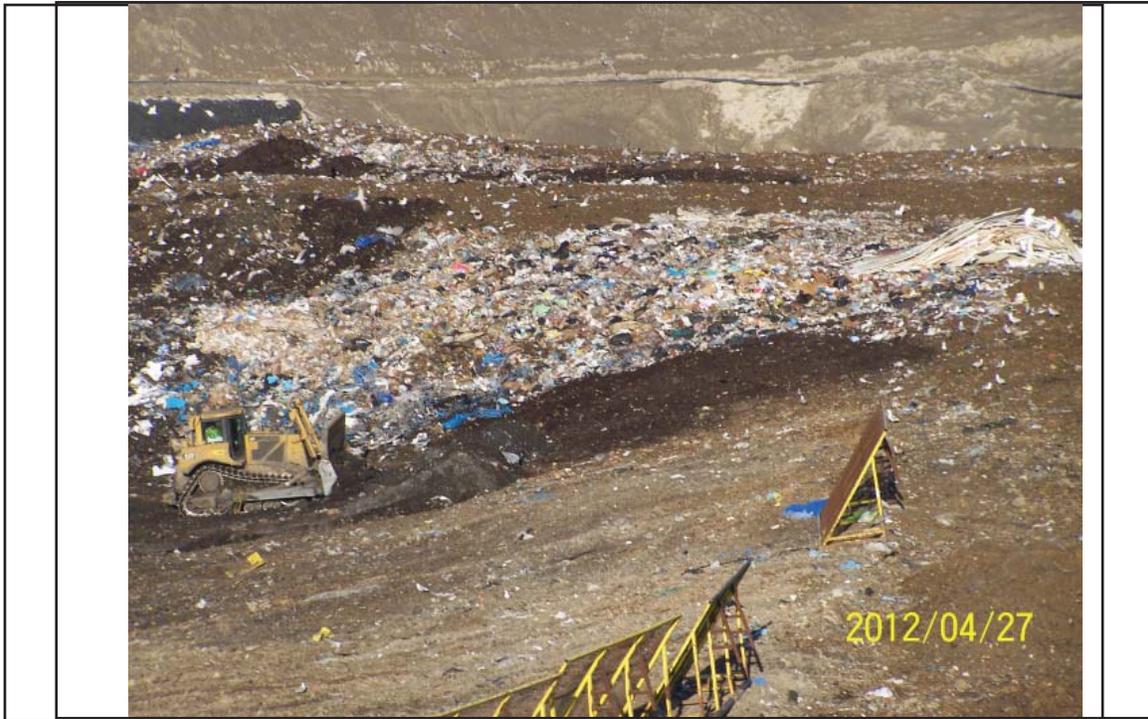
Working face receiving some cover

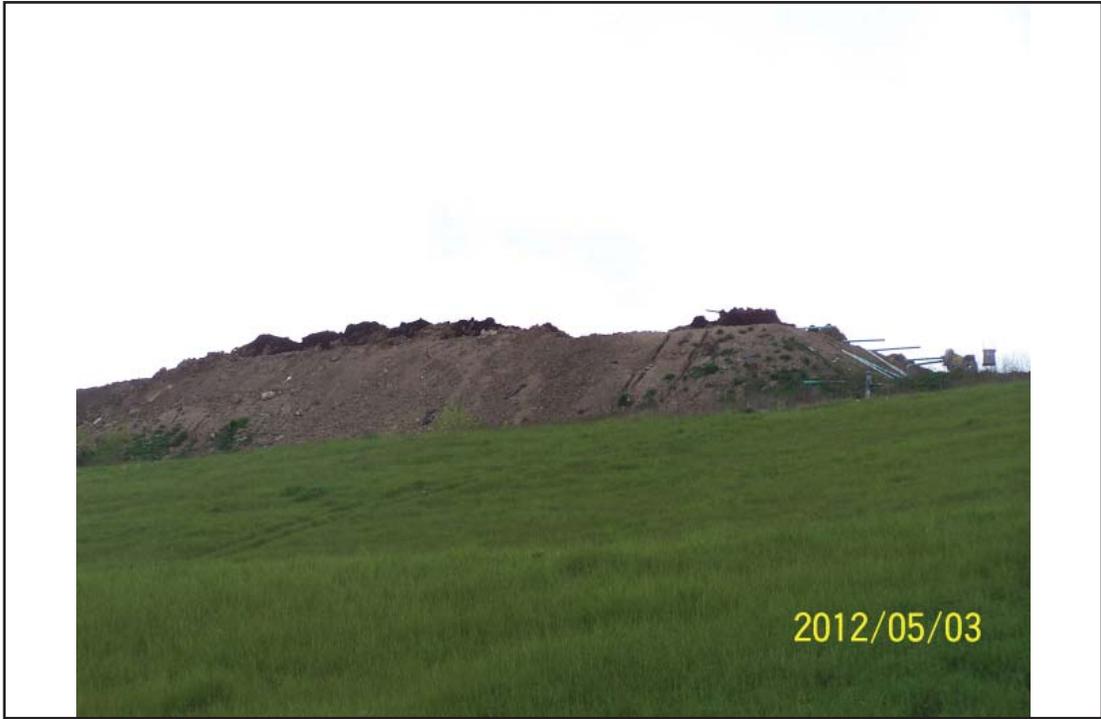
Bio pile being prepared for treatment

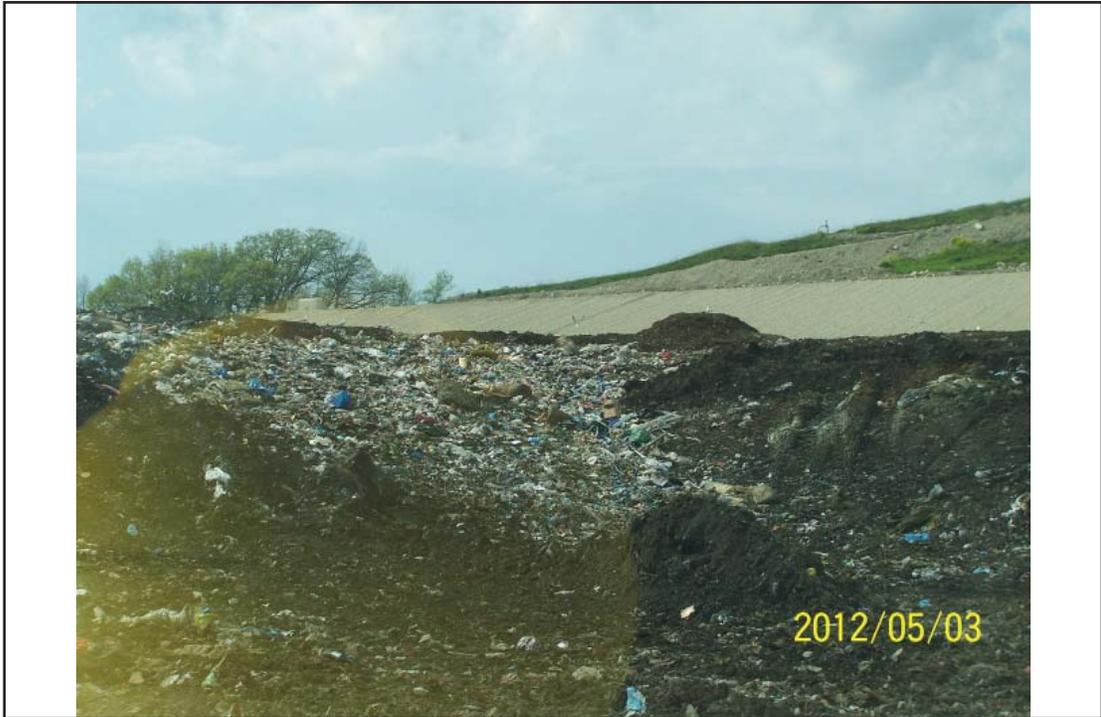
Working face being covered

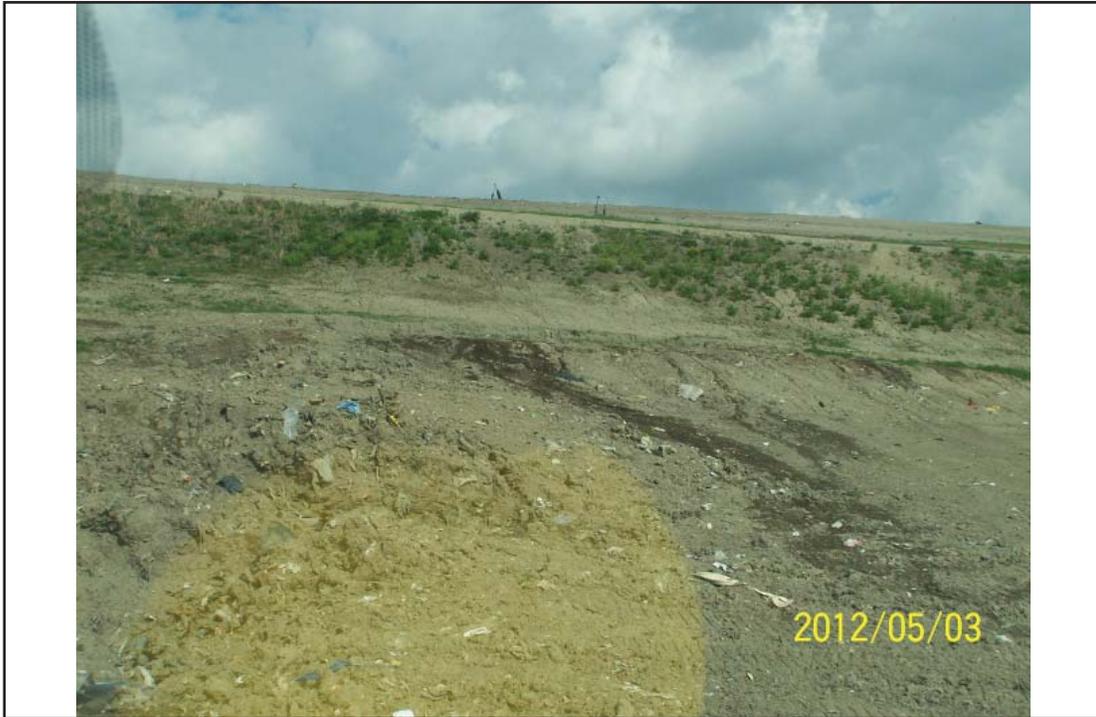
Minor seep on inboard, West slope of Phase 6

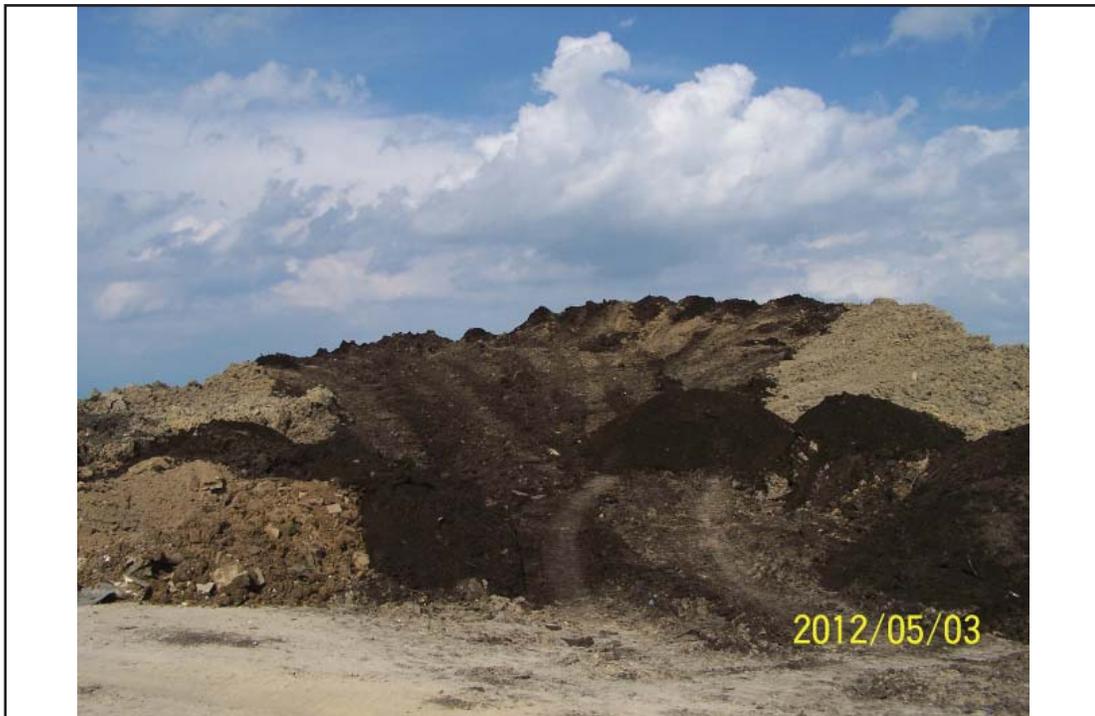
Bio soil pile being prepared for treatment

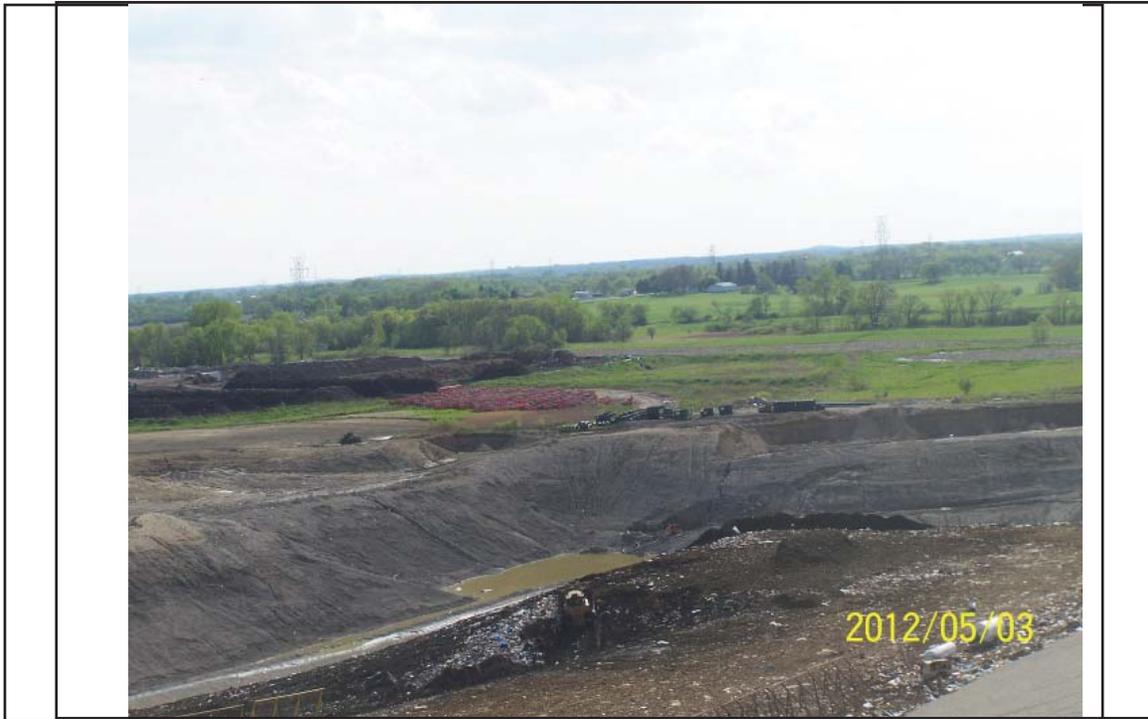
Active area, cover being placed on working face

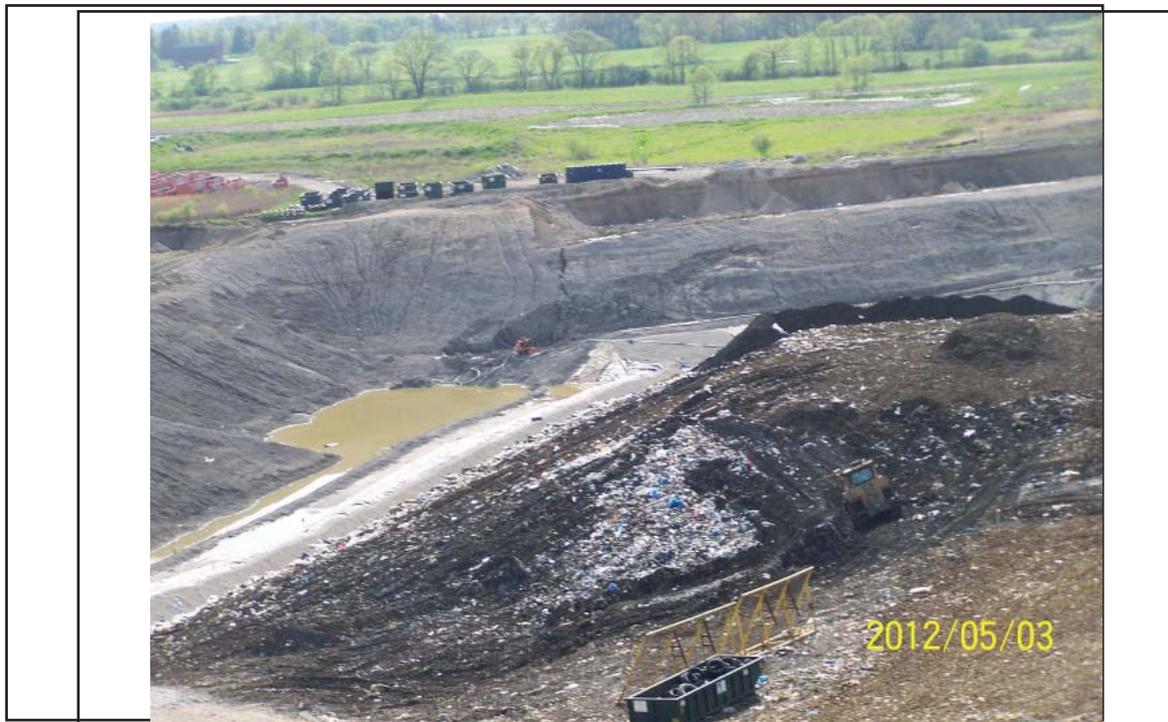
Working face and temp sed basin

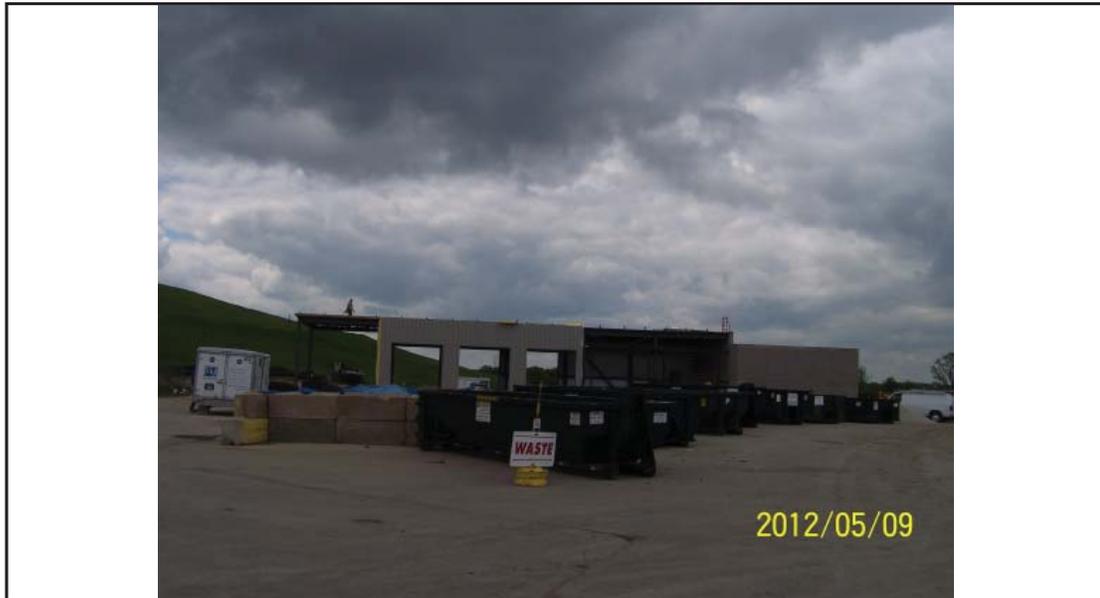
Gas building construction on going

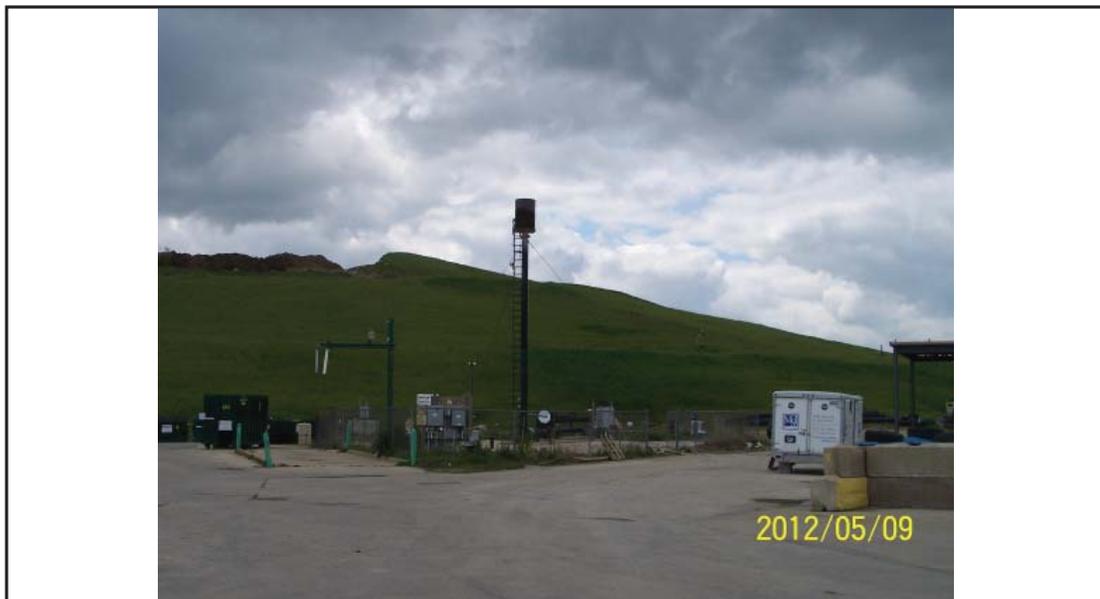
Flare and Phase 3

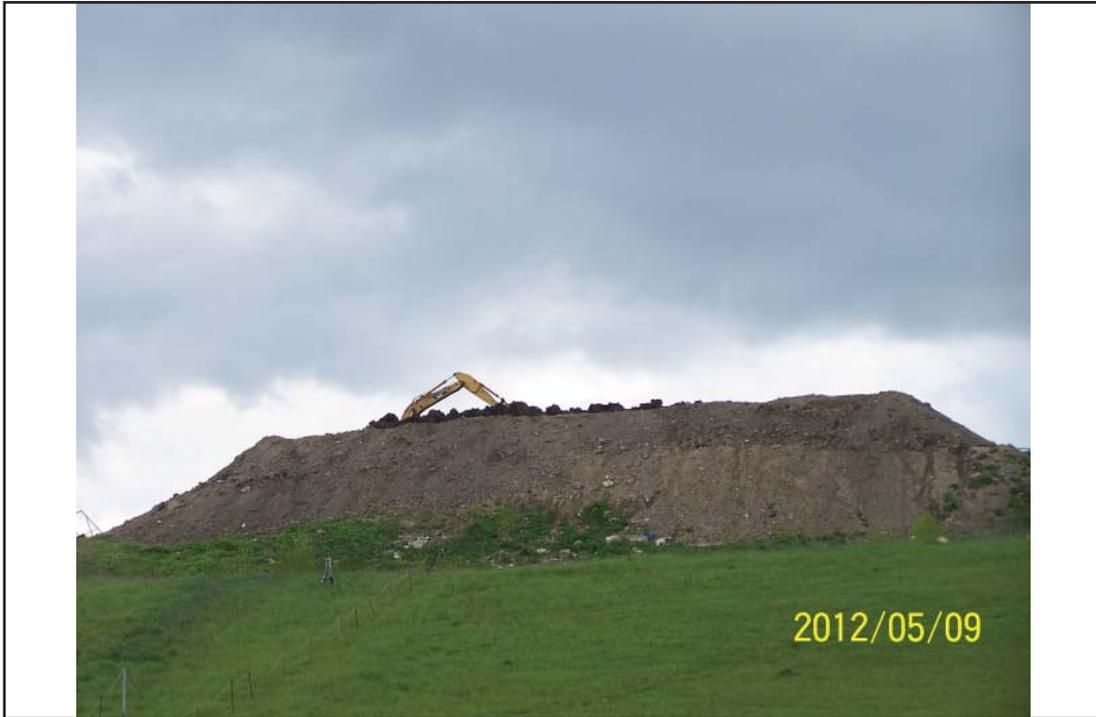
Bio pile being prepared for treatment

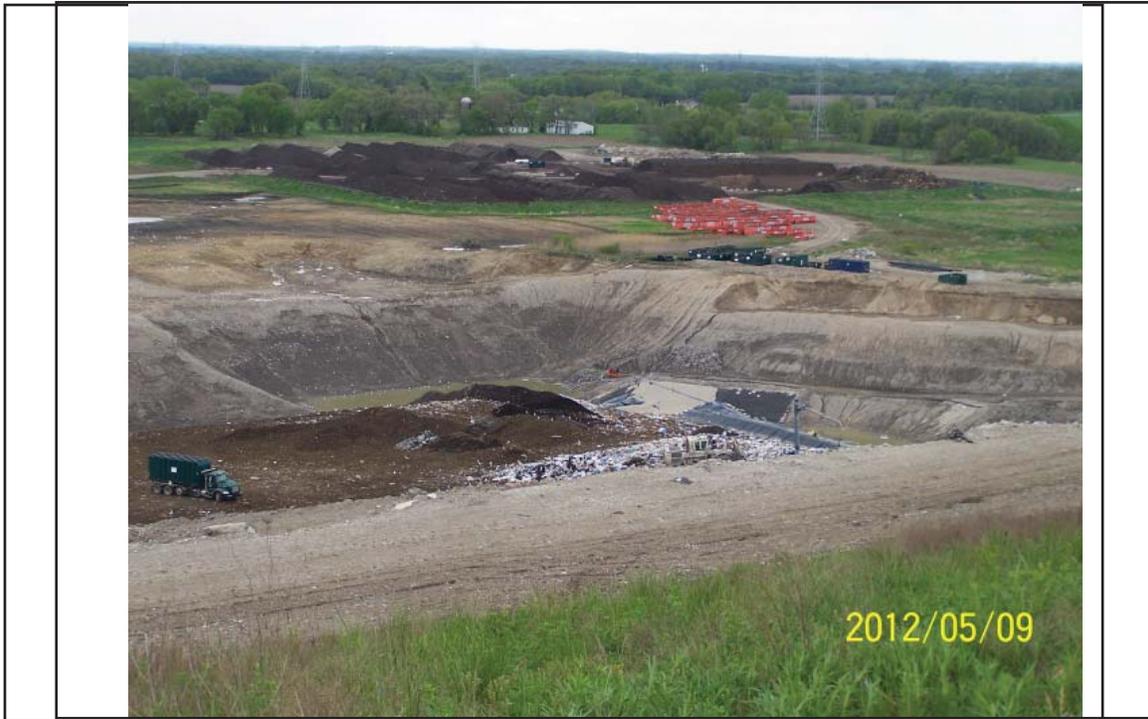
Working face and milorganite stockpile

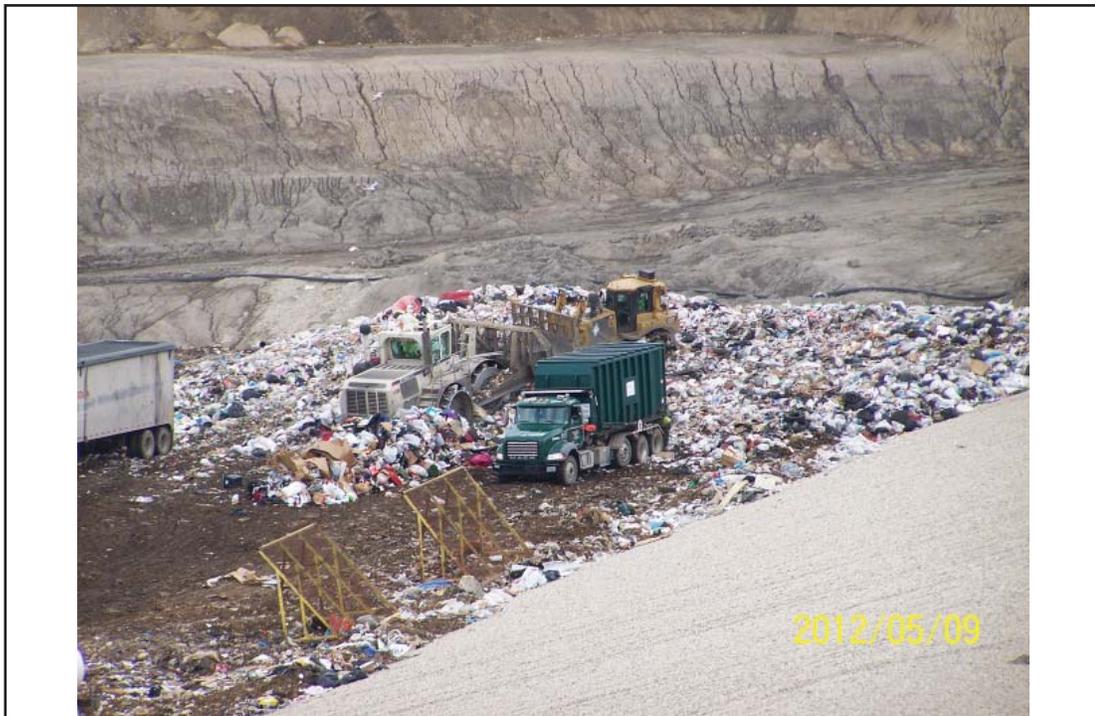
Working face in Northwest corner

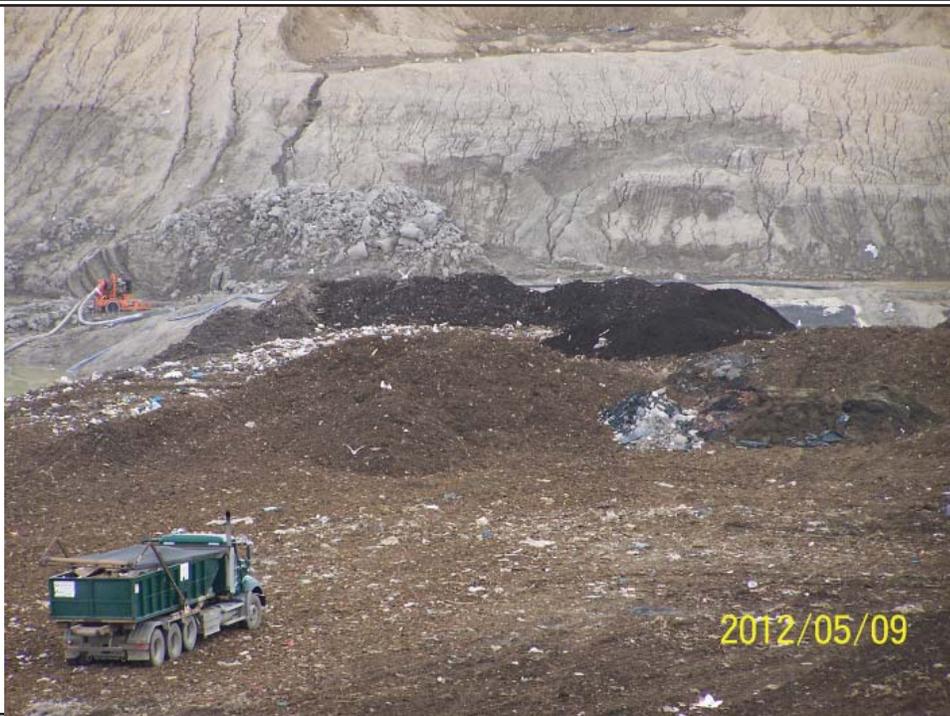
Autofluff cover

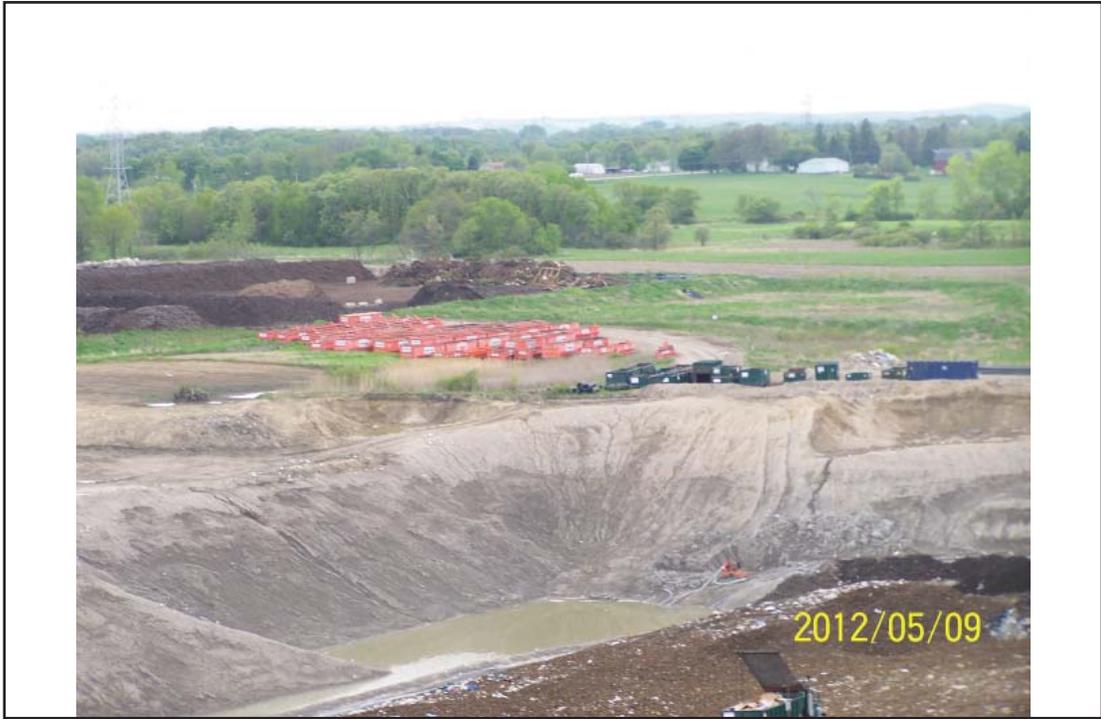
Temp sed basin

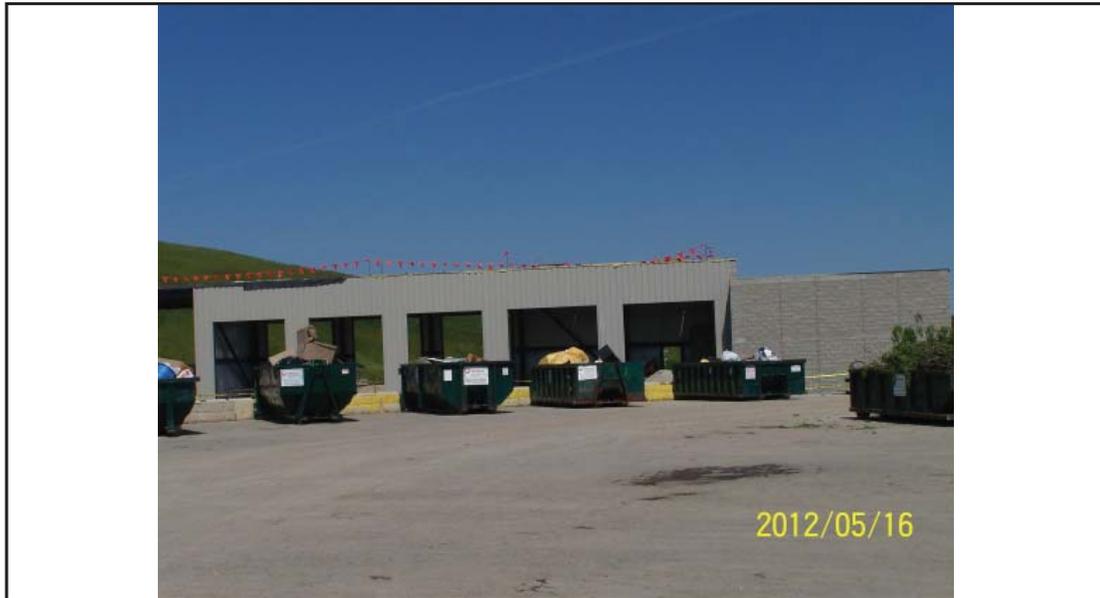
Gas building construction on going

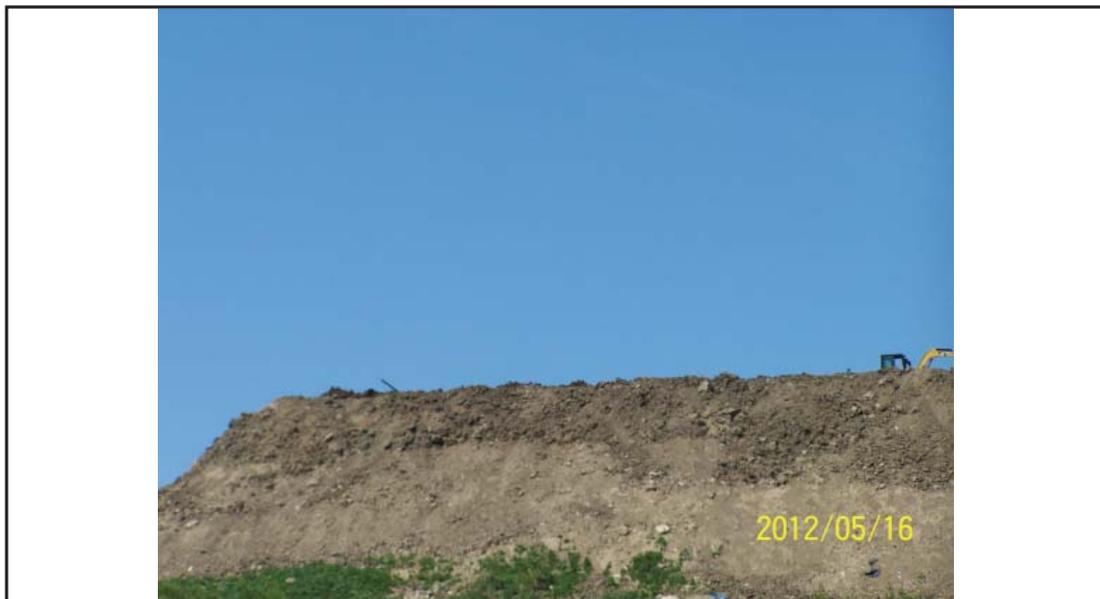
Bio-pile being prepared for treatment phase

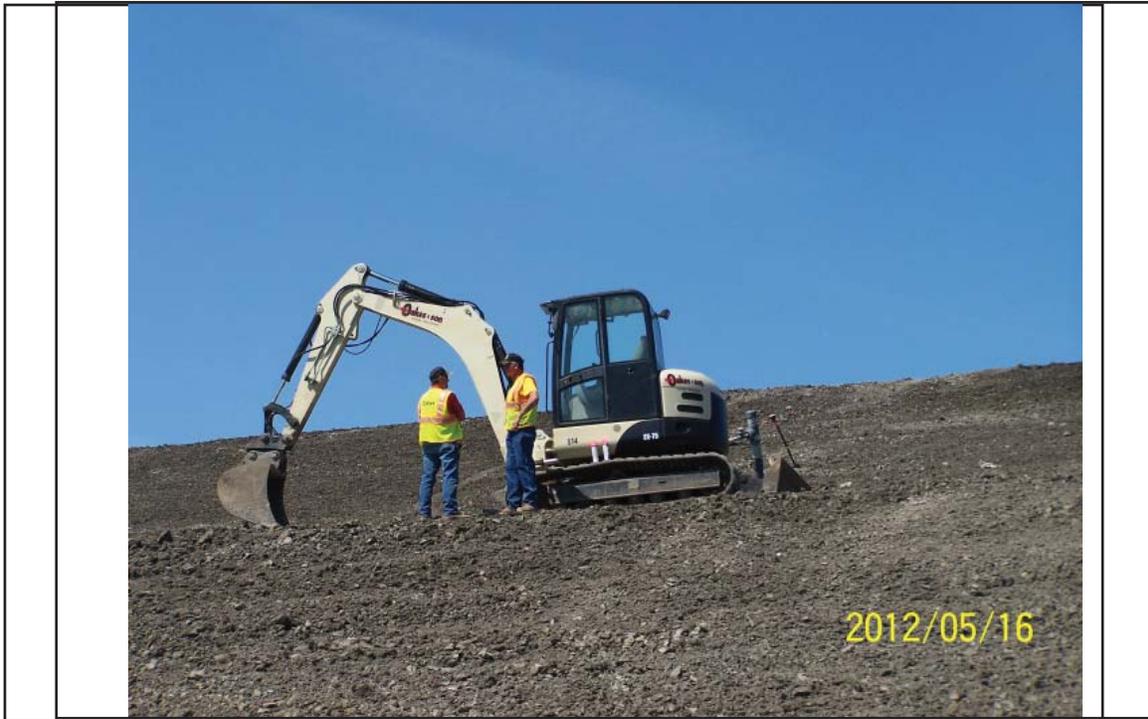
Oaks preparing Closure Area III for seeding

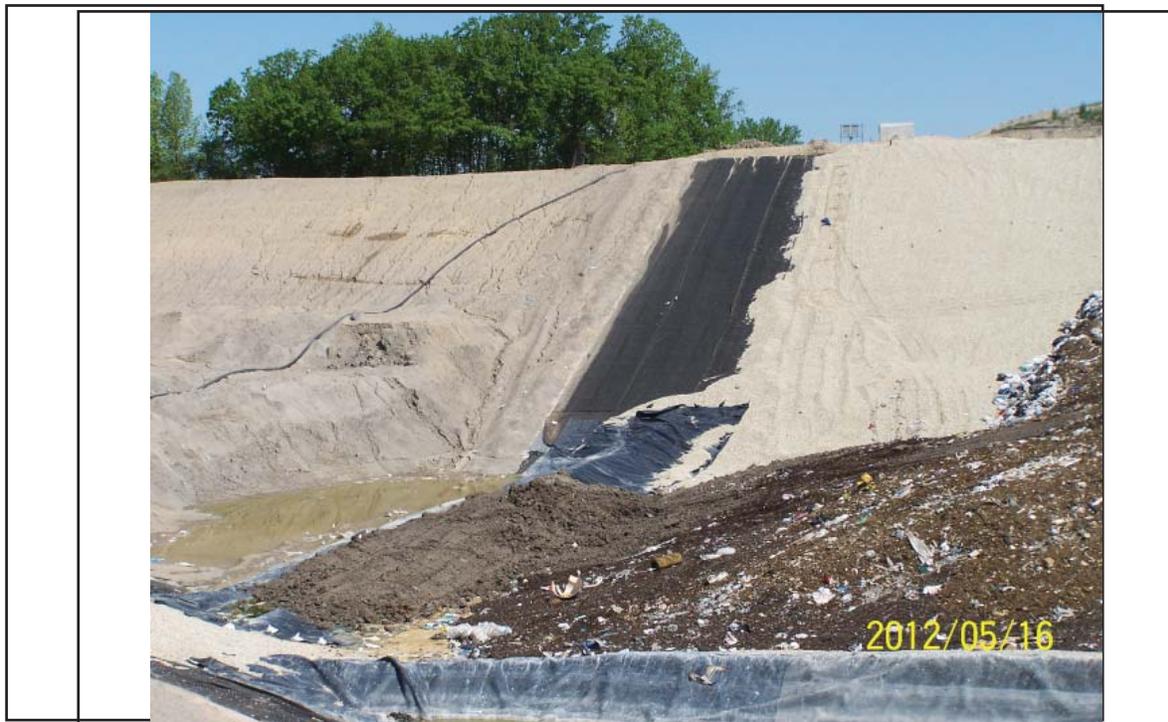
Clay base for toe of slope waste placement

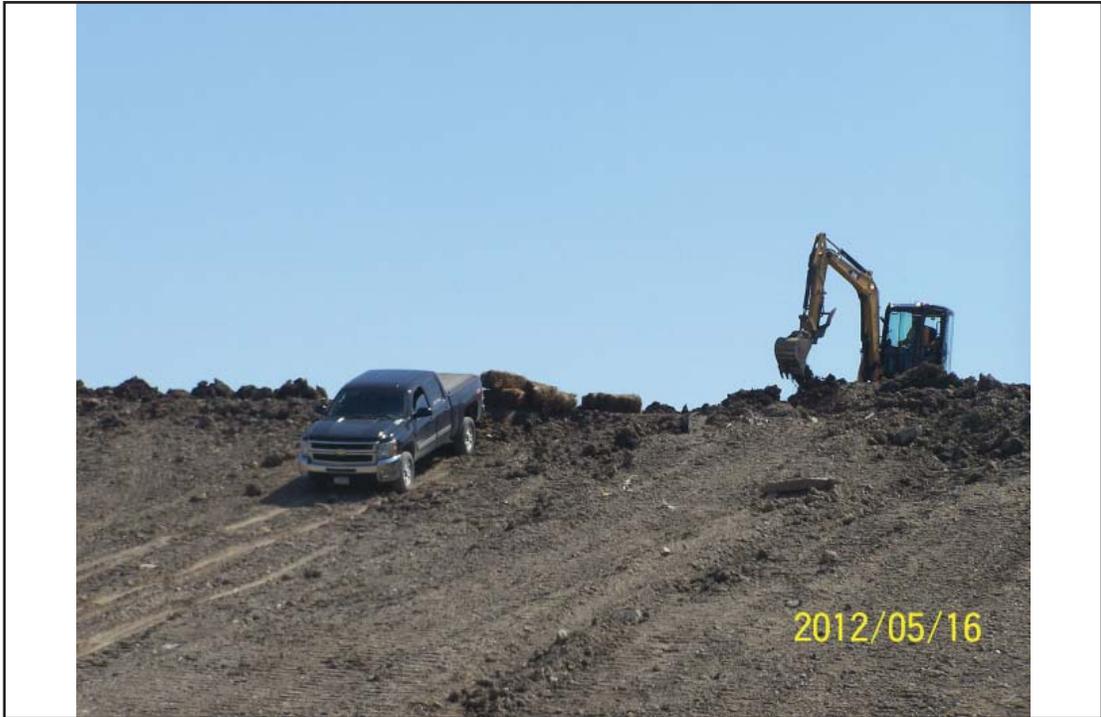
Bio-pile treatment trench installation

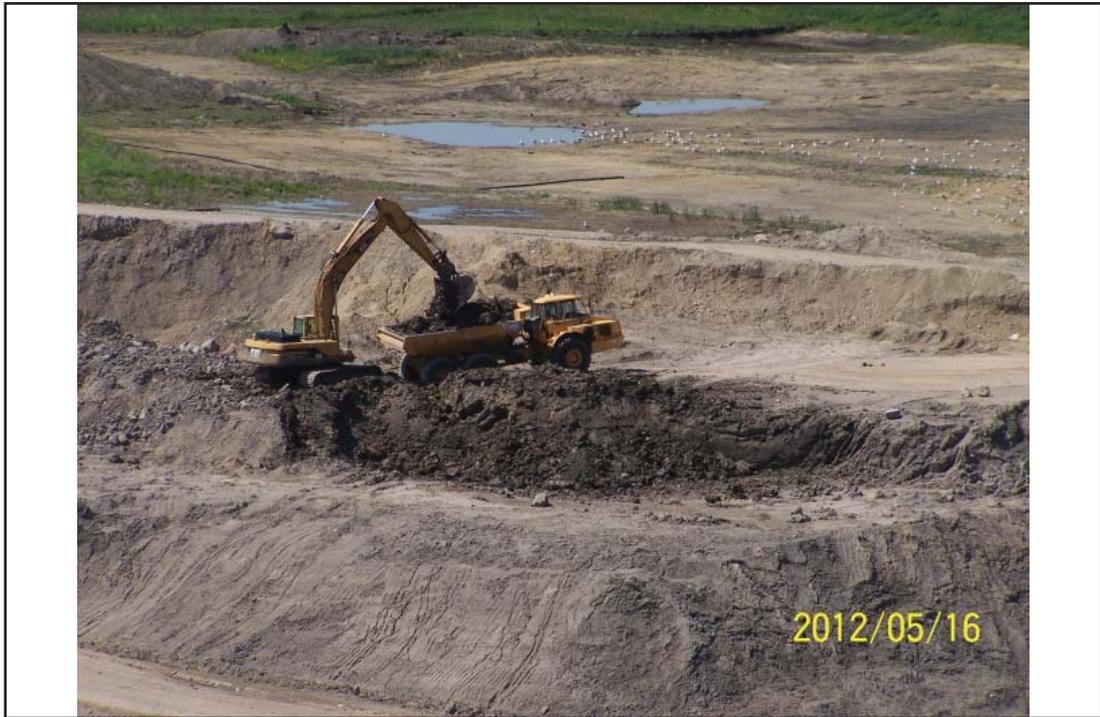
Clay excavation, Phase 8

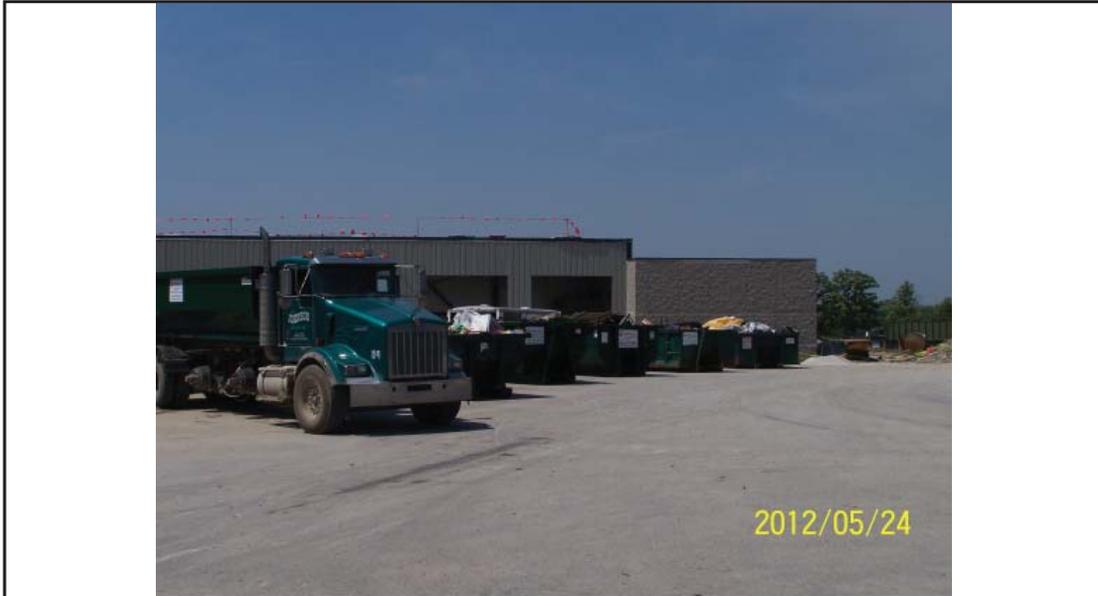
Gas building construction on going

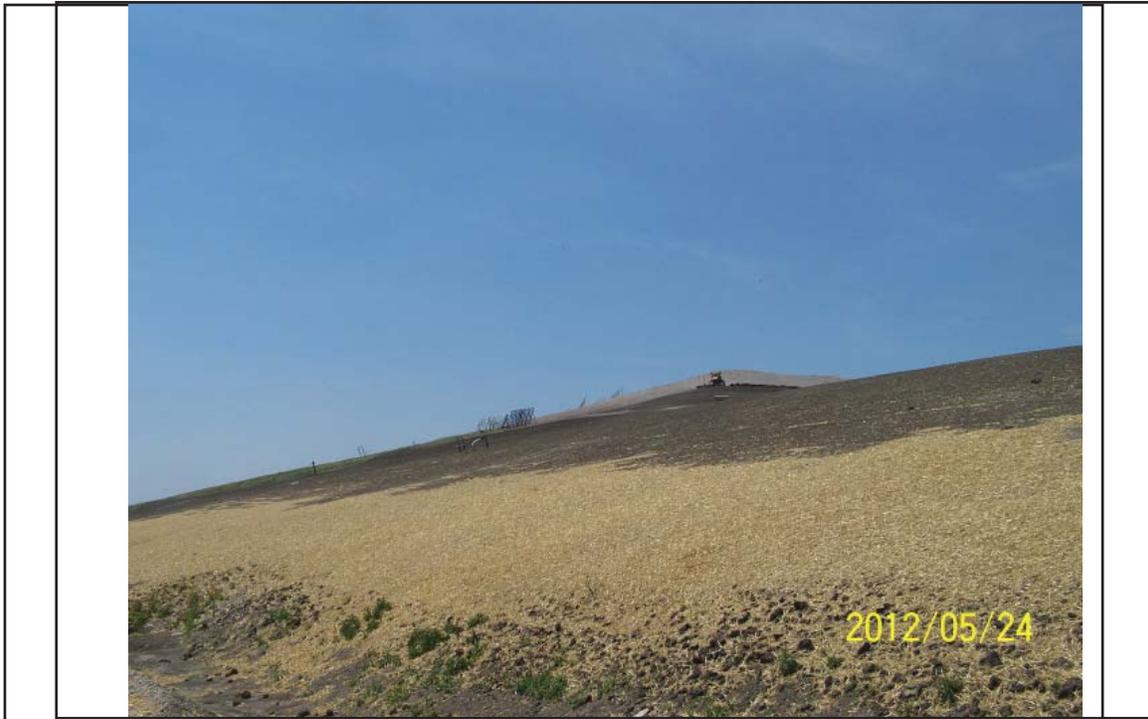
Some portion of Closure Area III has been seeded and treated with straw cover

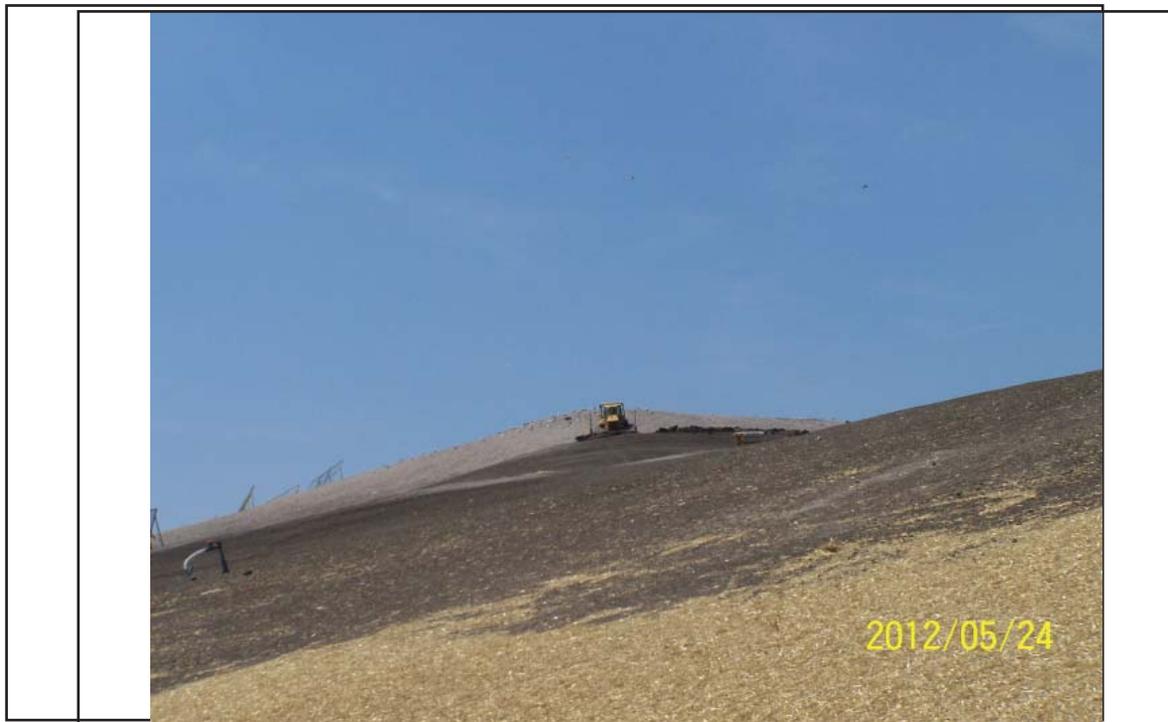
Closure area III berm being completed

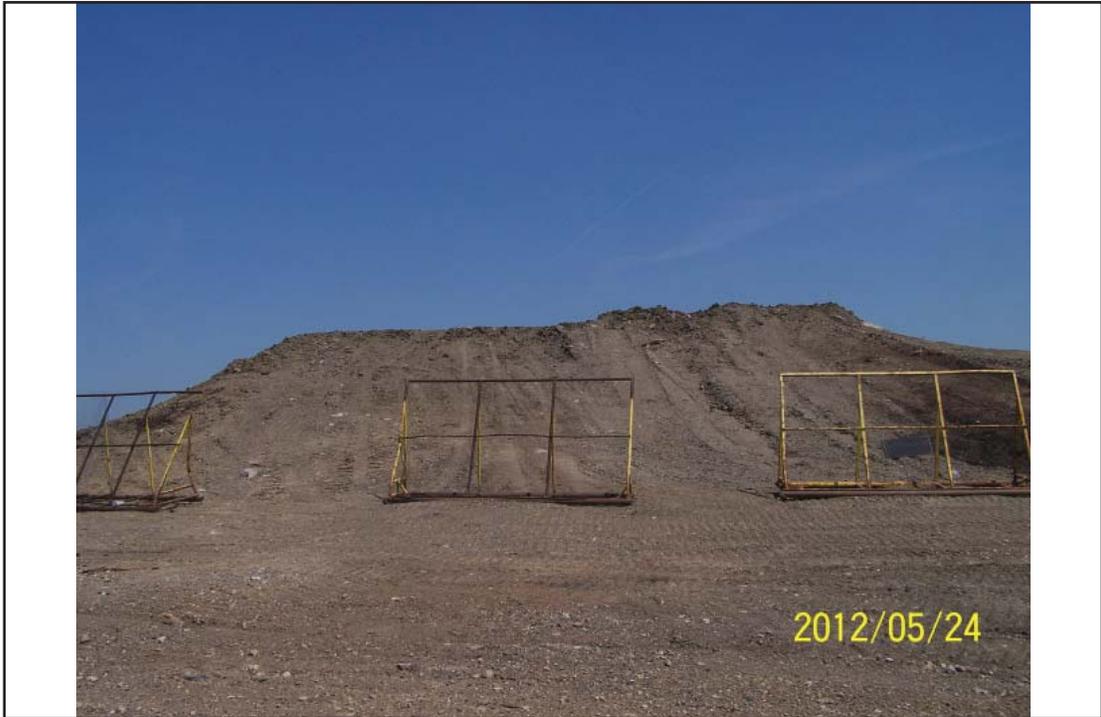
Bio-soil pile ready for treatment

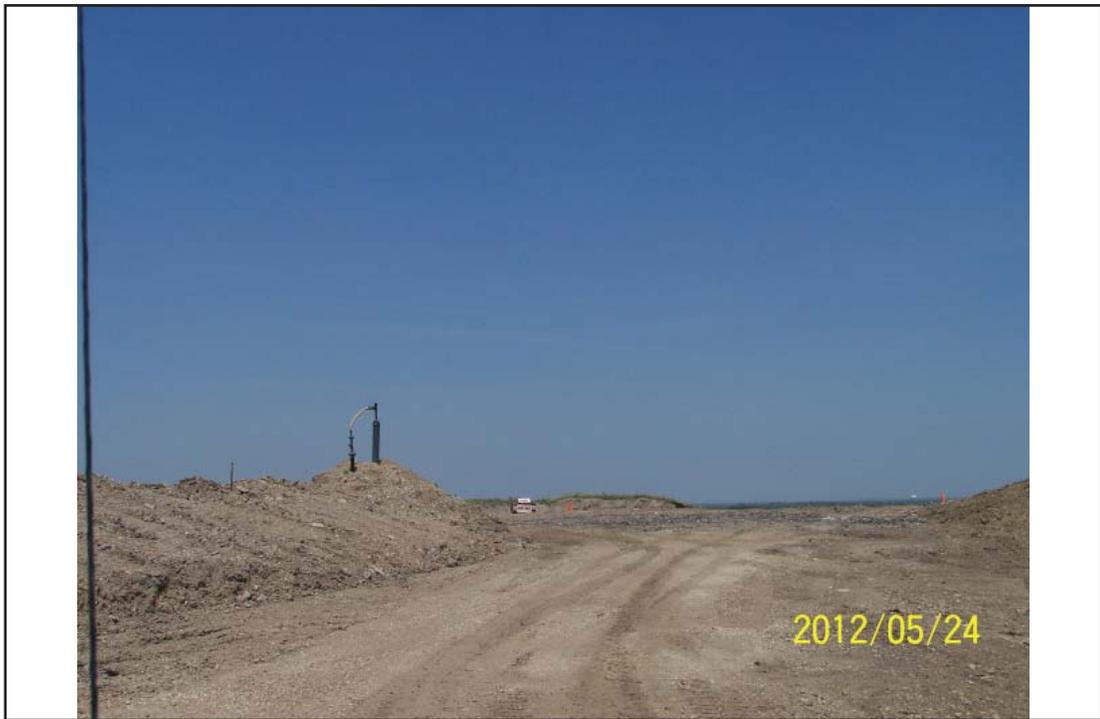
Area to receive landfill direct soils

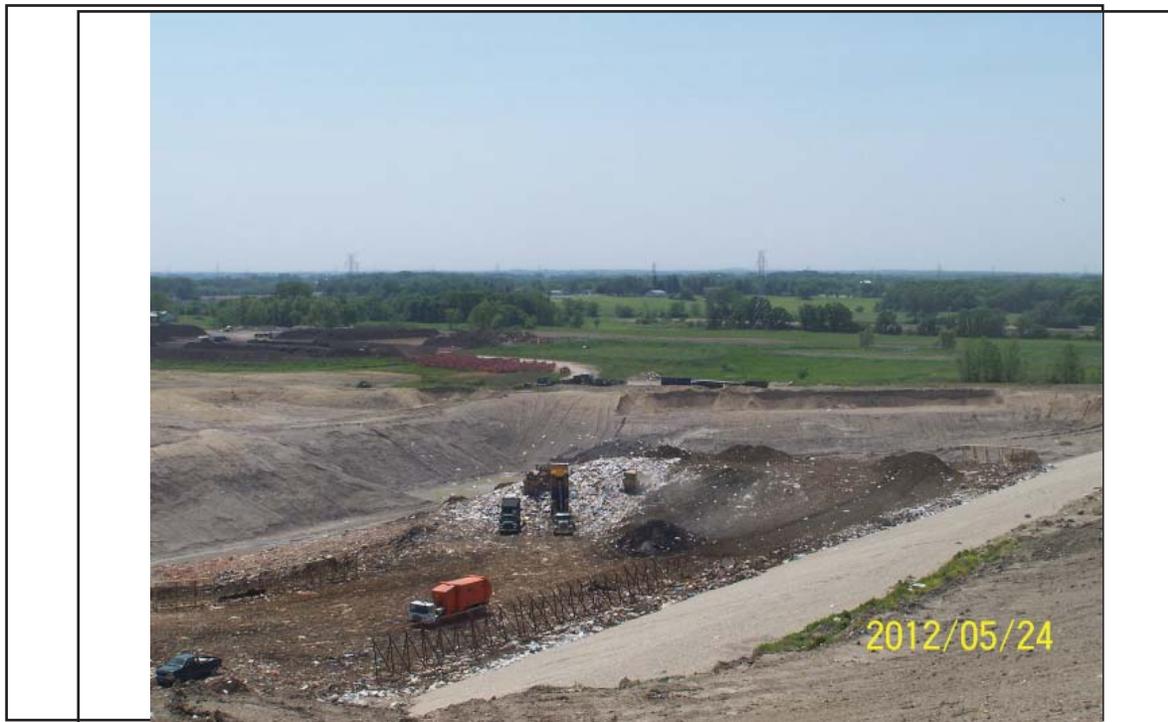
Active area

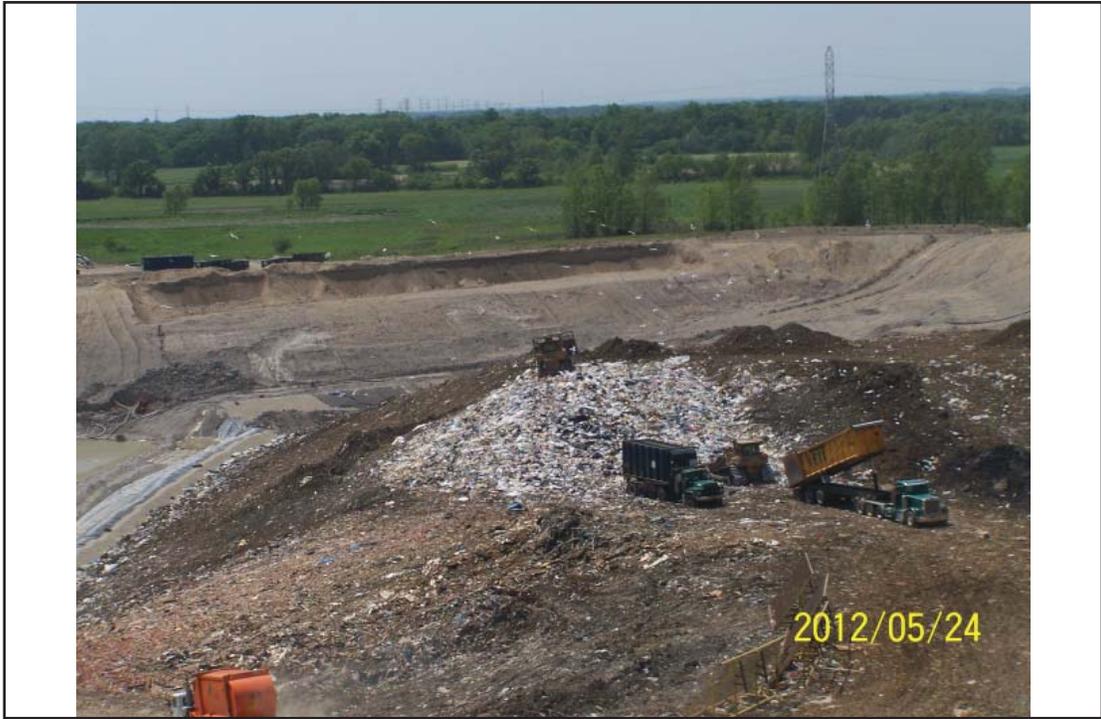
Working face

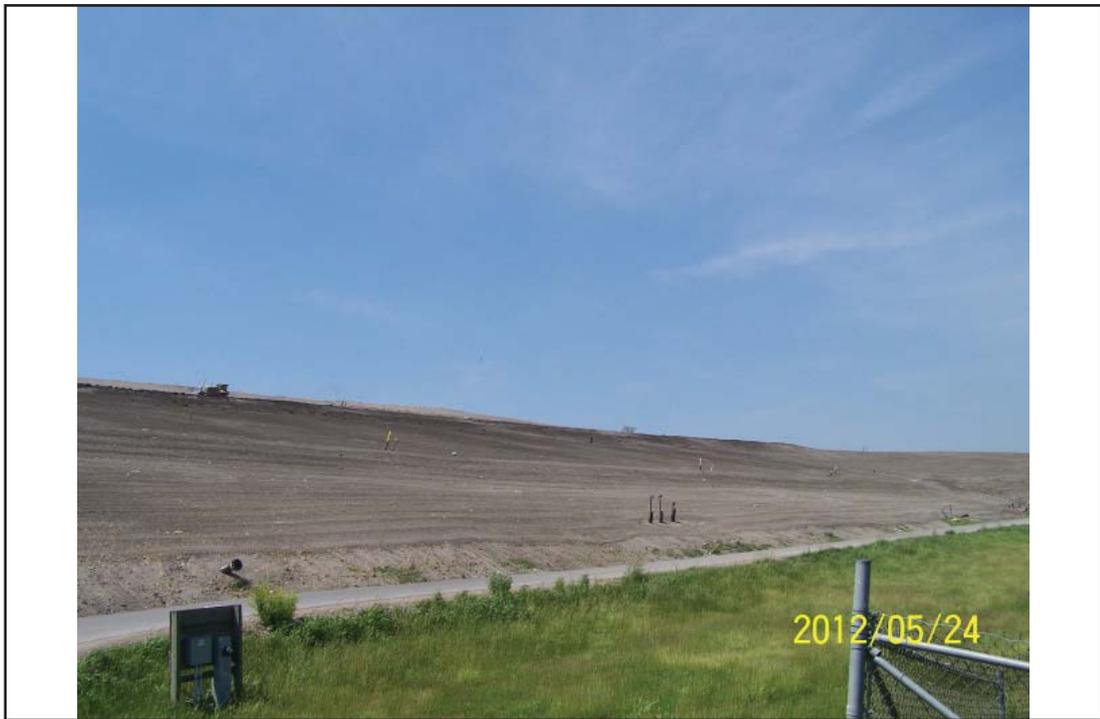
Closure Area III ready for seeding

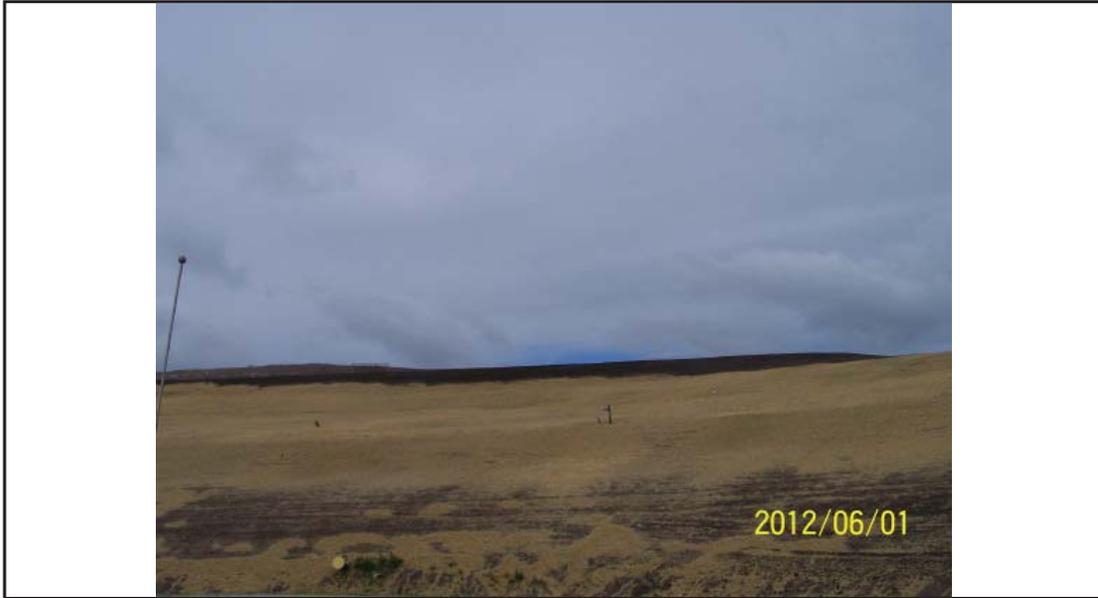
Closure area III seeding and covering completed

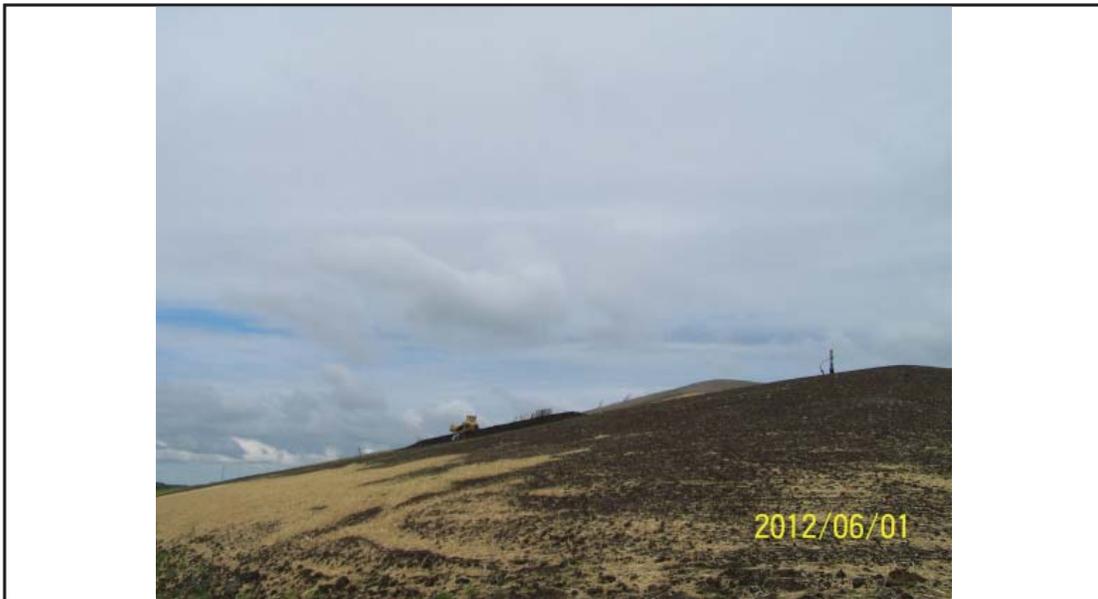
Closure area III
