2012 Advanced Disposal Services Emerald Park Landfill Year End Compliance Officer Report and Audit Summary

TO: Veolia Emerald Park Standing Committee
FROM: Jo-Walter Spear, Jr., P.E.
COPIES: File
DATE: 04/04/13
PROJECT NUMBER: 1012.10030

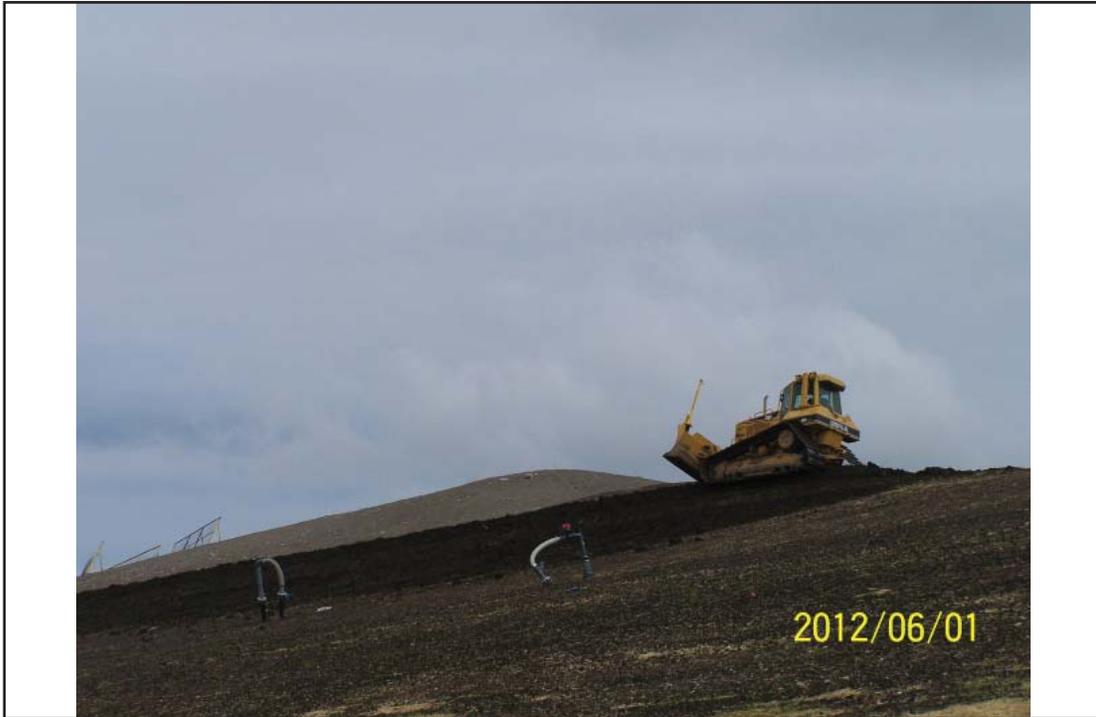
Closure area III - construction of South slope diversion berm.

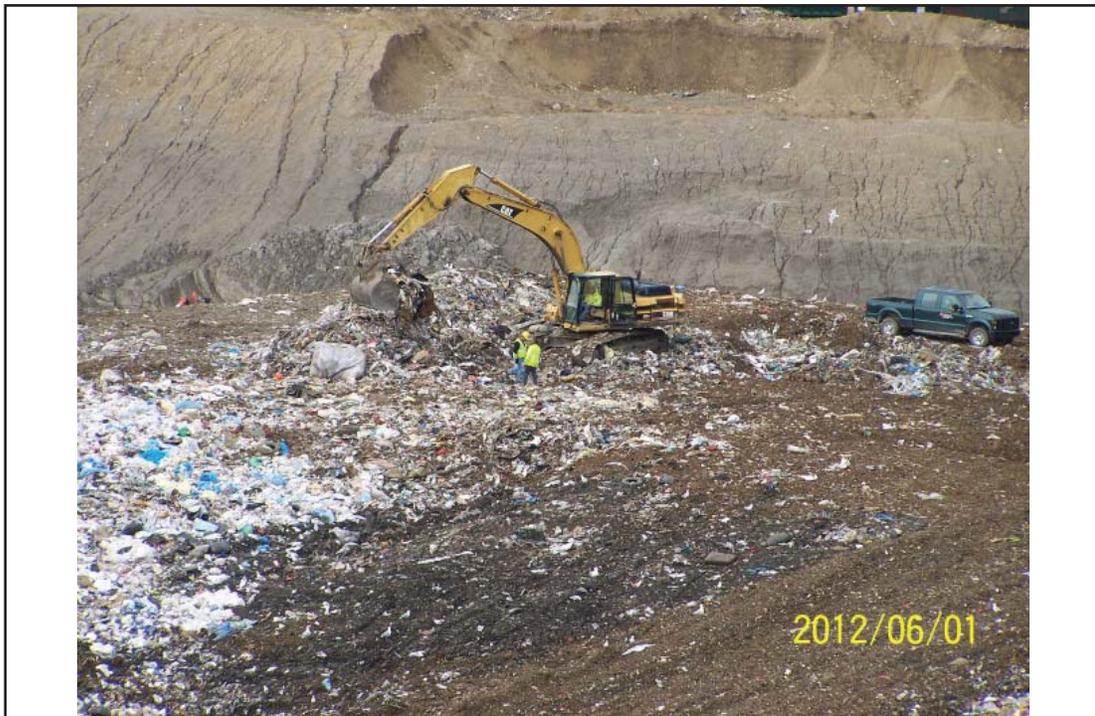
Search for lost money, excavation of previously covered waste

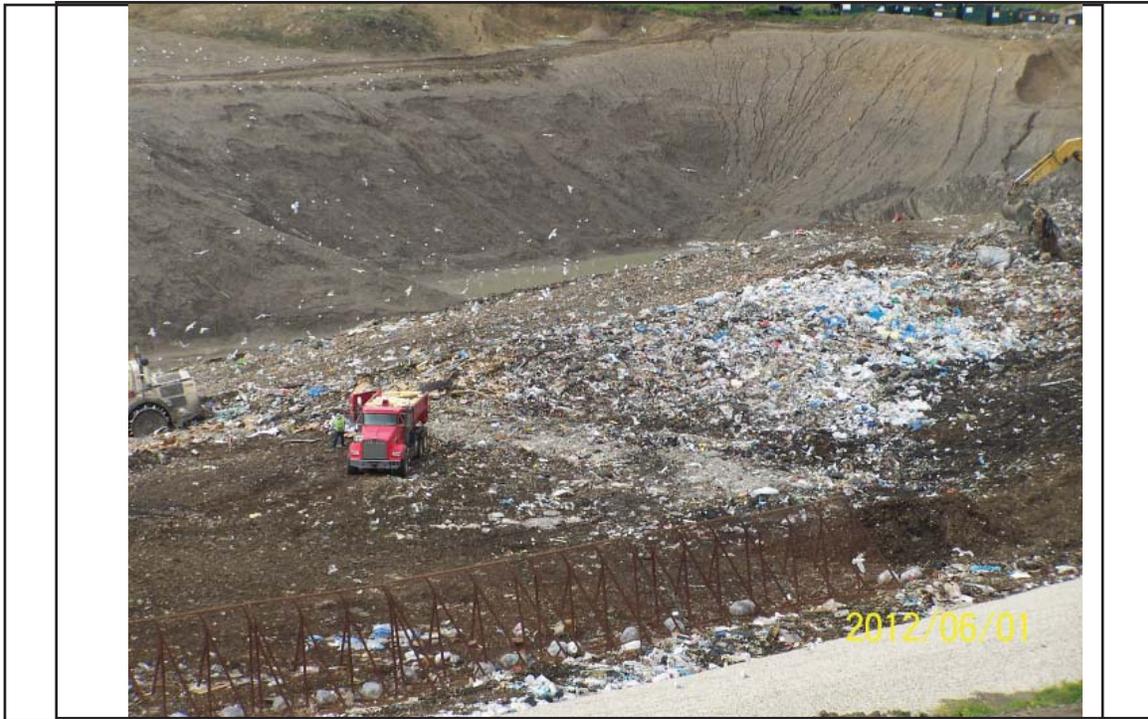
Working face

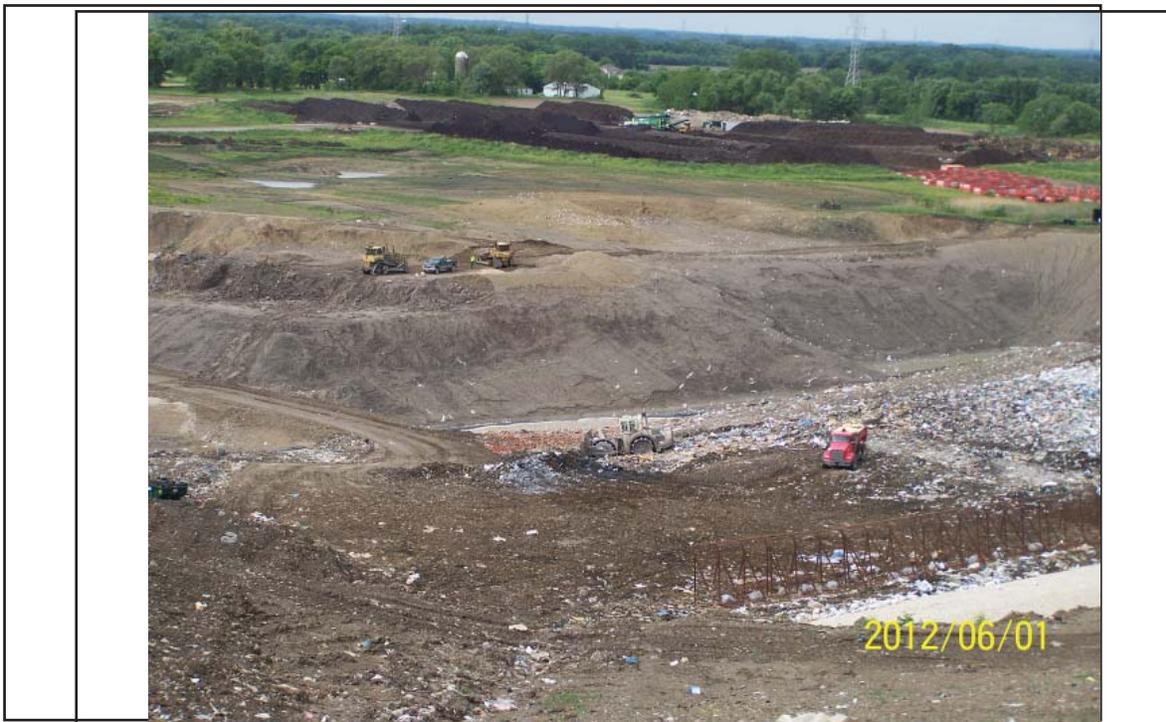
Active area

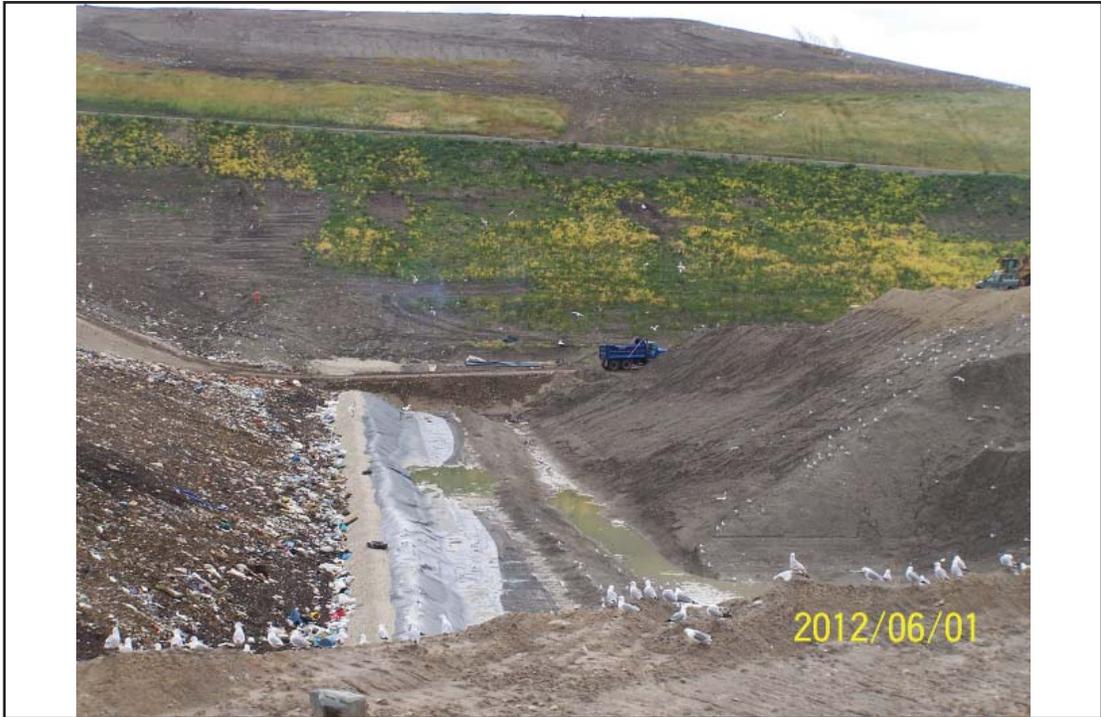
Temp sed basin

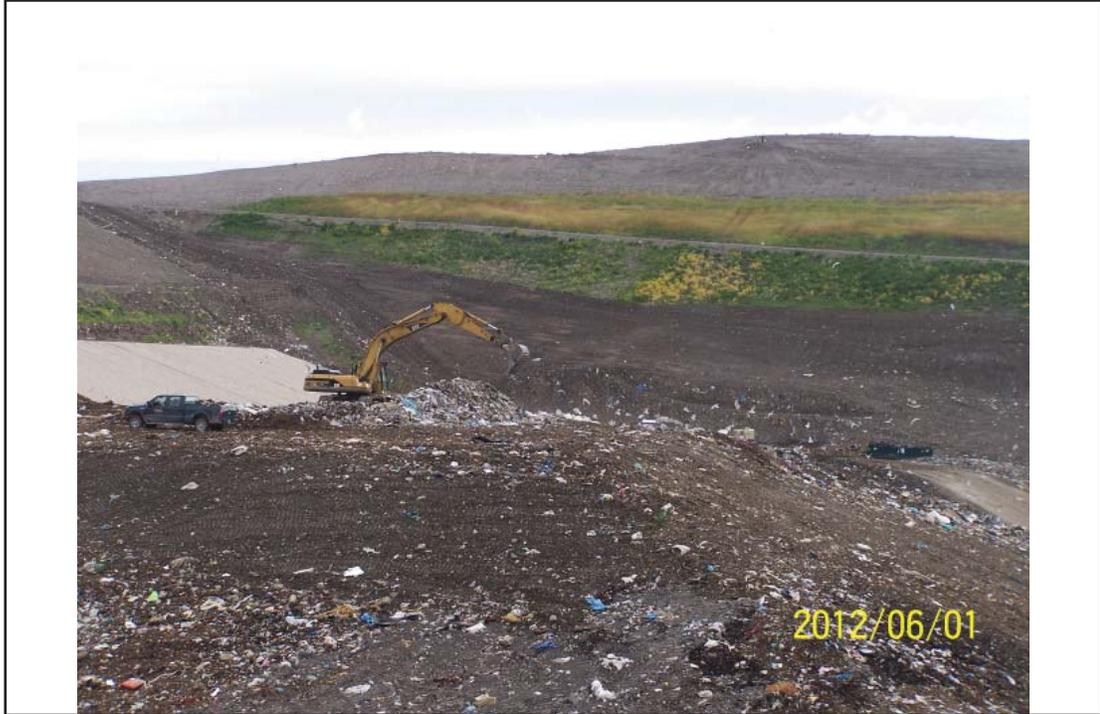
Search in waste mass

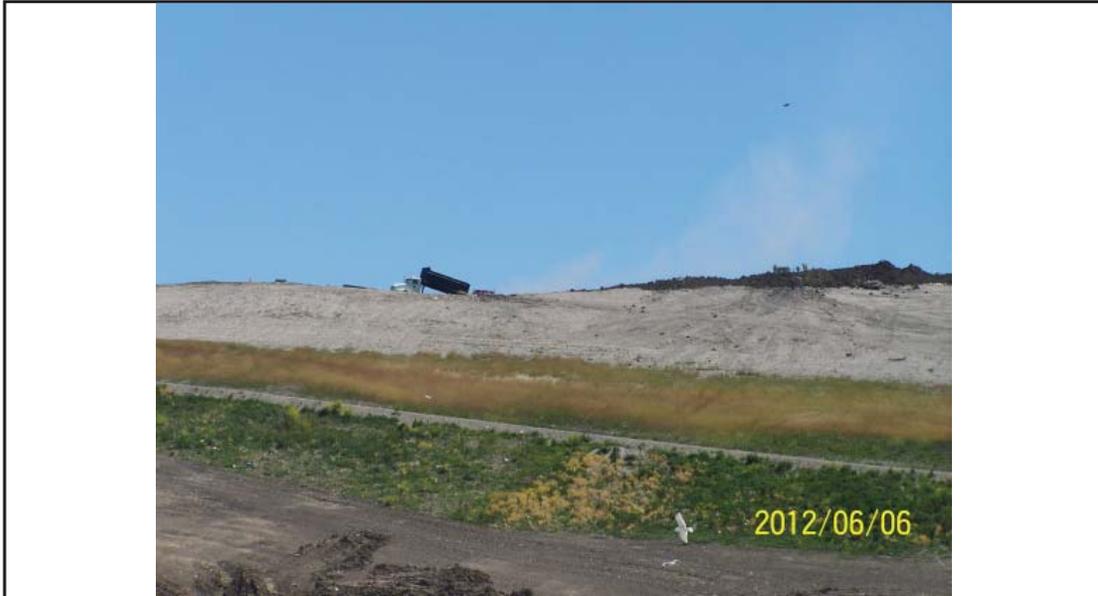
Soil tipping on Phase 5&6

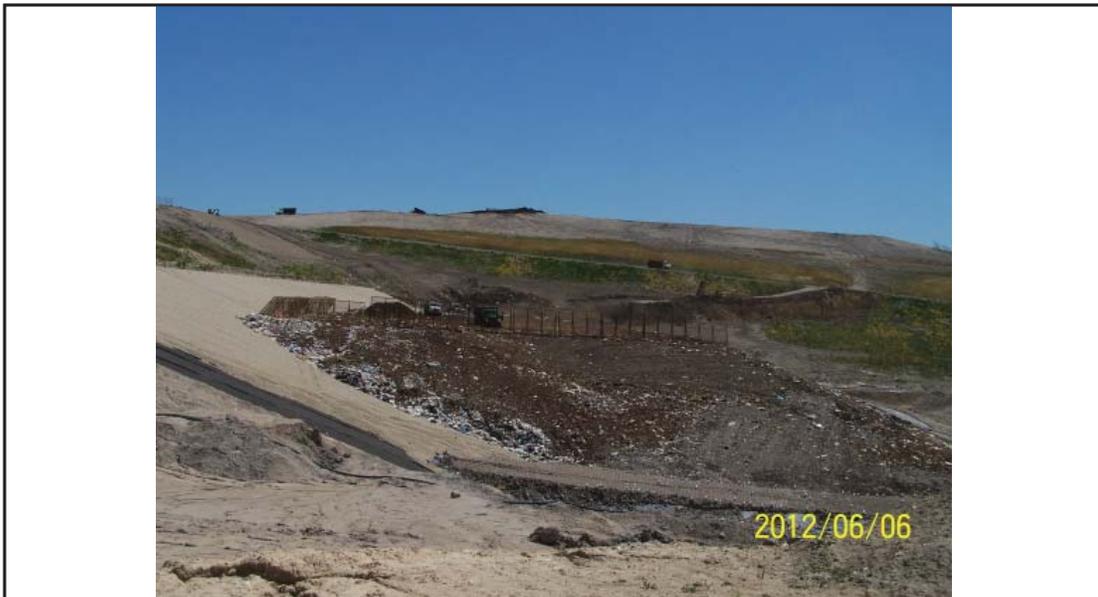
Active Area

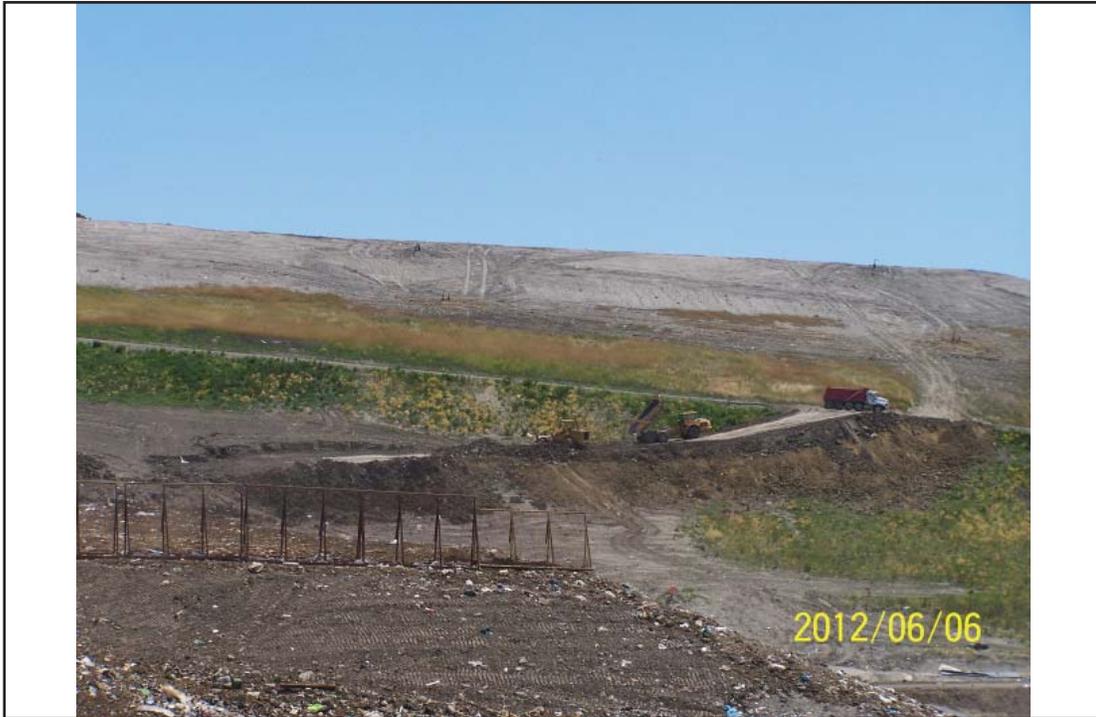
Construction of new access road to Phase 7

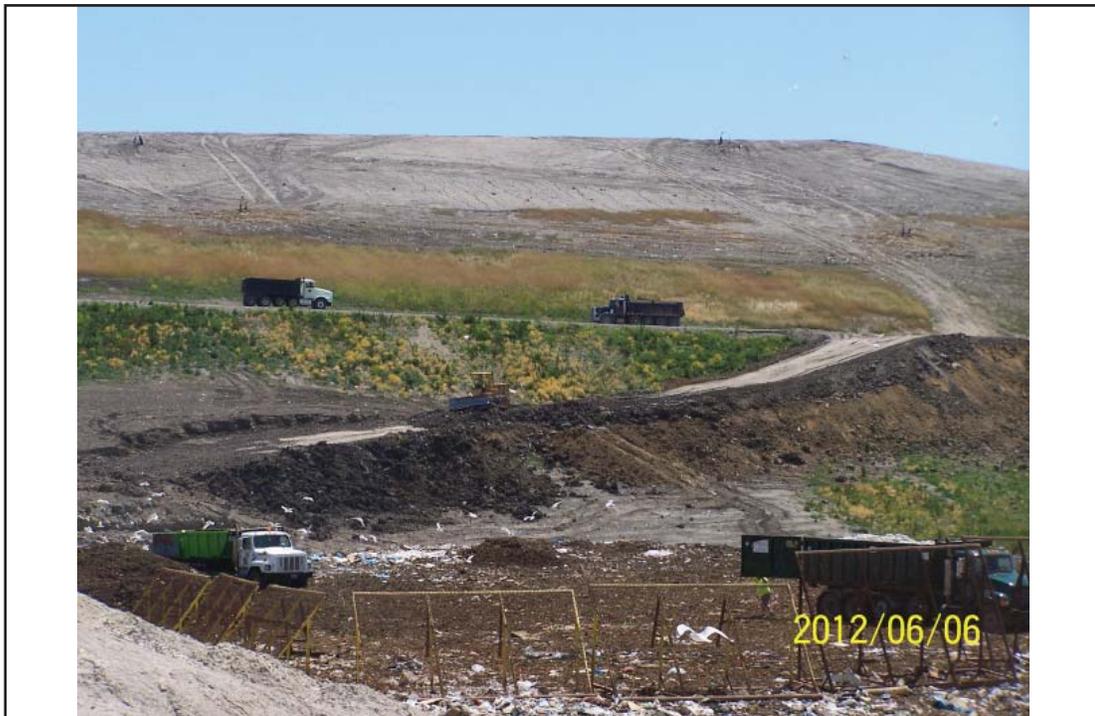
Working face

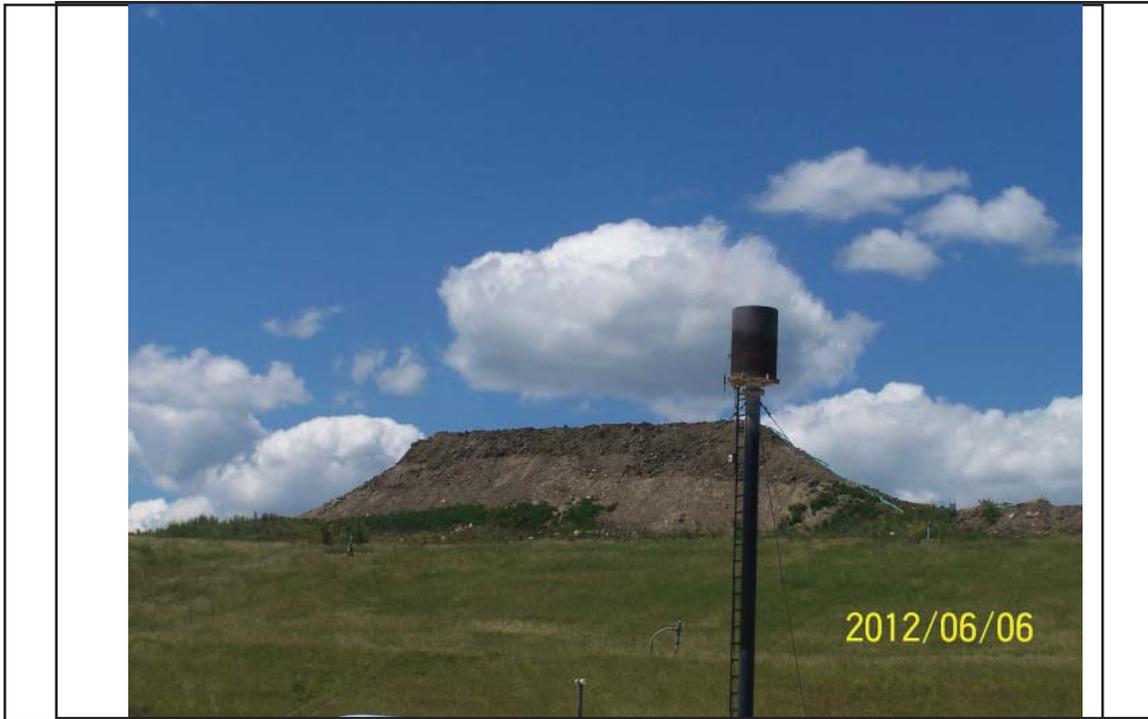
Bio pile undergoing treatment

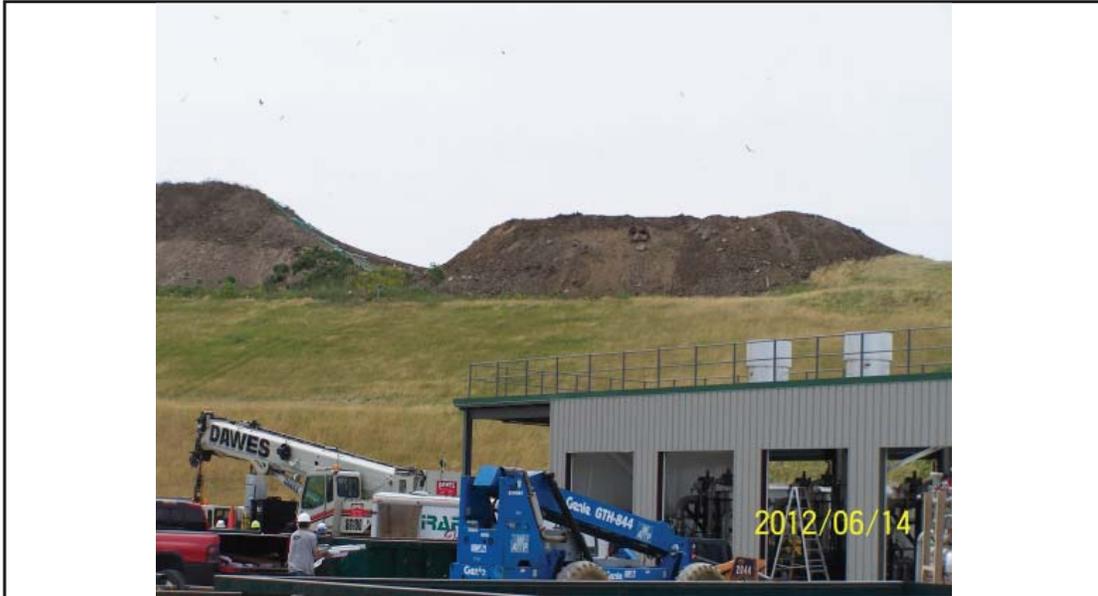
Gas building construction

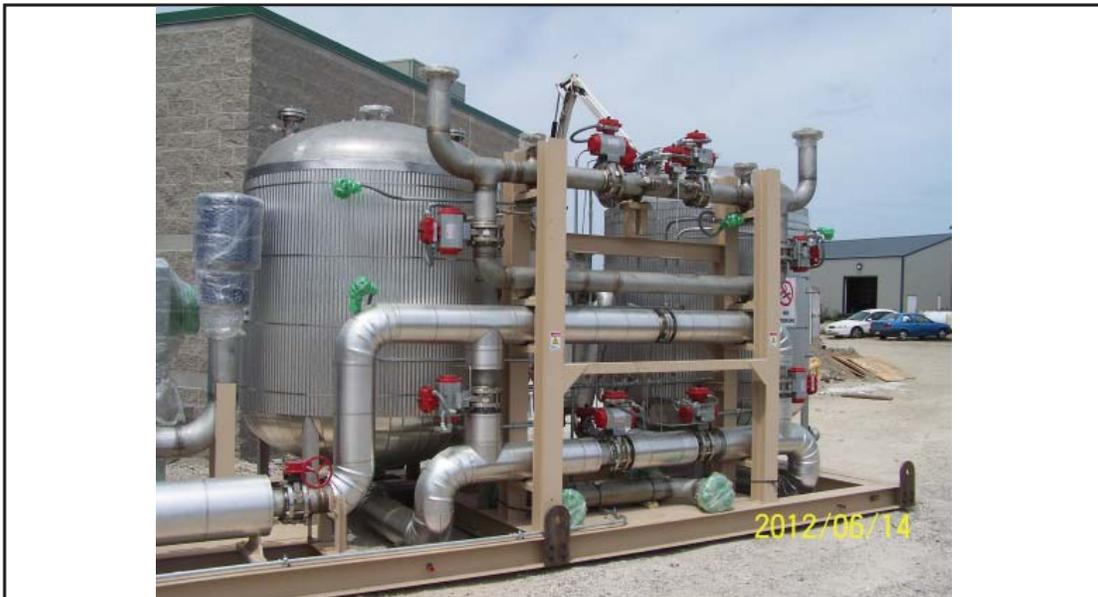
Skid awaiting install.

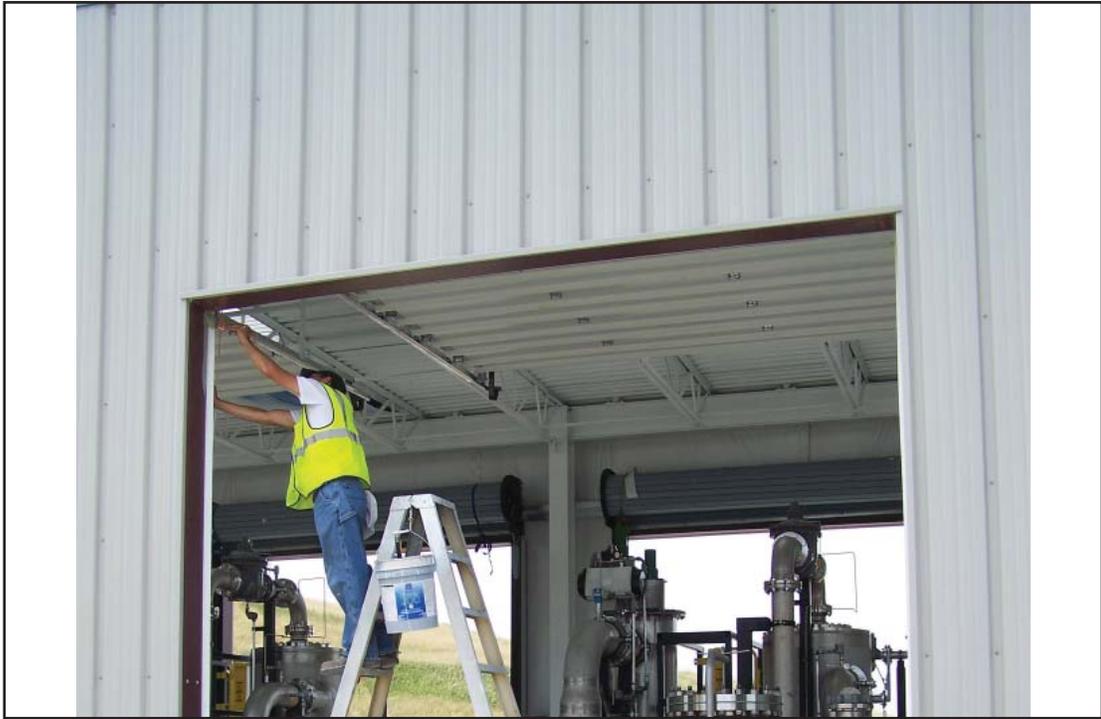
Gas building construction

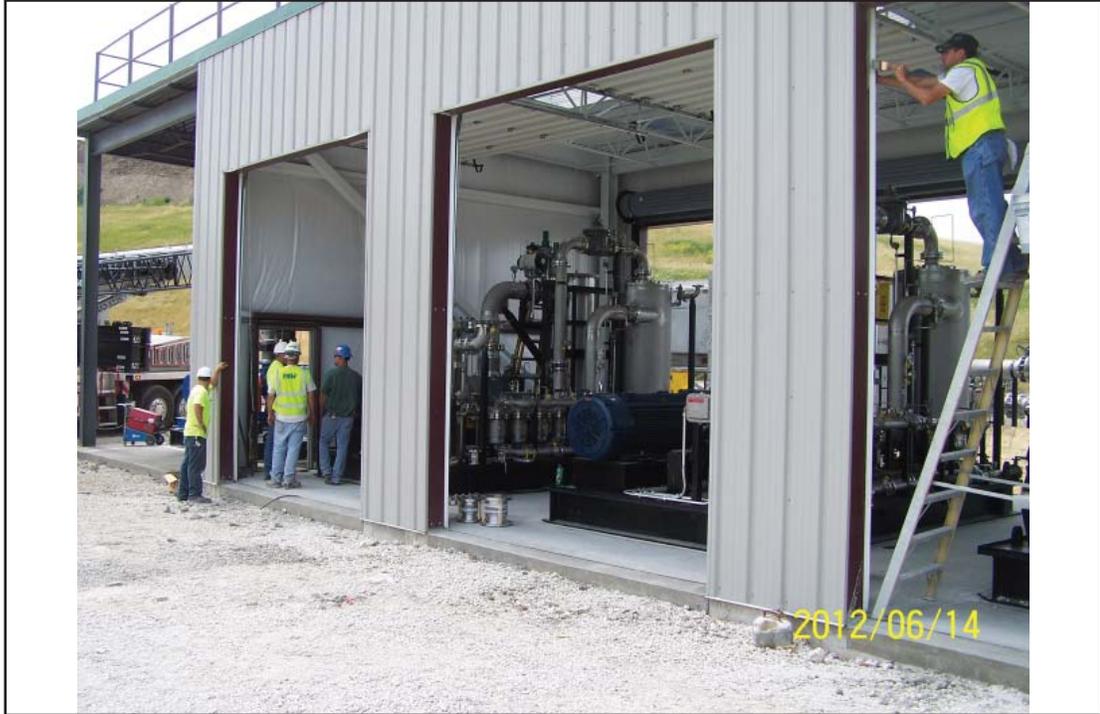
Gas building construction

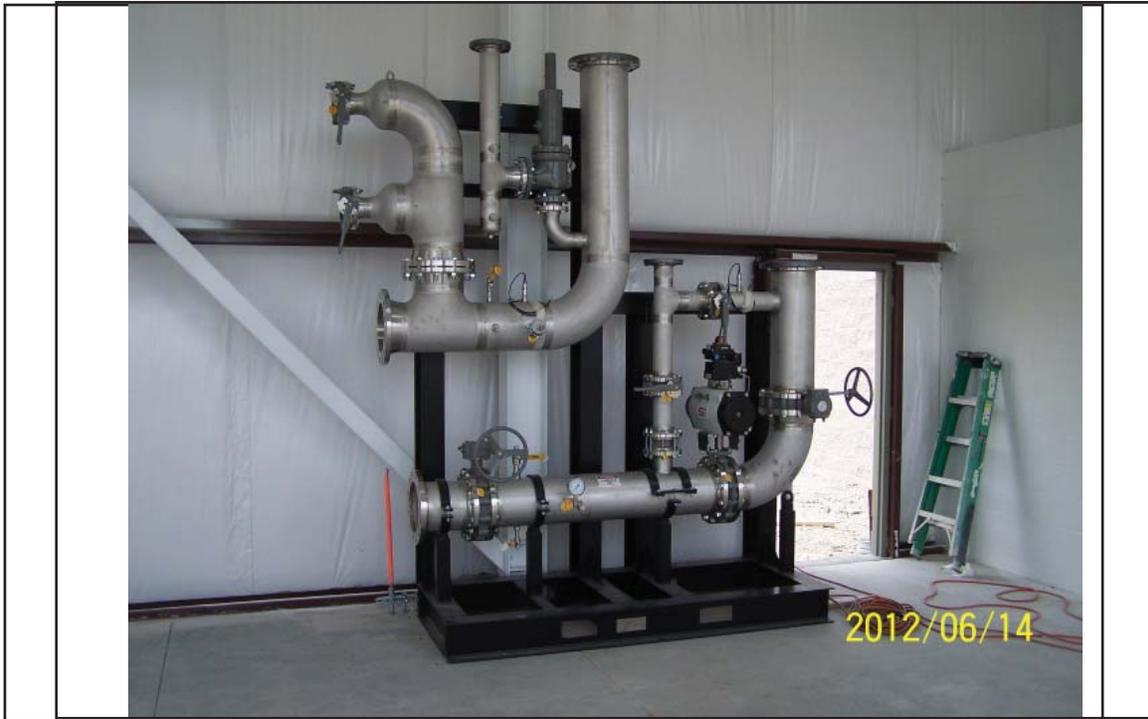
Sampling skid

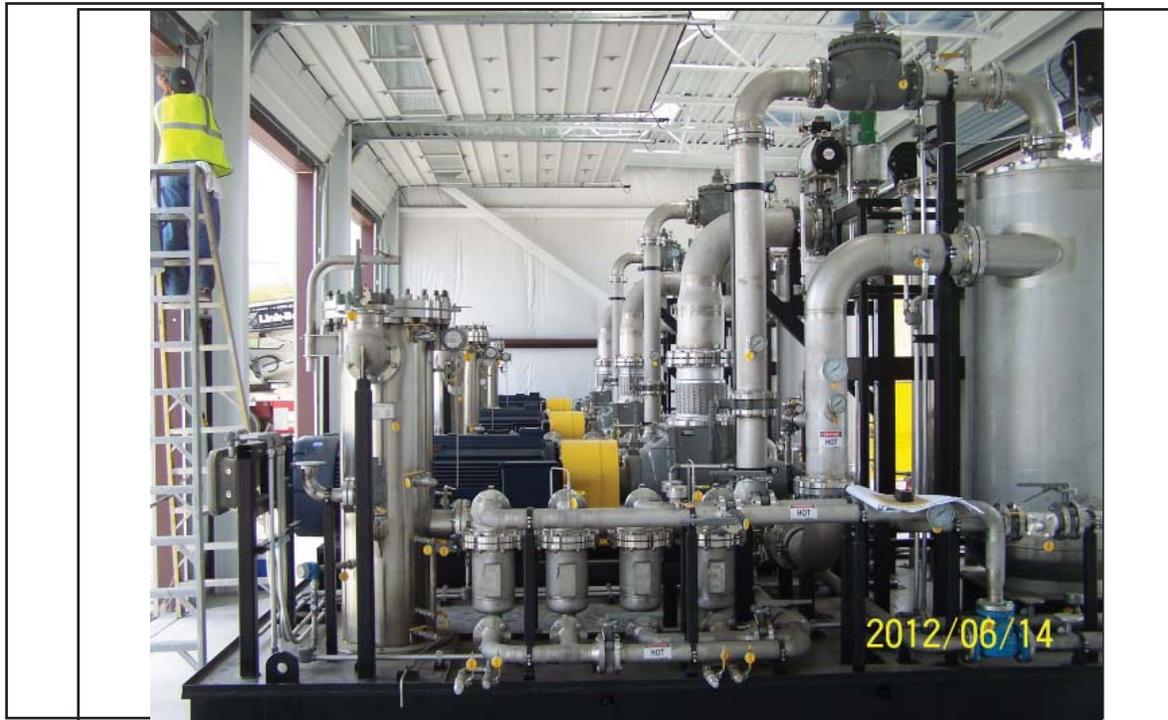
Gas building

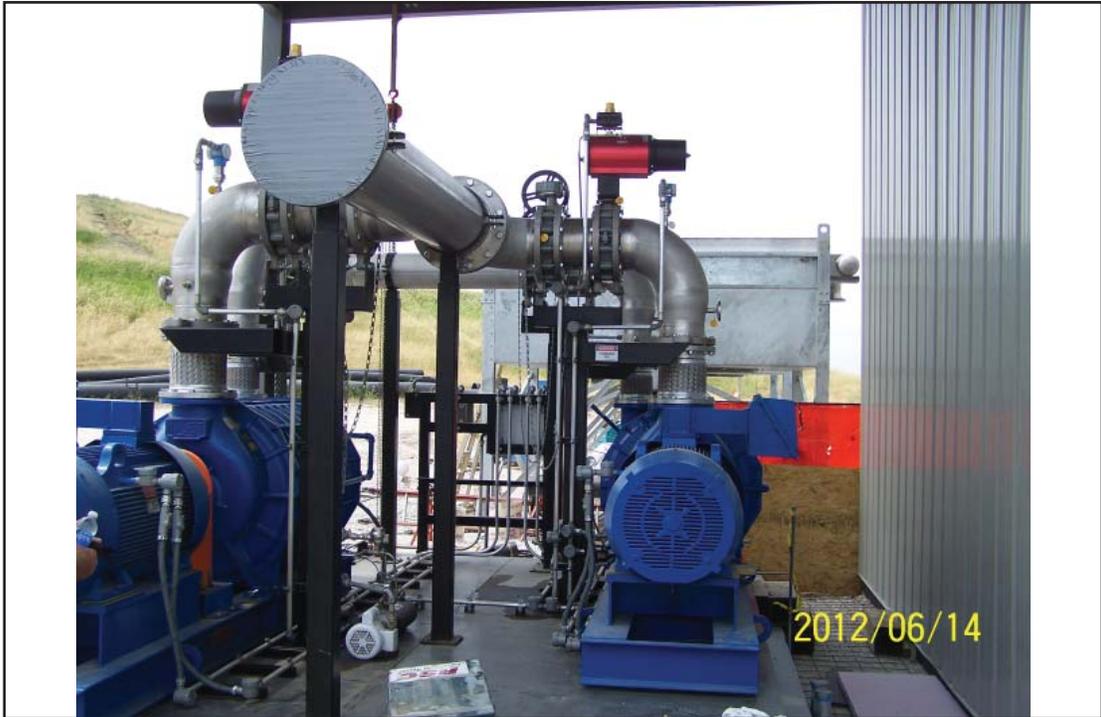
Blowers for gas project

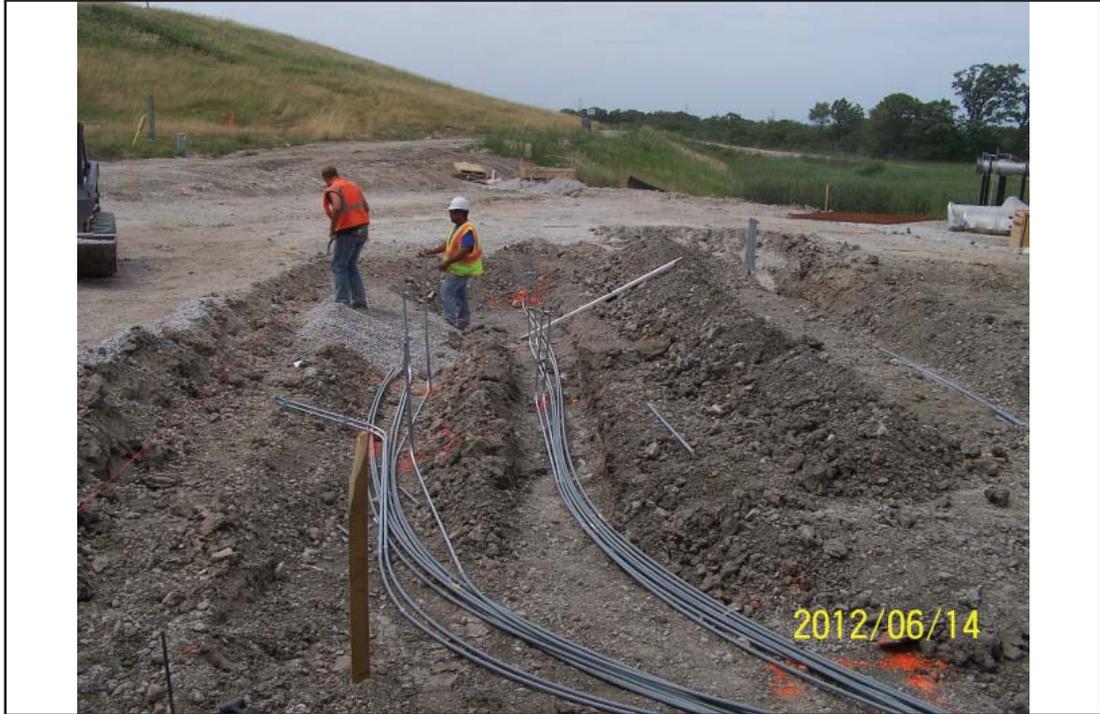
Conduits and cables being placed under concrete pad location for chillers

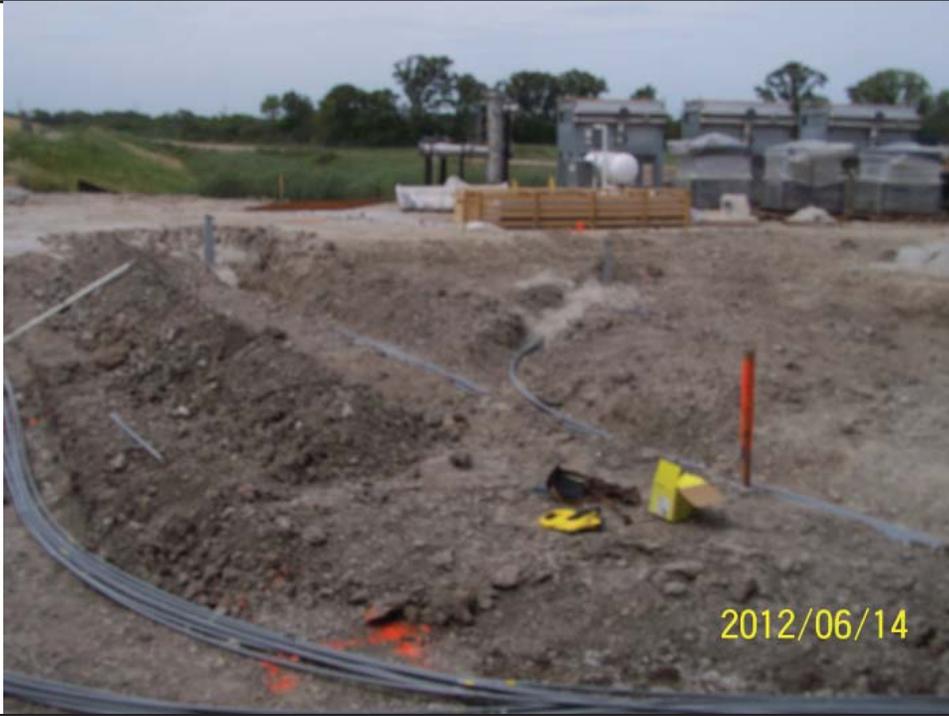
Electrical conduits

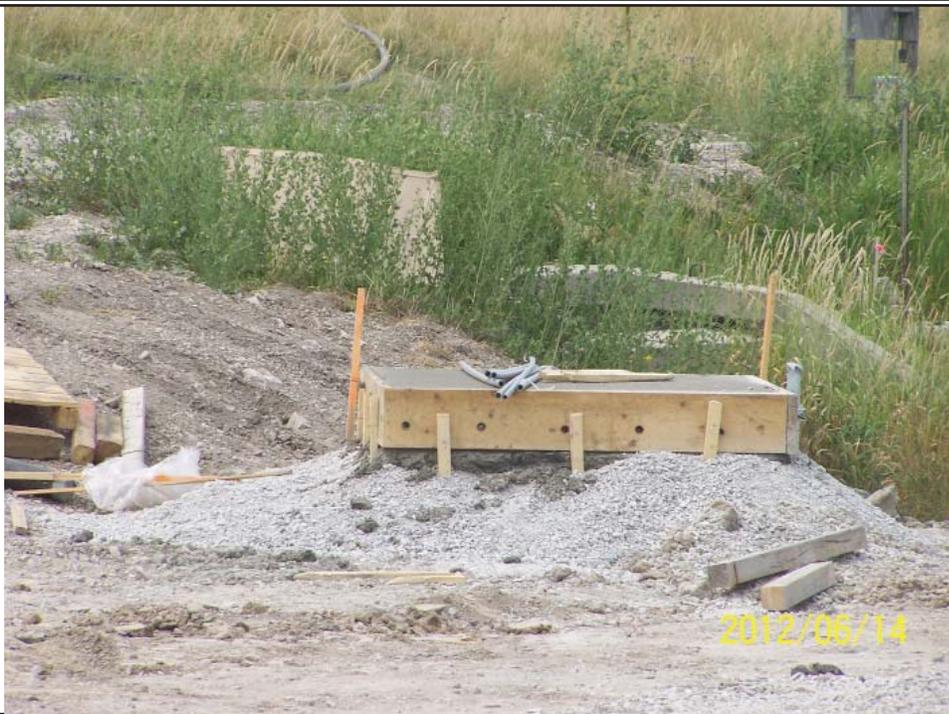
New flare pad

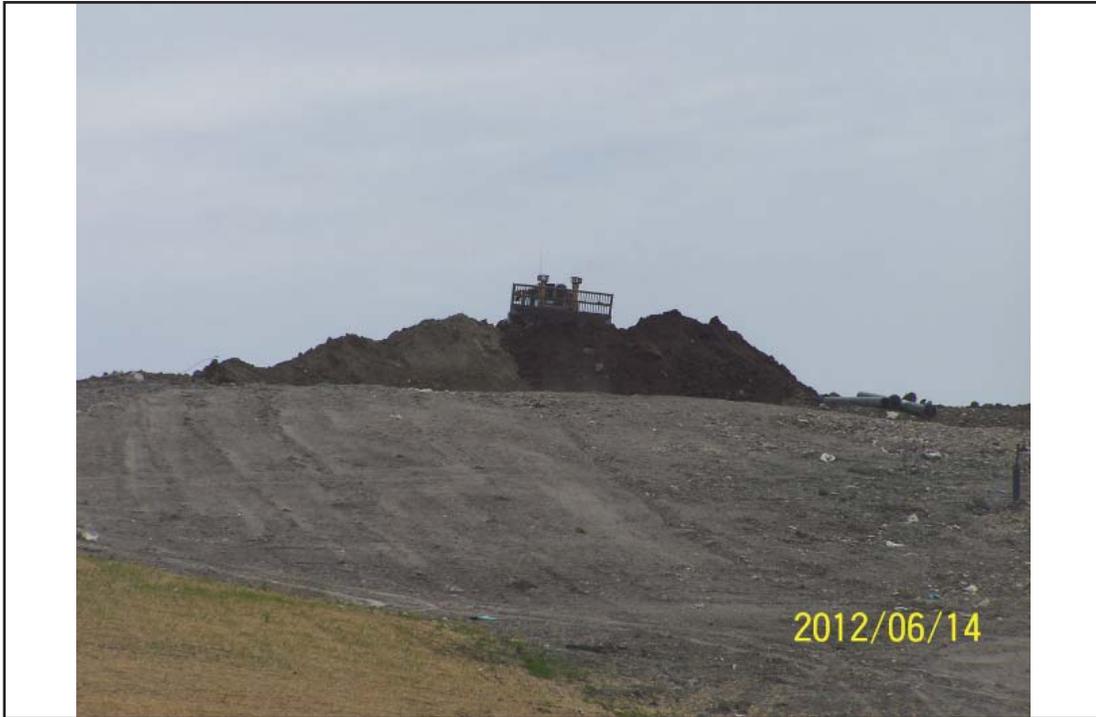
Landfill direct soil being spread to maximize tipping area in Phases 5 & 6

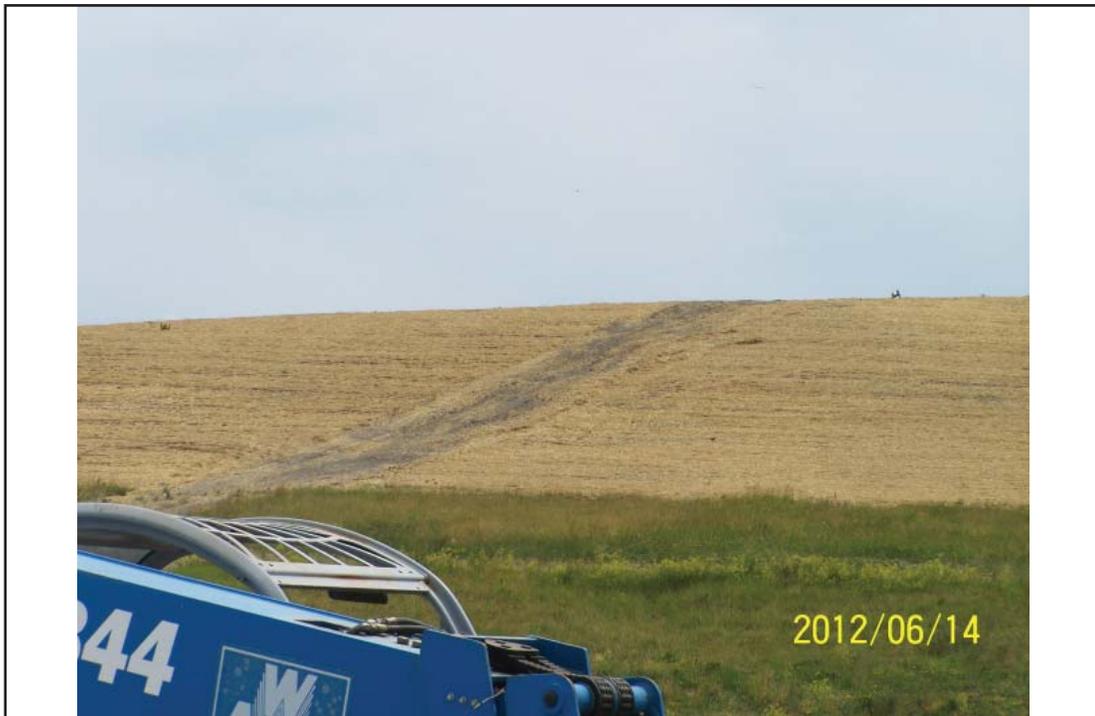
Closure area III North slope seeded and starting to green, vehicle path from placement of pneumatic line

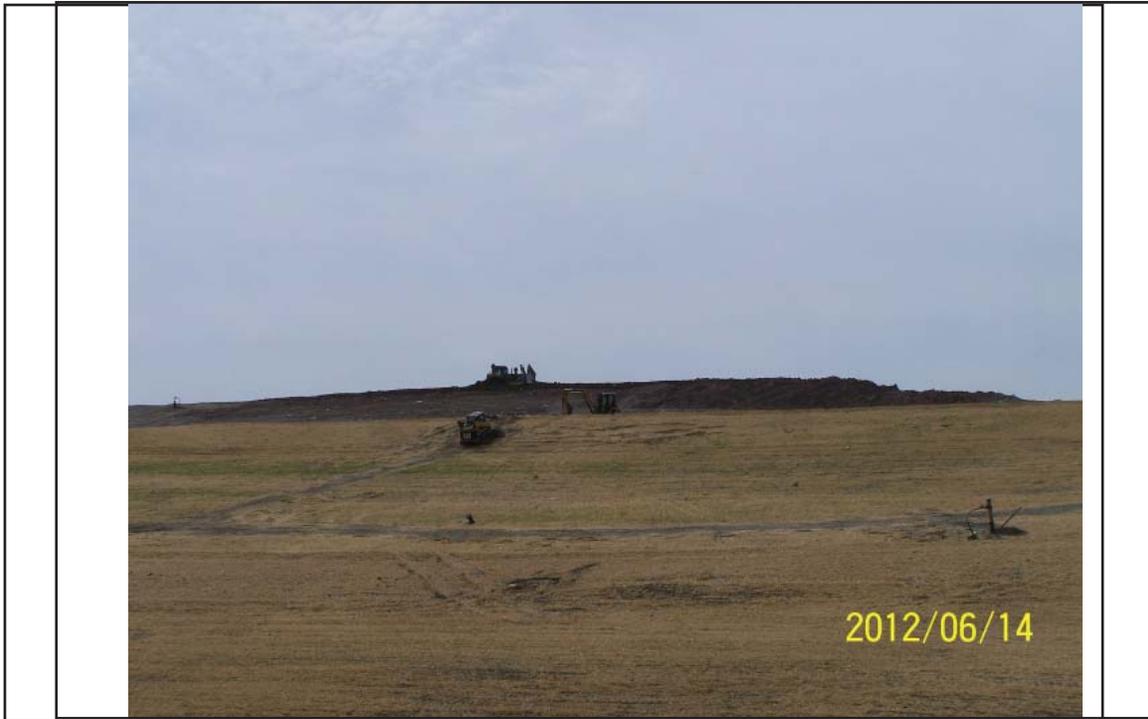
Landfill direct soils on top of Phase 5/6, closure area III East side slope

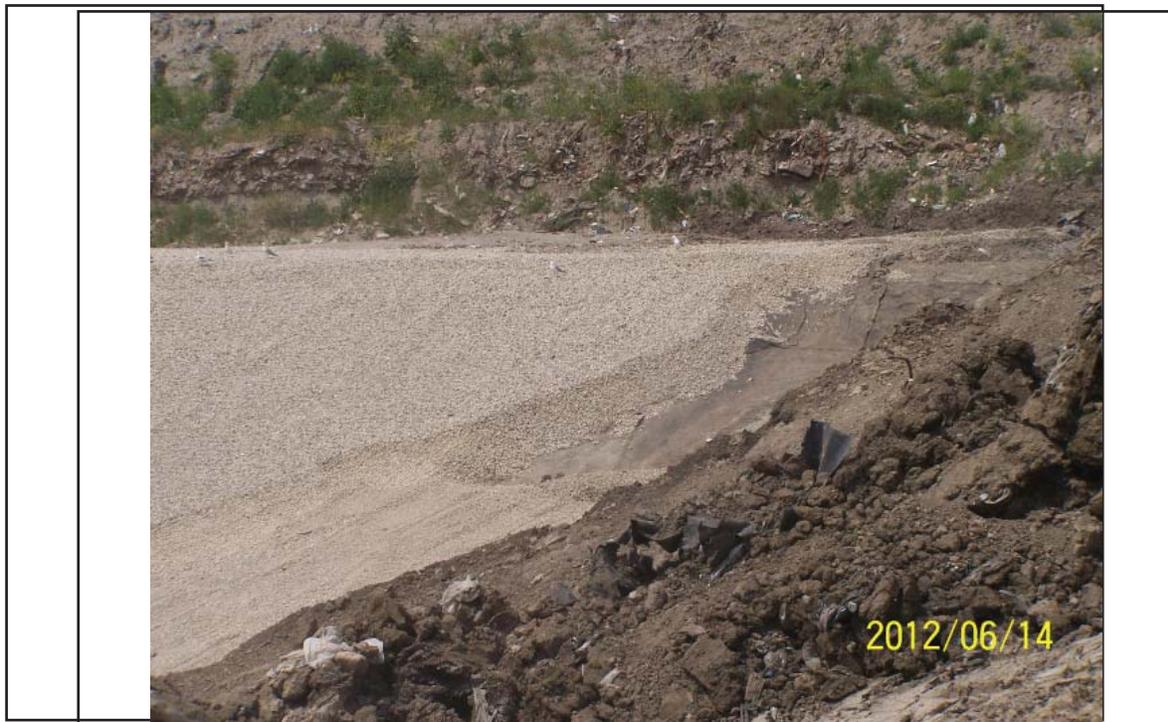
Liner cleaned and new stone to be placed for leachate collection layer at Phase 7/3/6 junction

- Auditor conducted audit without vest
- Pea gravel/drainage layer repairs in Phase 7 nearly complete
- Gas testing at Phase 5 detected leaks which were treated with clay placement

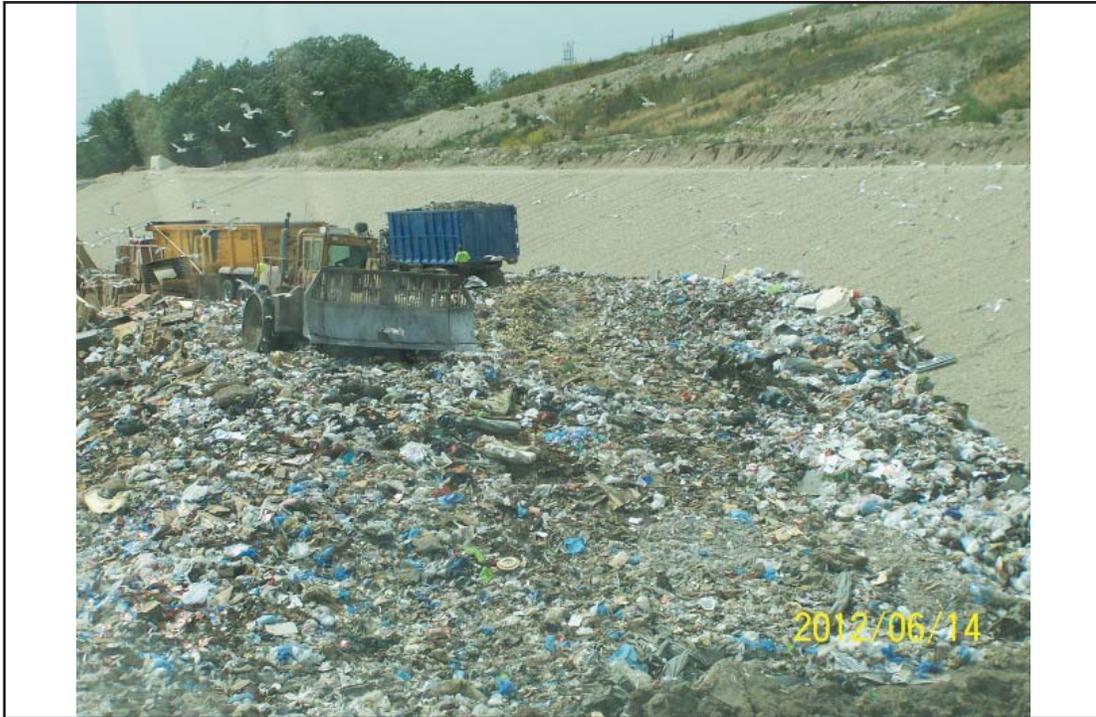
Working face

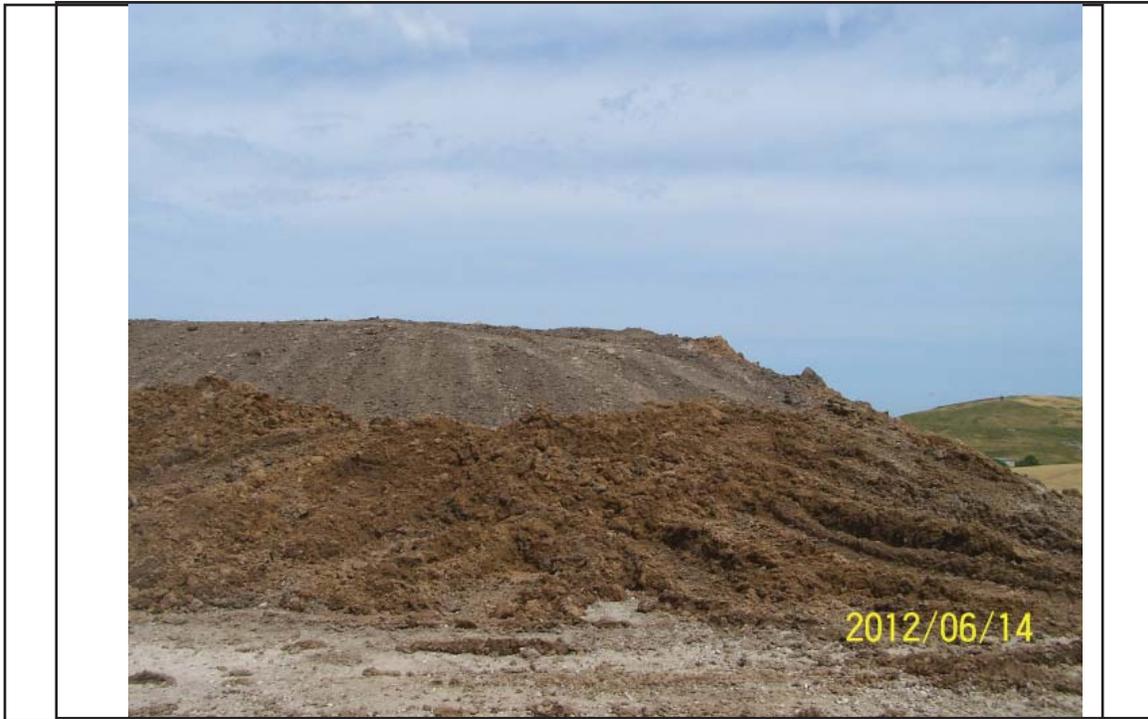
Bio soils placed before existing pile, existing pile awaiting blower for treatment

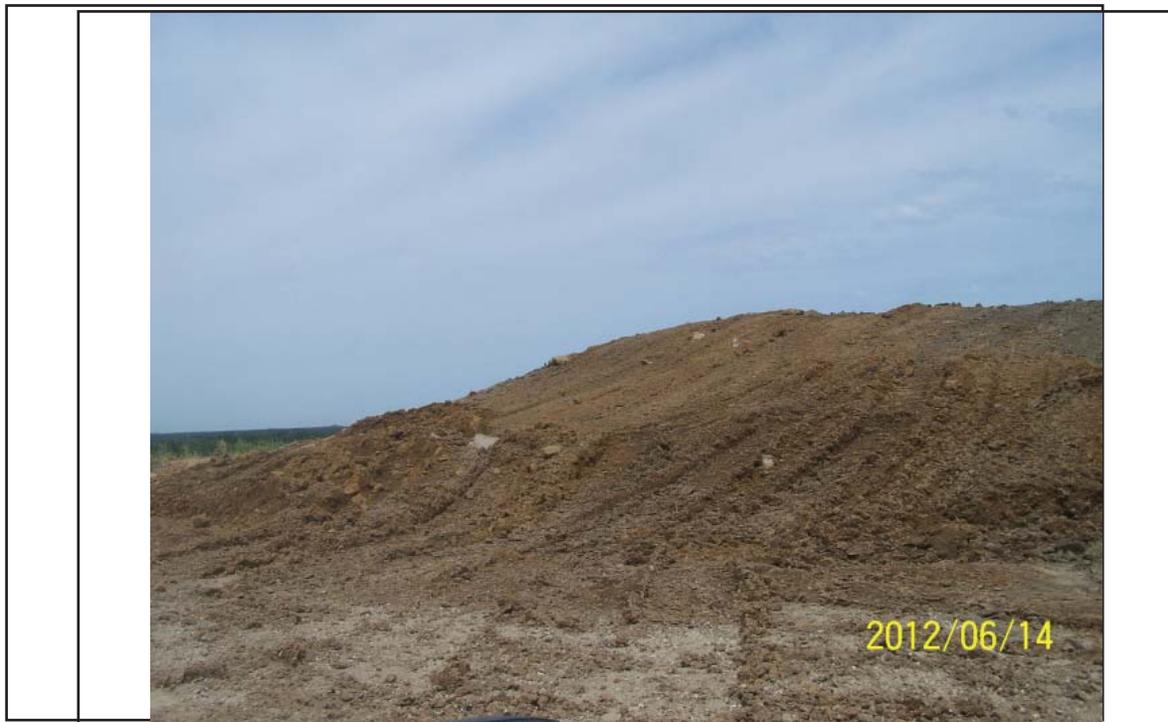
Bio soils on Phase 3

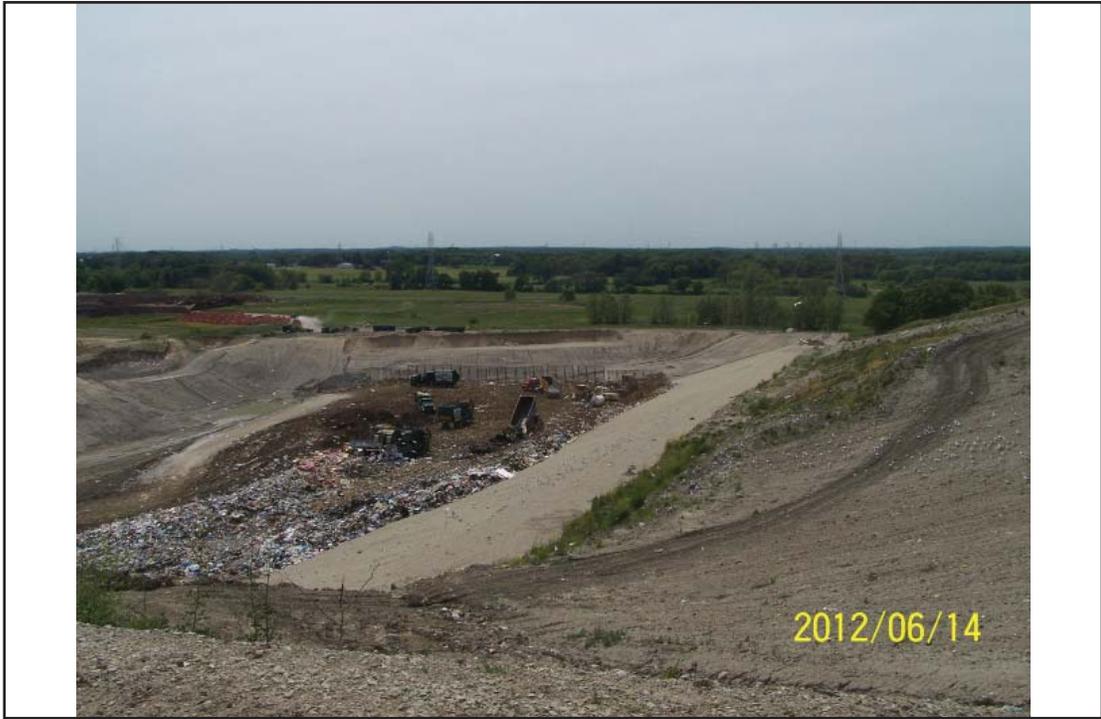
Active area viewed from Northeast
