2012 Advanced Disposal Services Emerald Park Landfill Year End Compliance Officer Report and Audit Summary

TO: Veolia Emerald Park Standing Committee
FROM: Jo-Walter Spear, Jr., P.E.
COPIES: File
DATE: 04/04/13
PROJECT NUMBER: 1012.10030

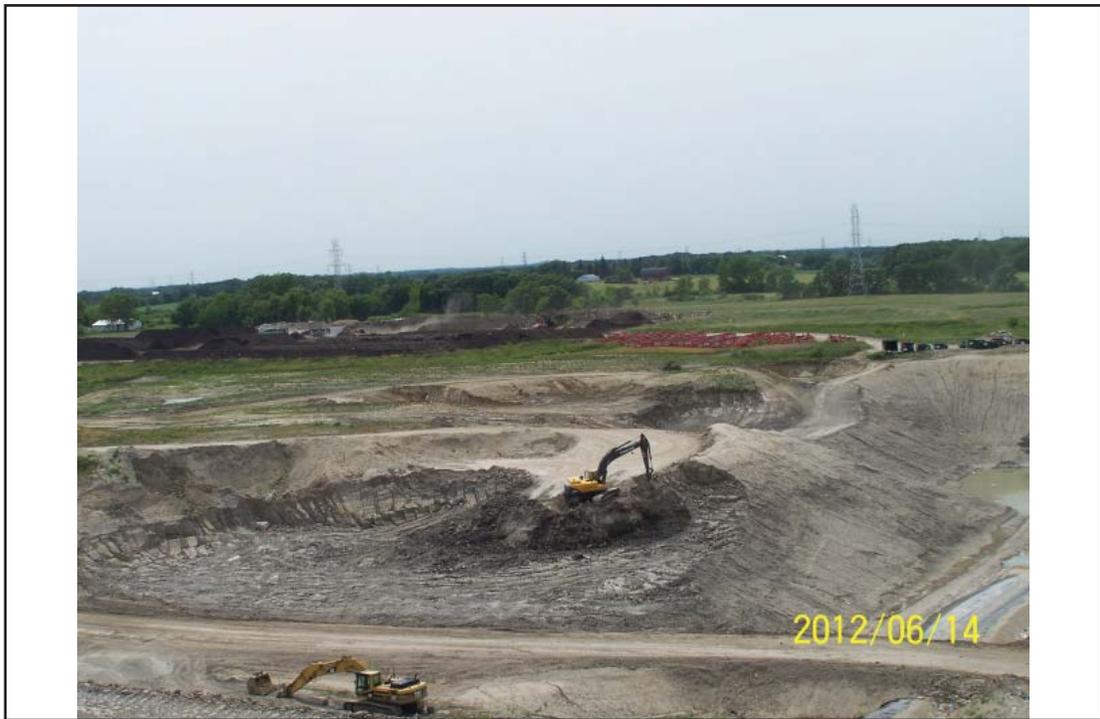
Clay excavation for use on site

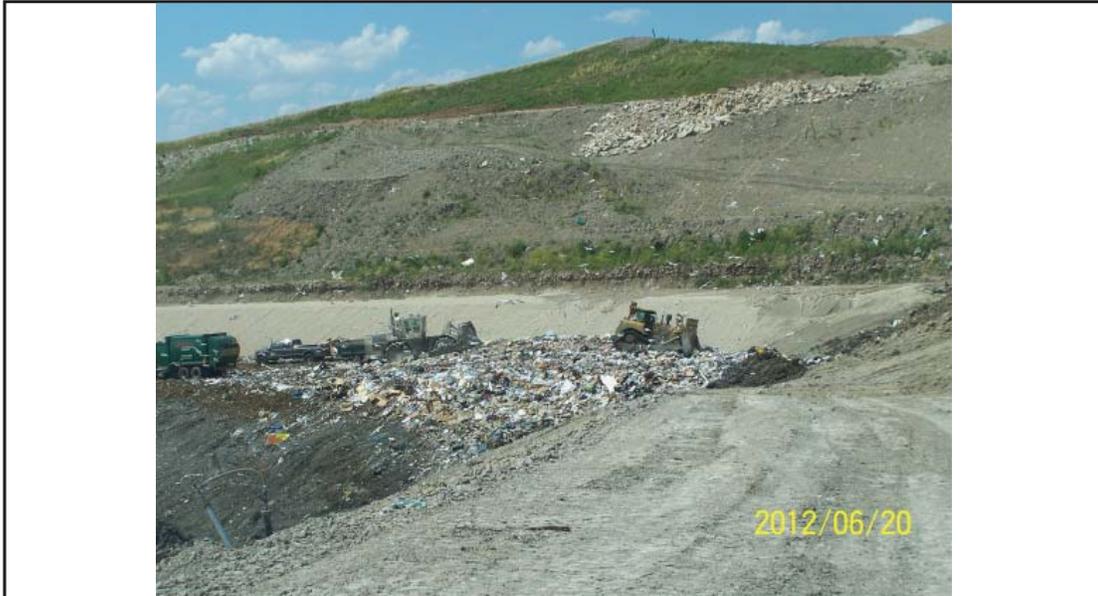
Working face

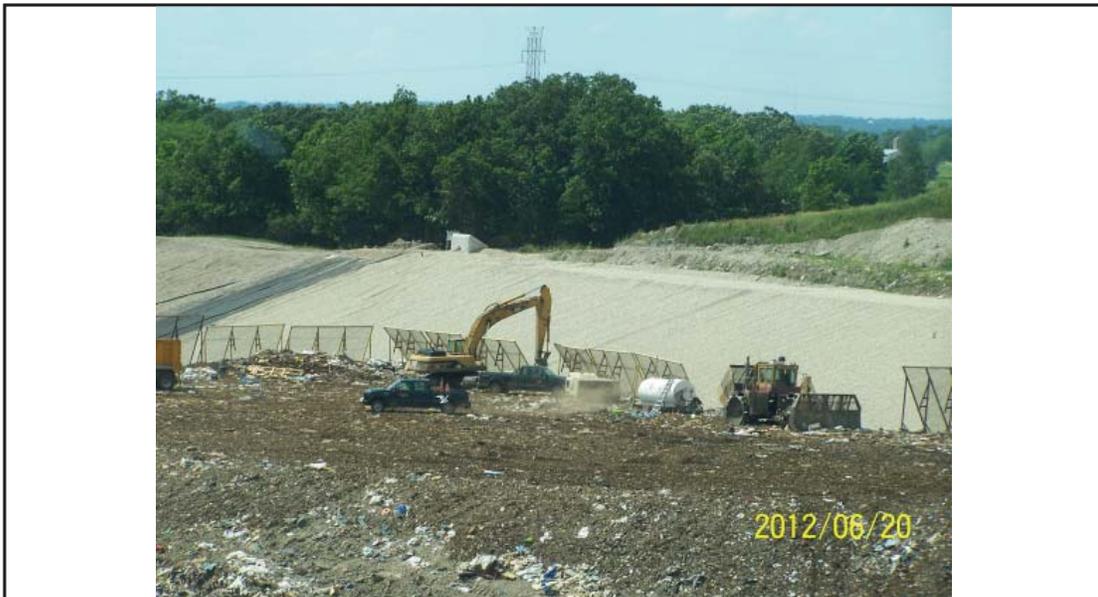
Active area

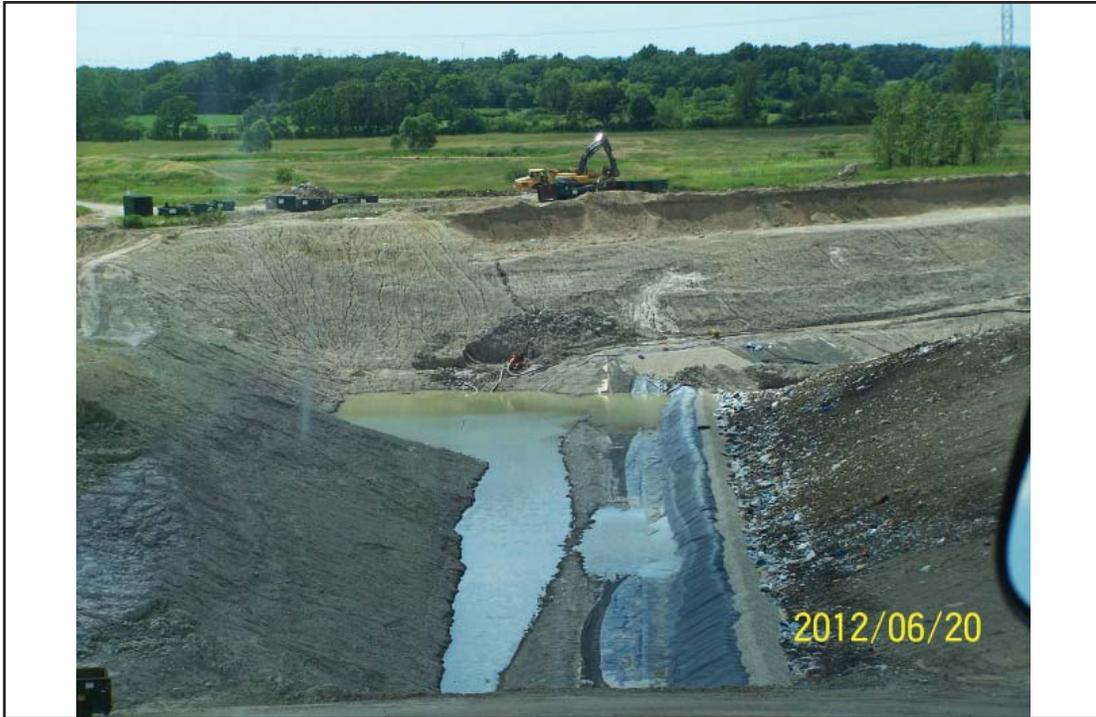
Temp sed. basin after 2" storm

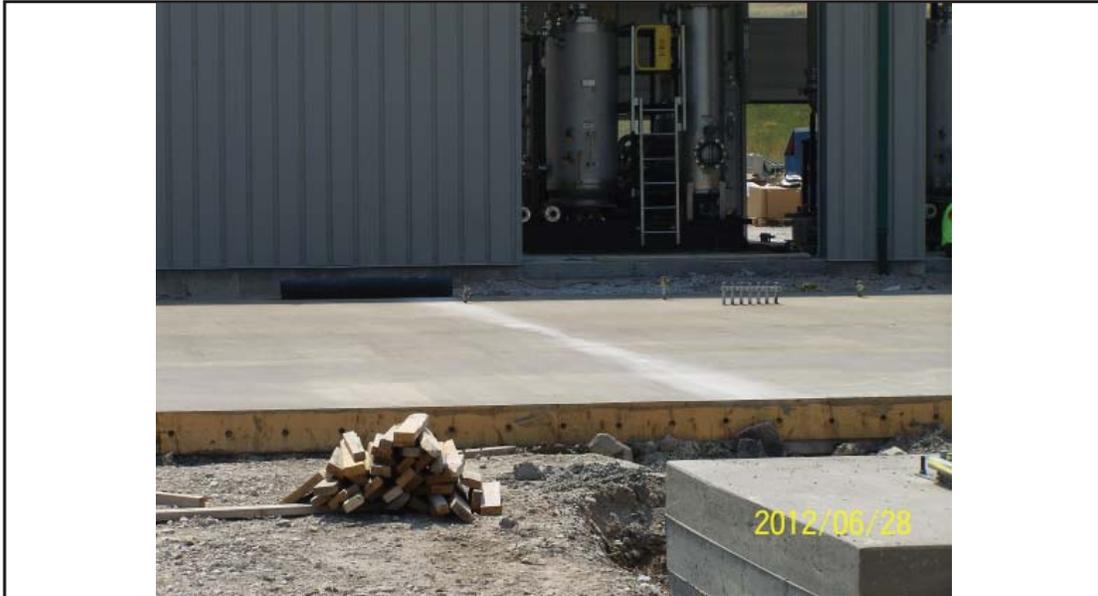
New pad for dryers at Gas building

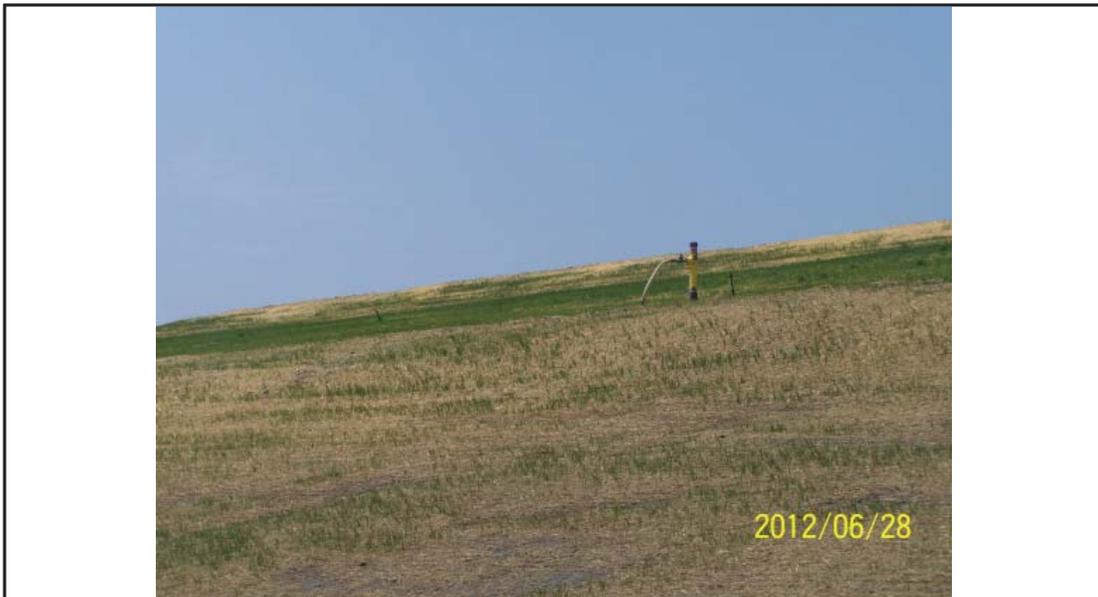
Closure Area III

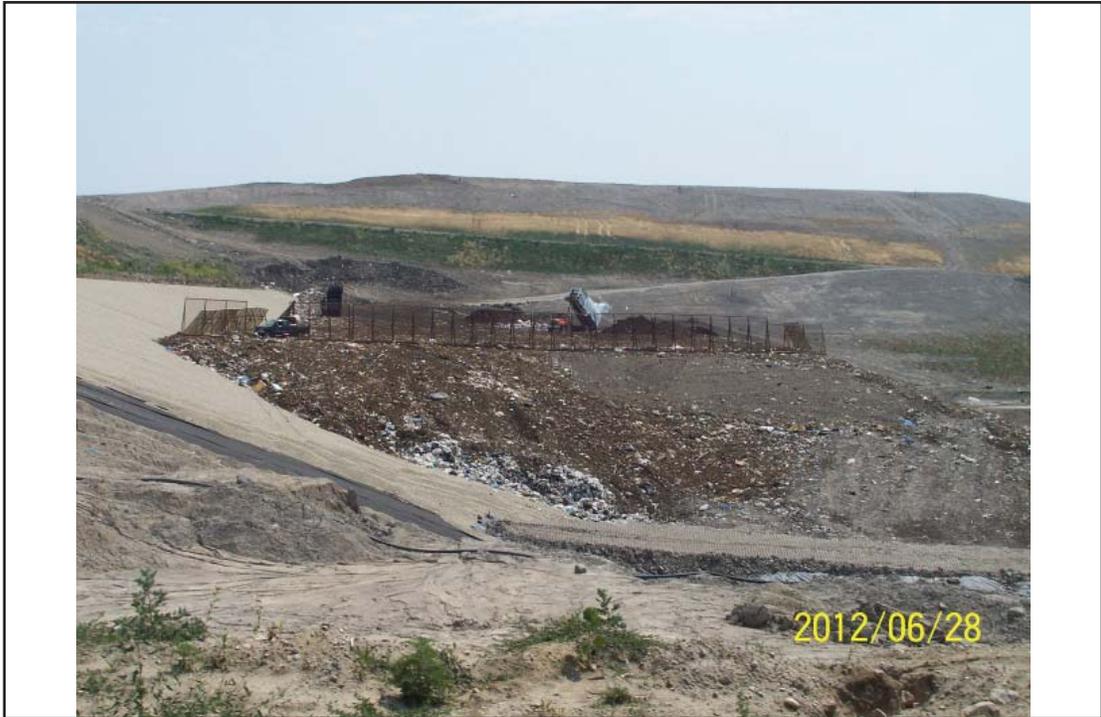
Active area

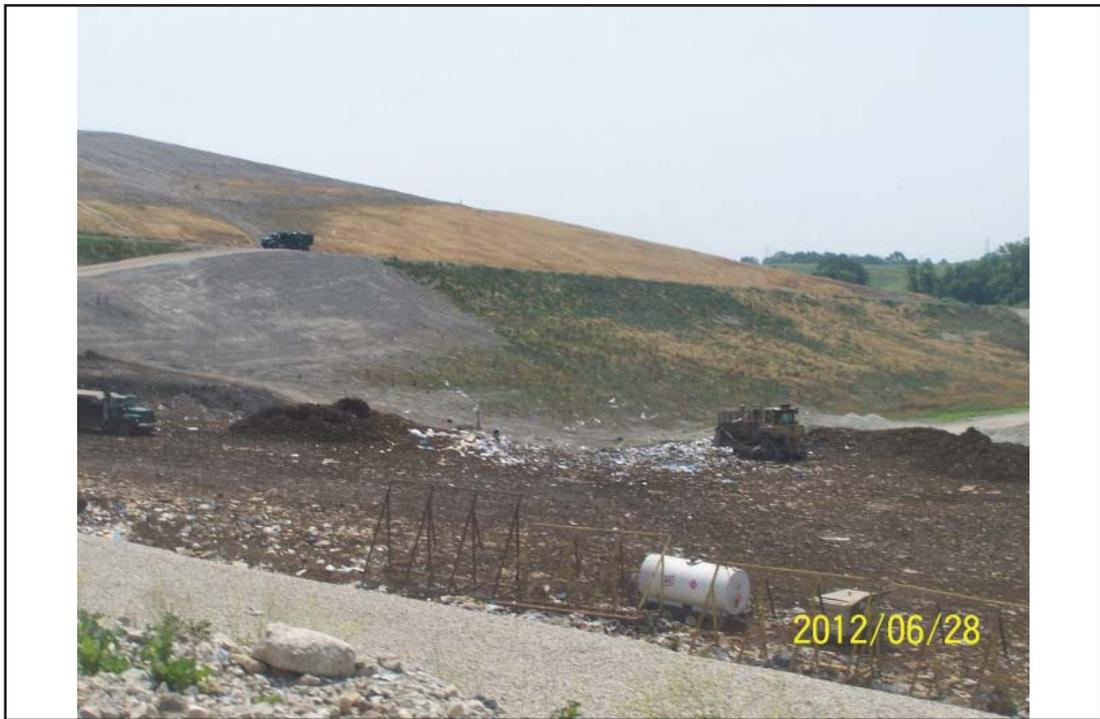
Working face

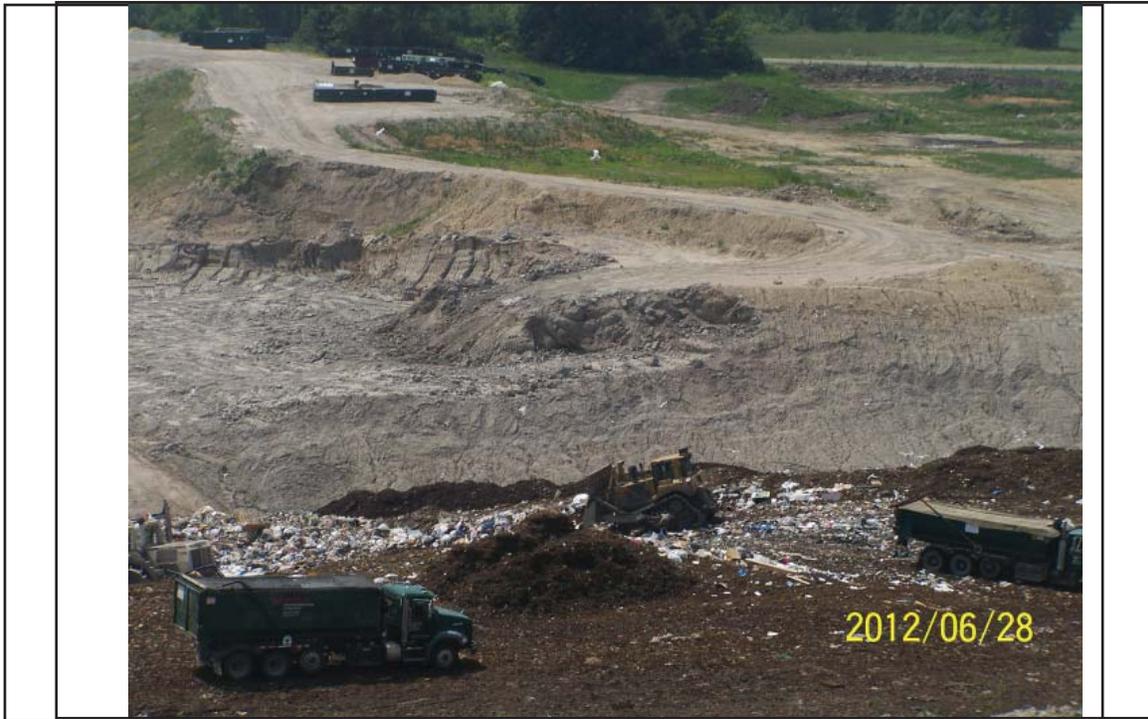
Working face

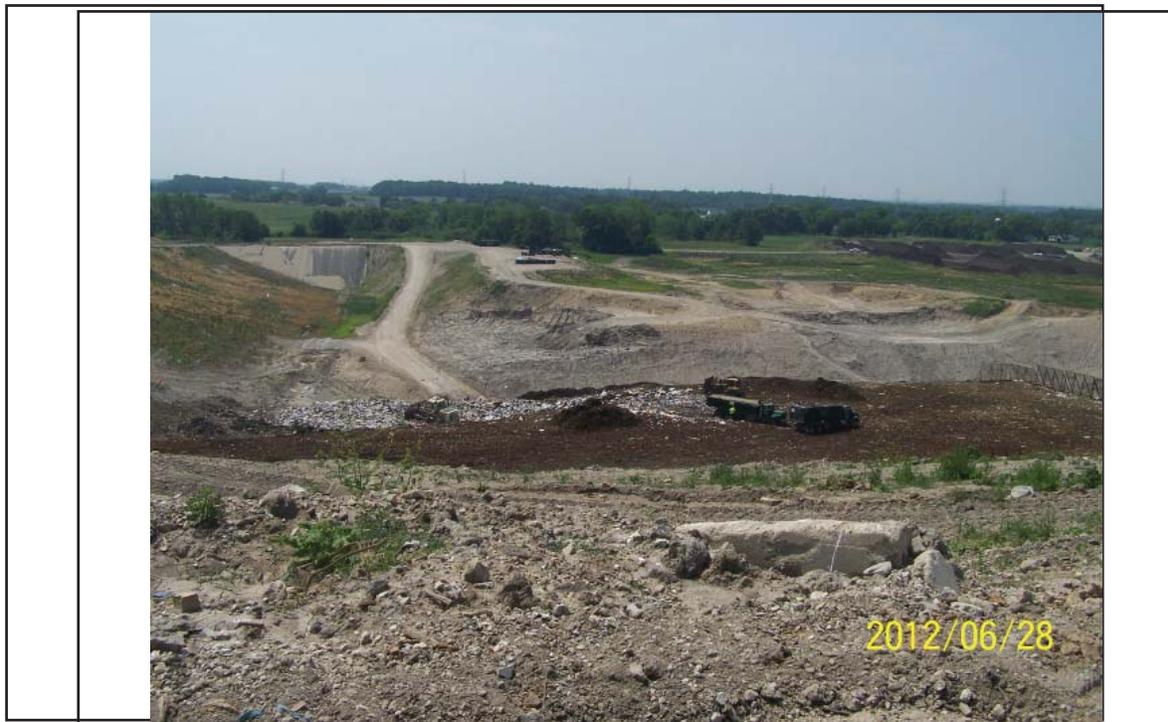
Active area

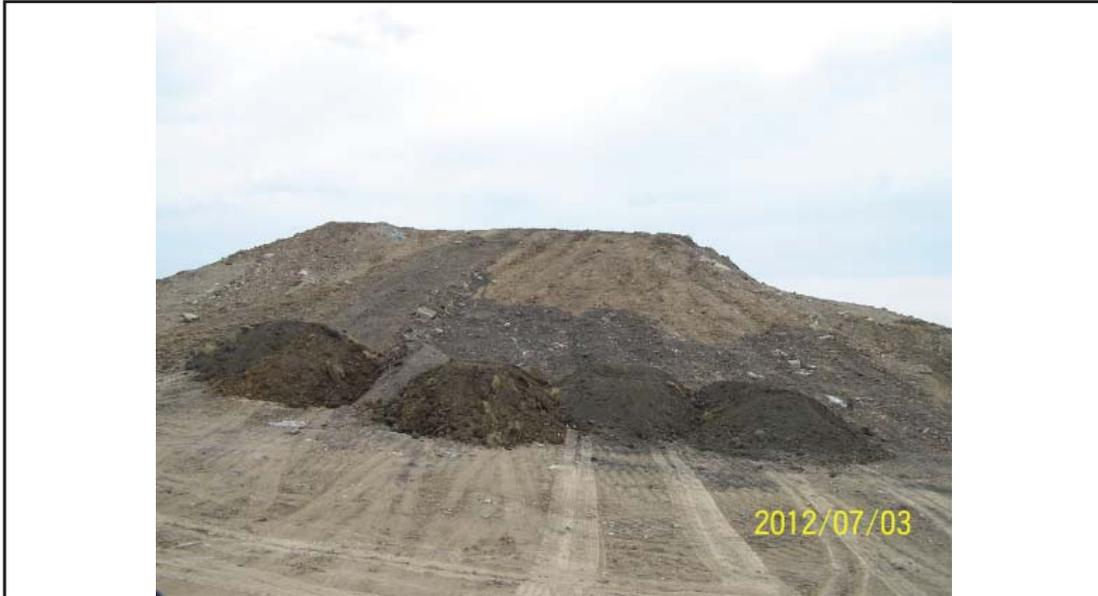
Bio soils received today

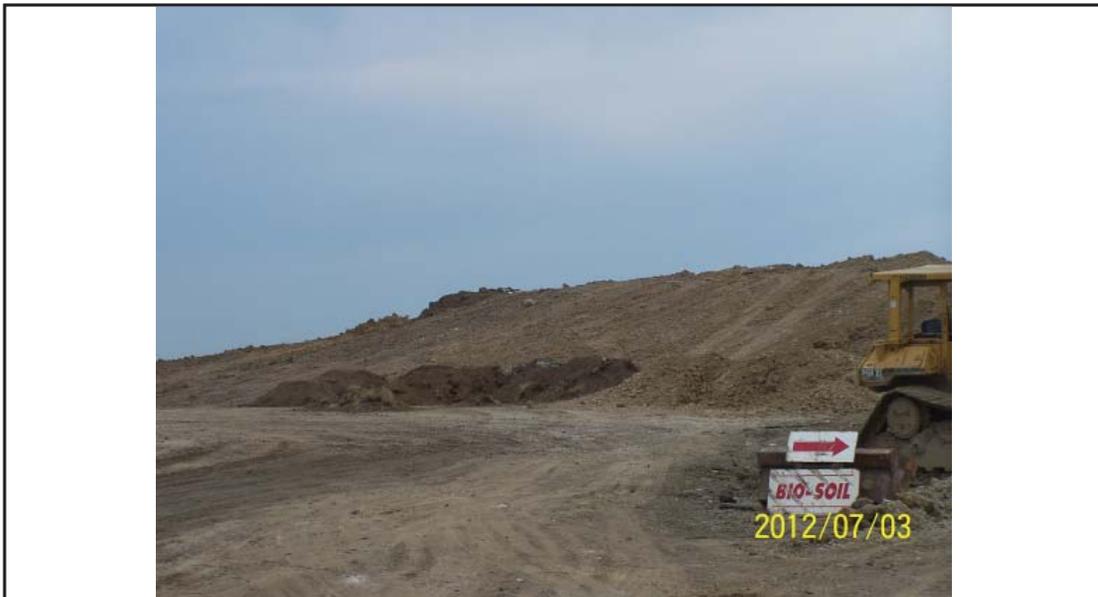
Landfill direct loads

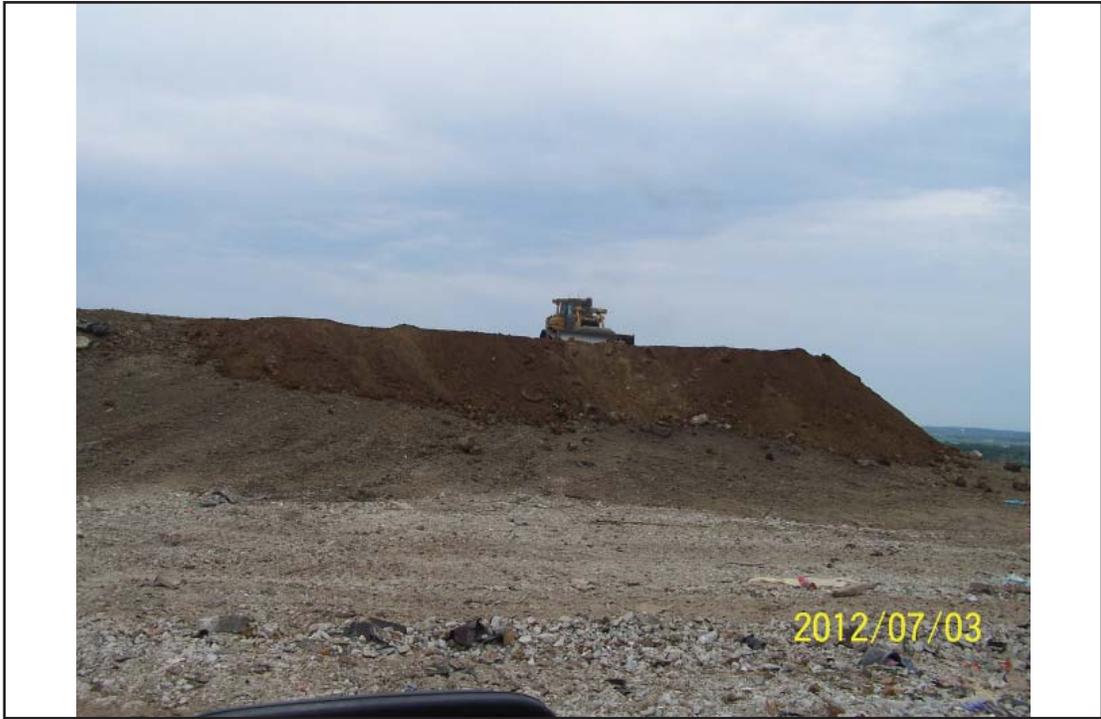
Landfil direct soils

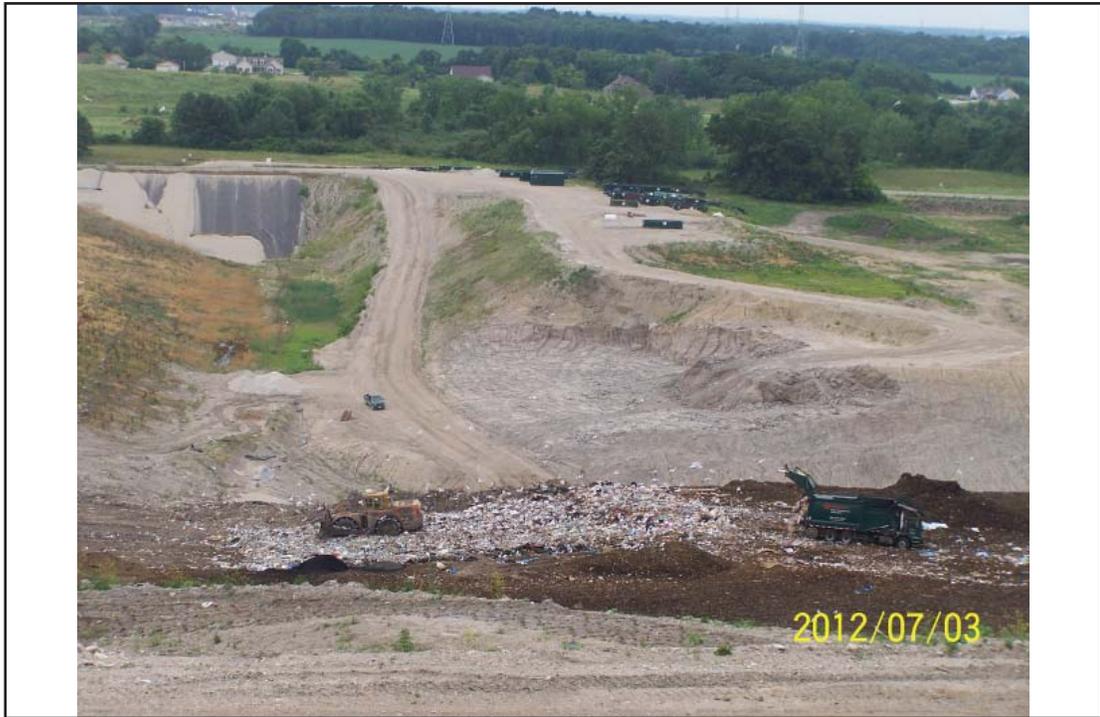
Working face

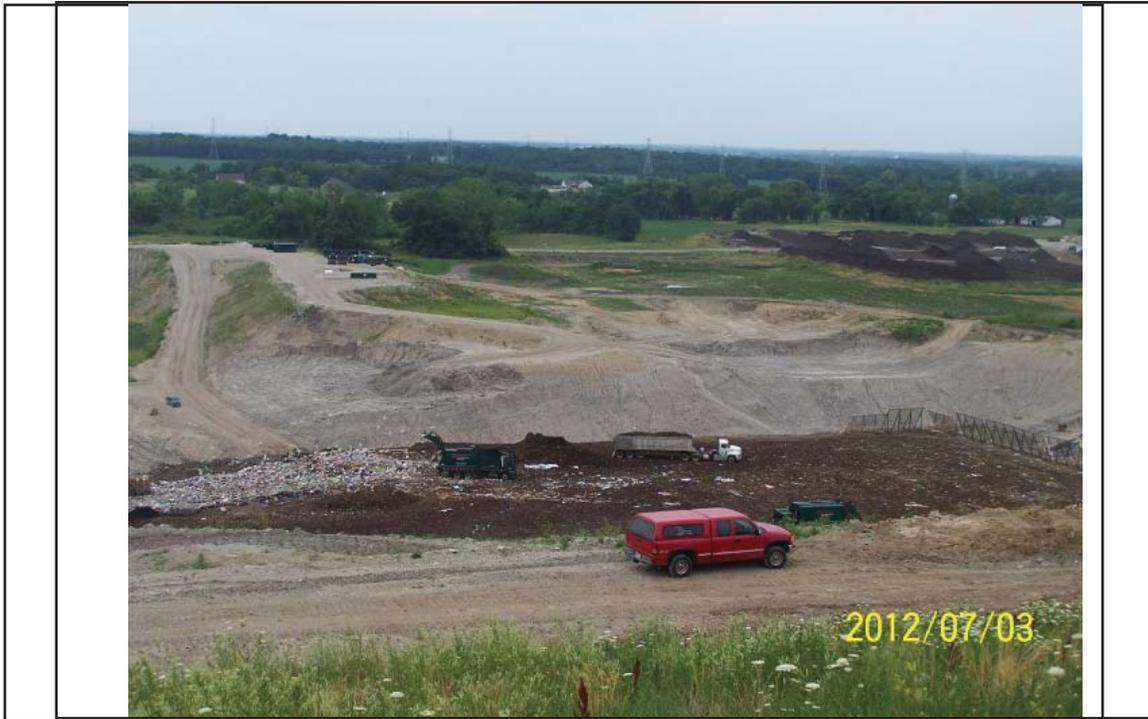
Active area

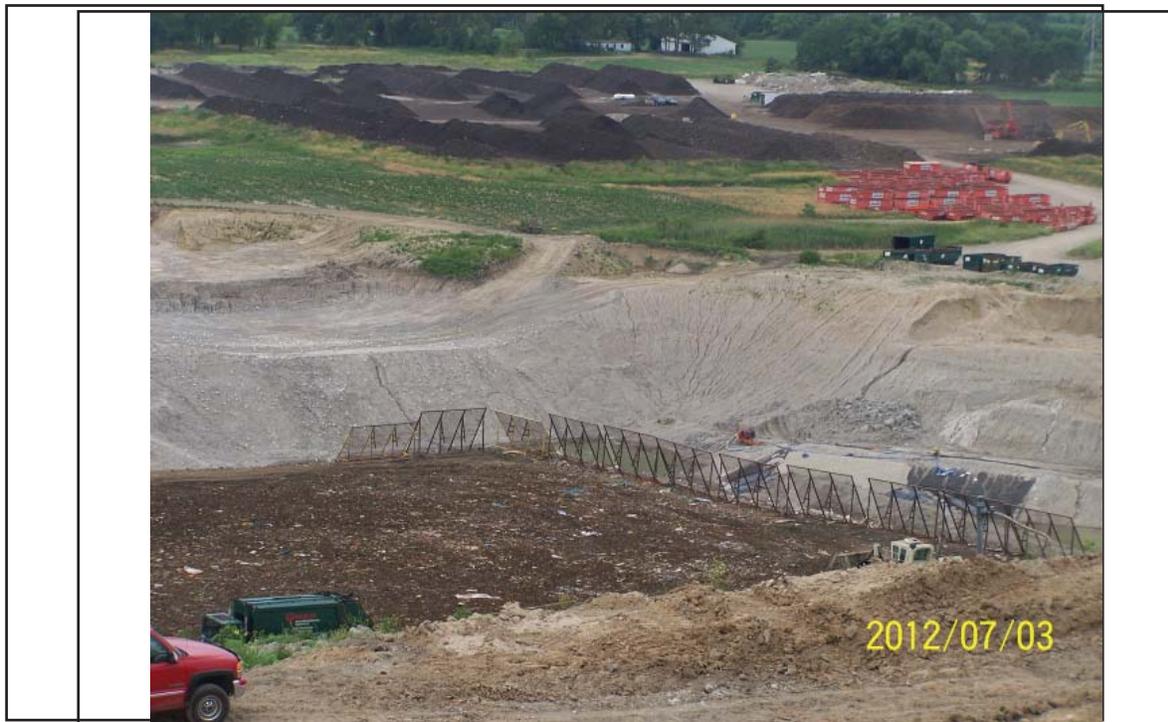
Active area

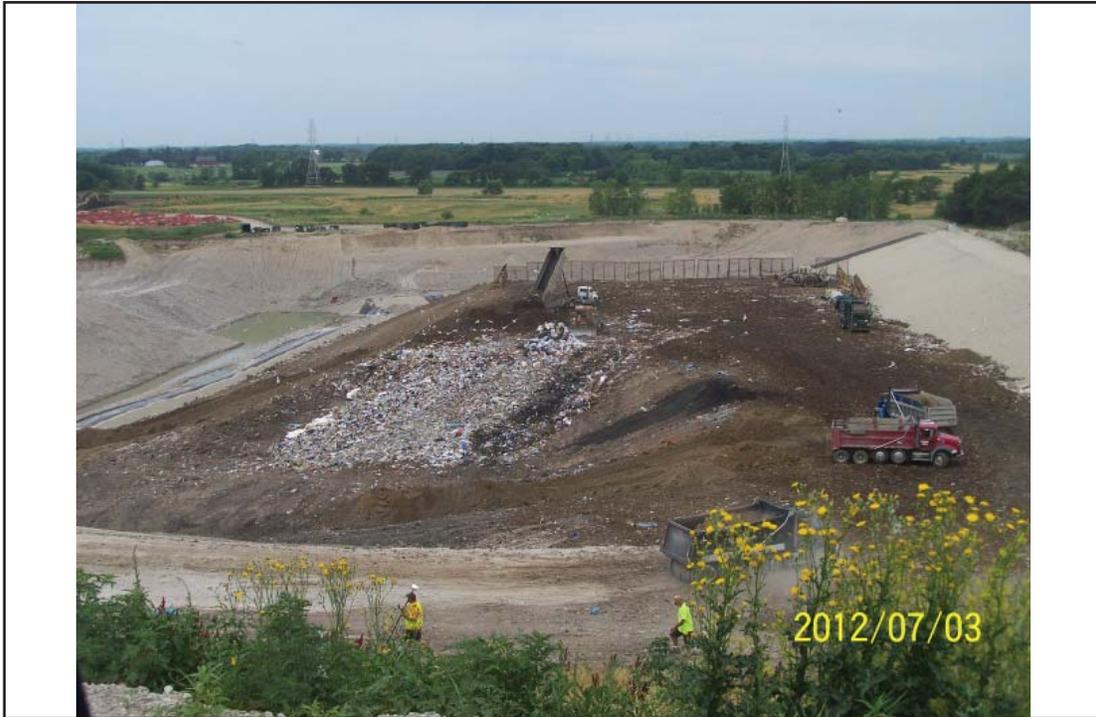
Working face

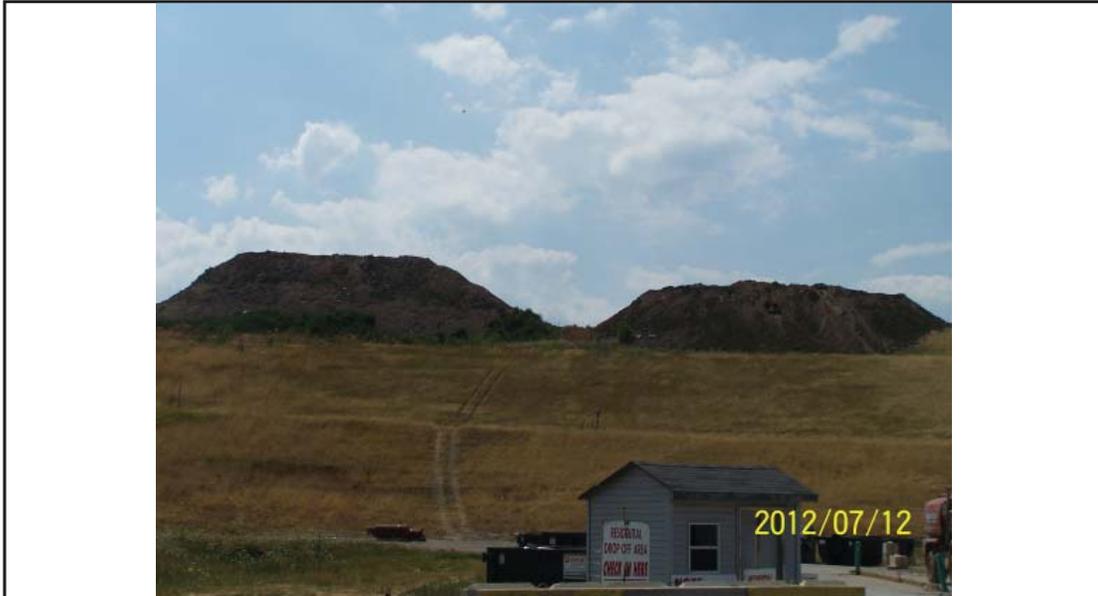
Previously tipped Bio-soil and Landfill direct soils

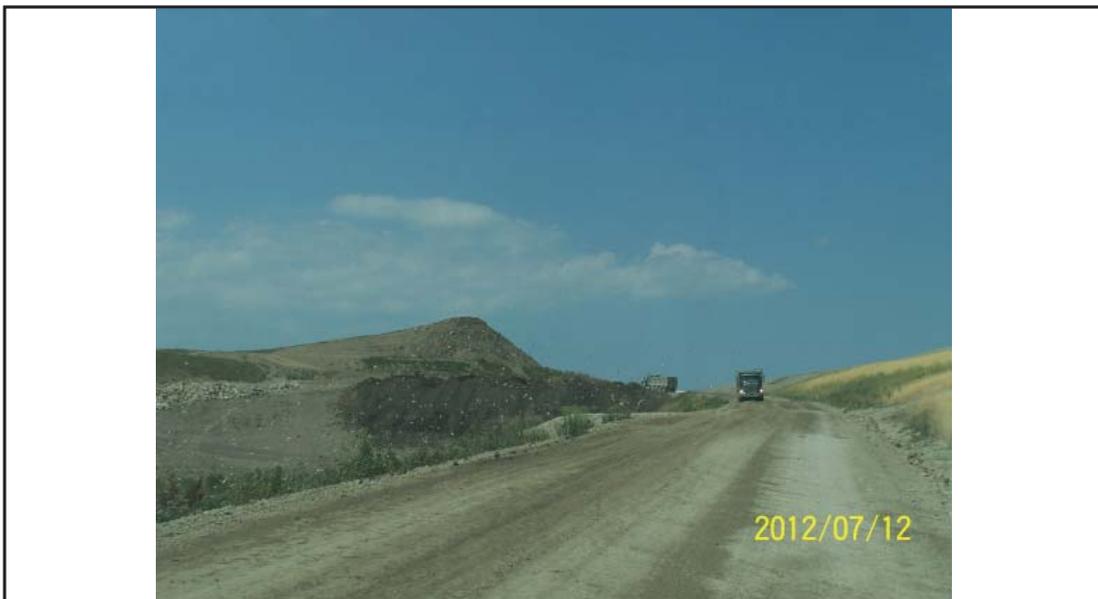
Soils being placed above Phase 7

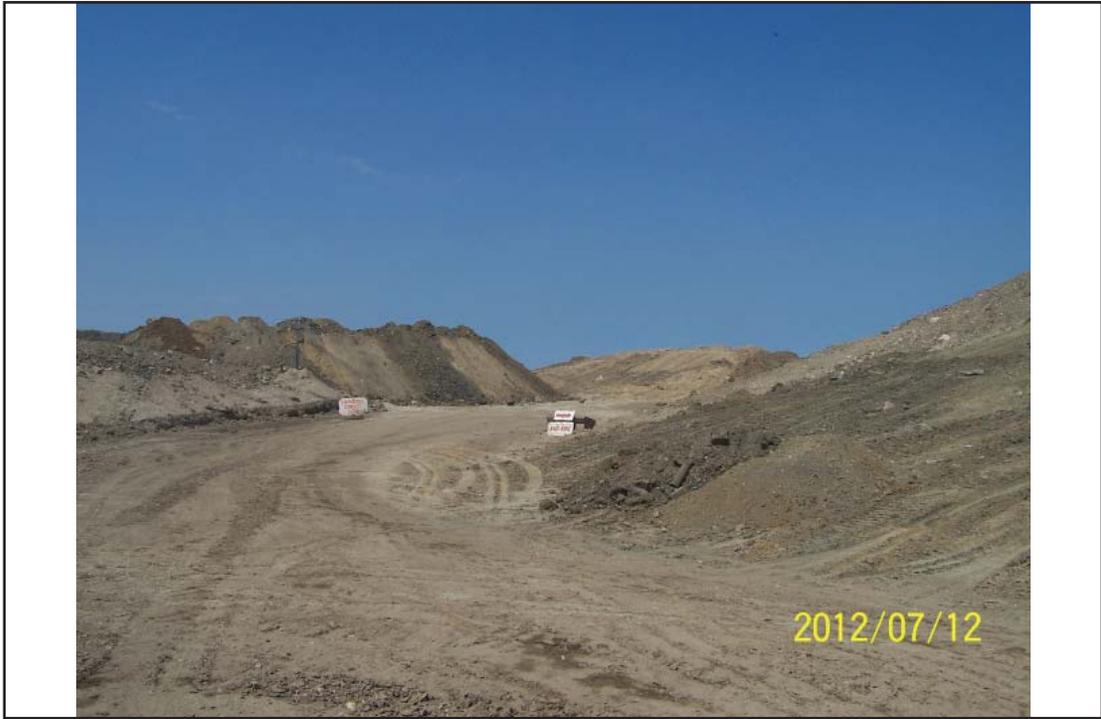
Soils in phases 2 & 3

Phase 2 & 3 have been receiving soils all week, except for today due to wet conditions.

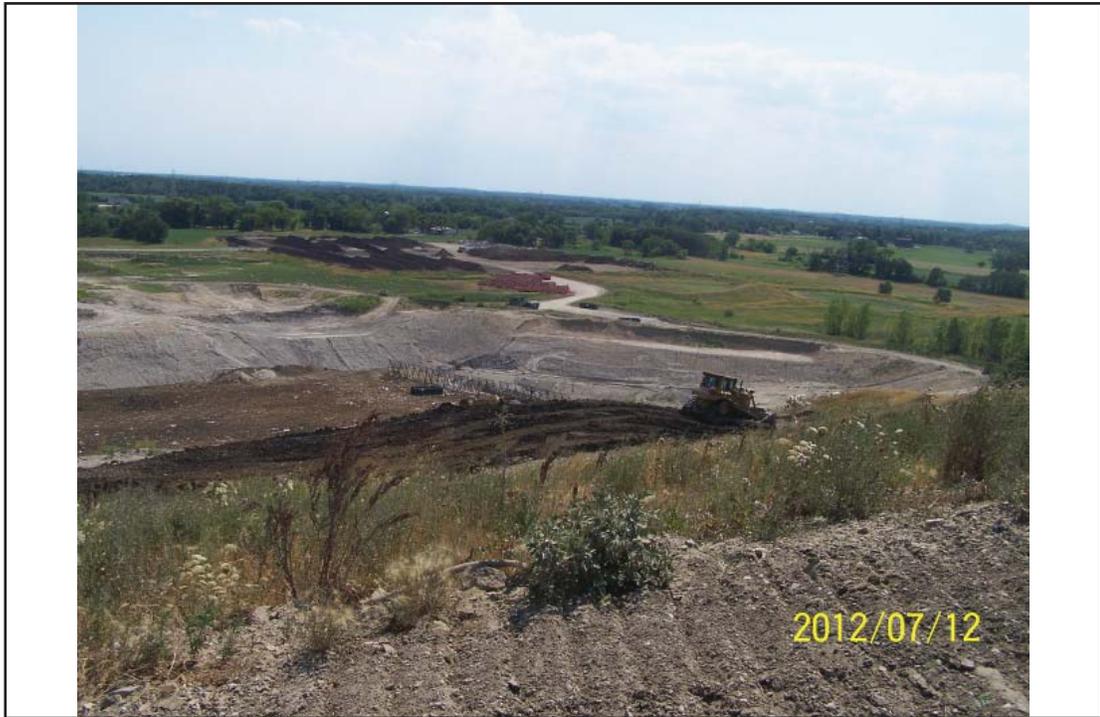
Soil loads being spread

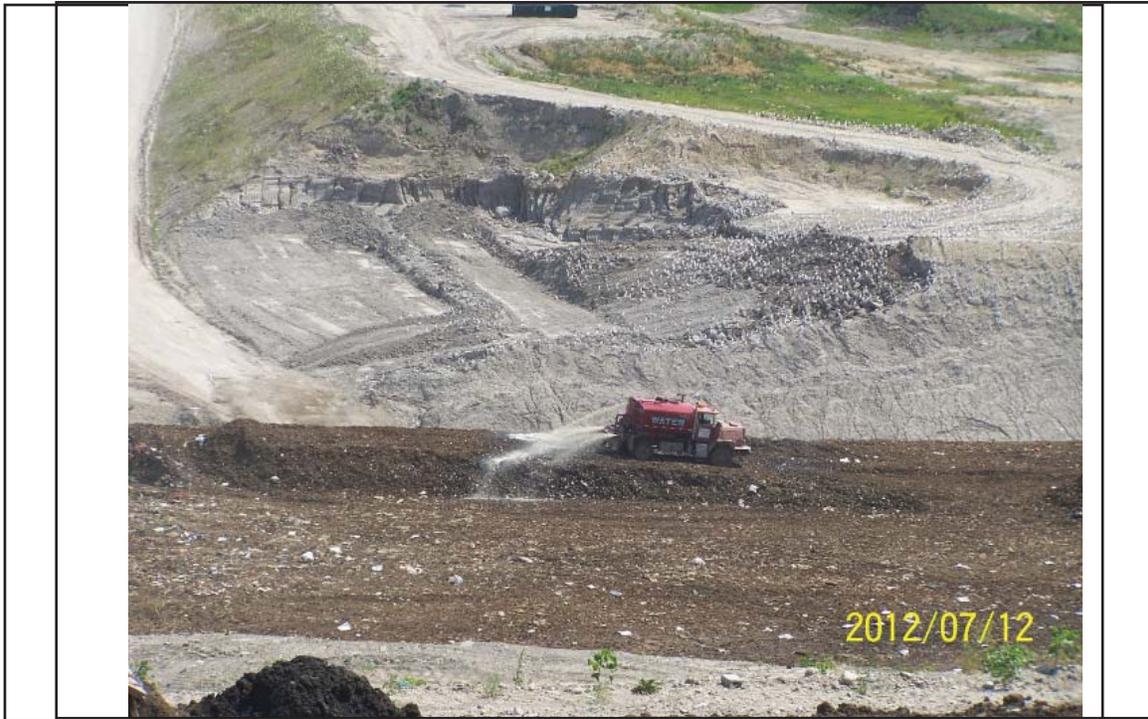
Leachate from Future Parkland being applied in active area, Phase 7

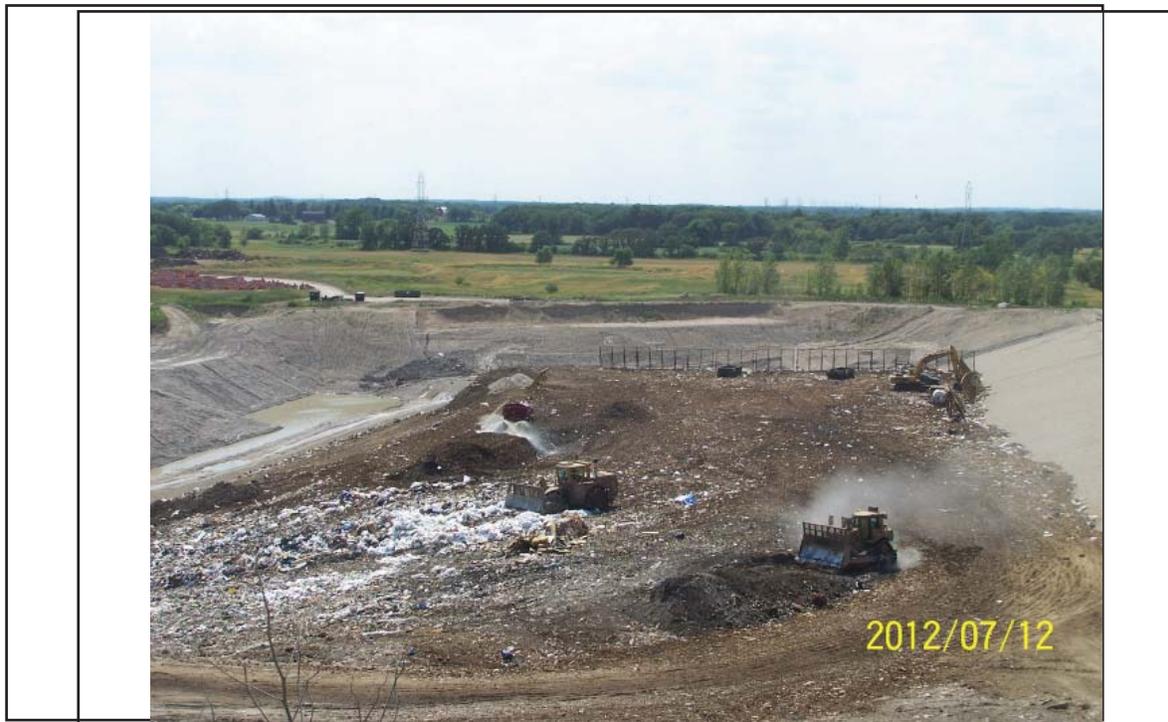
Active area

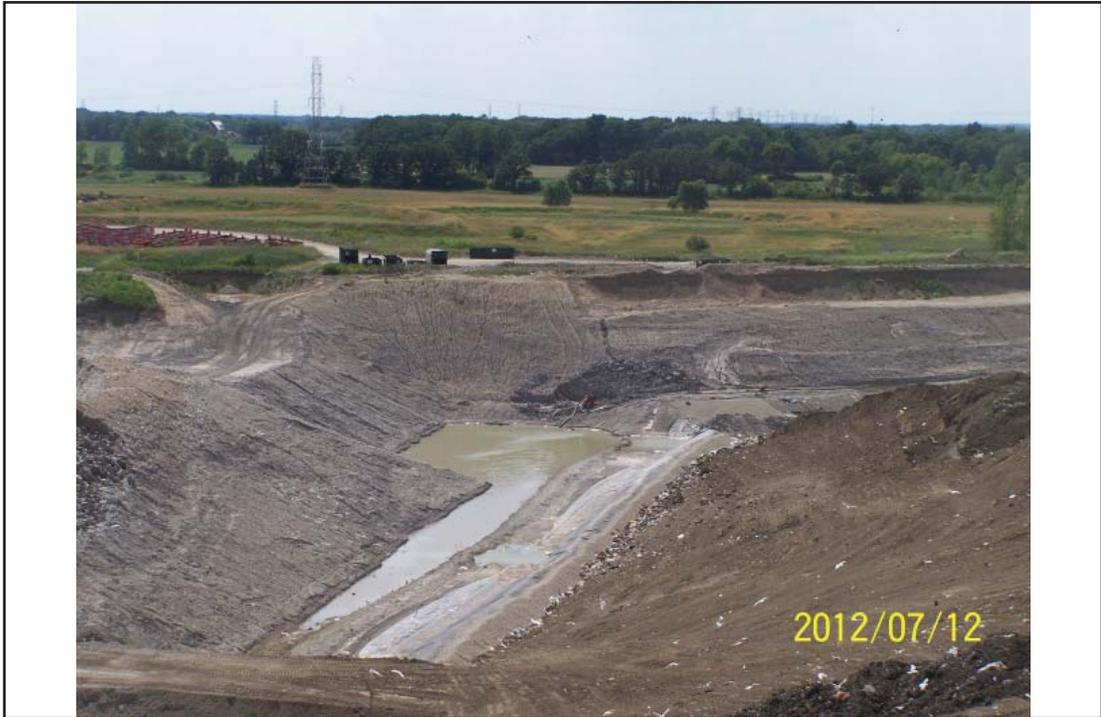
Temp sed basin adjacent to Phase 7

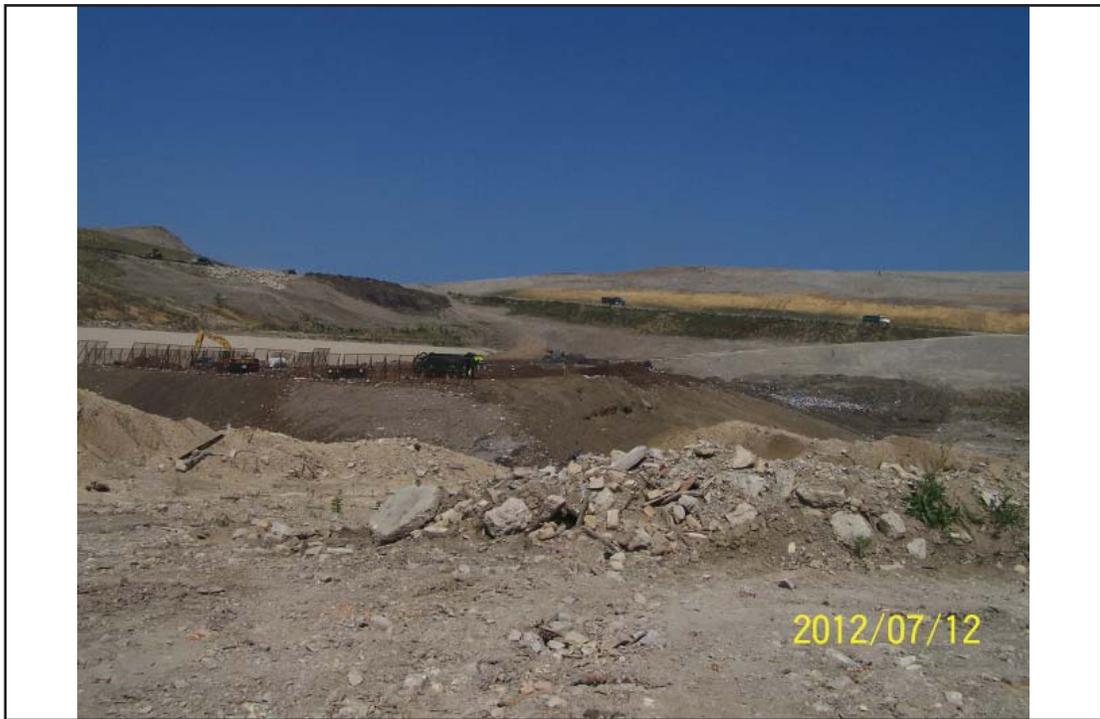
Phase 7 viewed from Southwest

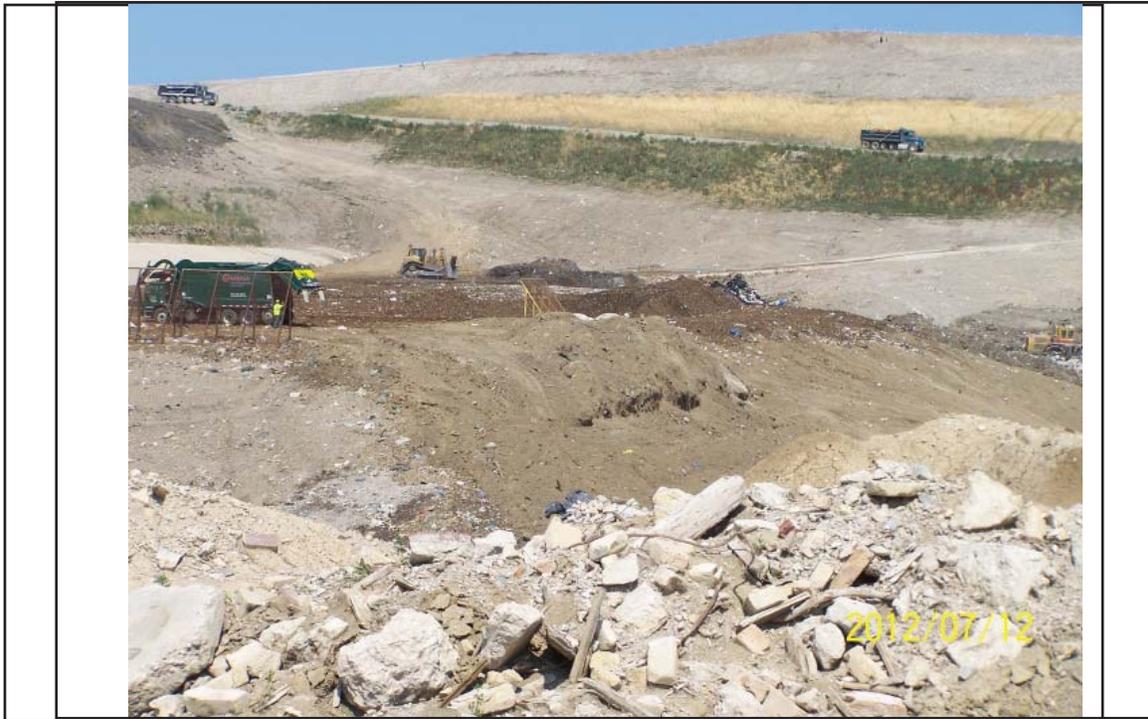
Soils previously tipped in Phase 7

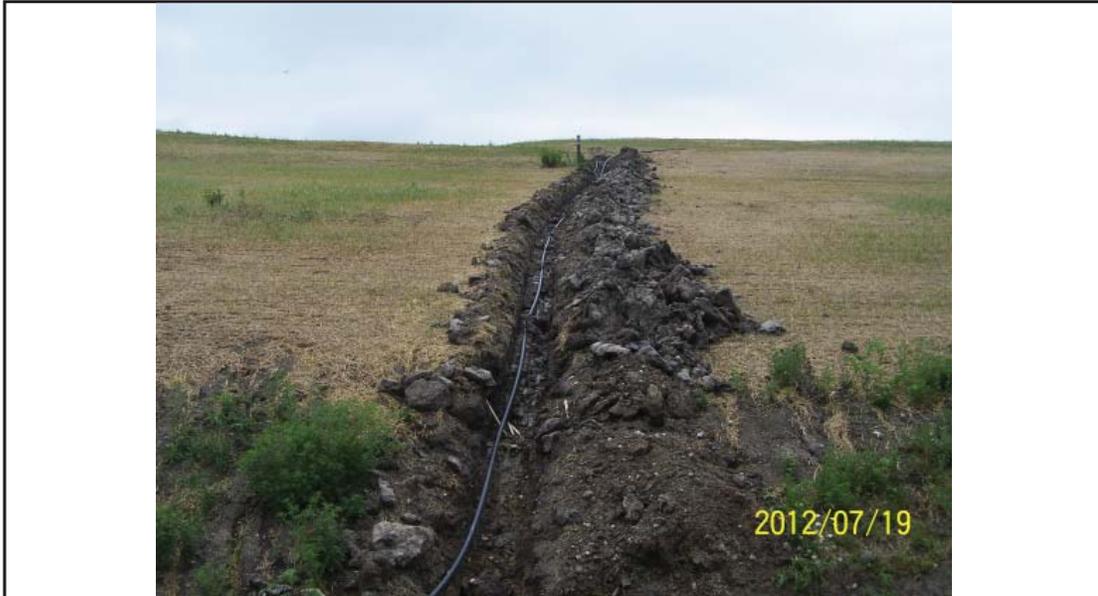
Trenching in new cover of Closure Area III to place pneumatic lines

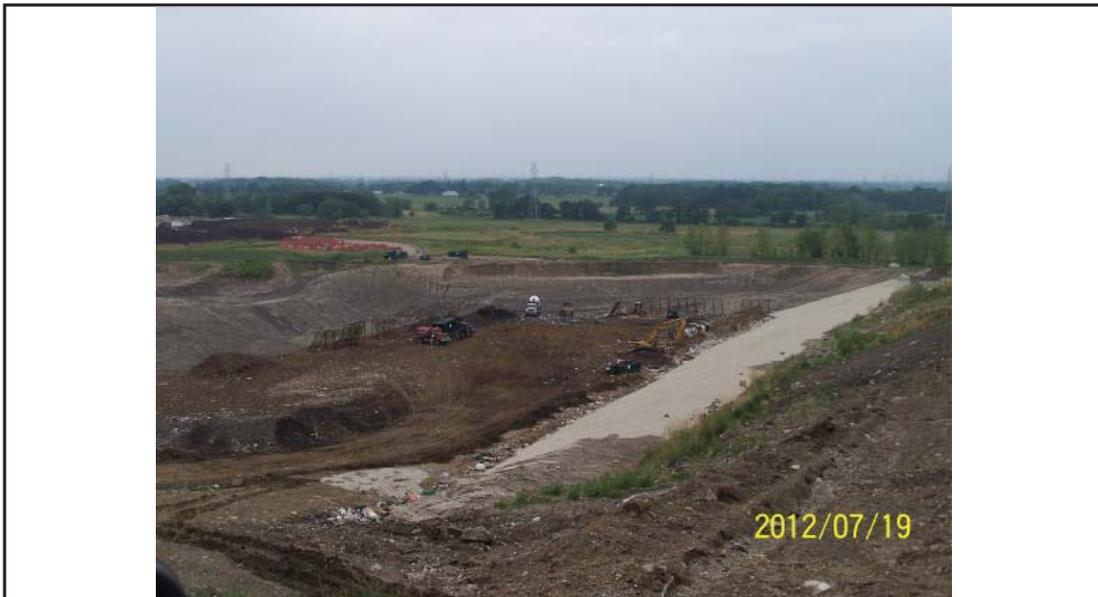
Active ara

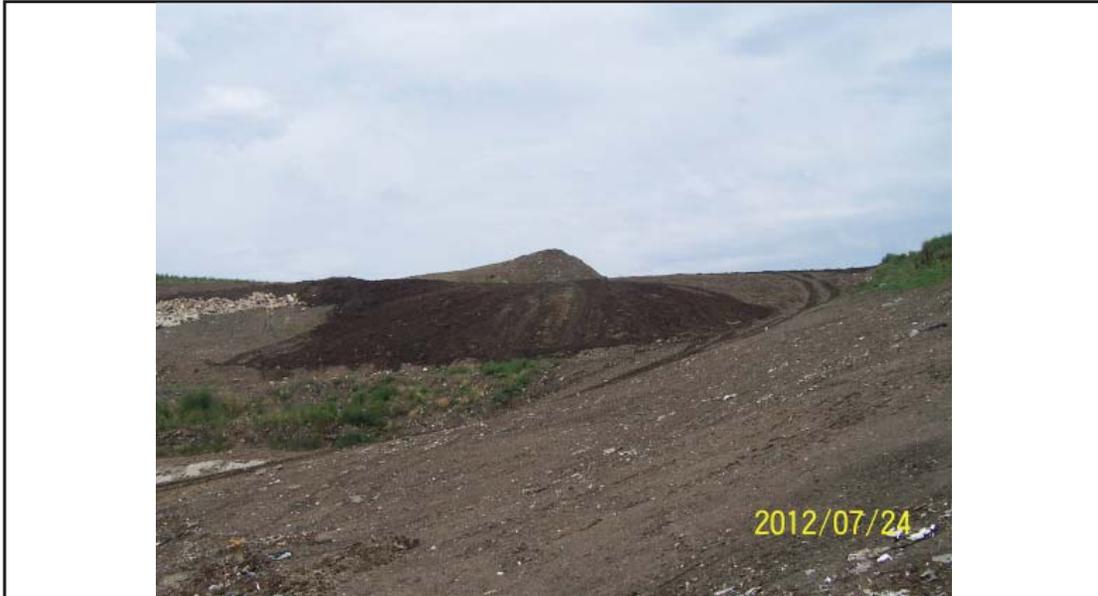
Landfill direct soil on South Slope of Phase 2/3

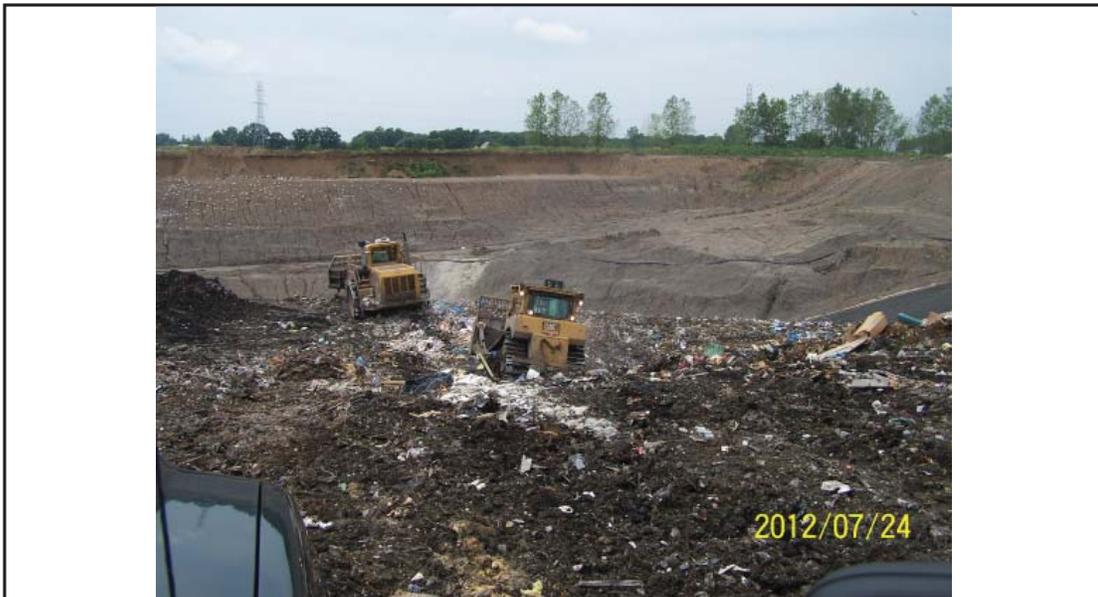
Active area
