2012 Advanced Disposal Services Emerald Park Landfill Year End Compliance Officer Report and Audit Summary

TO: Veolia Emerald Park Standing Committee
FROM: Jo-Walter Spear, Jr., P.E.
COPIES: File
DATE: 04/04/13
PROJECT NUMBER: 1012.10030

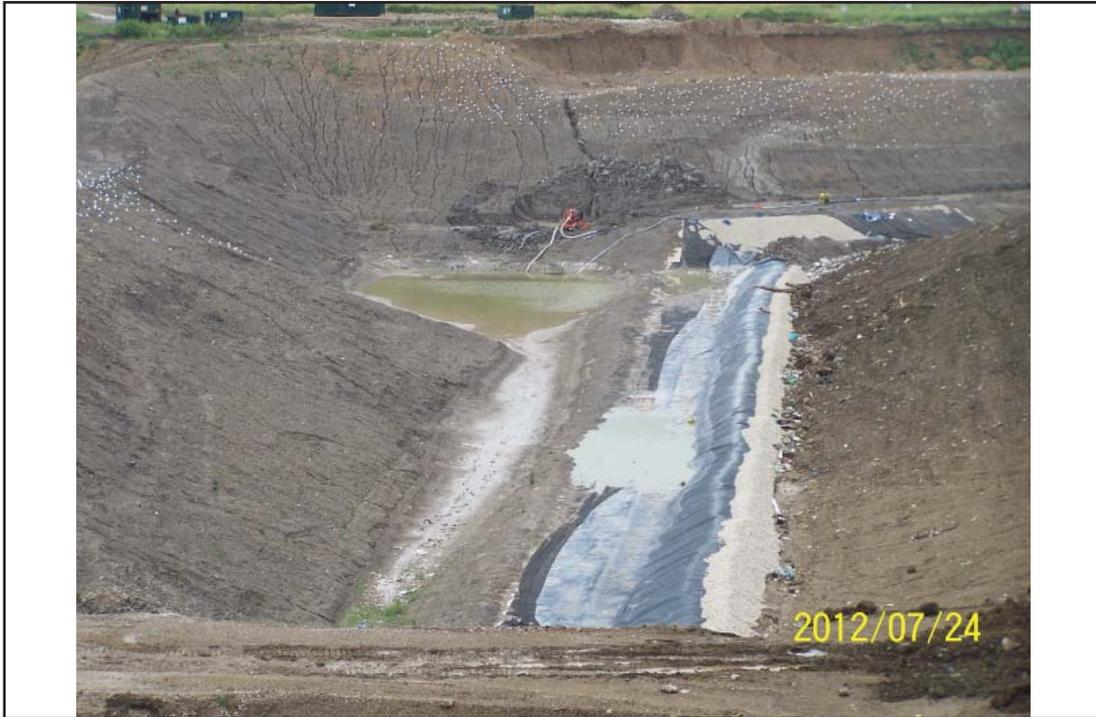
Temp sed basin, pumped down to an acceptable level this AM

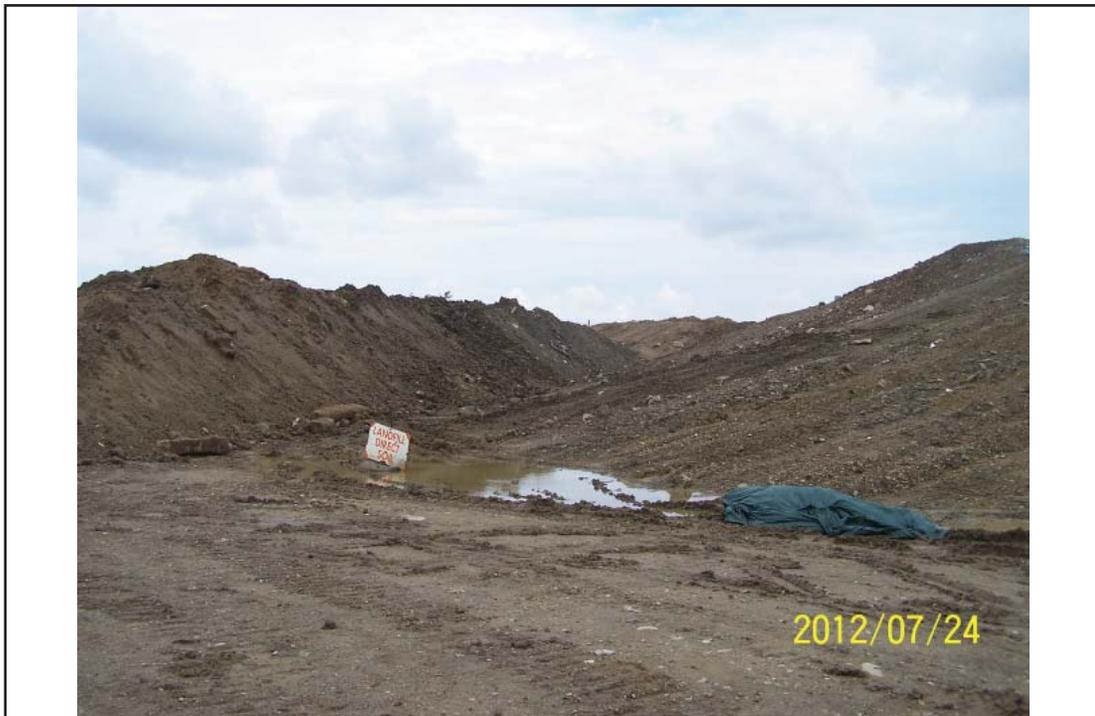
Landfill direct soils adjacent to bio-soil pile

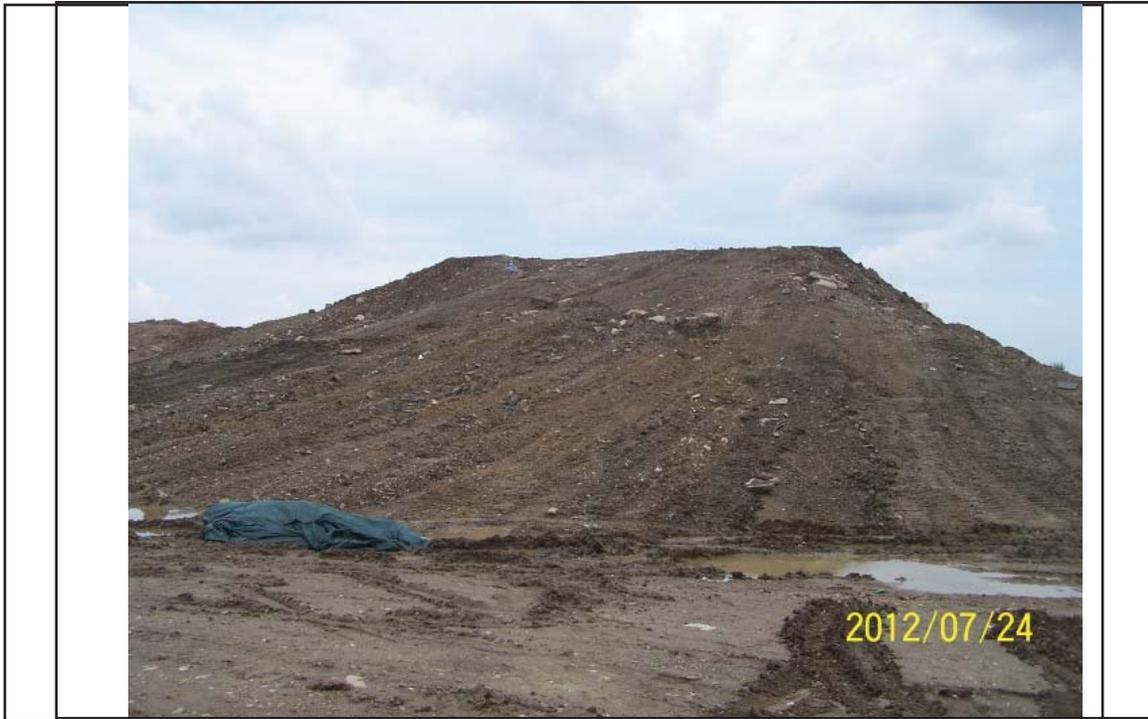
Bio-soil pile

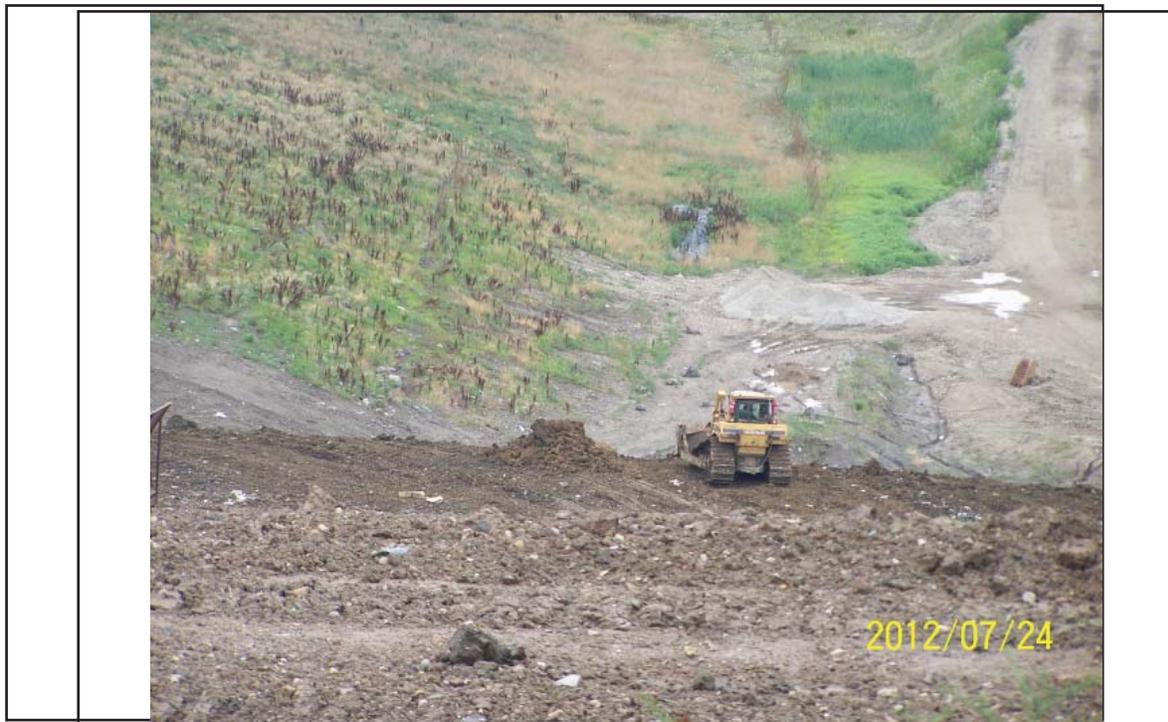
Dozer manipulating landfill direct soils on Phase 7 South slope

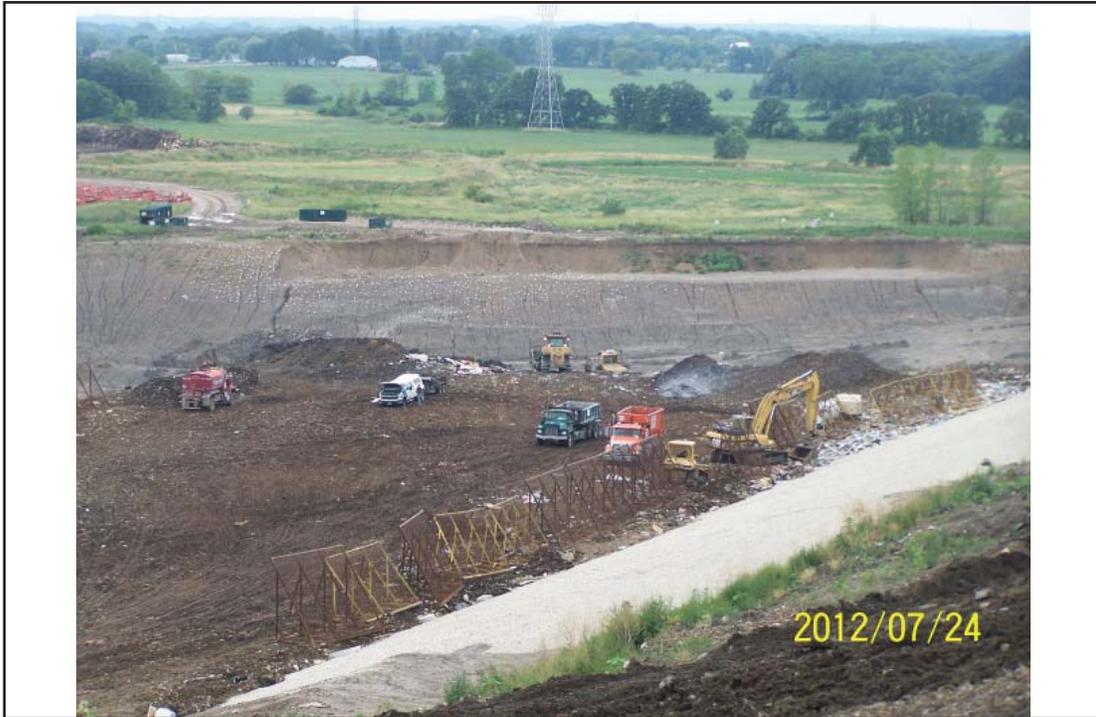
Active area, working face is on first lift at far end

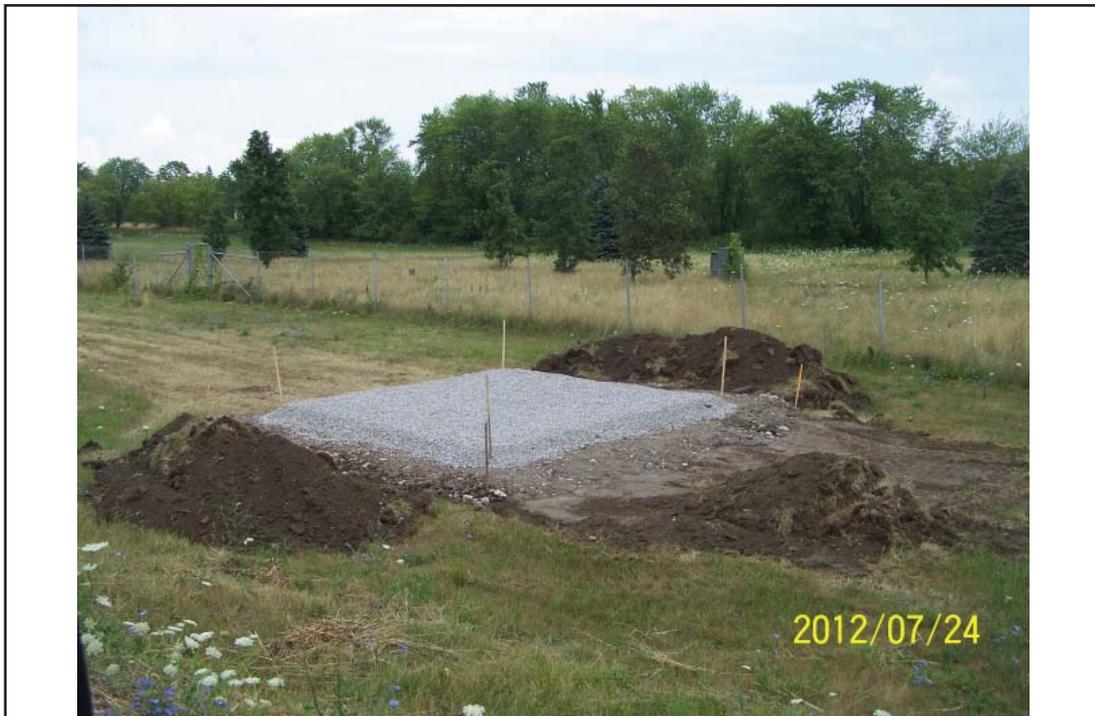
Stone pad for air compressor, for pneumatic well system

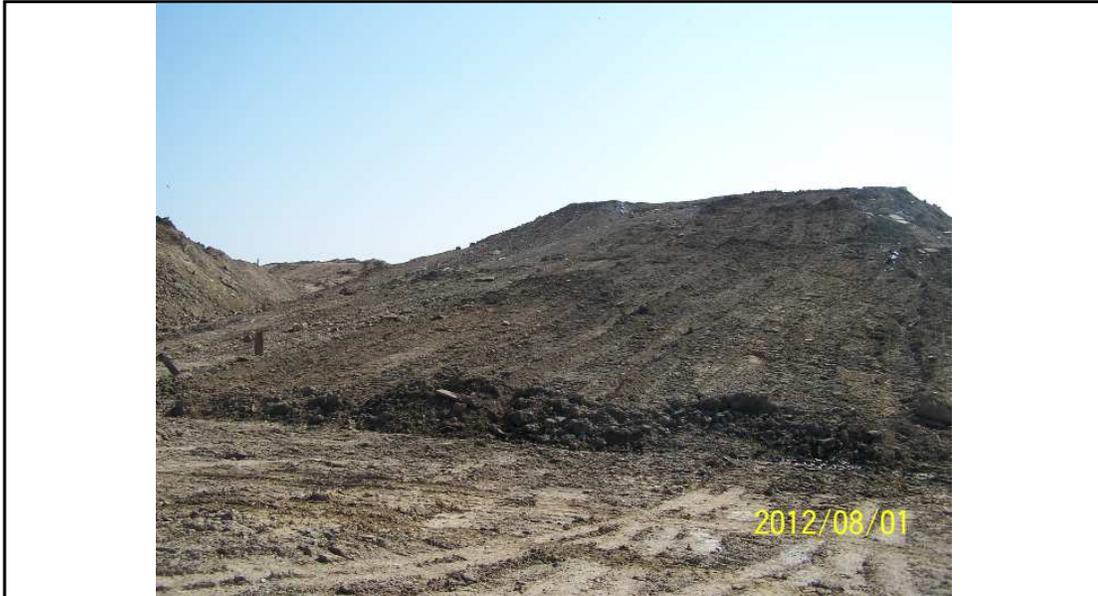
Bio soil stockpile on Phase 3

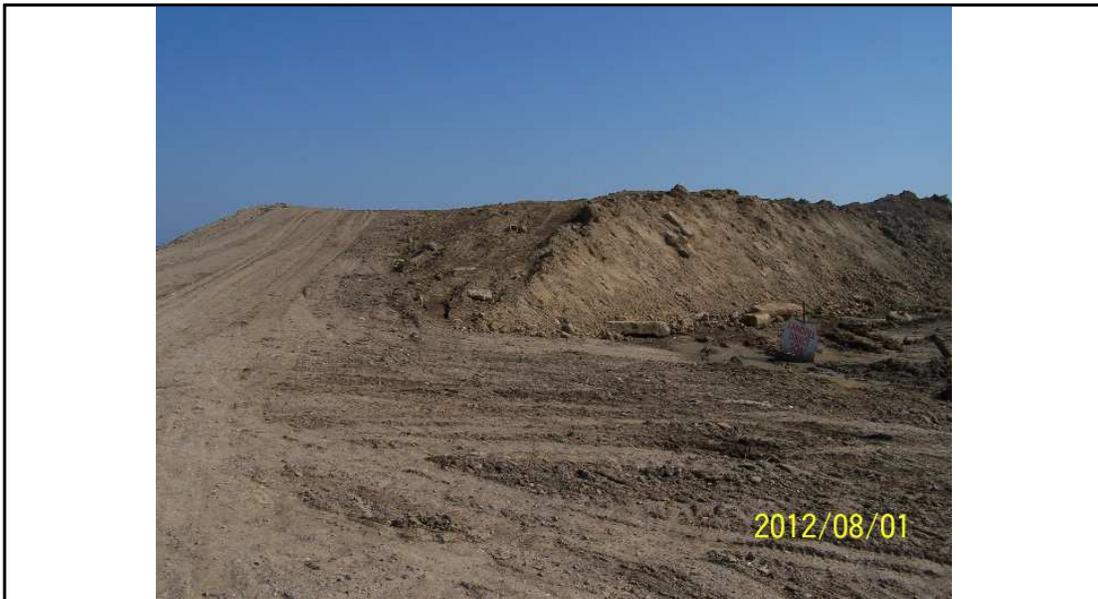
Landfill direct soil stockpile on Phase 1/2

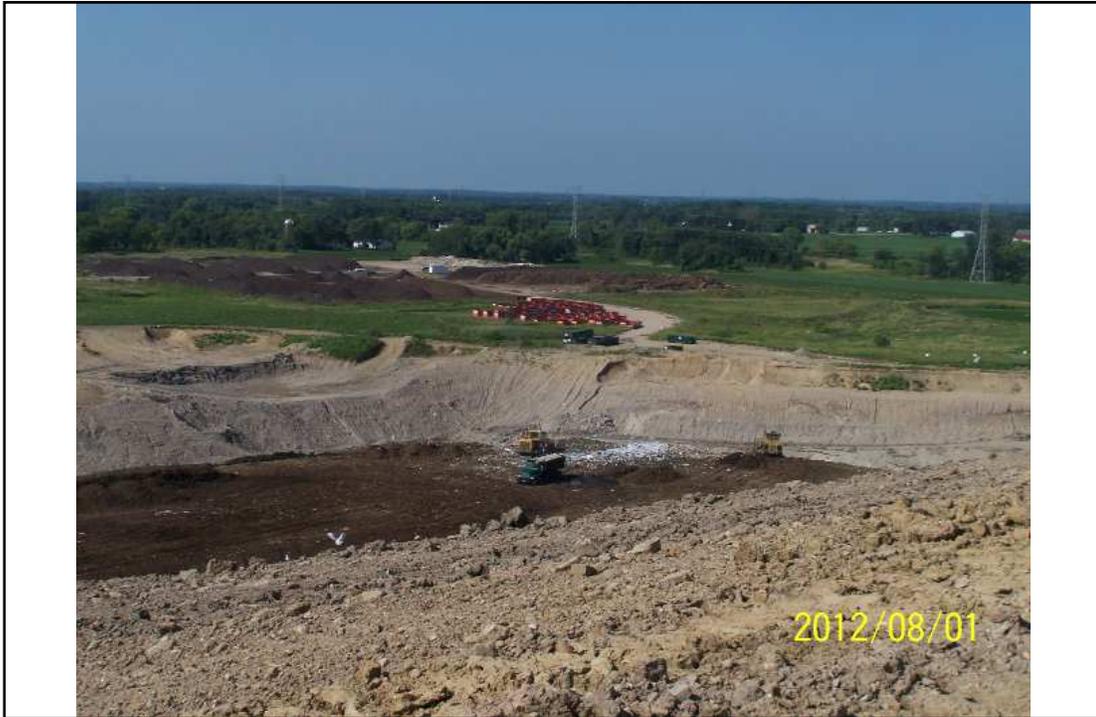
West edge of Active area

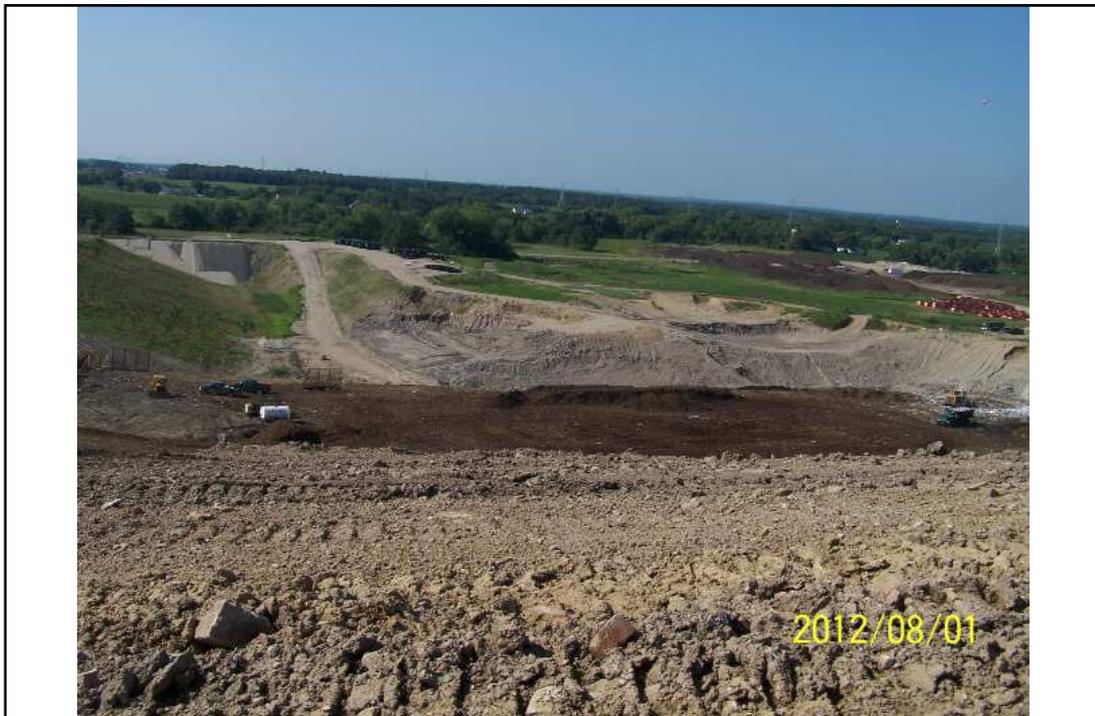
Active Area, note large stockpile of Auto-fluff

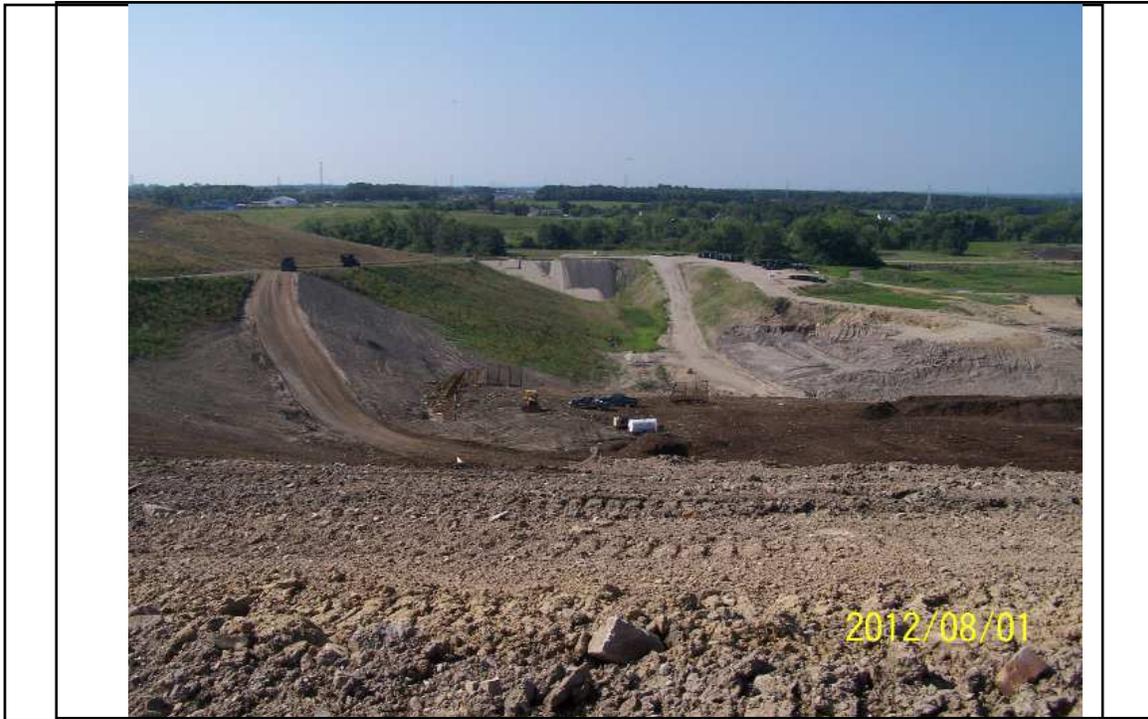
Soil placement above active area

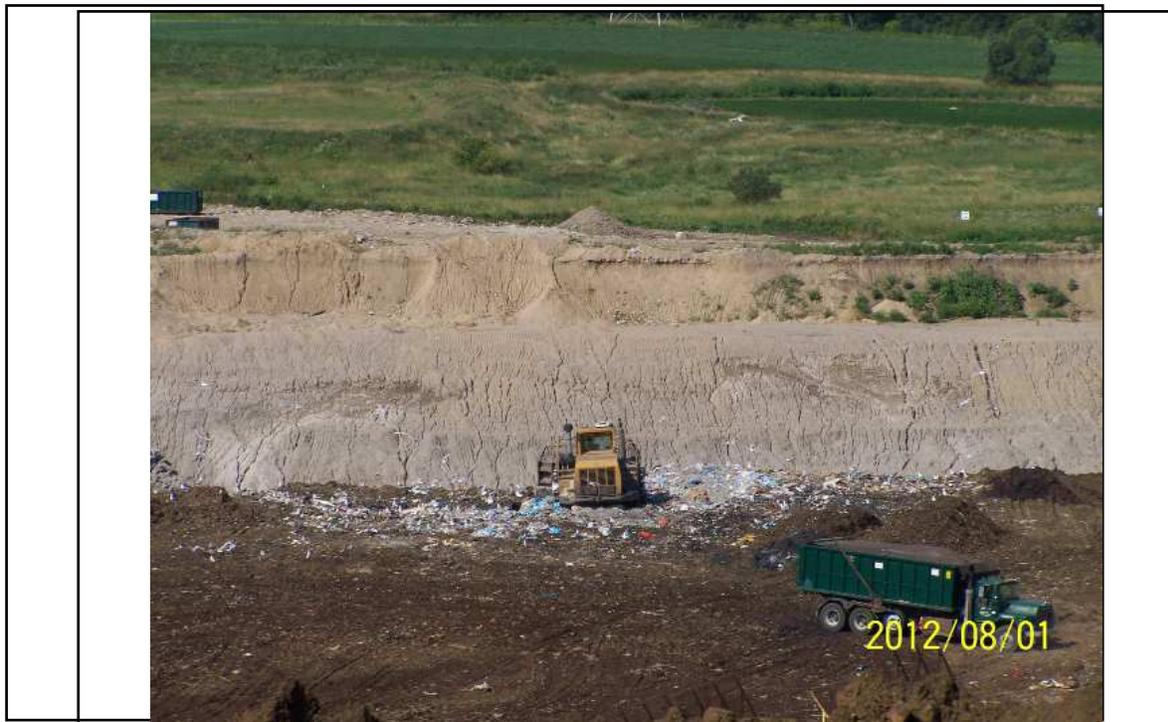
Working face at West and Southwest of Phase 7

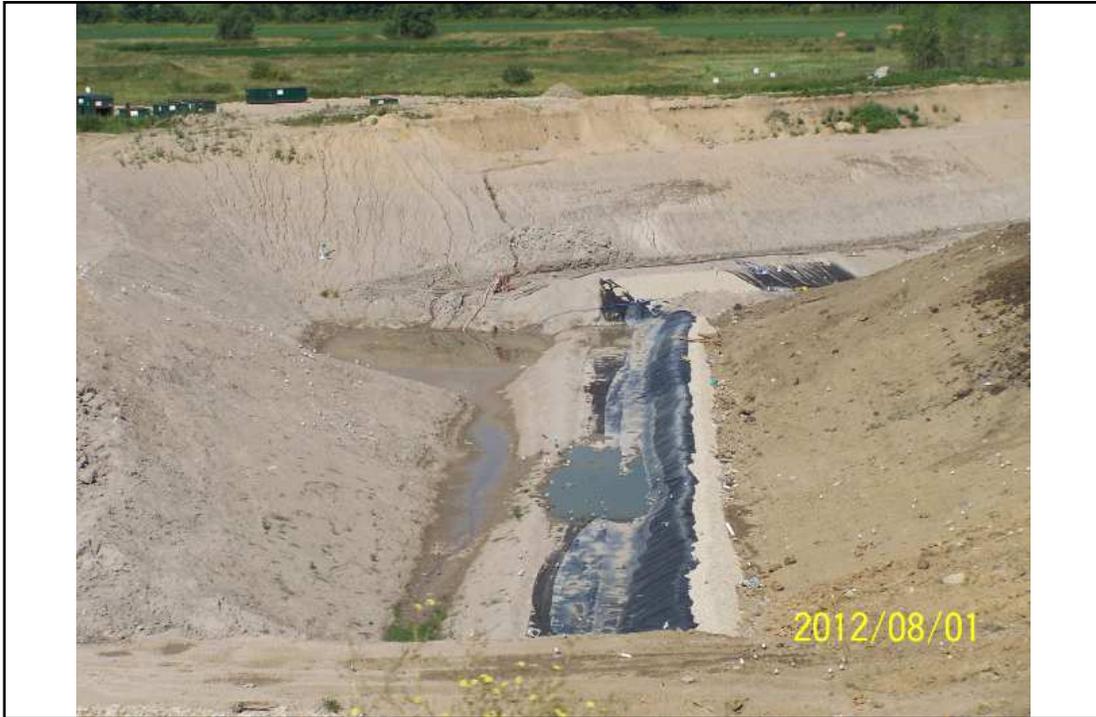
Phase 7 Temp sed basin nearly dry

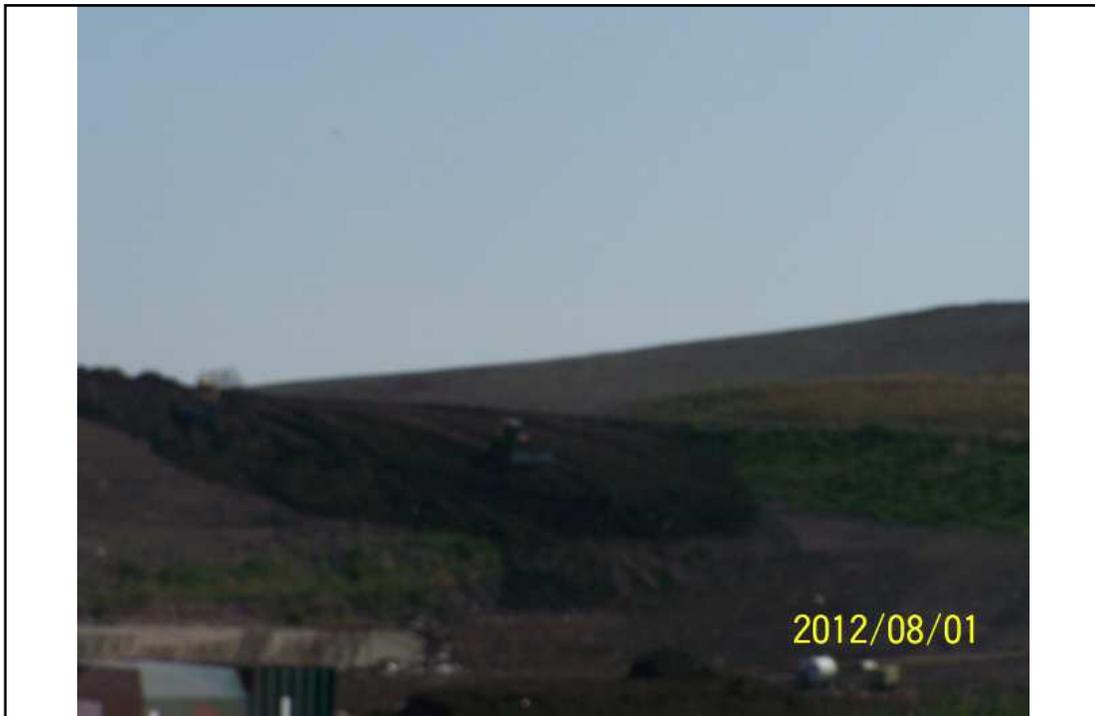
Dozer spreading landfill direct soils on slope above Phase 7

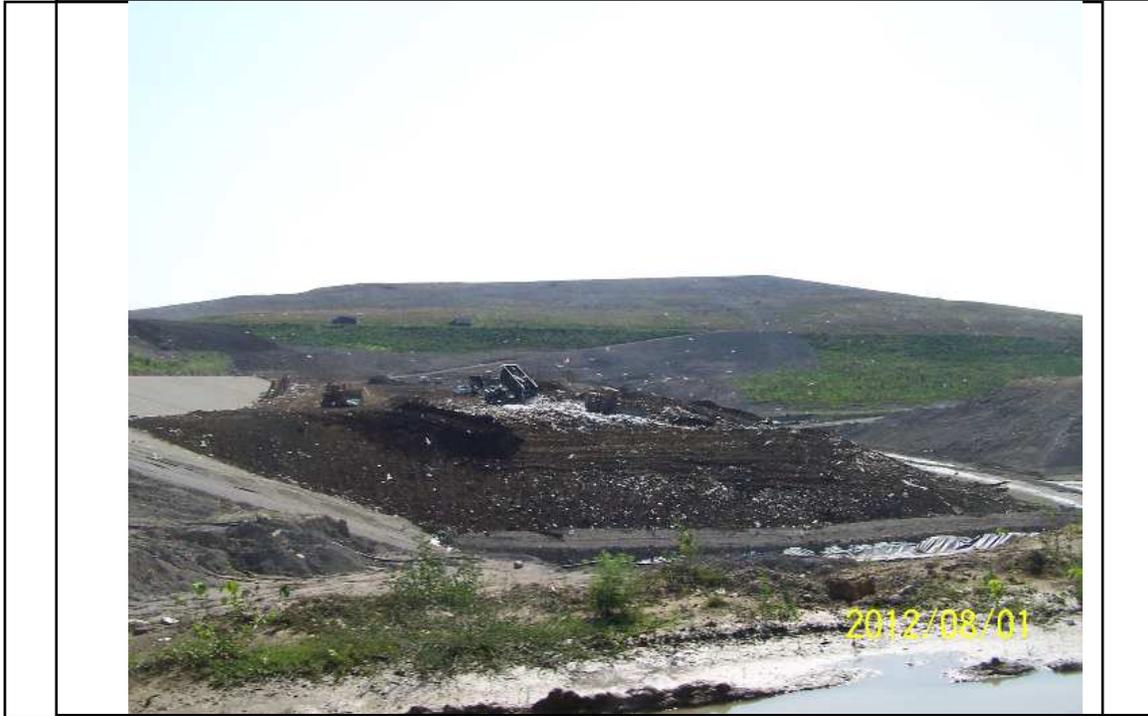
Active area viewed from the West

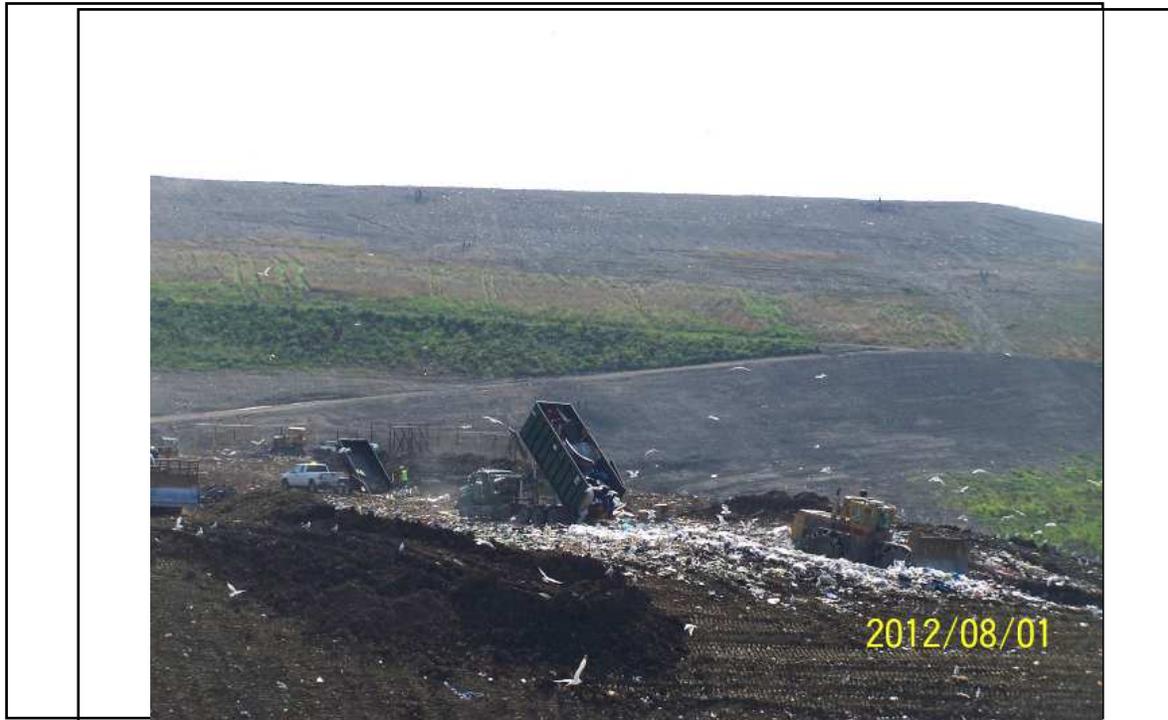
Active area from Northwest

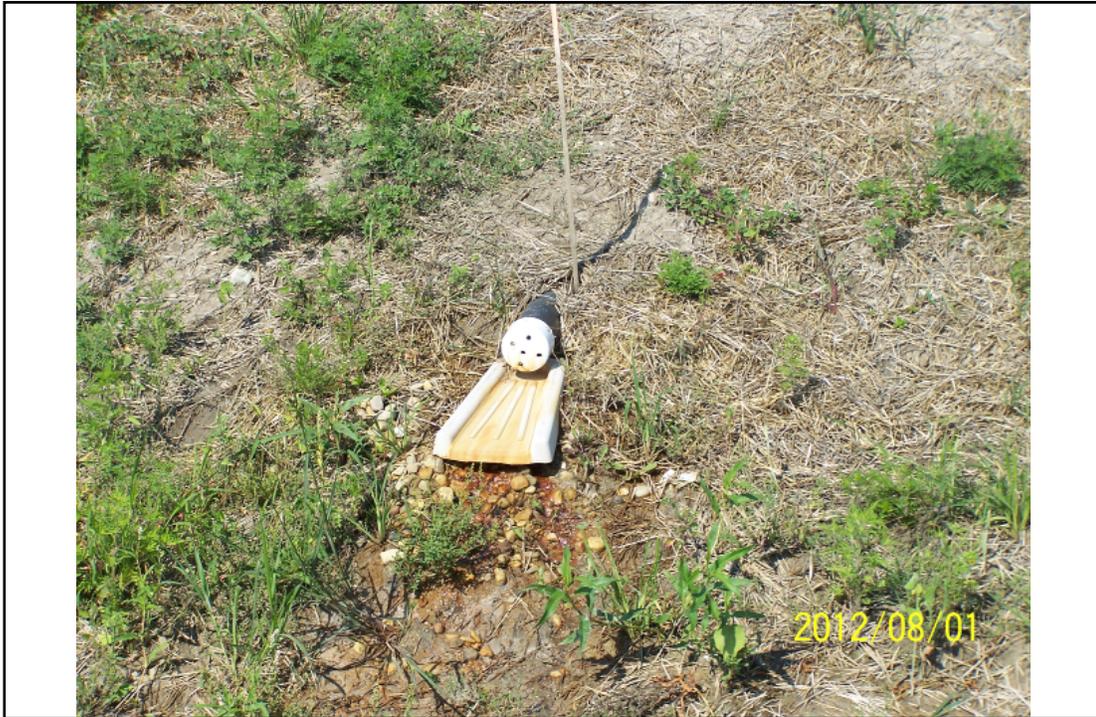
Toe drain for Closure Area III, discoloration may be due to many reasons and Veolia will investigate

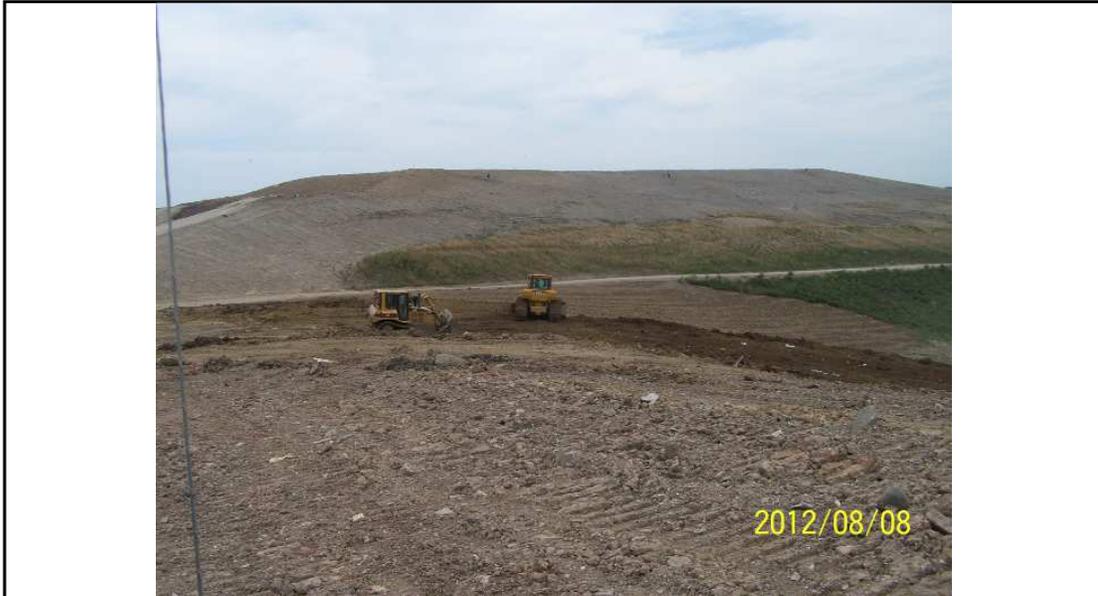
Soils above Phase 7, in Northeast corner

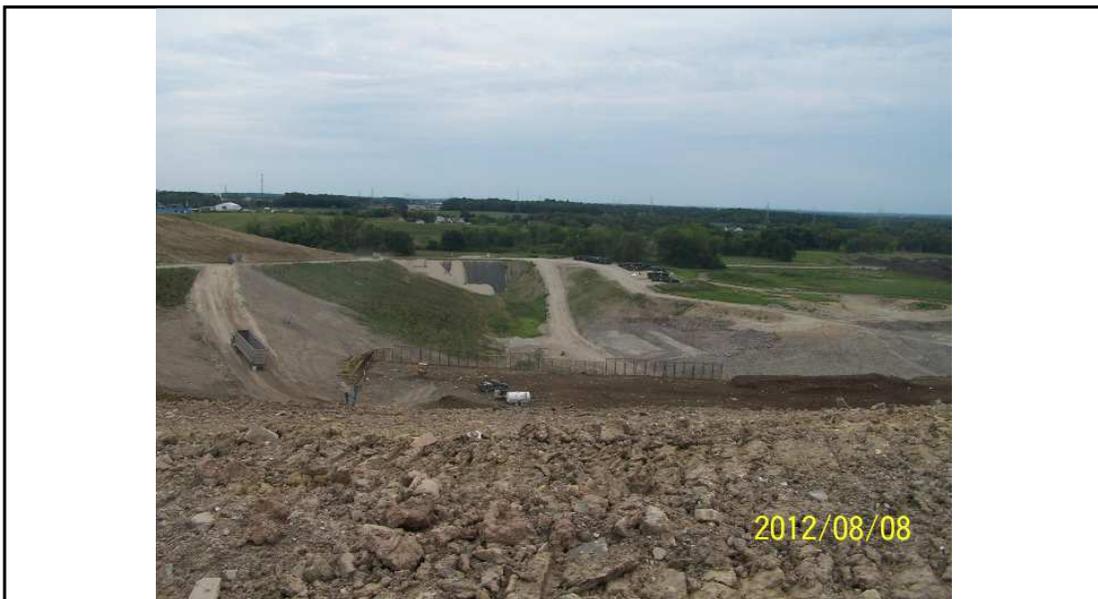
Soils area above Phase 7

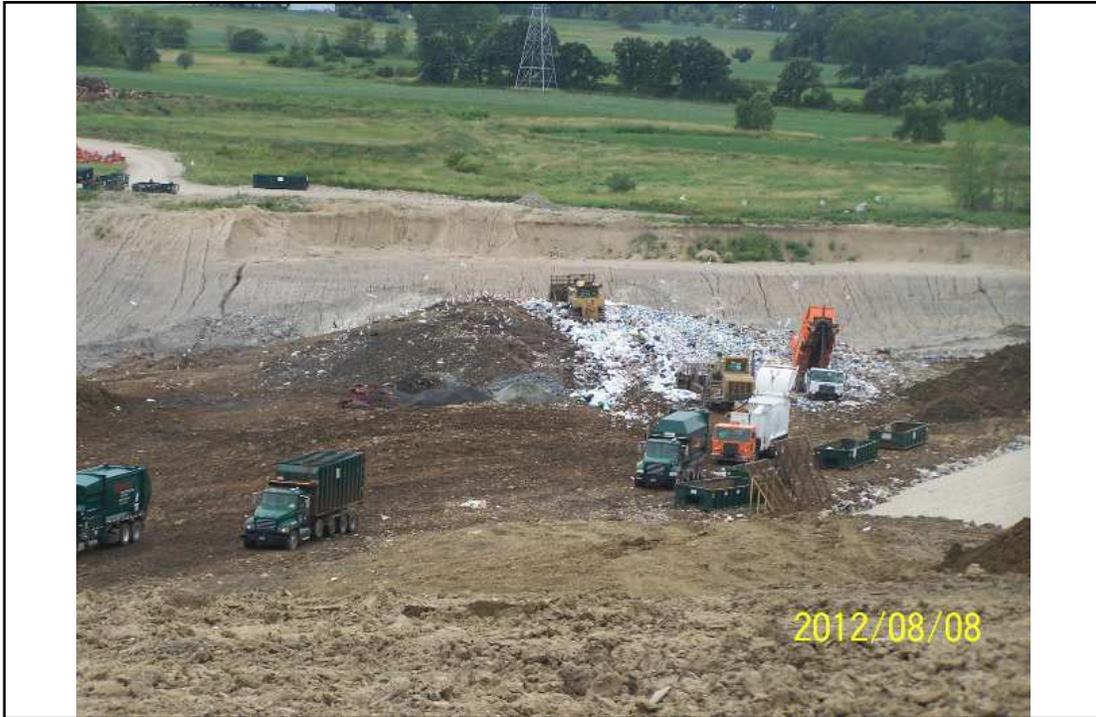
Active Area

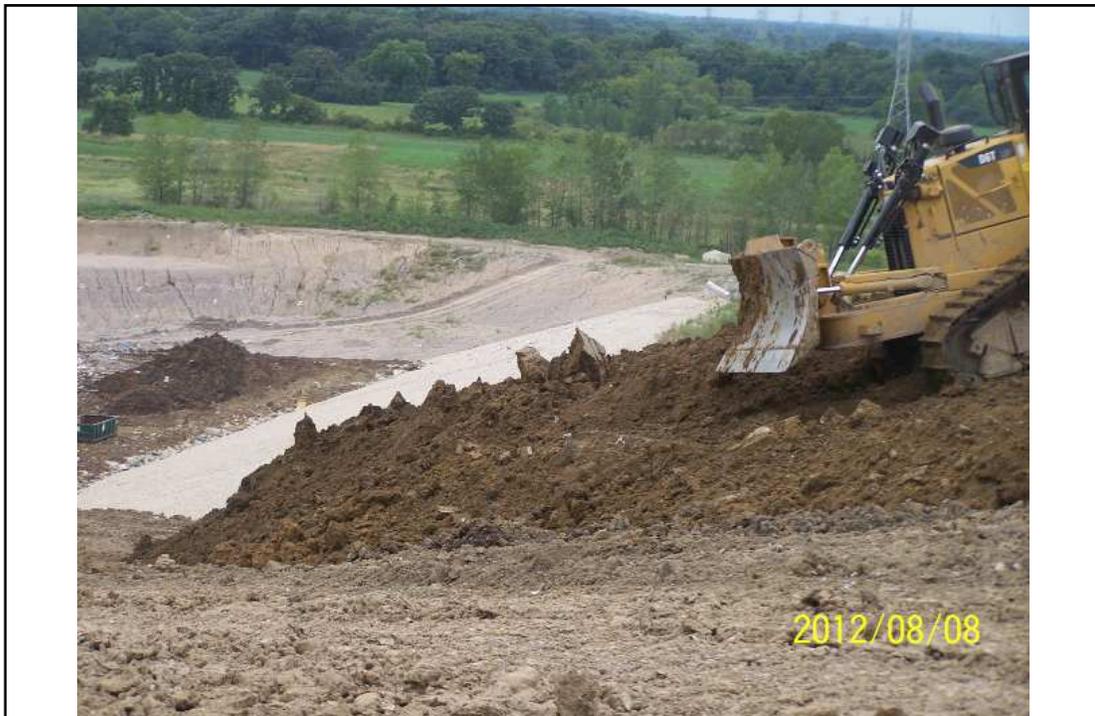
Soil, Landfill direct, loads being tipped on phase 3/7 slope above Phase 7

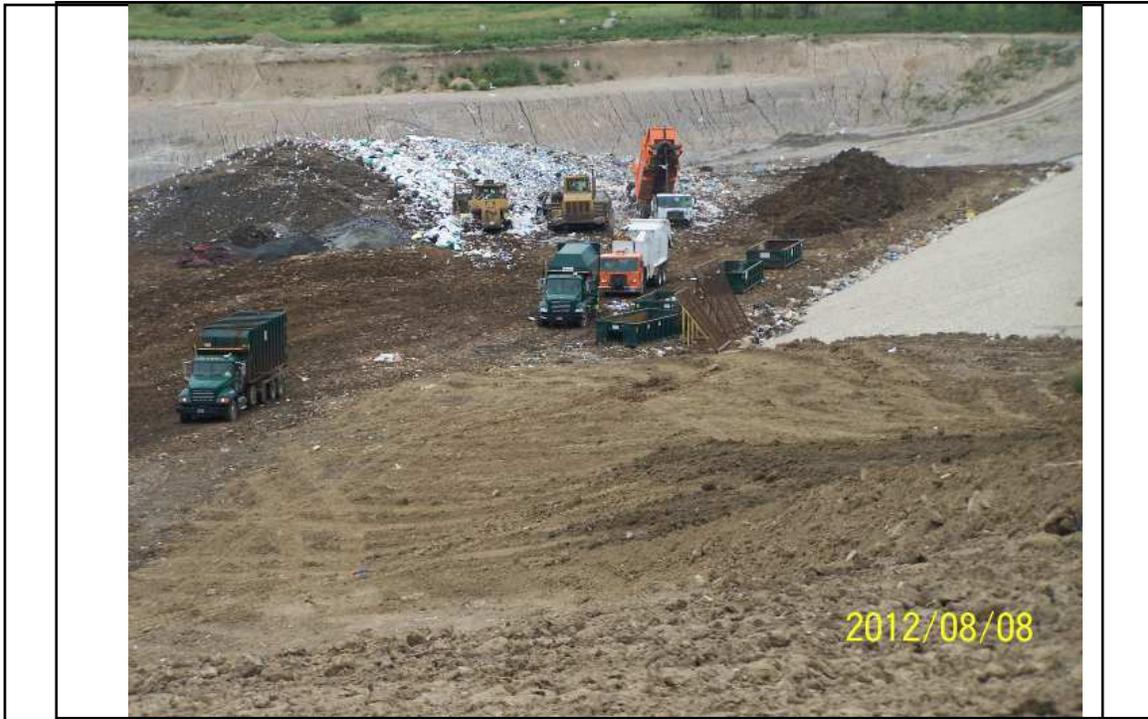
Working face, new lift, viewed from East

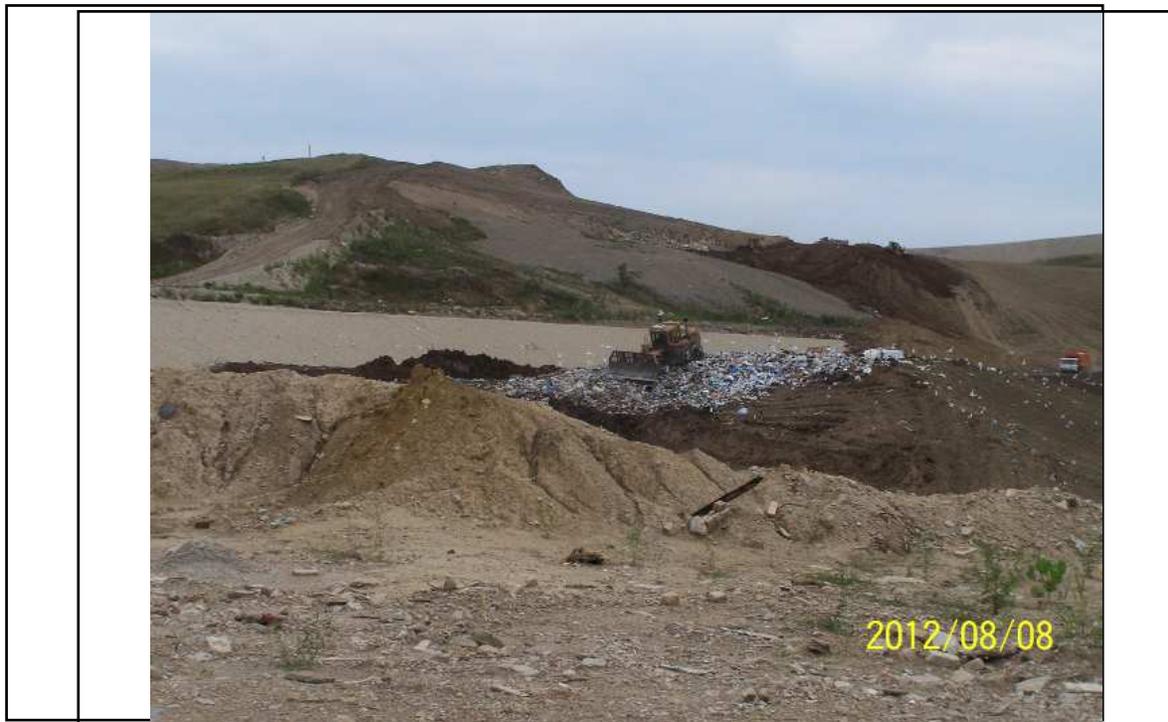
Working face, new lift, viewed from West

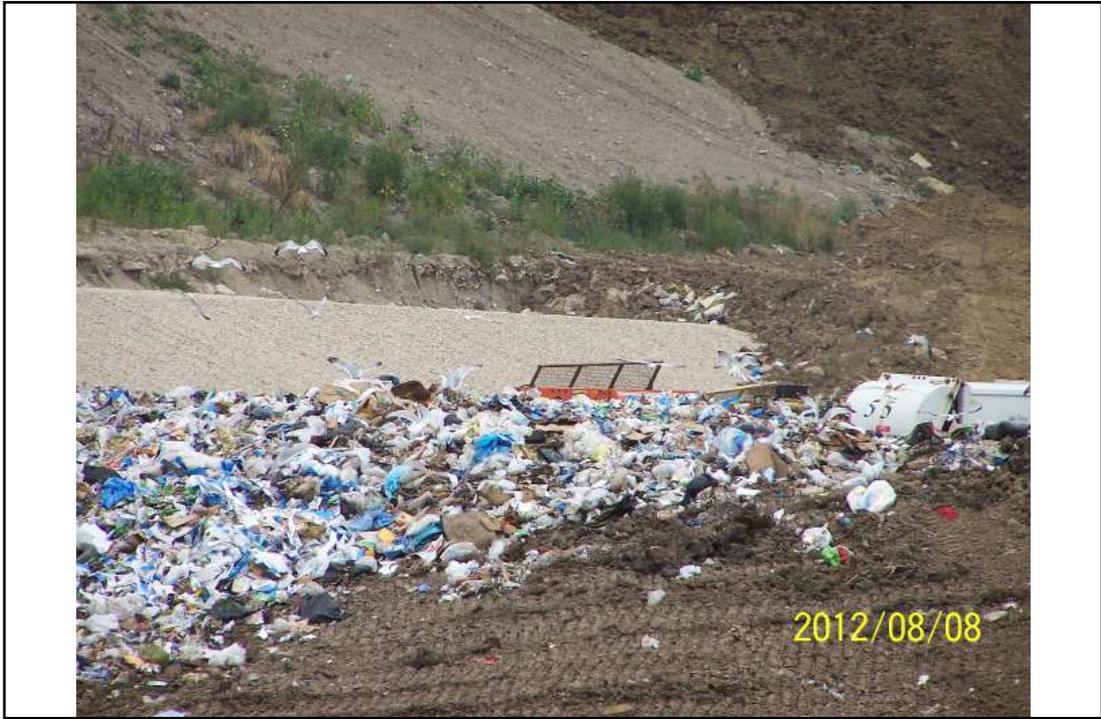
Working face

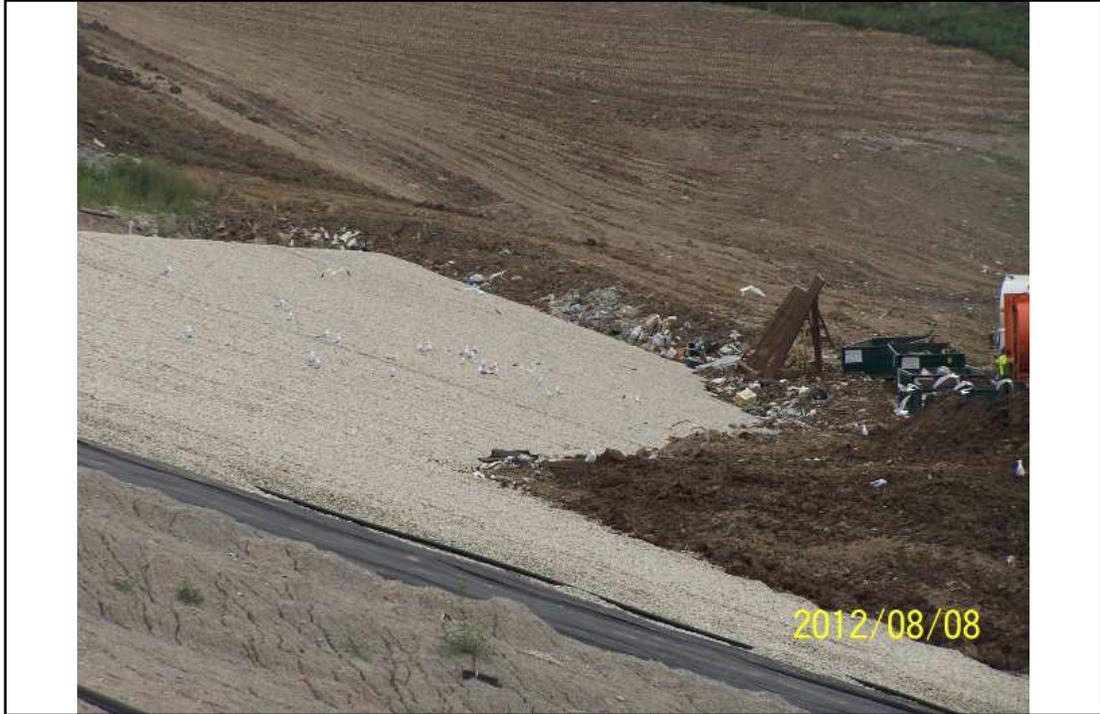
Transition from Phase 3 to Phase 7

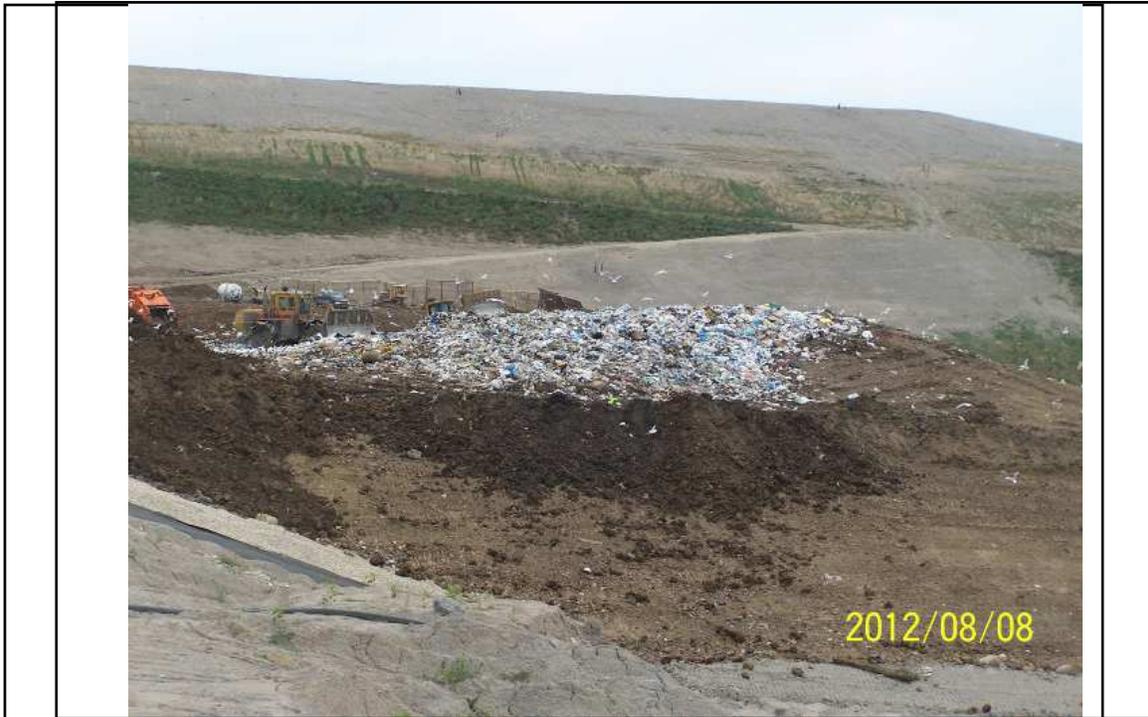
Working face trenched into previous lift

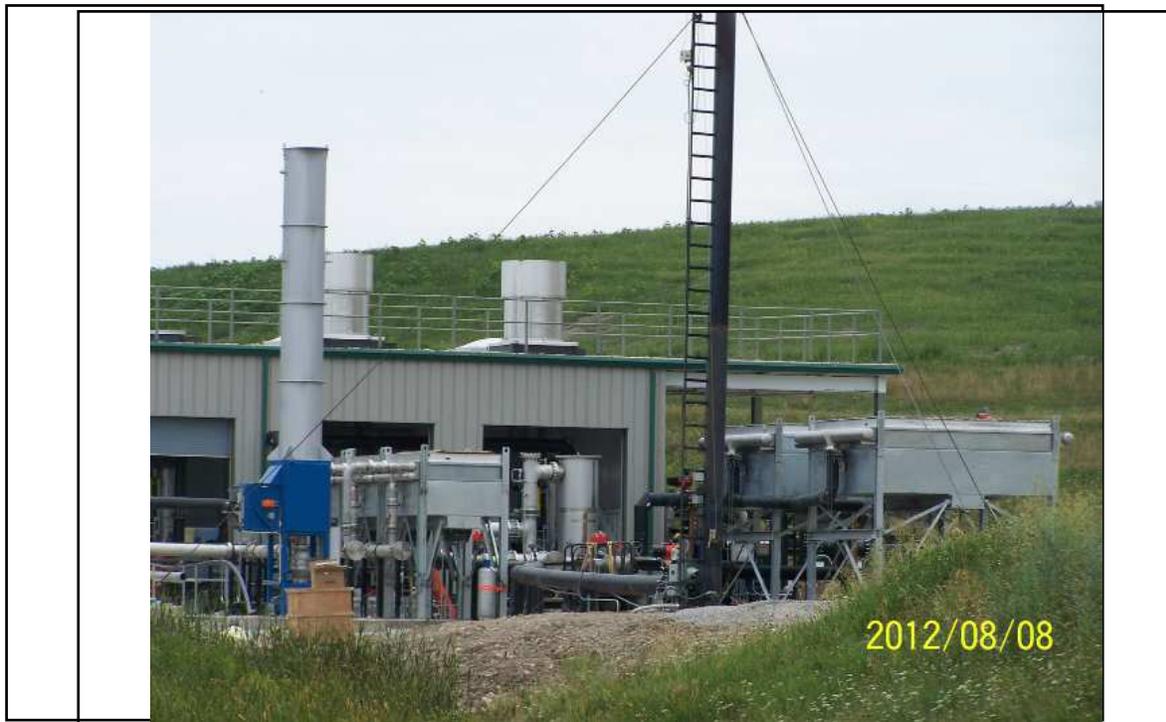
Gas building and new Flare location

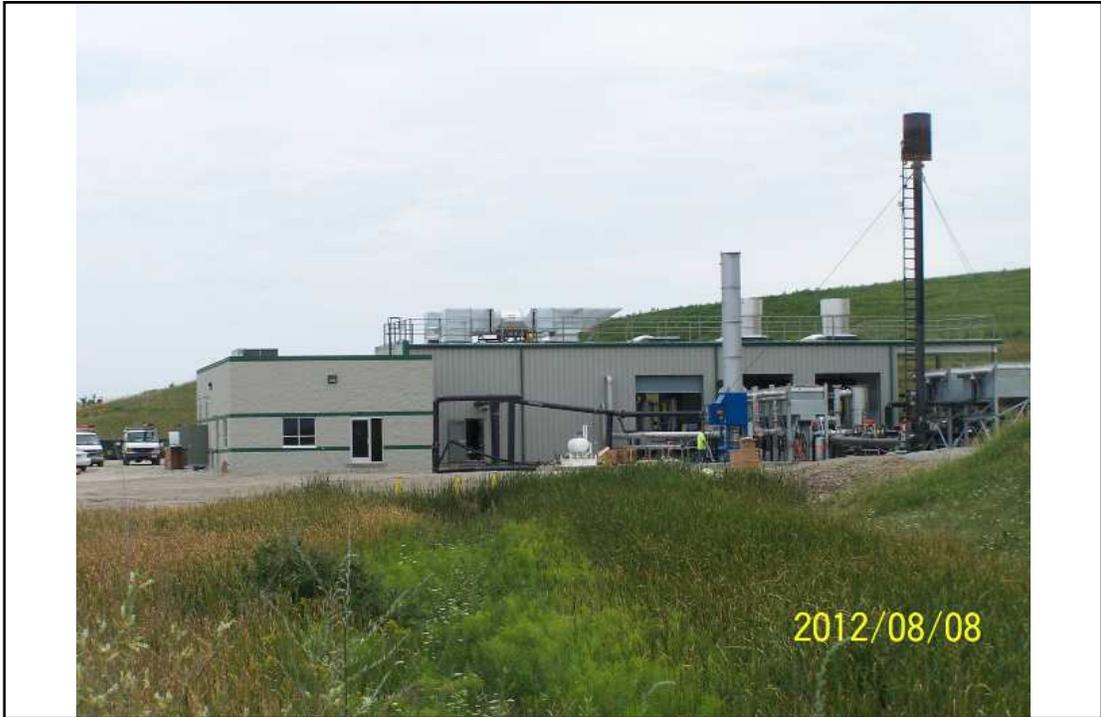
Gas building viewed from the North

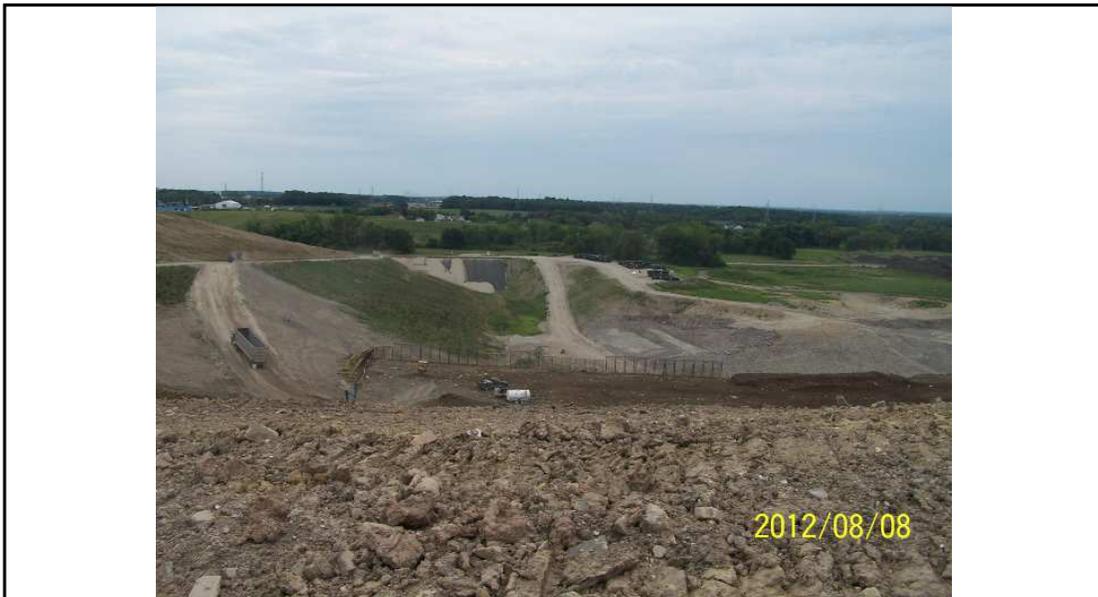
Soils area above Phase 7
