2012 Advanced Disposal Services Emerald Park Landfill Year End Compliance Officer Report and Audit Summary

TO: Veolia Emerald Park Standing Committee
FROM: Jo-Walter Spear, Jr., P.E.
COPIES: File
DATE: 04/04/13
PROJECT NUMBER: 1012.10030

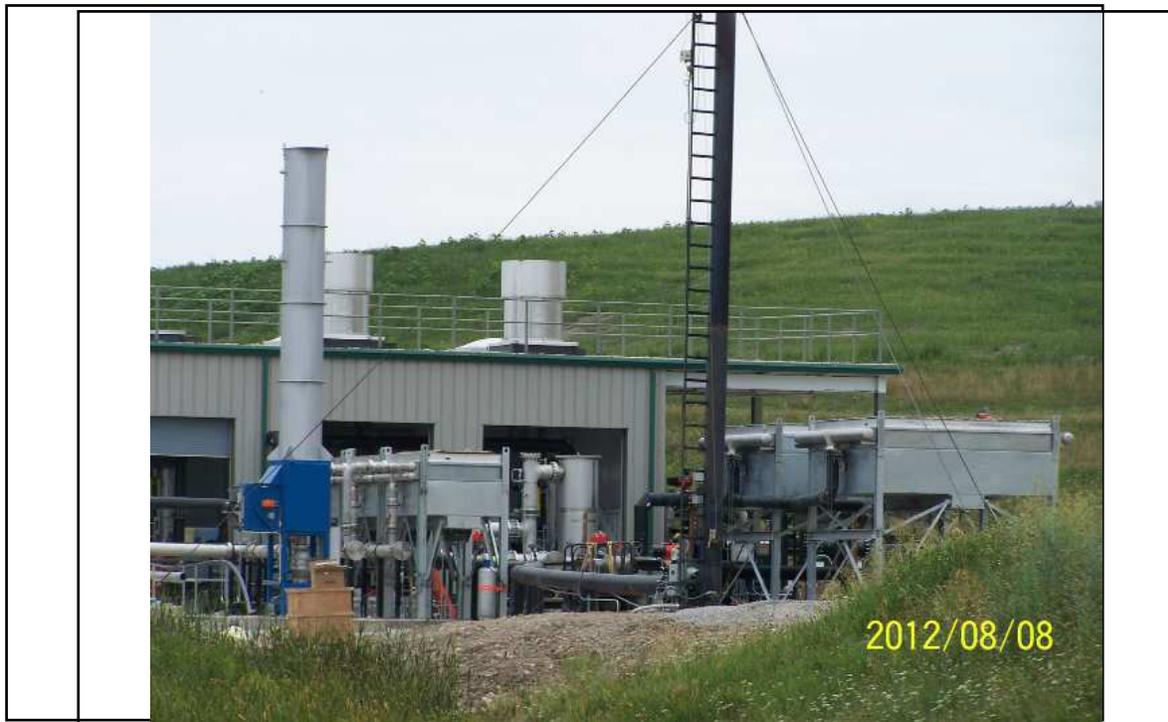
Gas building and new Flare location

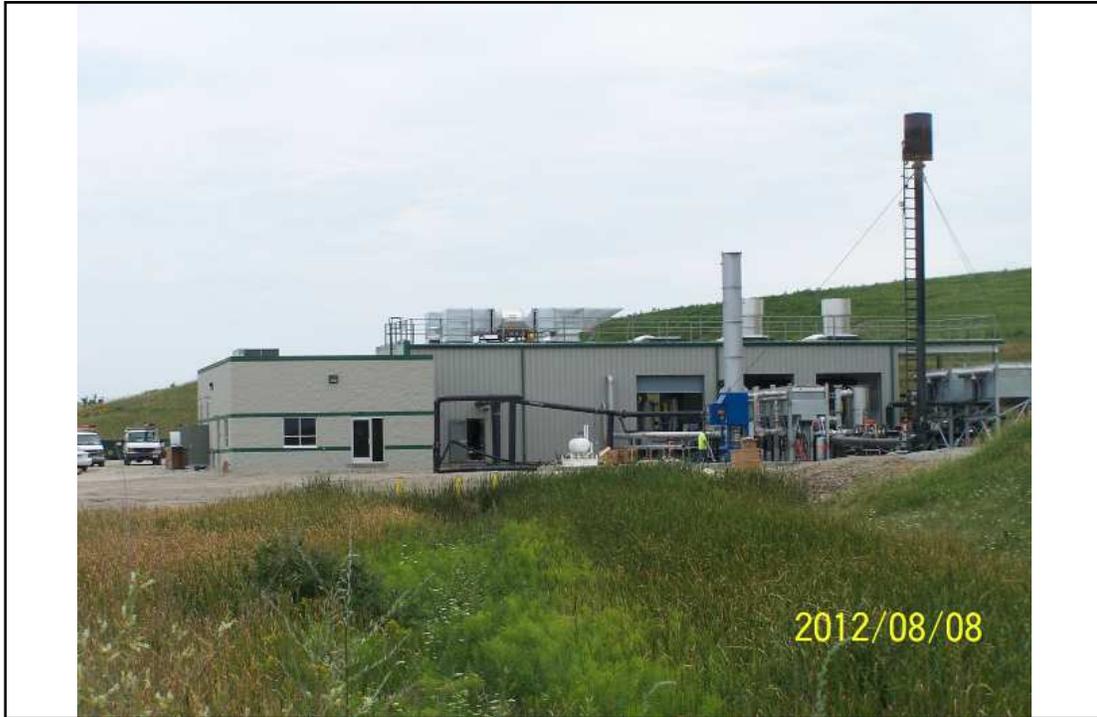
Gas building viewed from the North

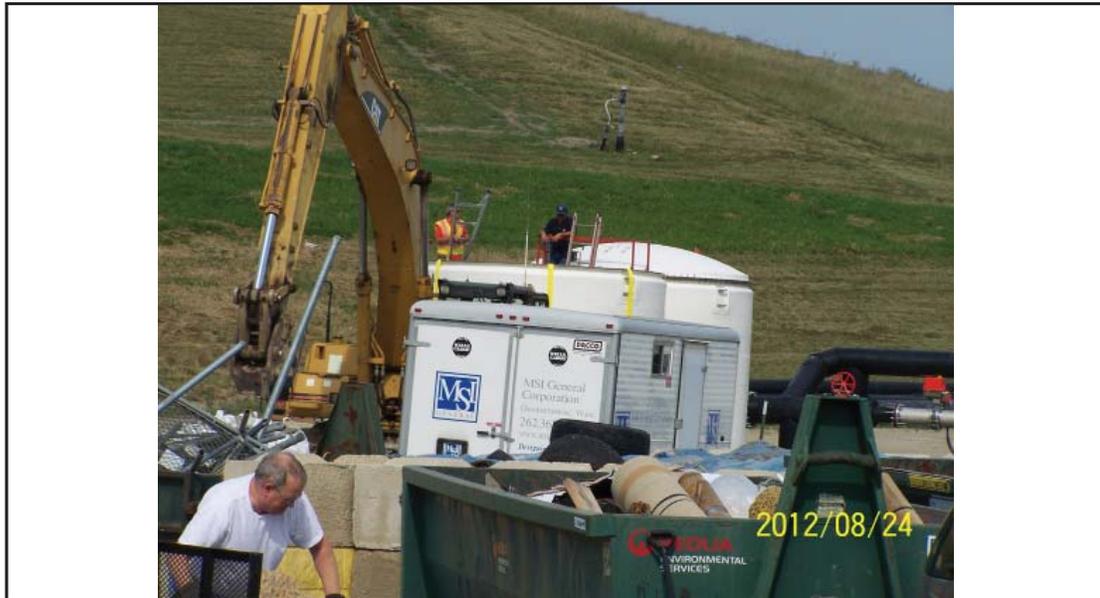
H2S scrubber tanks receiving filter media

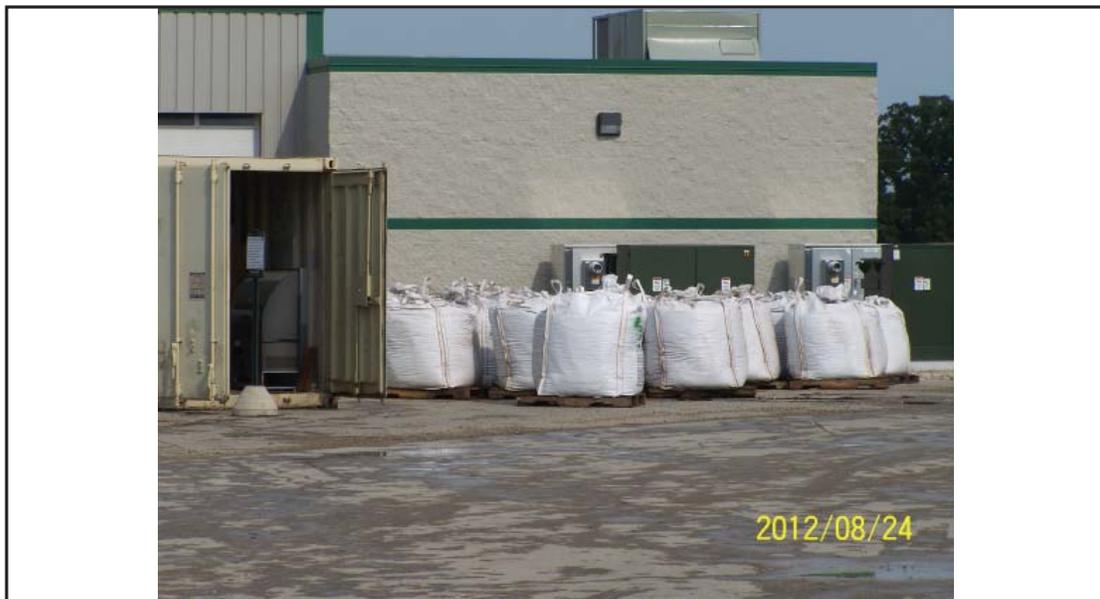
Filter media to be added to tanks

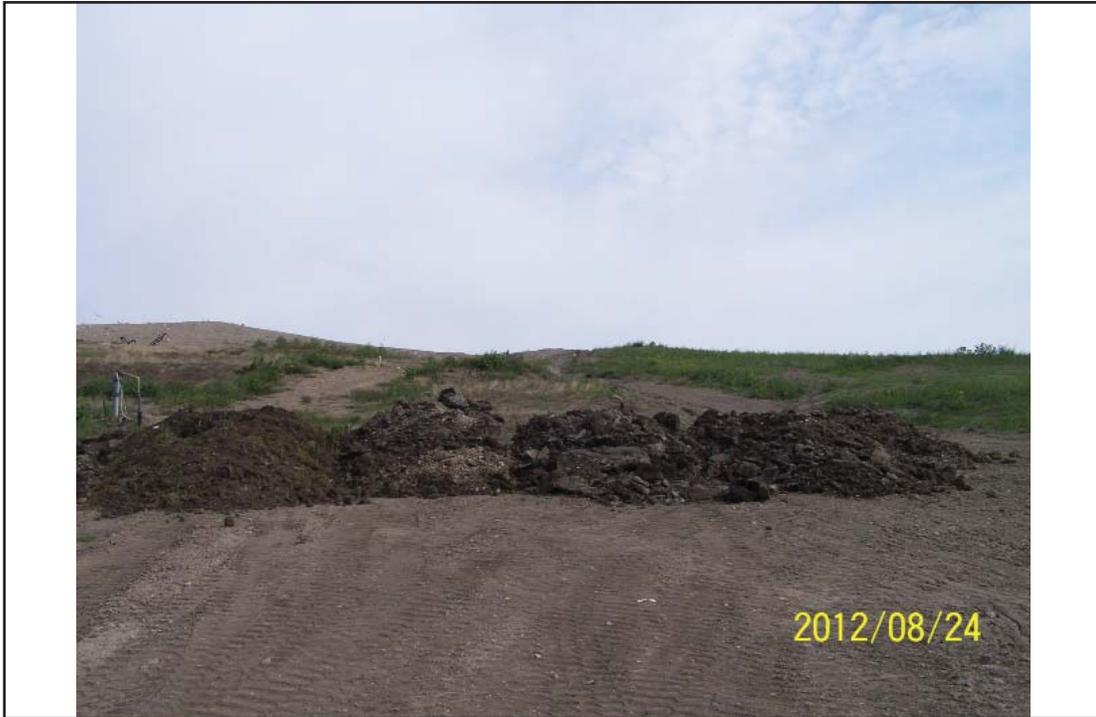
Soils from ditch cleaning

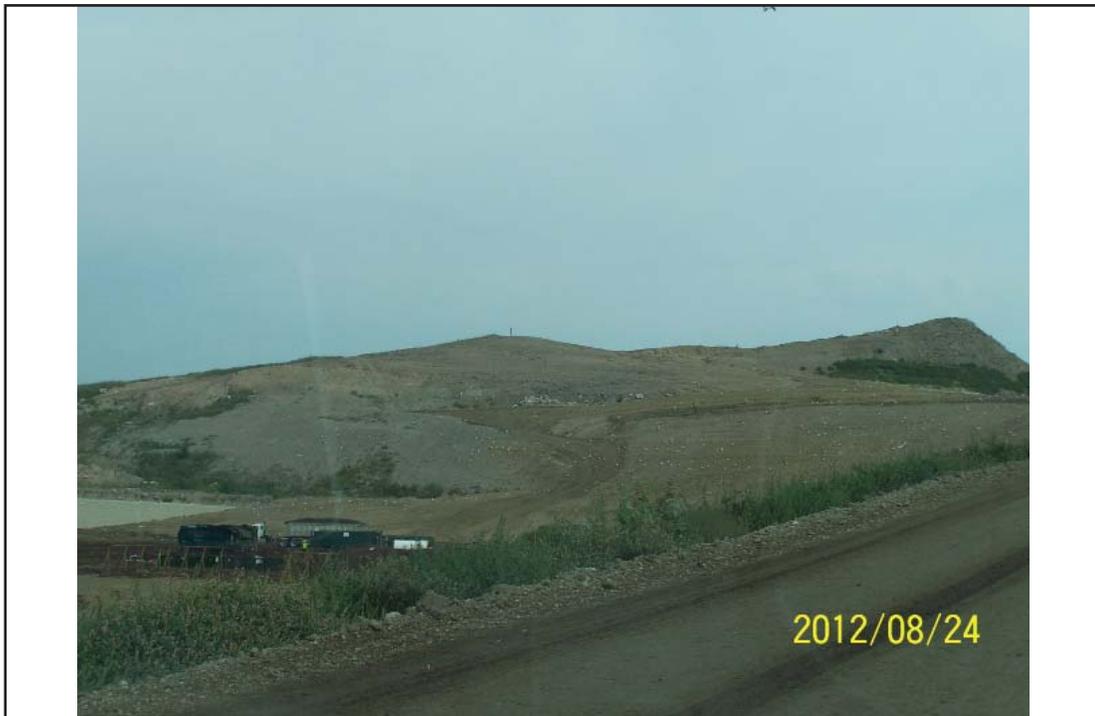
Soils tipped on junction between Phases 3 & 7

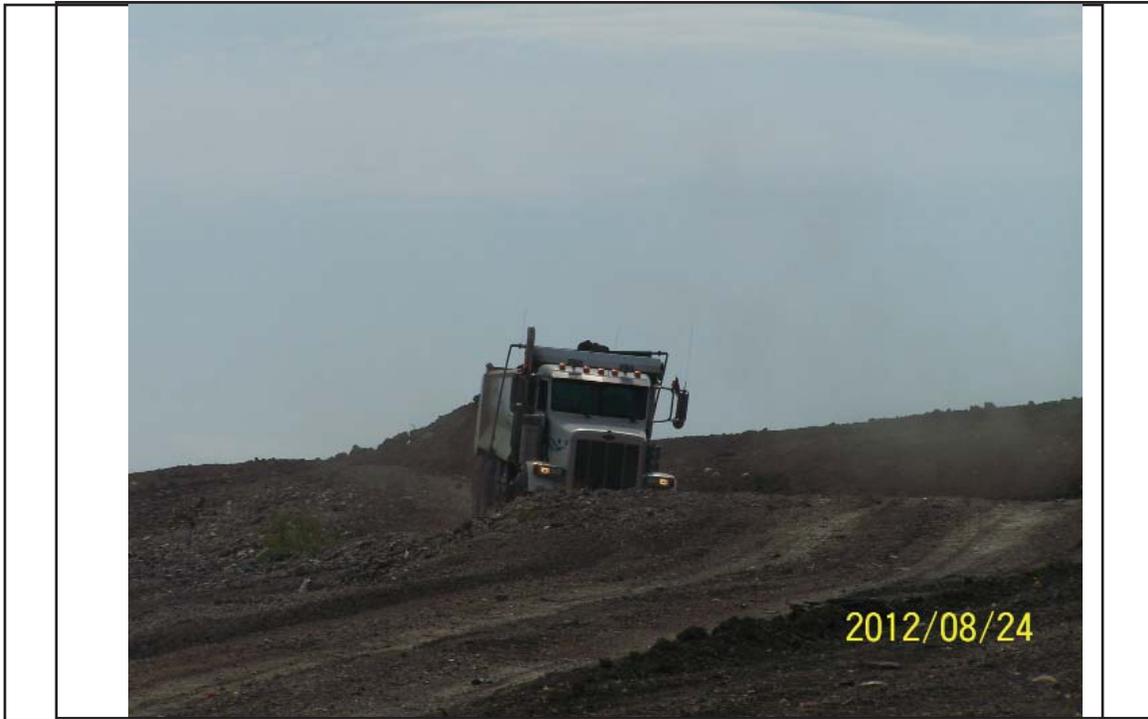
Trucks tipping on top of Phase 5/6, soils only to shape grades

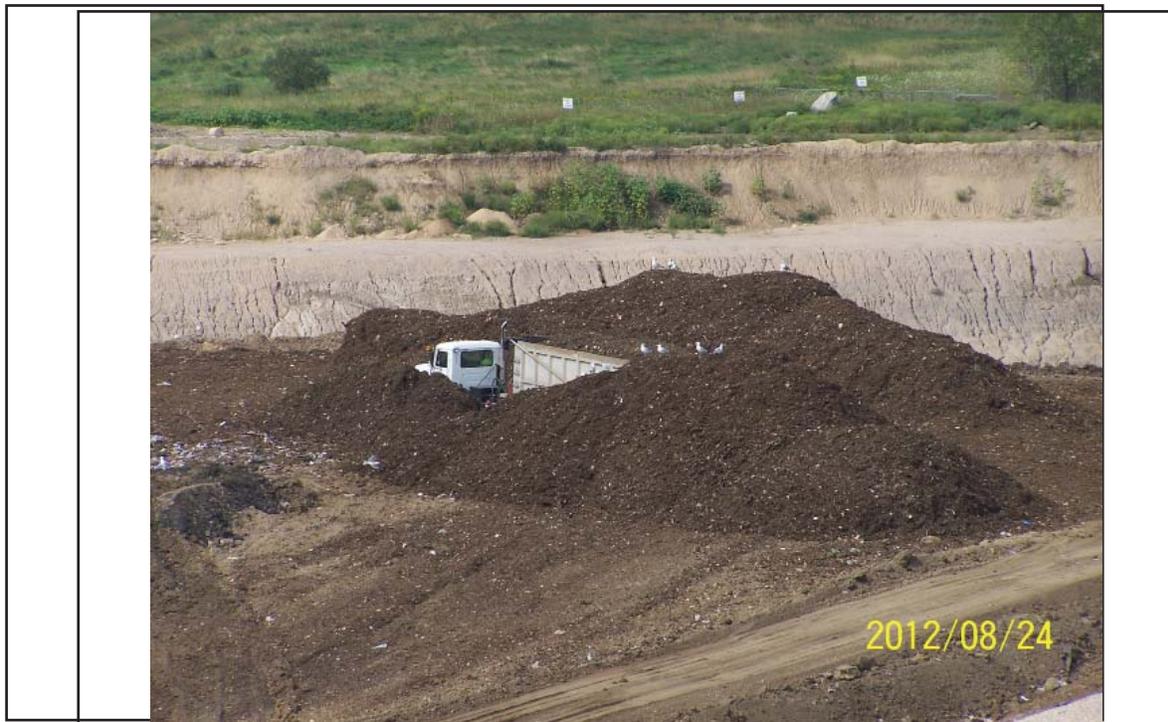
Autofluff stockpiles

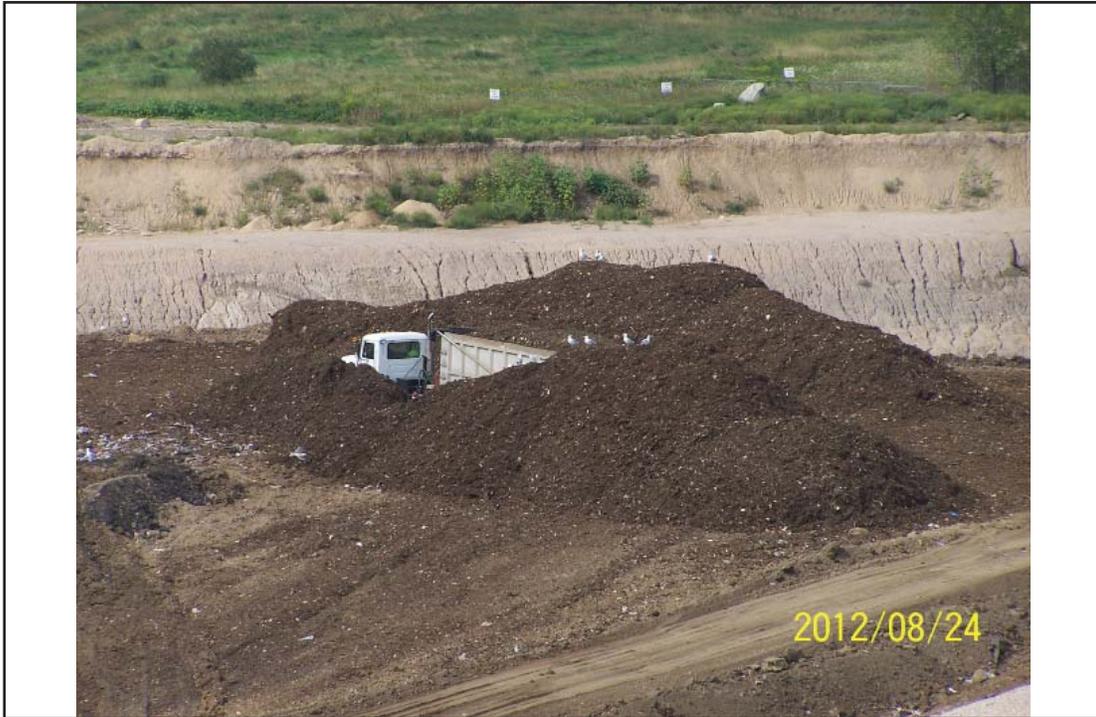
Autofluff stockpiles

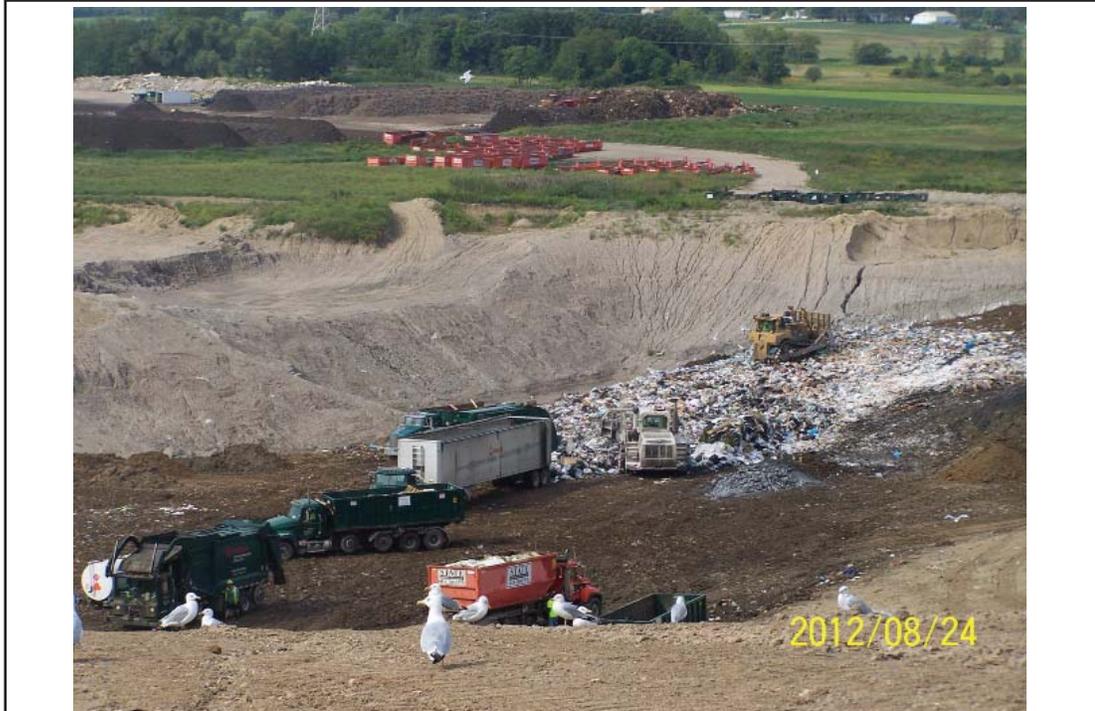
Active area

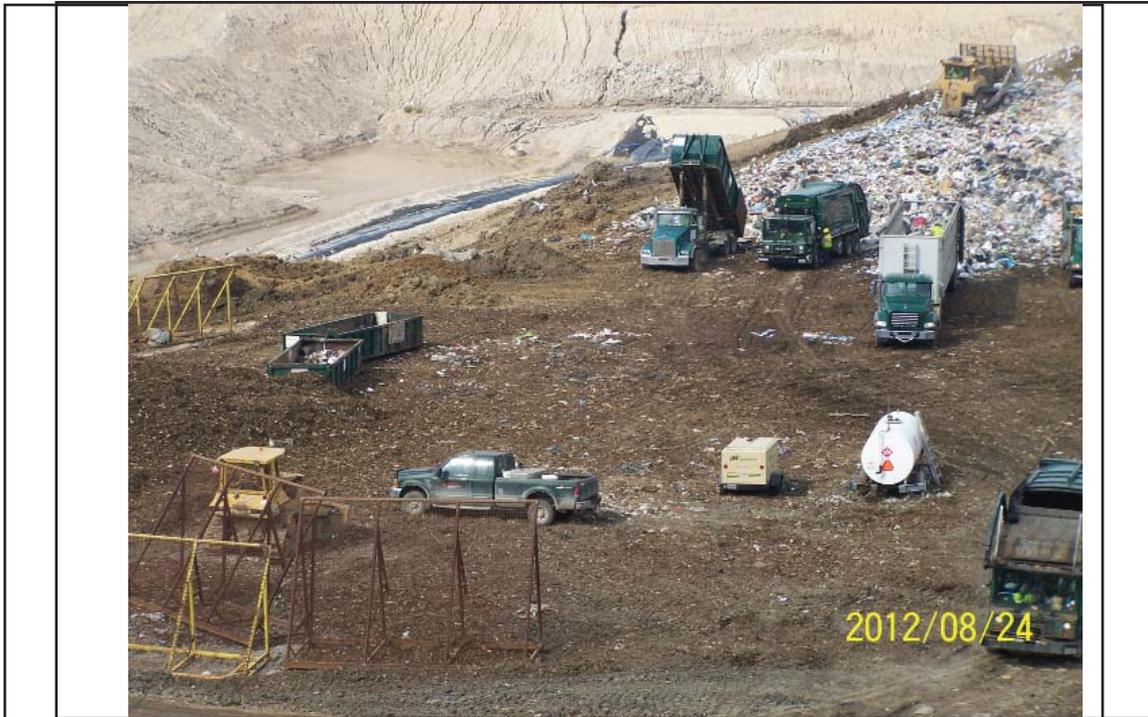
Active area

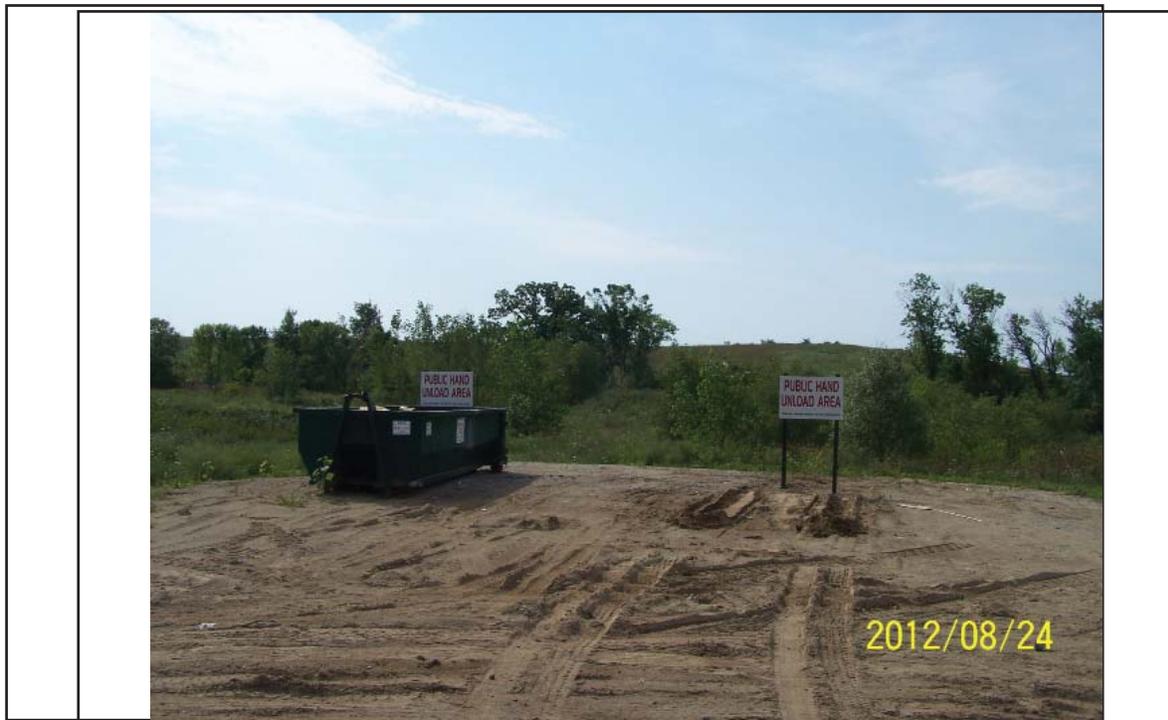
Public unload location for large loads rather than placement at working face, this is adjacent to Basin #2, South of Phase 5

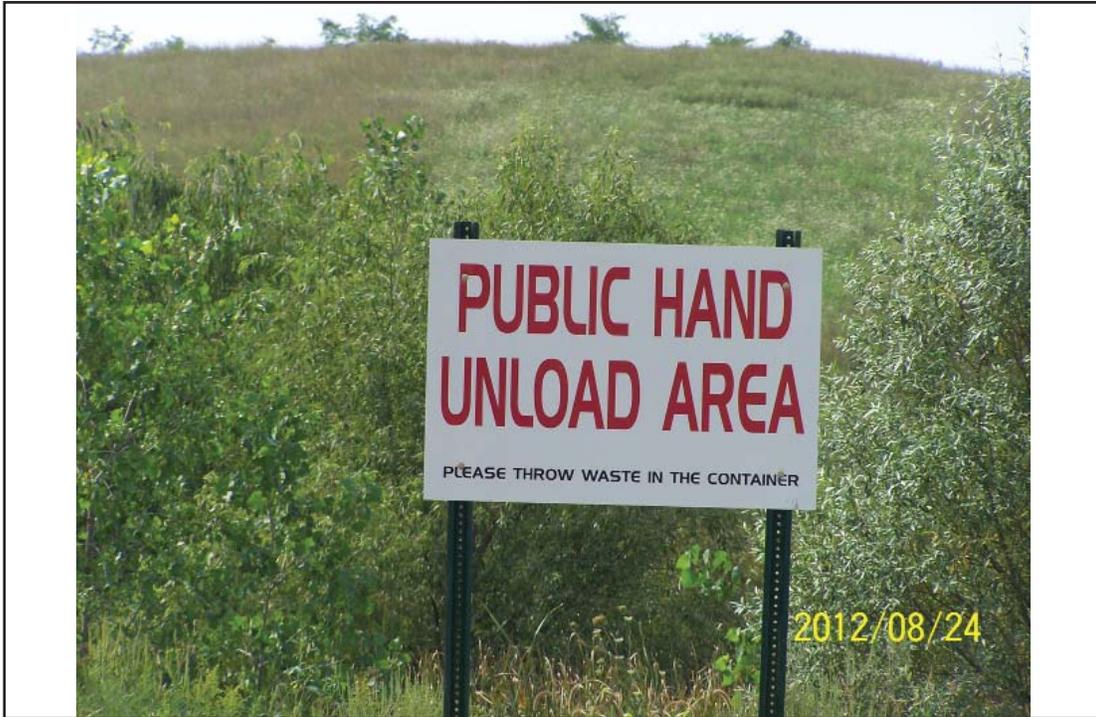
New signage

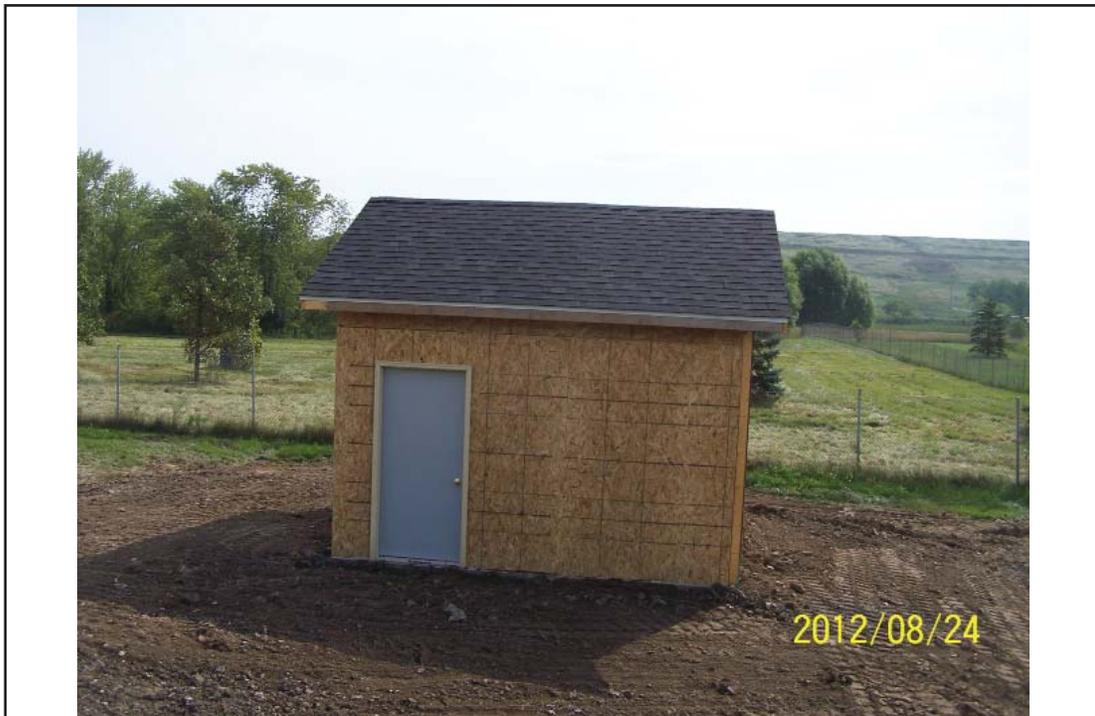
Pneumatic house, will house air compressor for pneumatic pump system

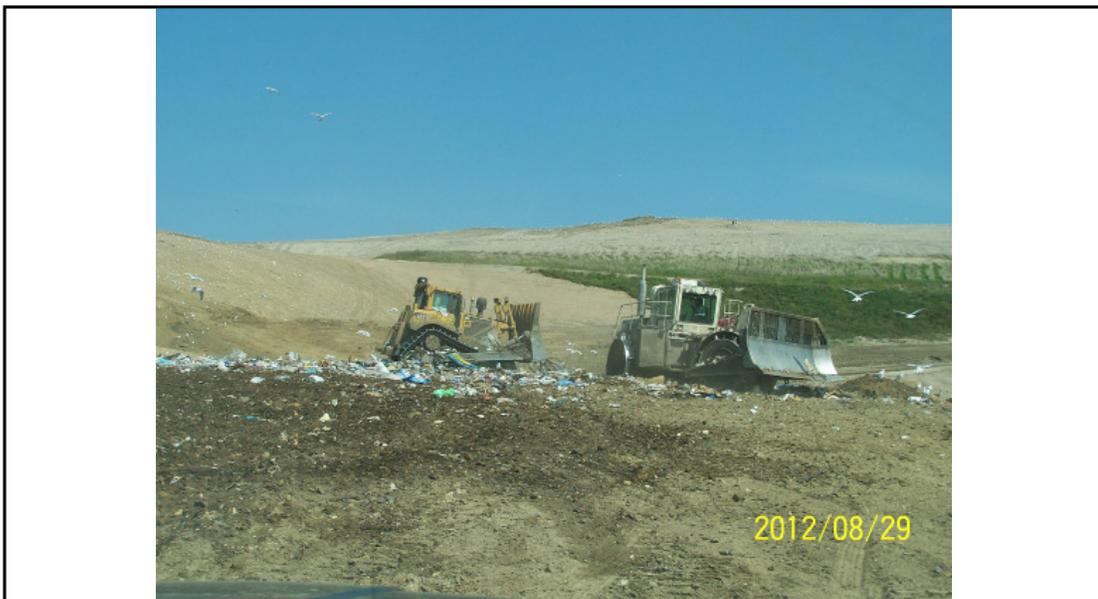
Working face

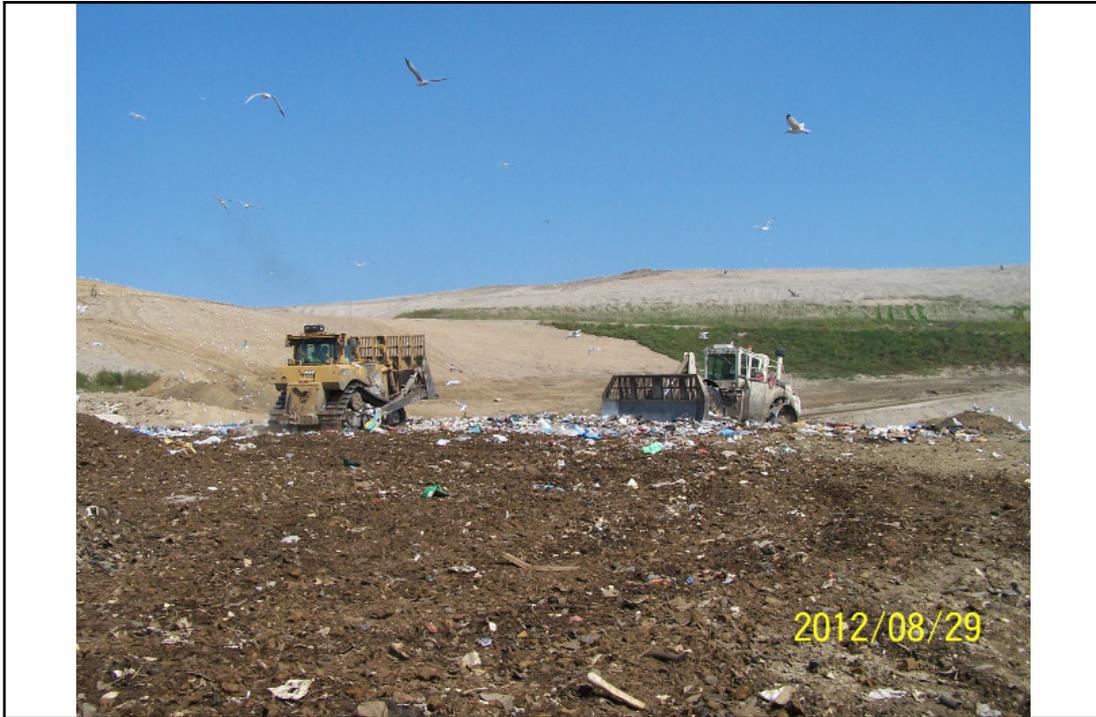
Working face with equipment

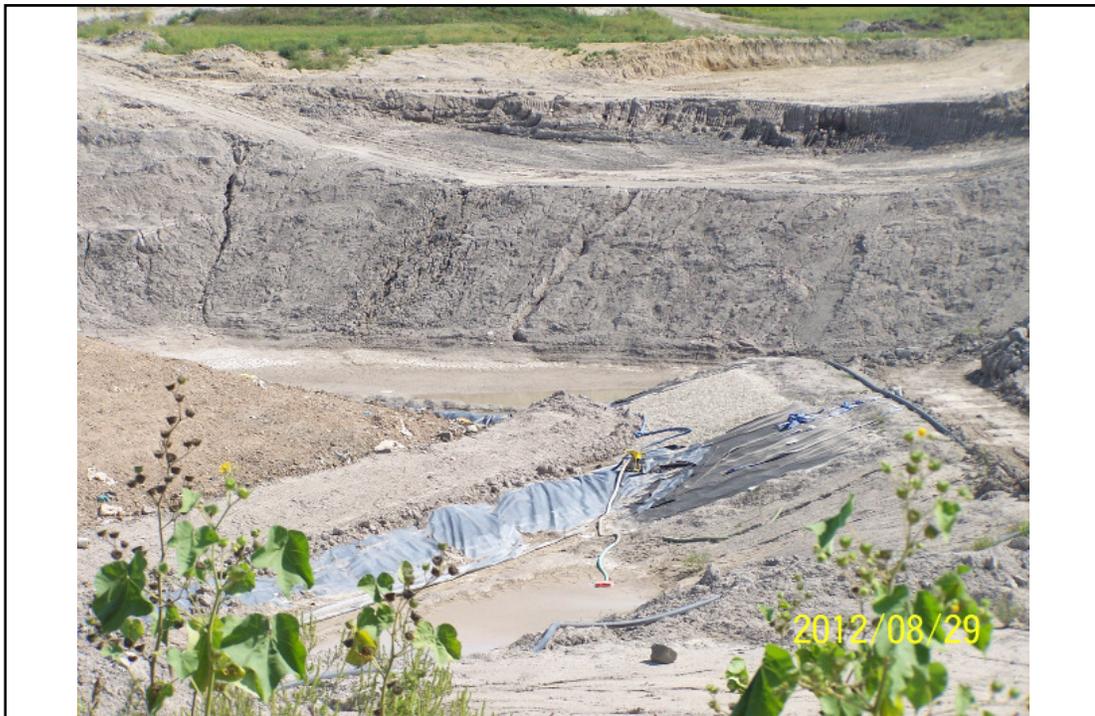
Temp Sed. Basins about Phase 8

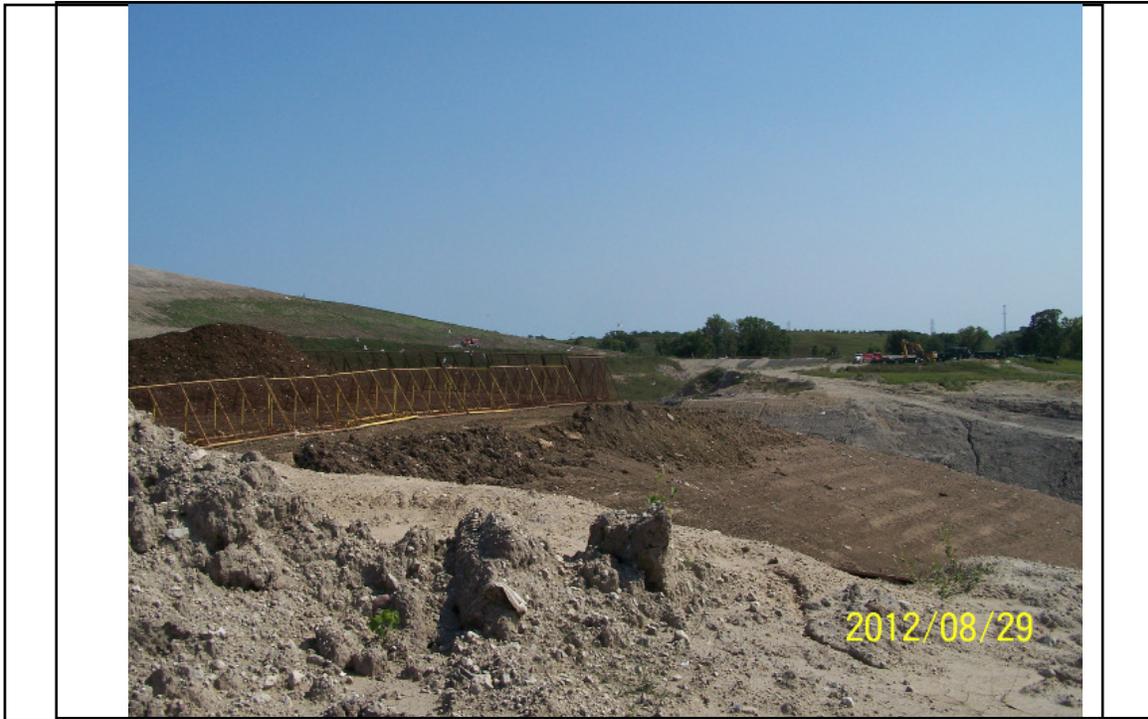
West slope of Phase 8

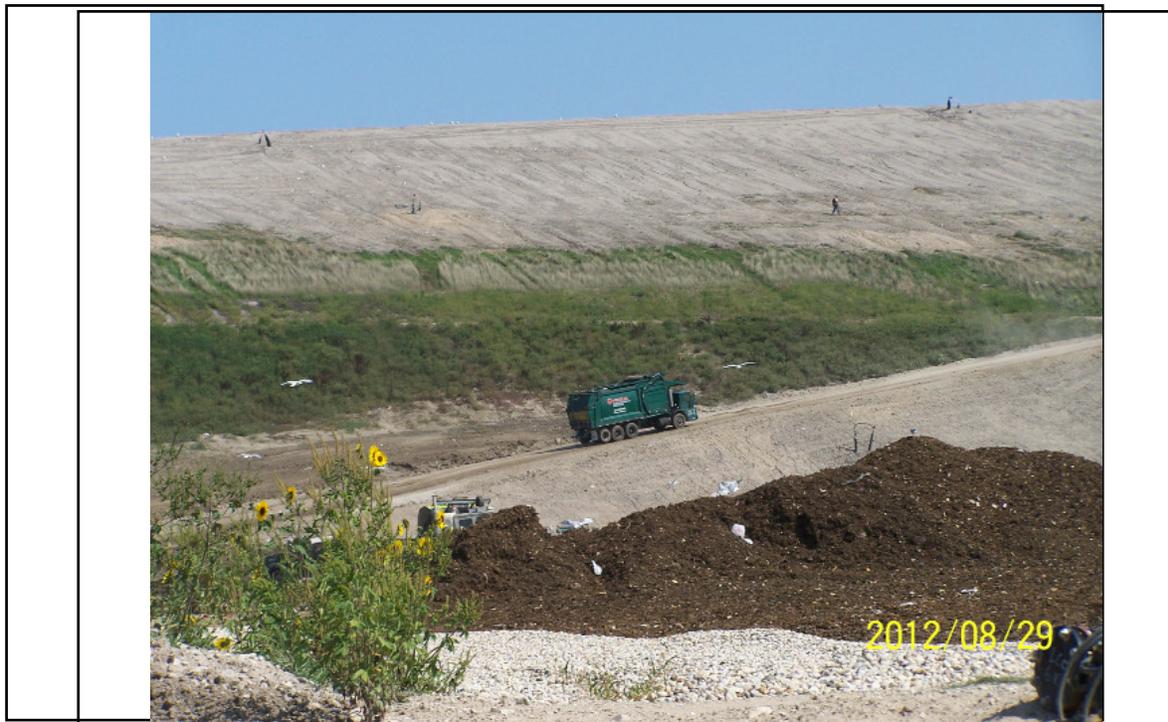
Autofluff Stockpile in active area

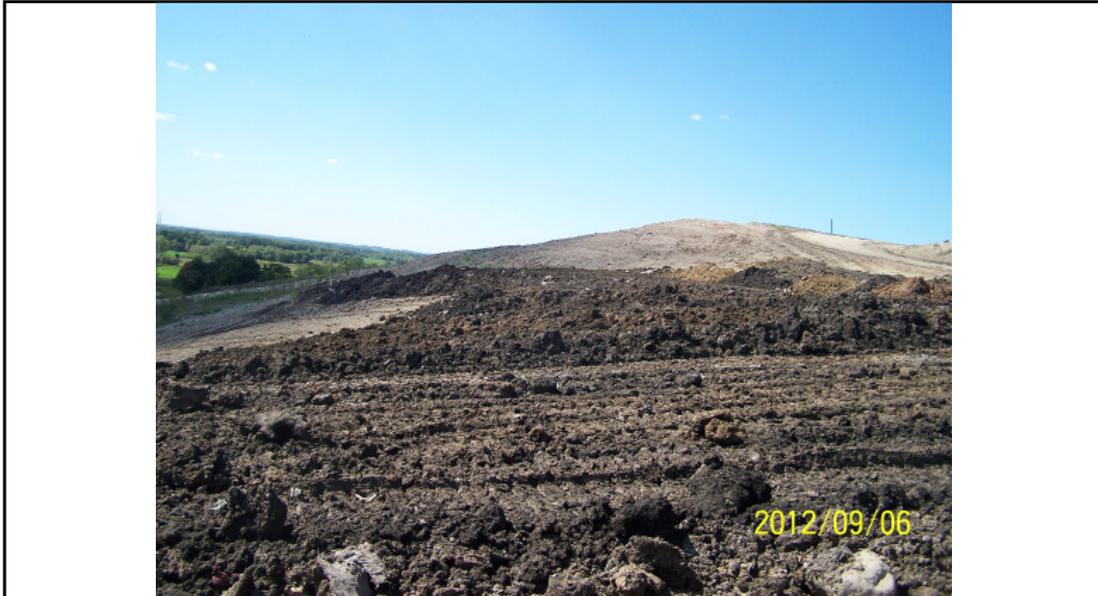
Soils tipped and placed above Phase 7

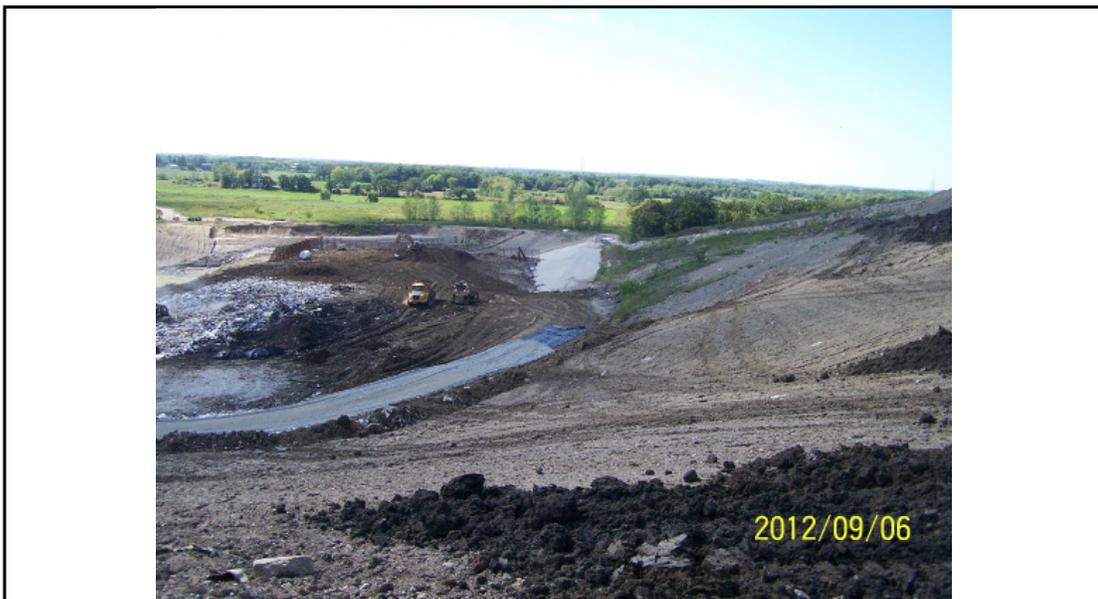
New Access road to Phase 7 under construction, note the use of load sharing fabric.

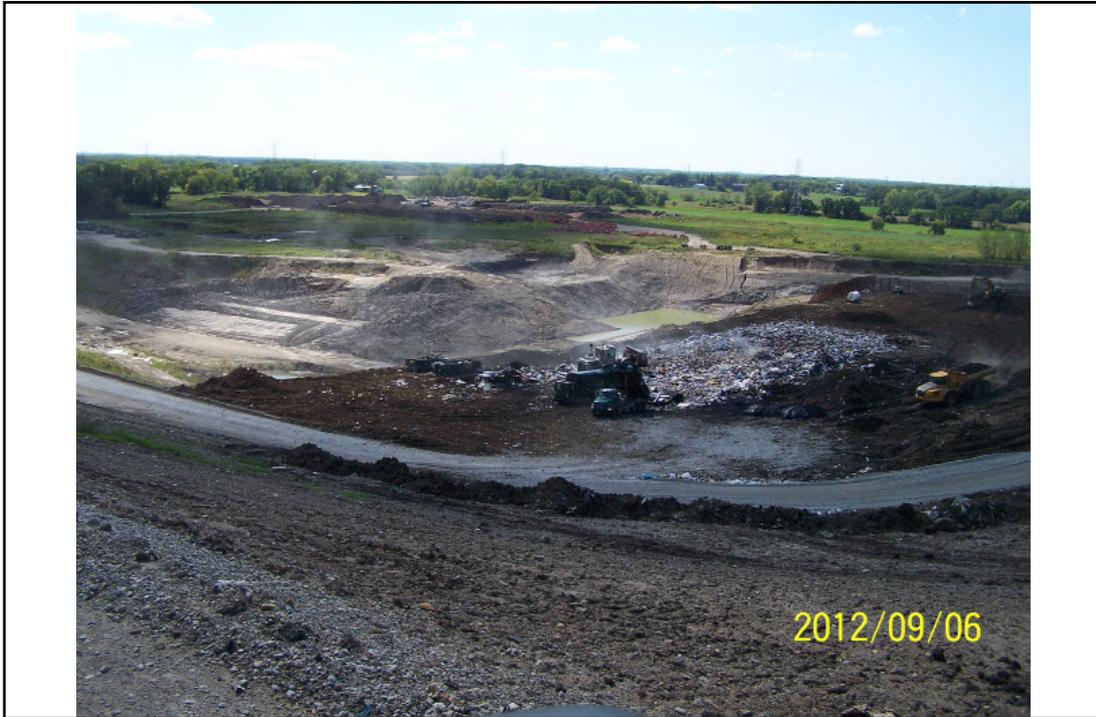
Working face with equipment

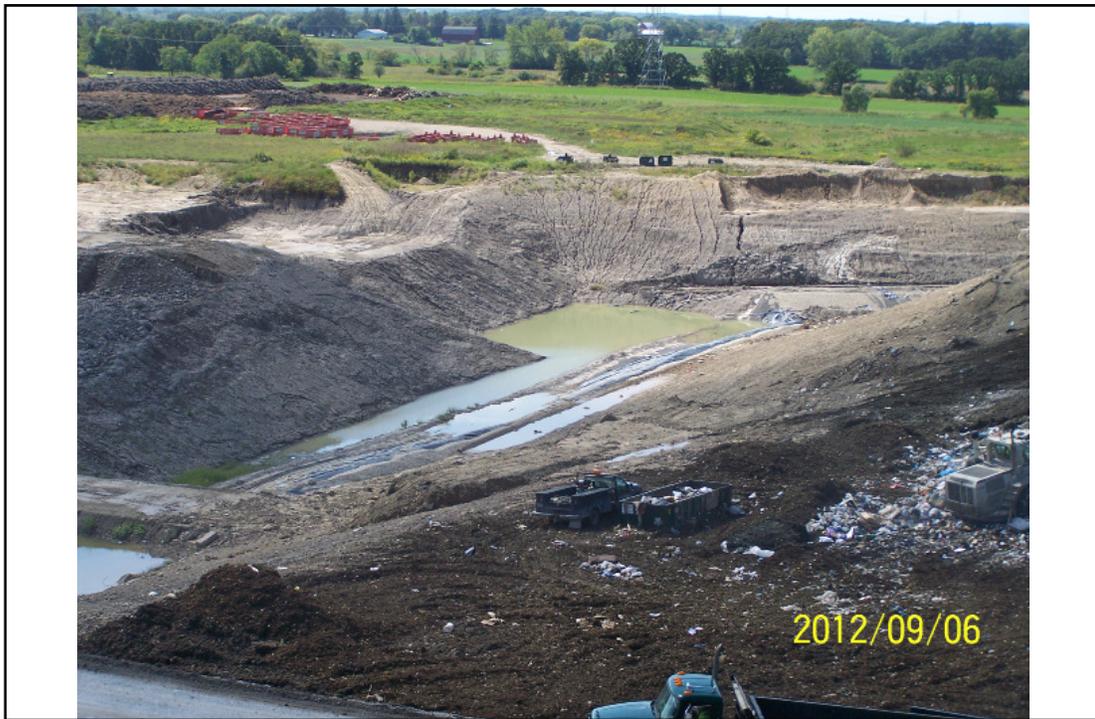
Temp Sed. Basins about Phase 7

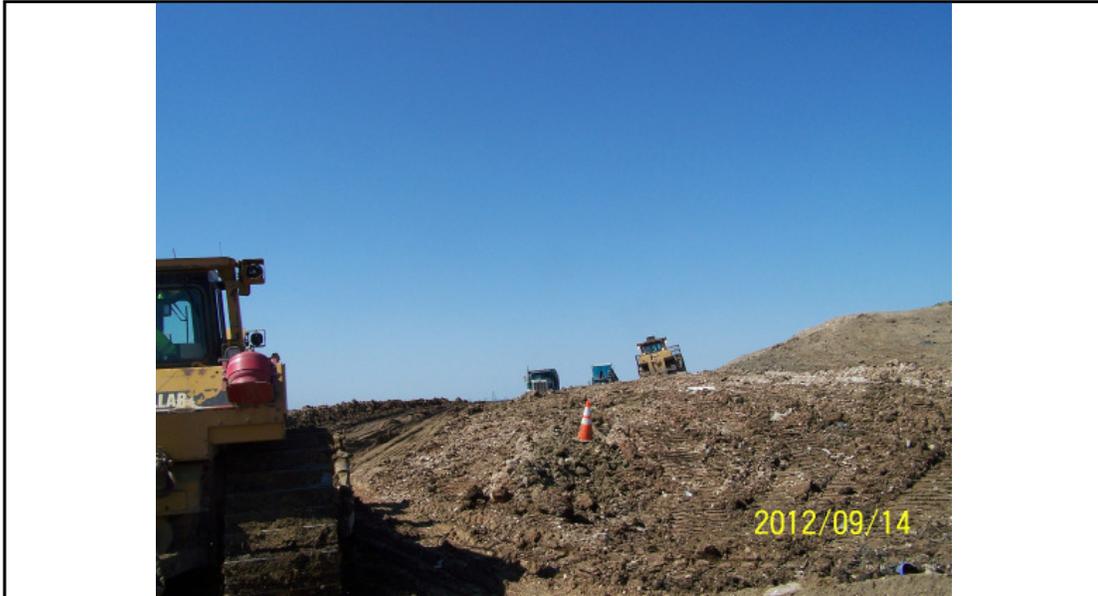
Soils being placed above active area on slope of Phase 3

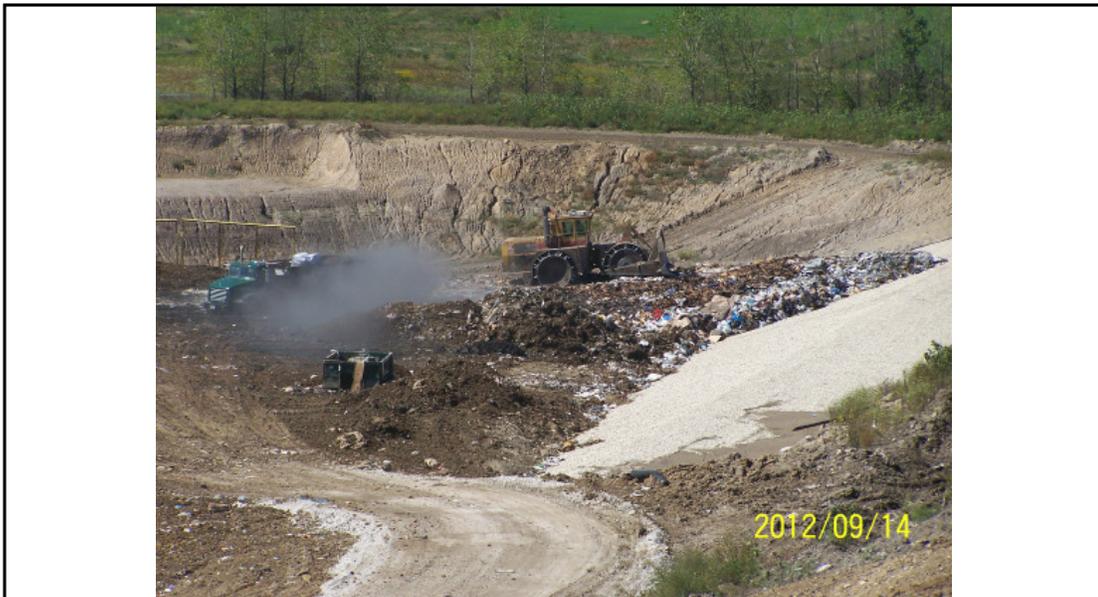
Dusty load being tipped at working face.

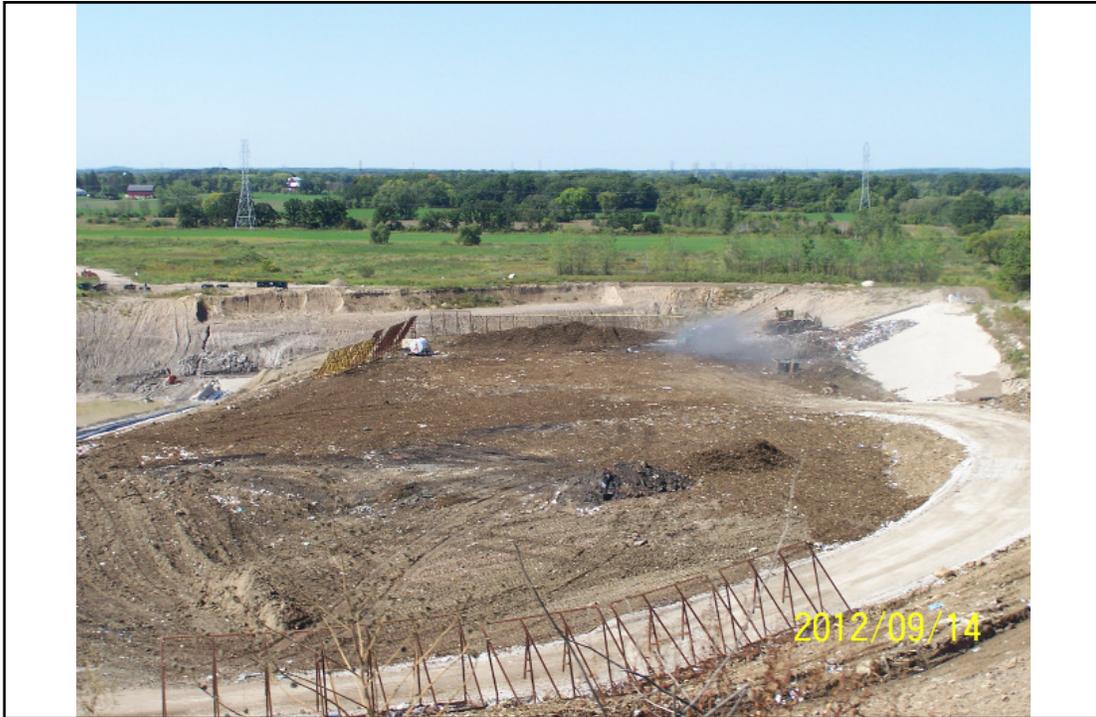
Active area with new equipment access road

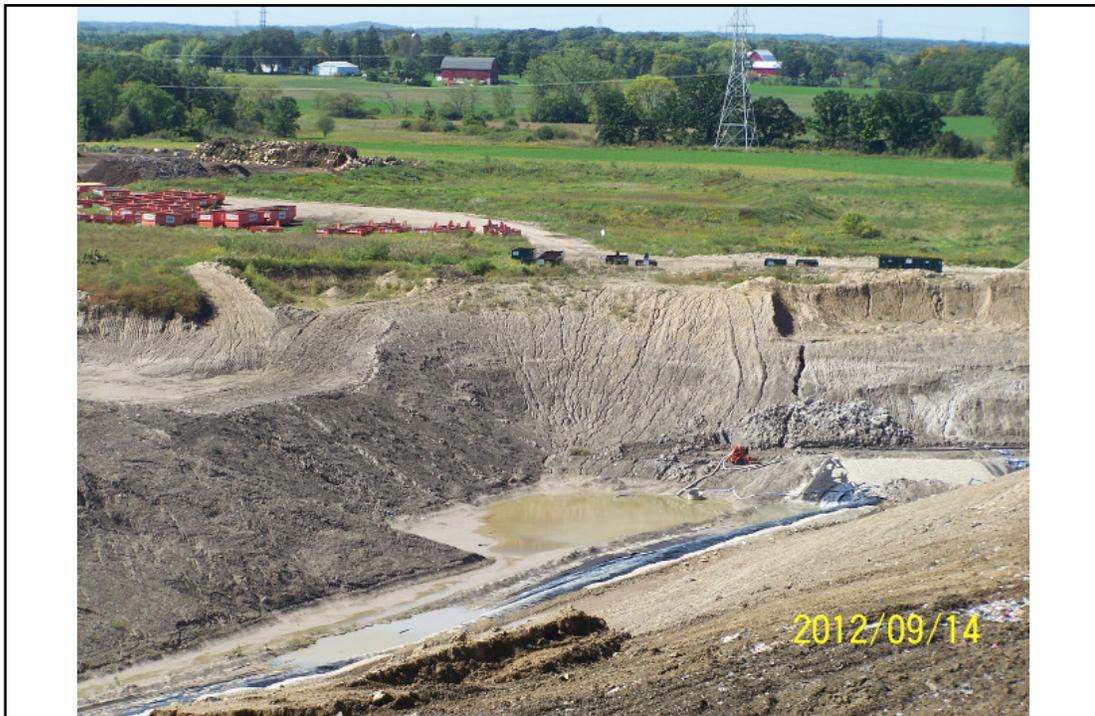
Temp Sed. Basins about Phase 7

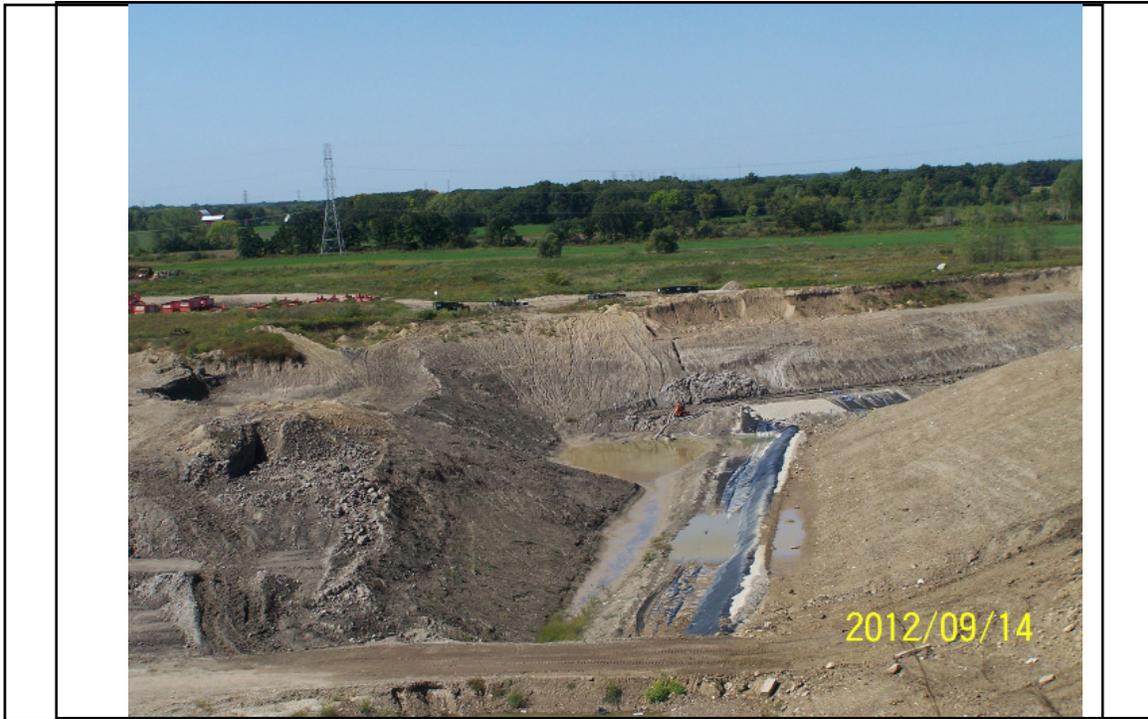
Temp sed basin with adequate freeboard

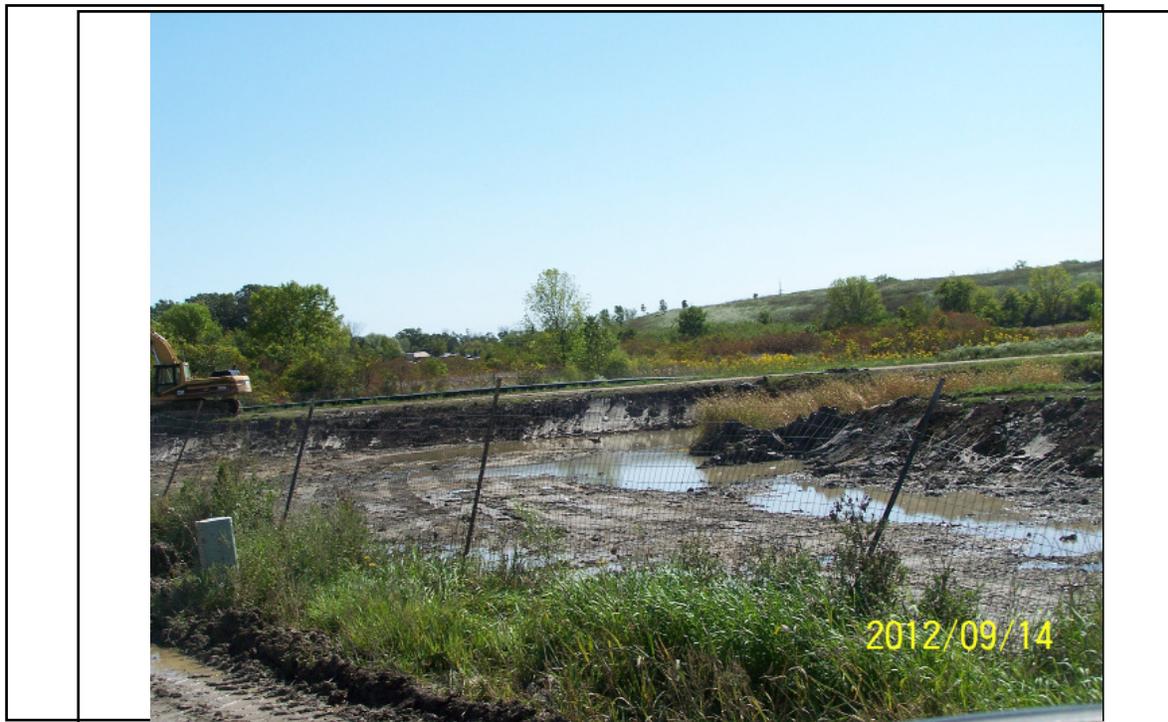
Basin 3 being cleaned
