2012 Advanced Disposal Services Emerald Park Landfill Year End Compliance Officer Report and Audit Summary

TO: Veolia Emerald Park Standing Committee
FROM: Jo-Walter Spear, Jr., P.E.
COPIES: File
DATE: 04/04/13
PROJECT NUMBER: 1012.10030

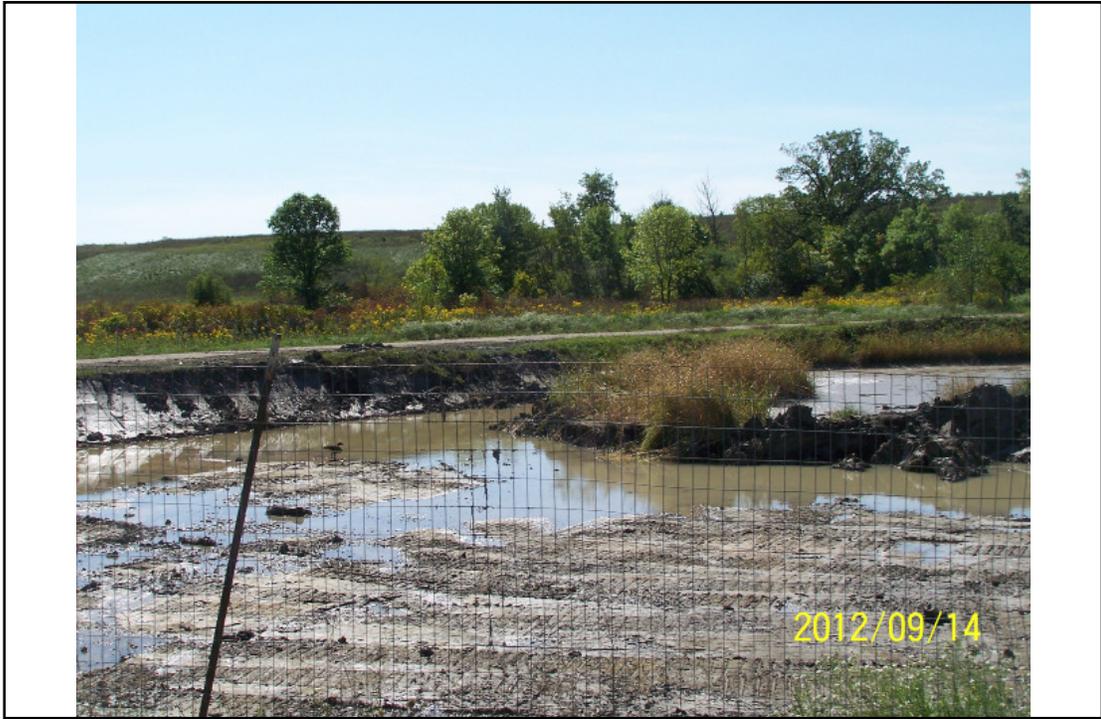
Basin 3 being cleaned

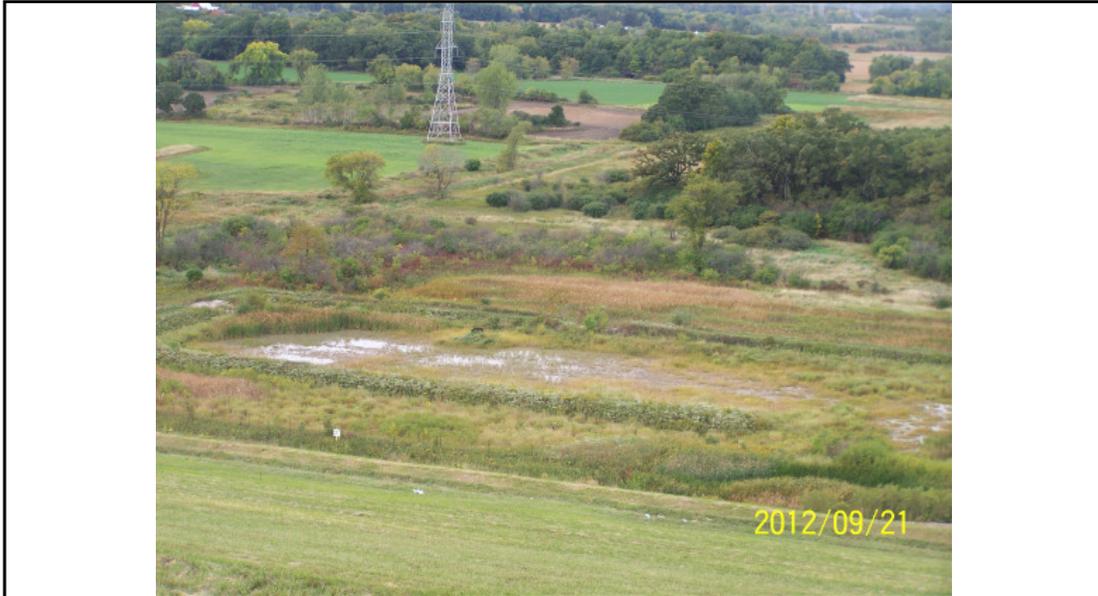
Basin #1, to be cleaned last

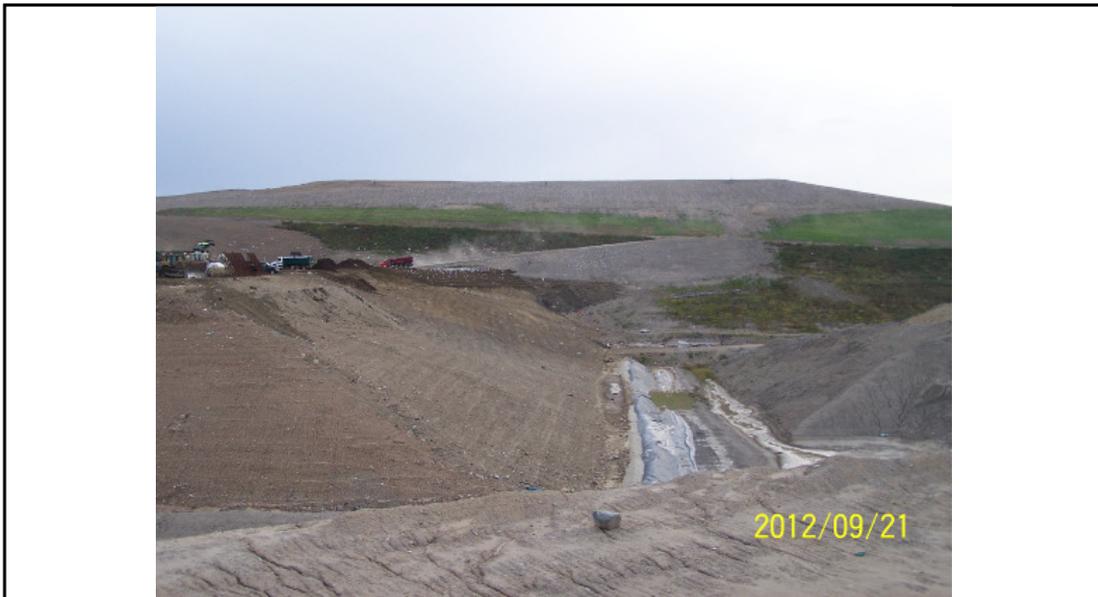
Temp basin South of Phase 7, plenty of free board

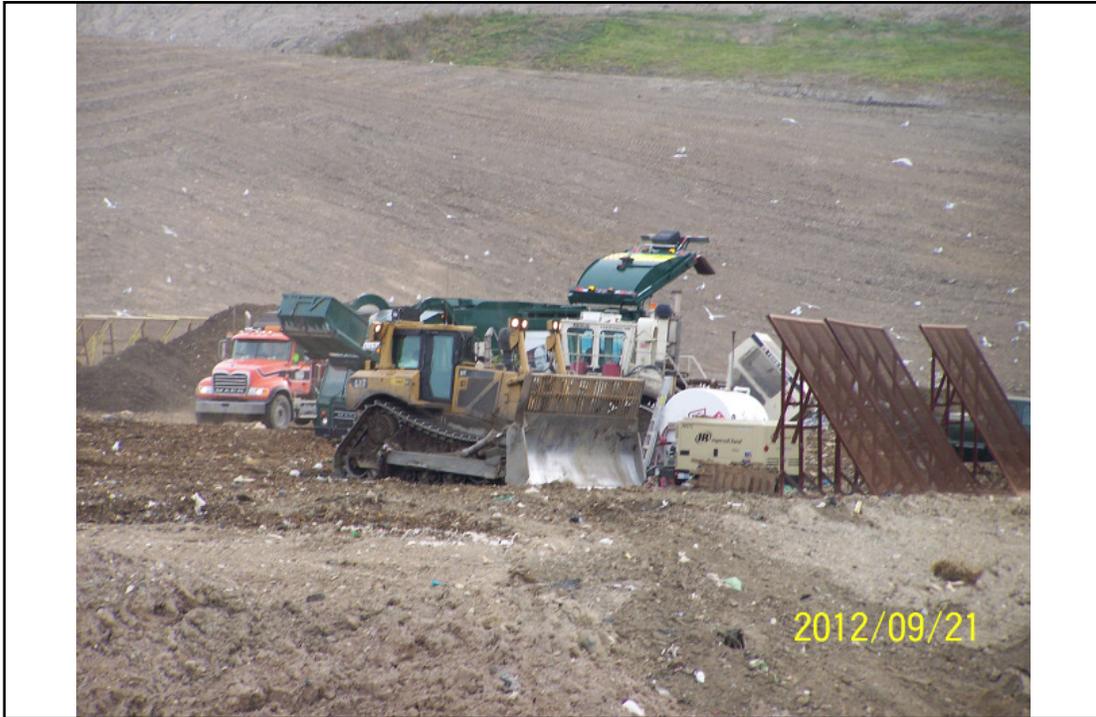
Active area

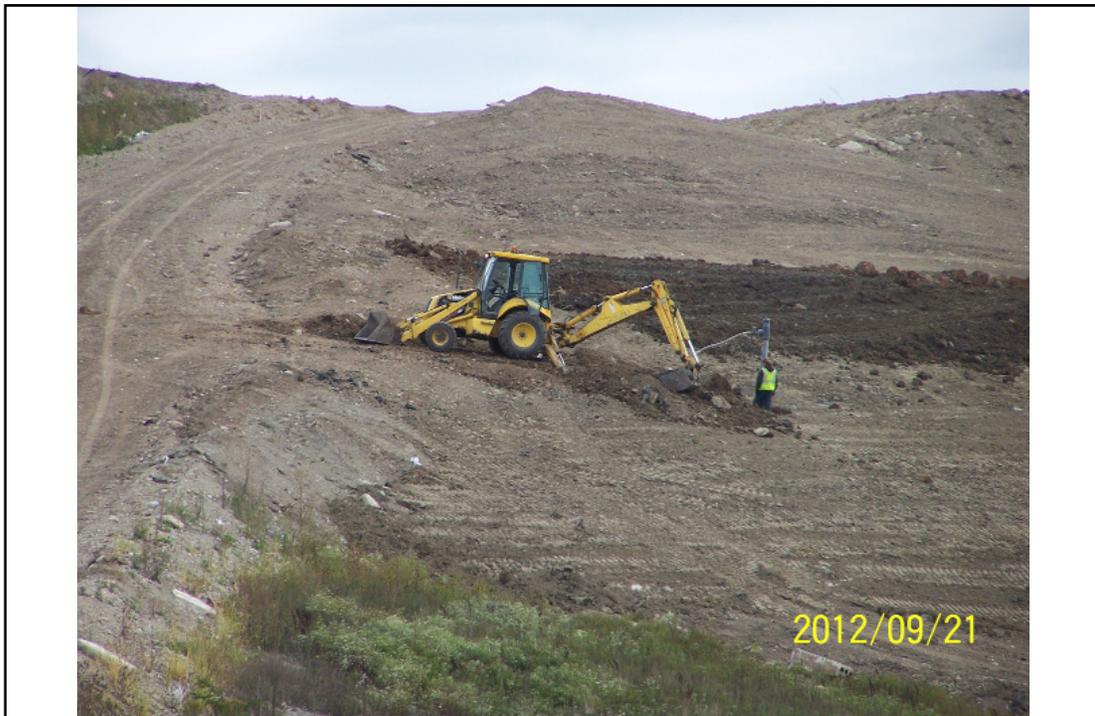
Soils being removed around well head

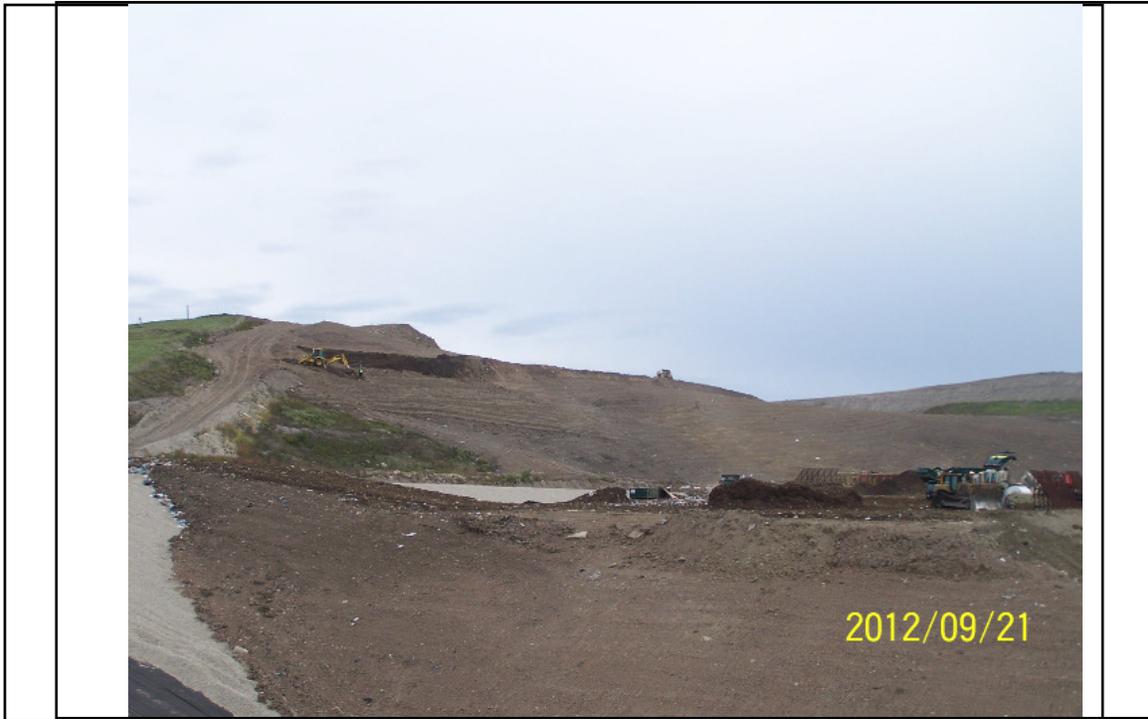
Slope expanded with soils

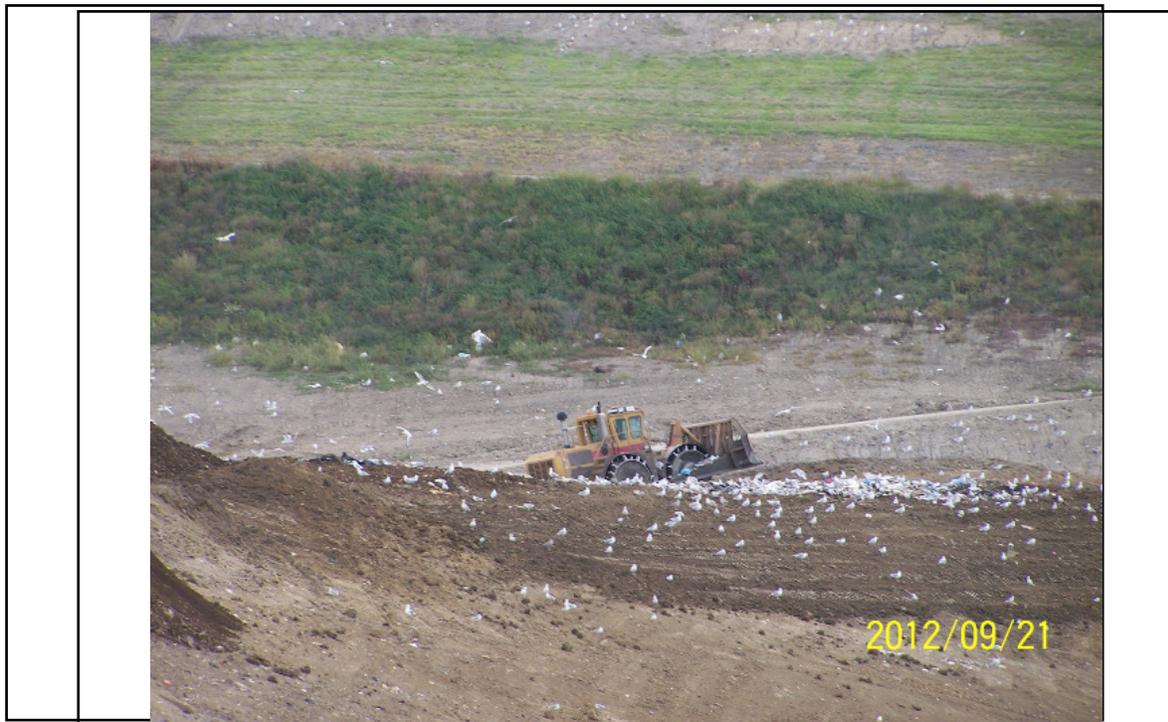
Compactor working waste

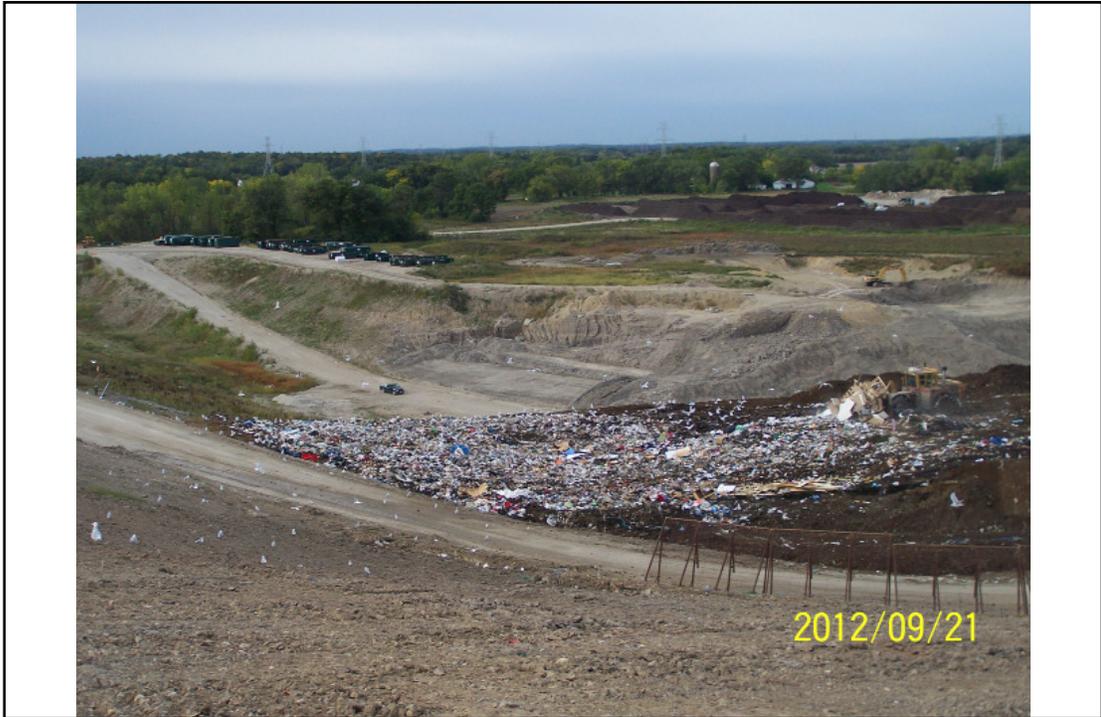
Working face in West portion of Phase 7

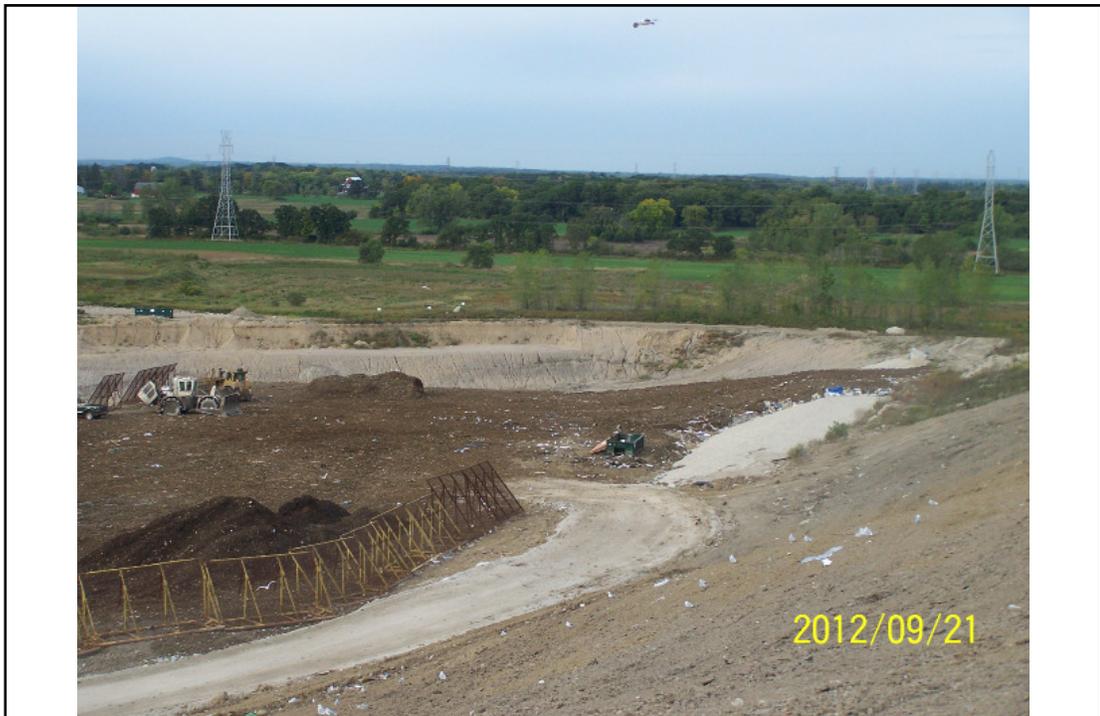
Access road construction for equipment to approach working face from the Northwest

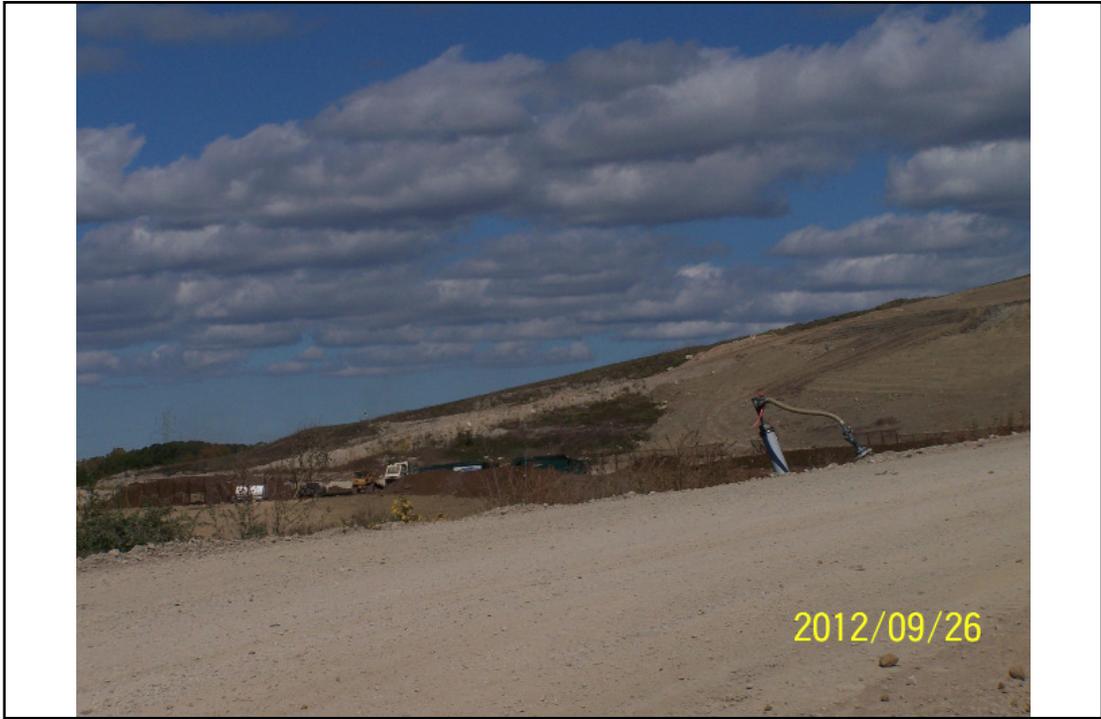
Active Area

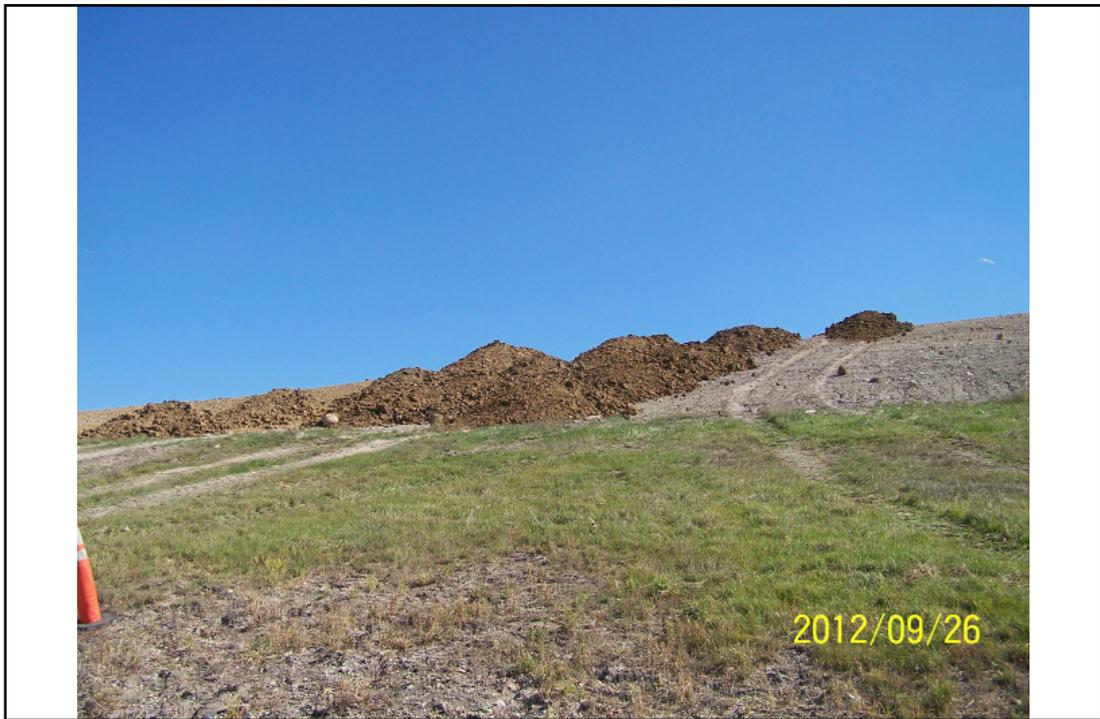
Stock piled soils

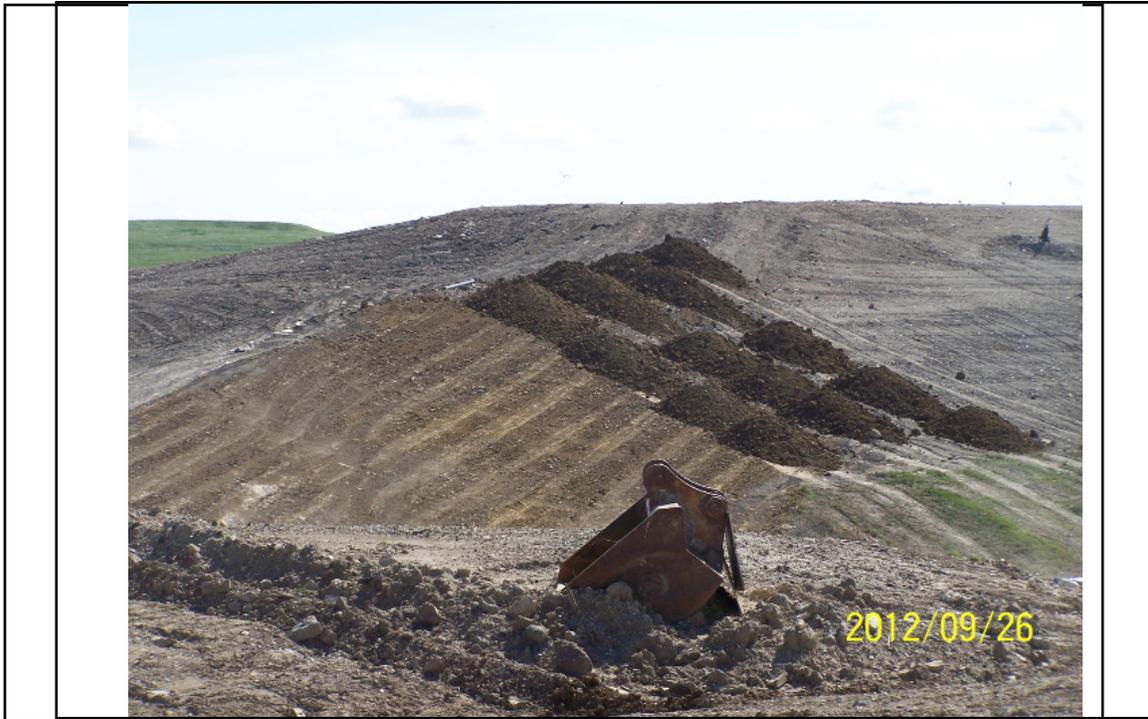
Stockpiled soils for intermediate cover on West slope of Phase 6

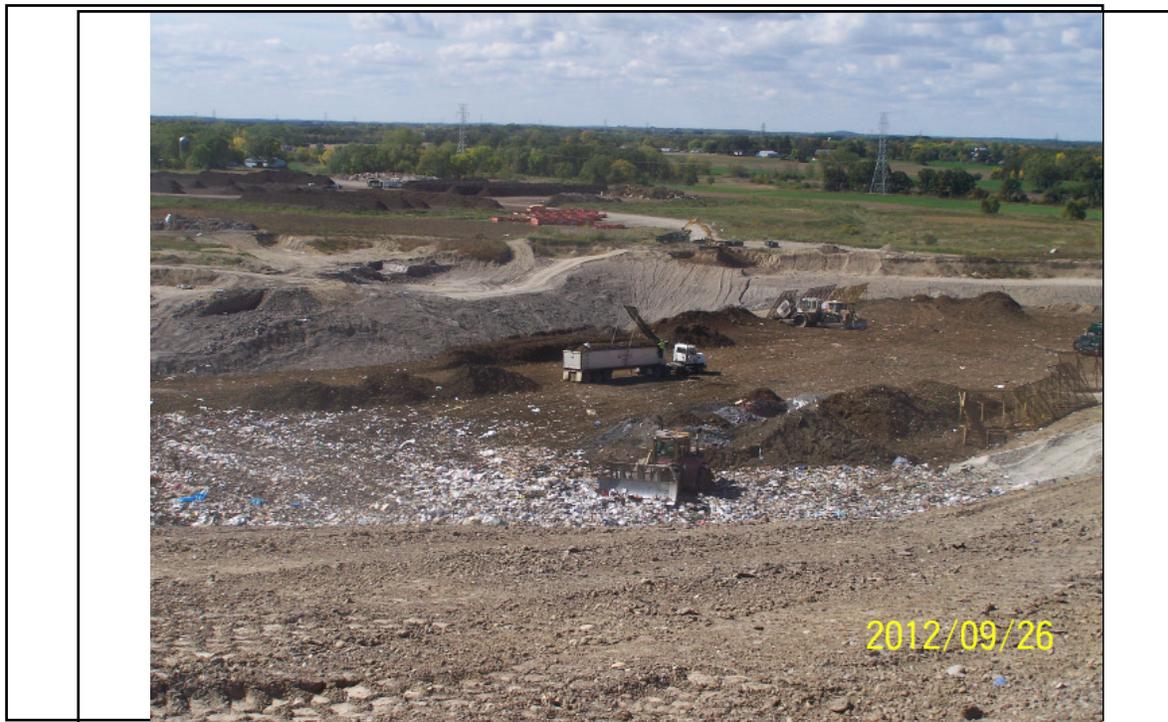
Working face viewed from Northeast

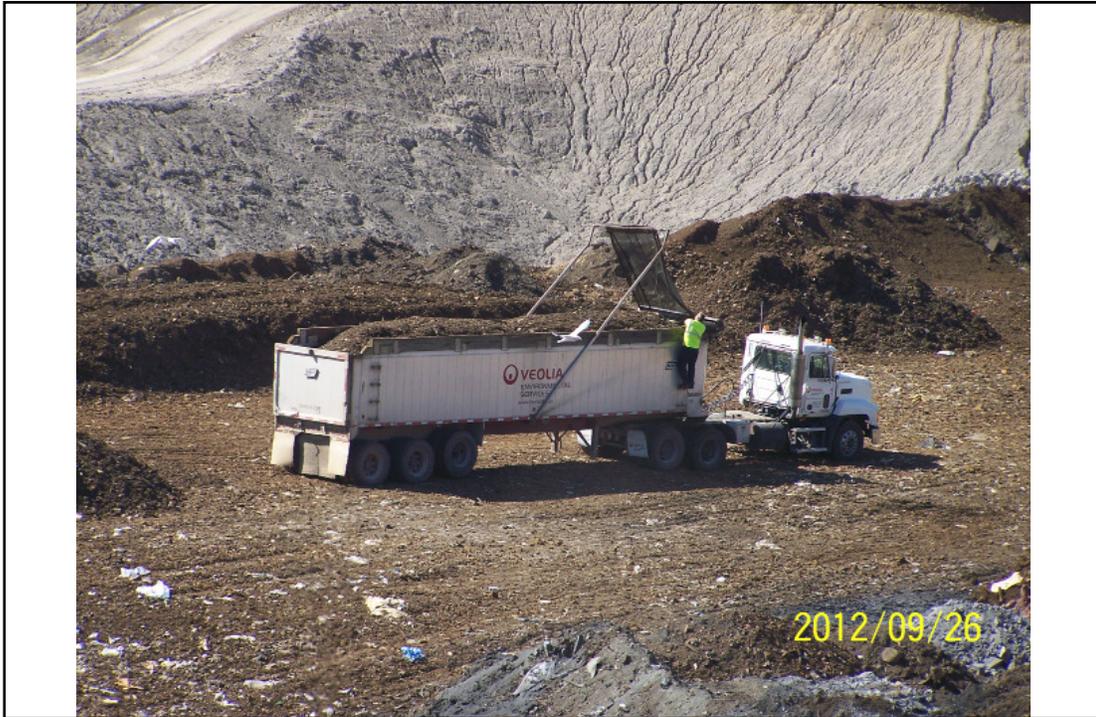
Stock piled autofluff and autofluff being tipped

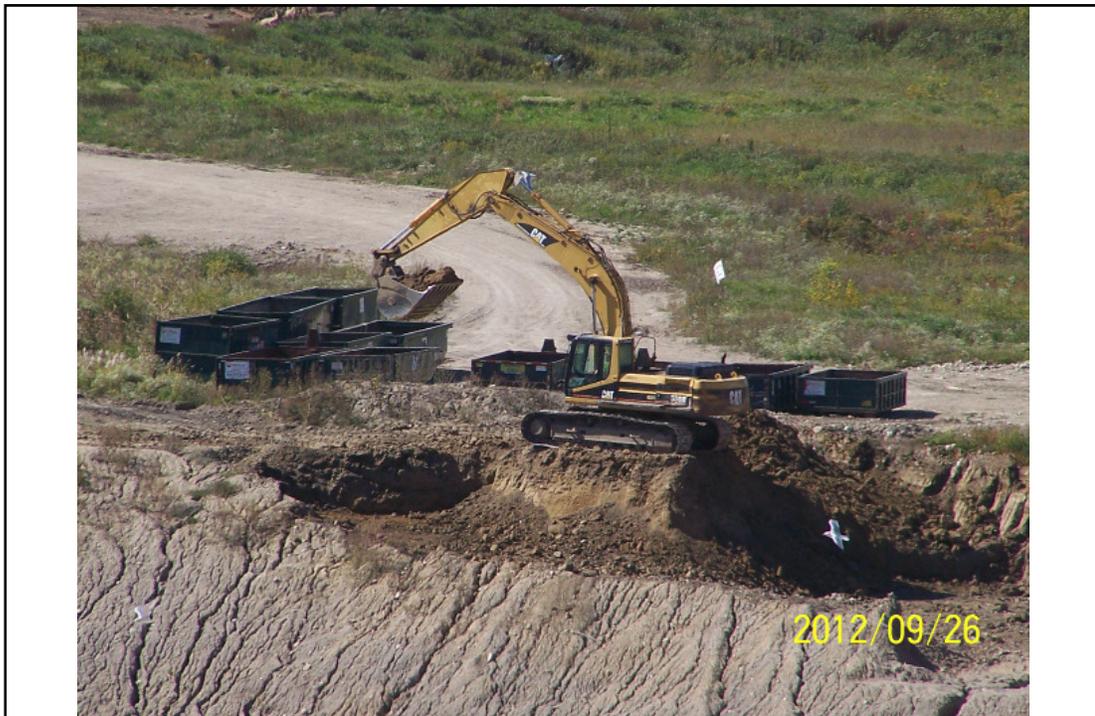
Soil excavation to be used for intermediate cover on Phase 6

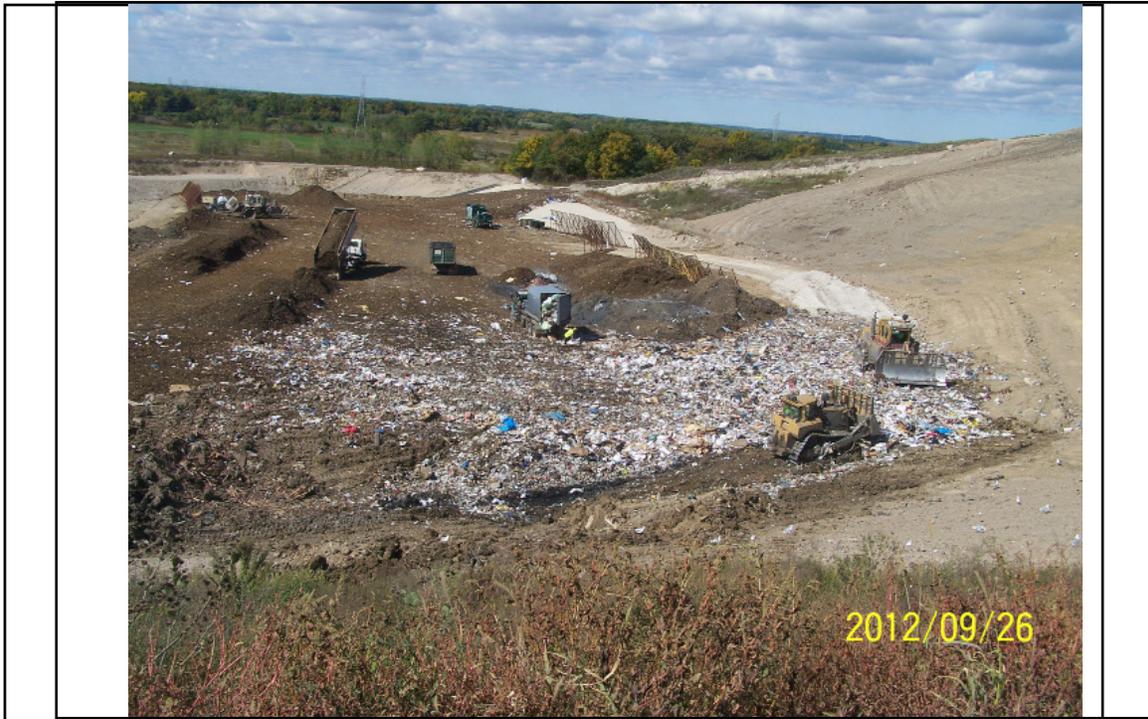
Working face

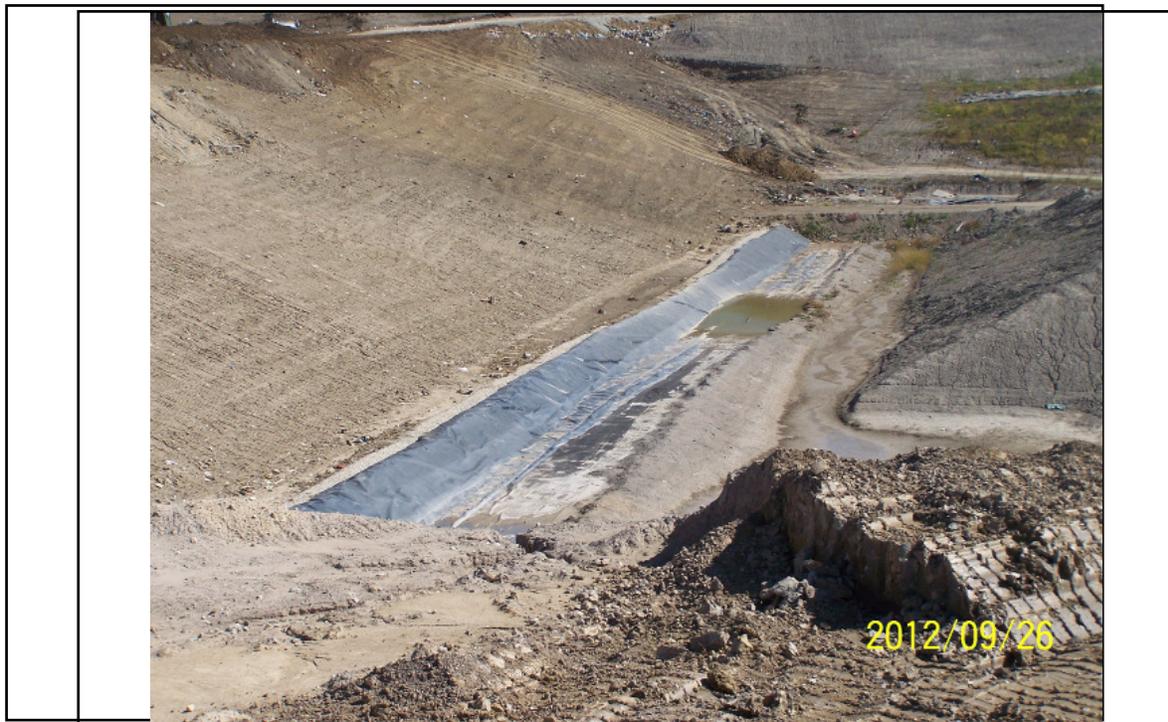
Temp Sed basin with some ponding areas

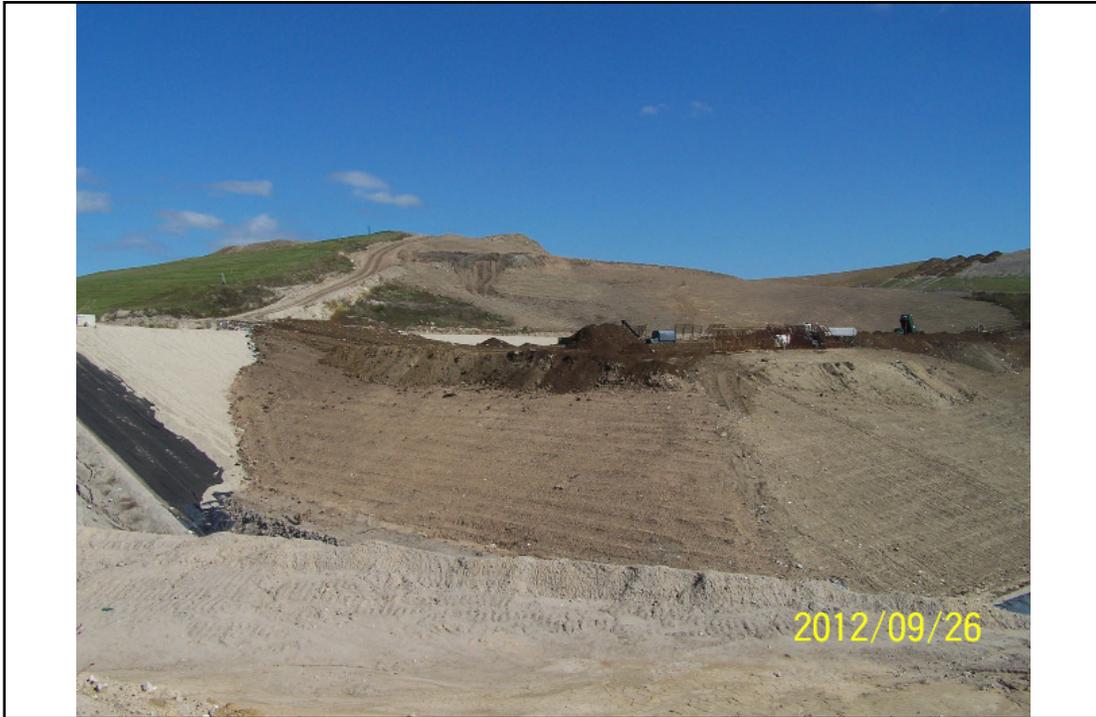
West and South slope of Phase 7 with intermediate cover

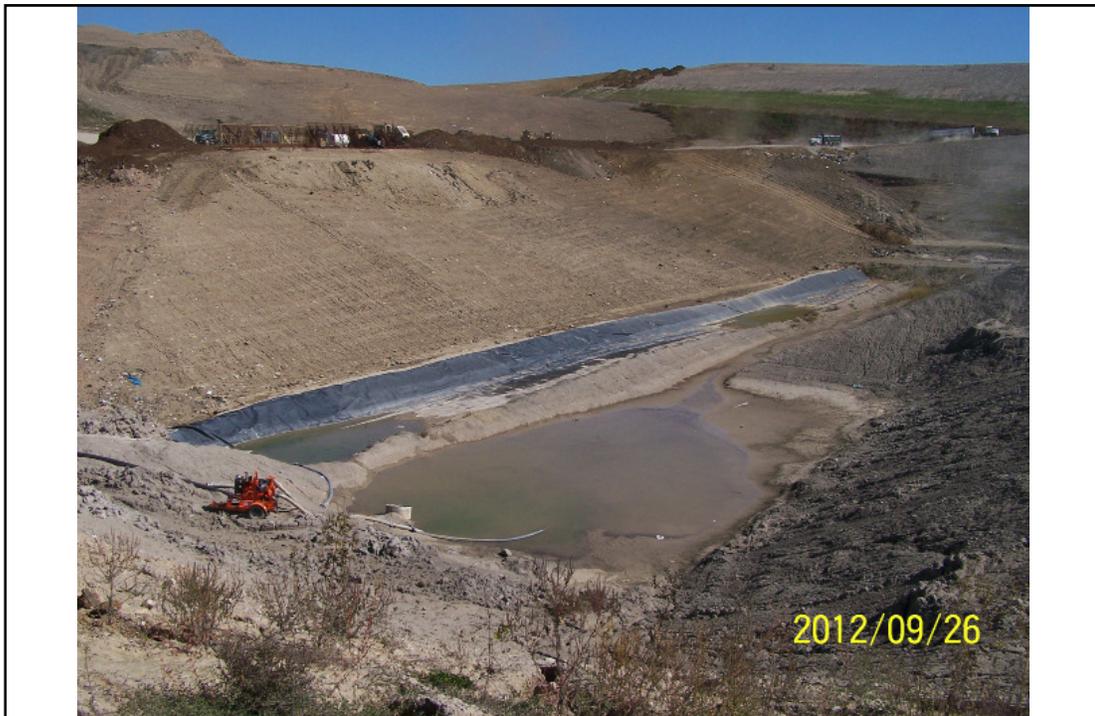
Temp Sed. Basin South of Phase 7

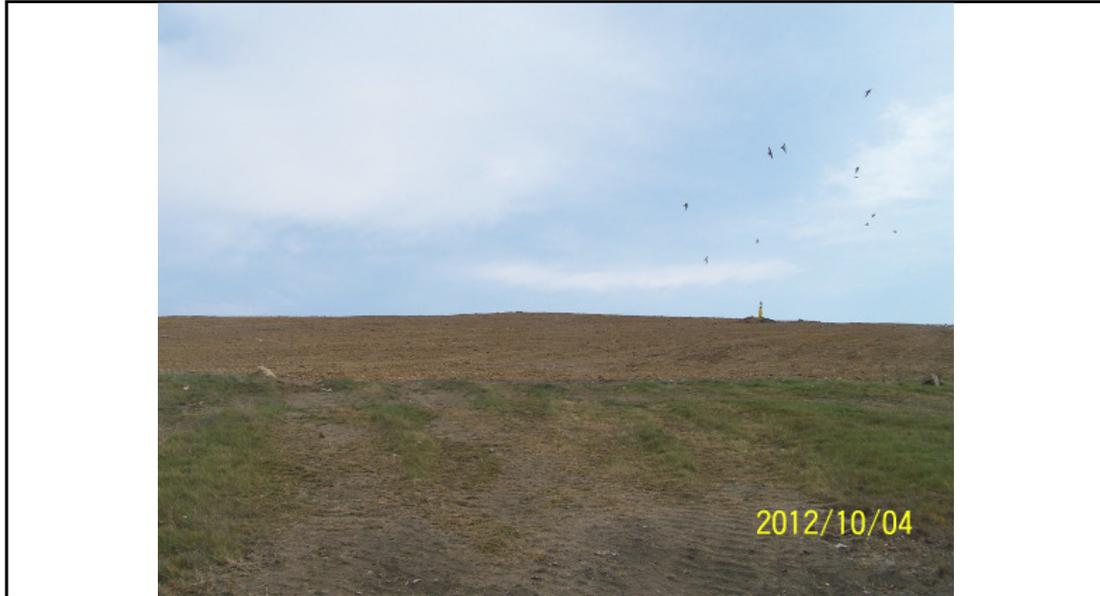
Regraded, and added cover, slope of Phase 6

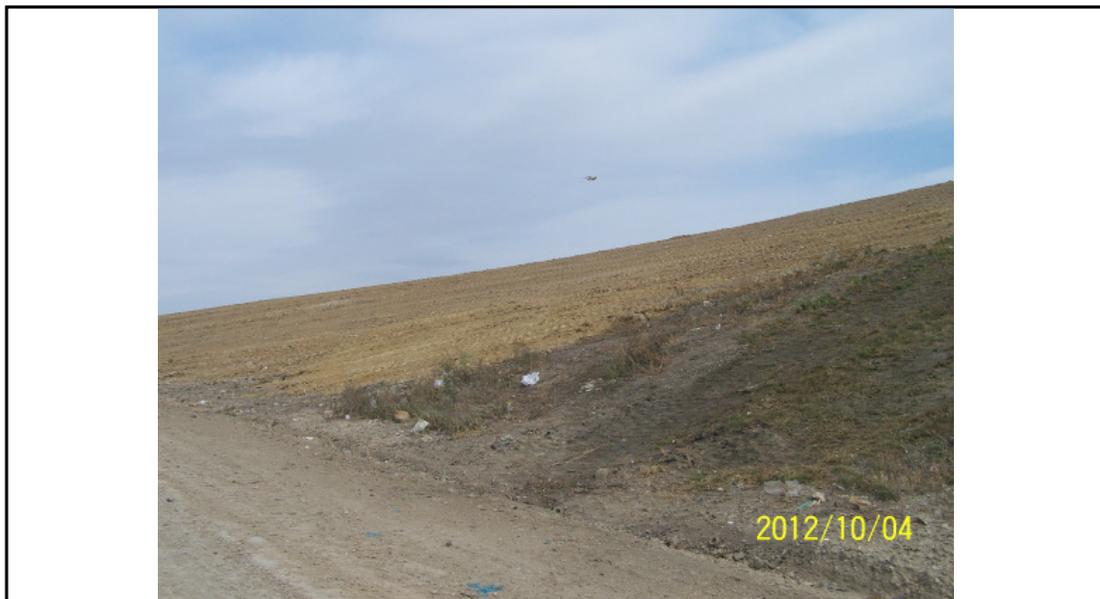
Regraded, and added cover, slope of Phase 6

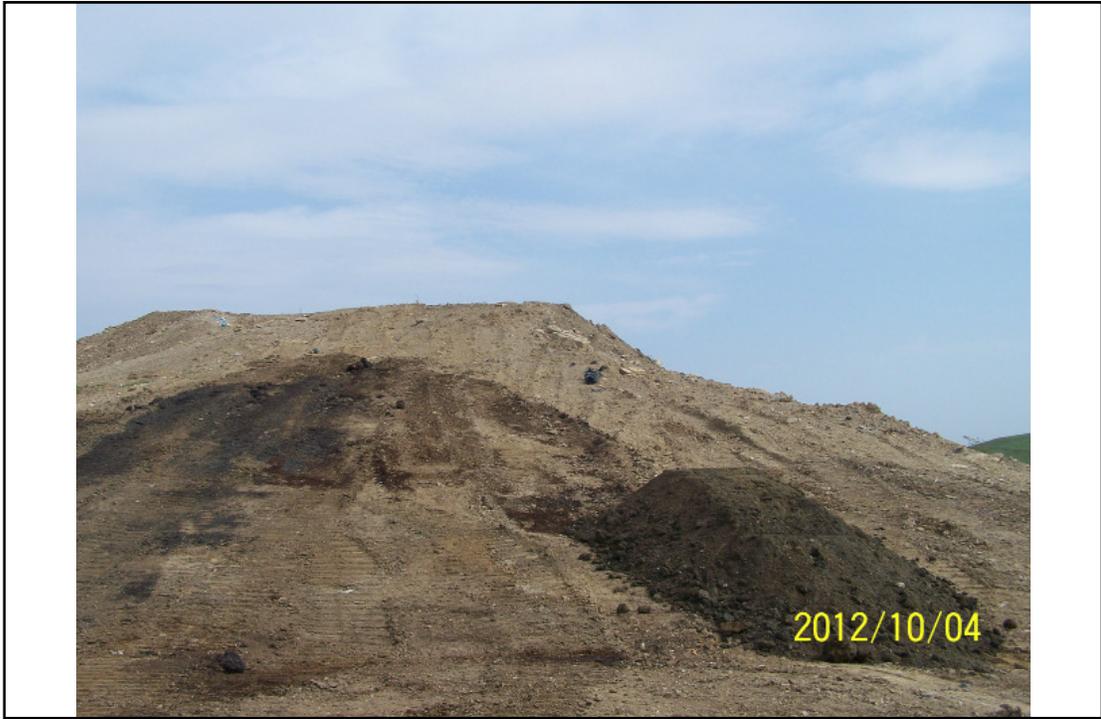
Bio soil pile in Phase 3

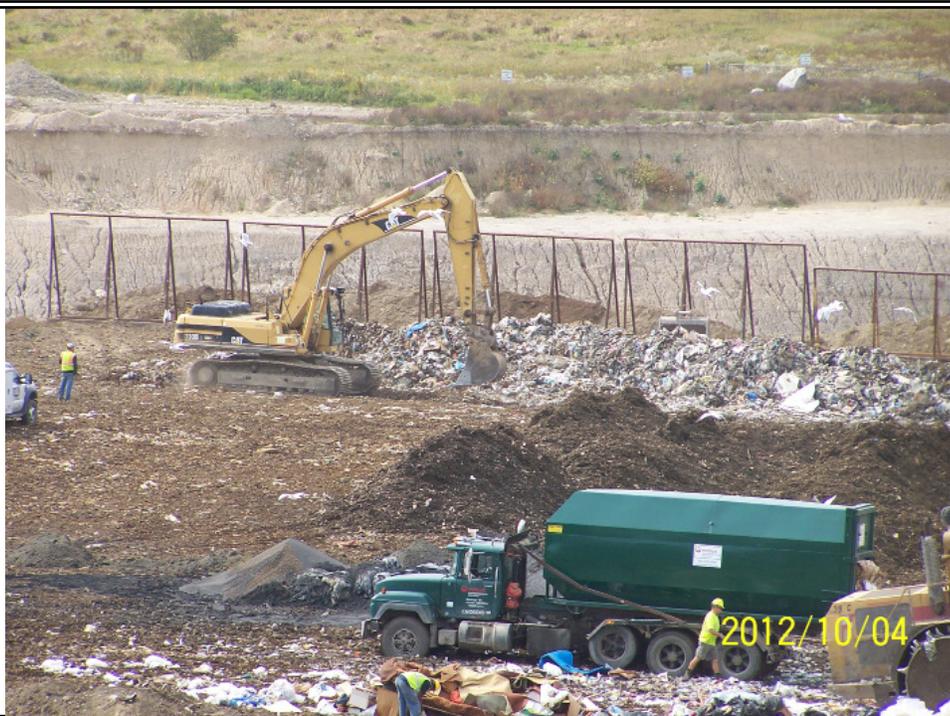
Trenching for placement of leachate recirculation lines

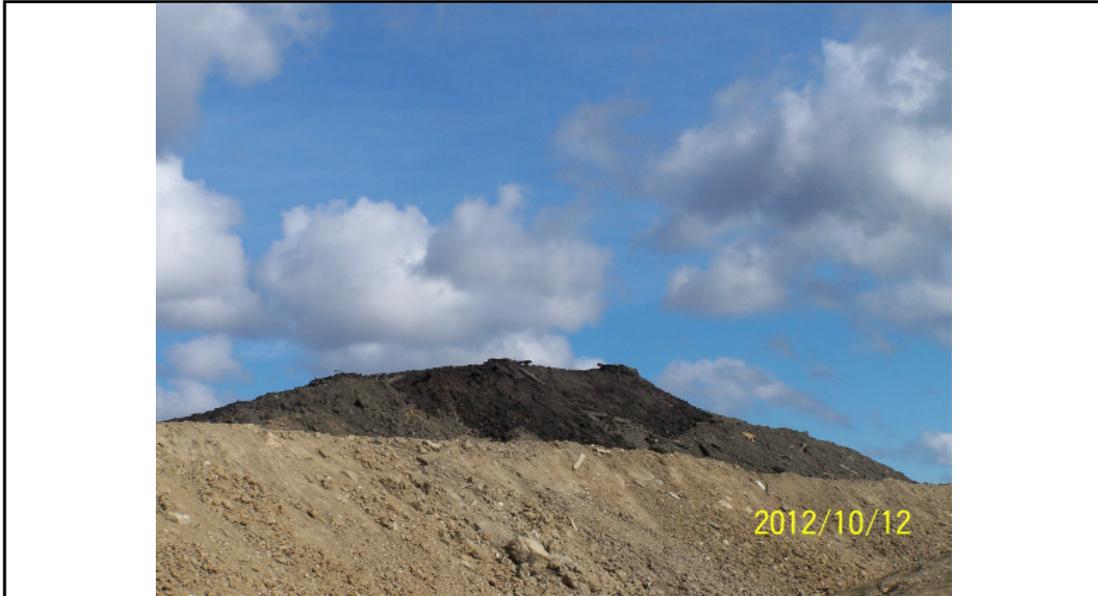
Biosoil, piled above landfill direct soils

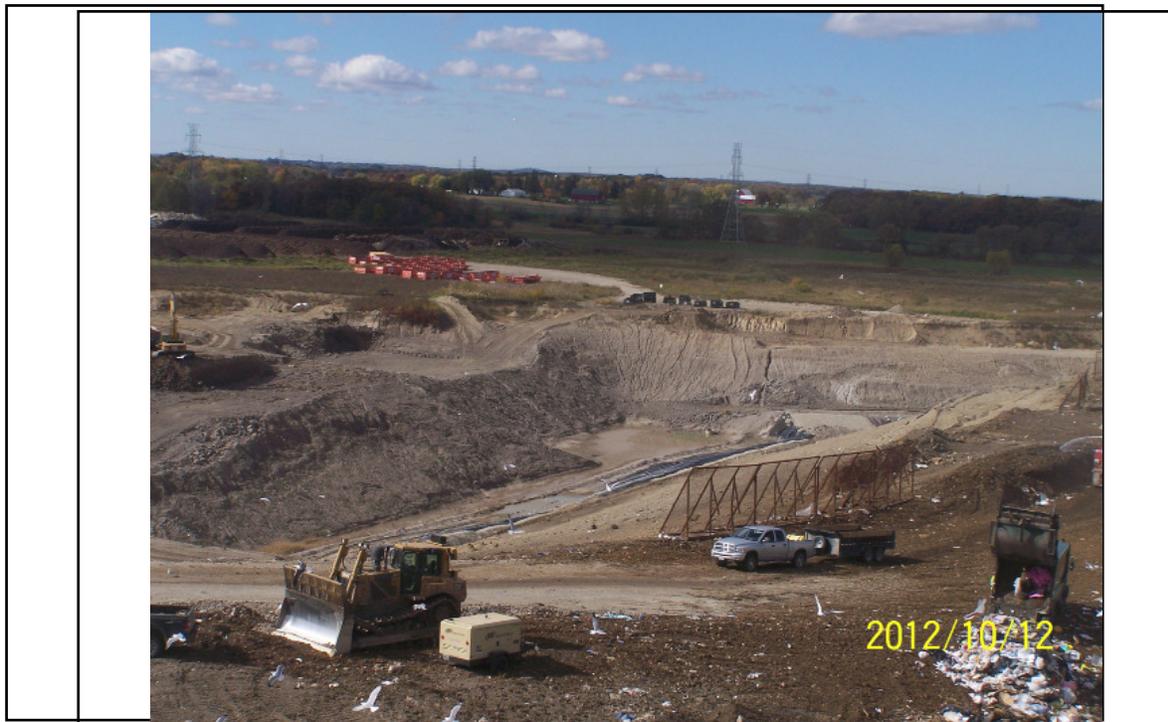
Temp Sed Bain drained prior to potential rain events.

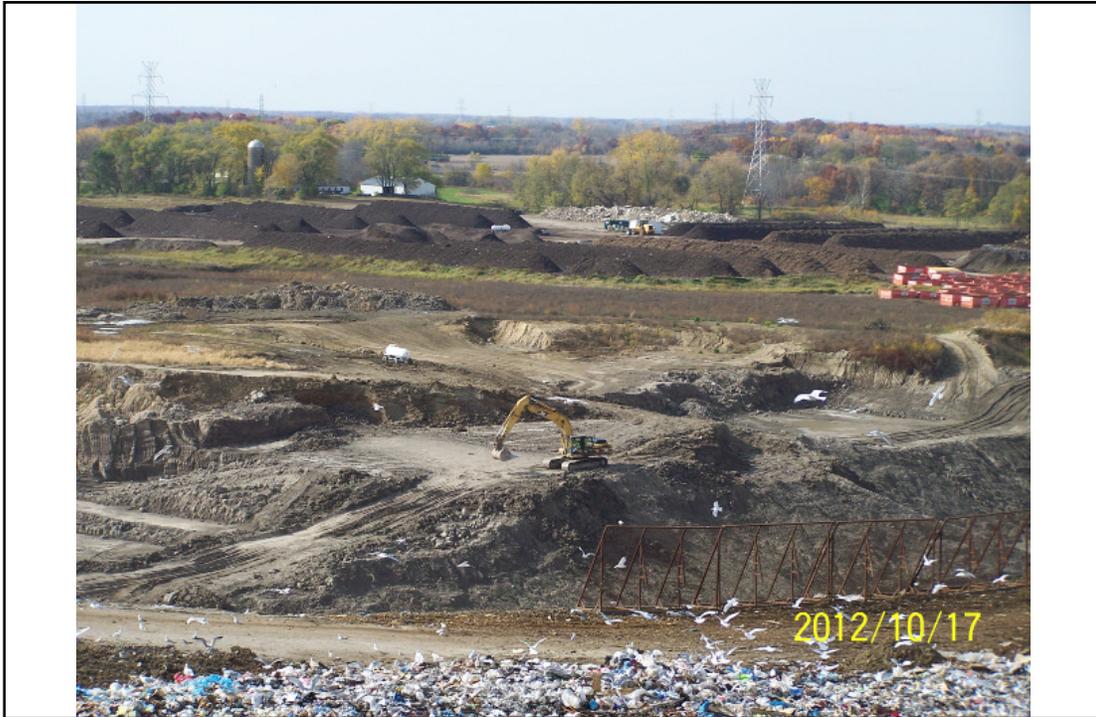
Excavation of clay for backhaul

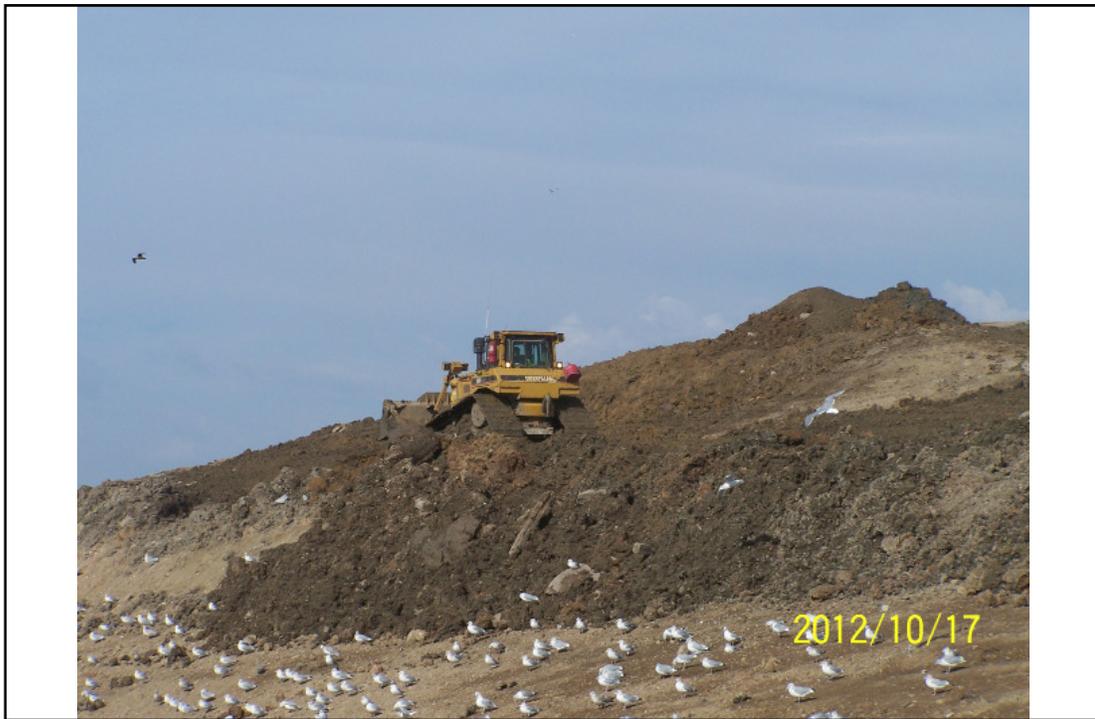
Landfill direct soils places above Phase 7

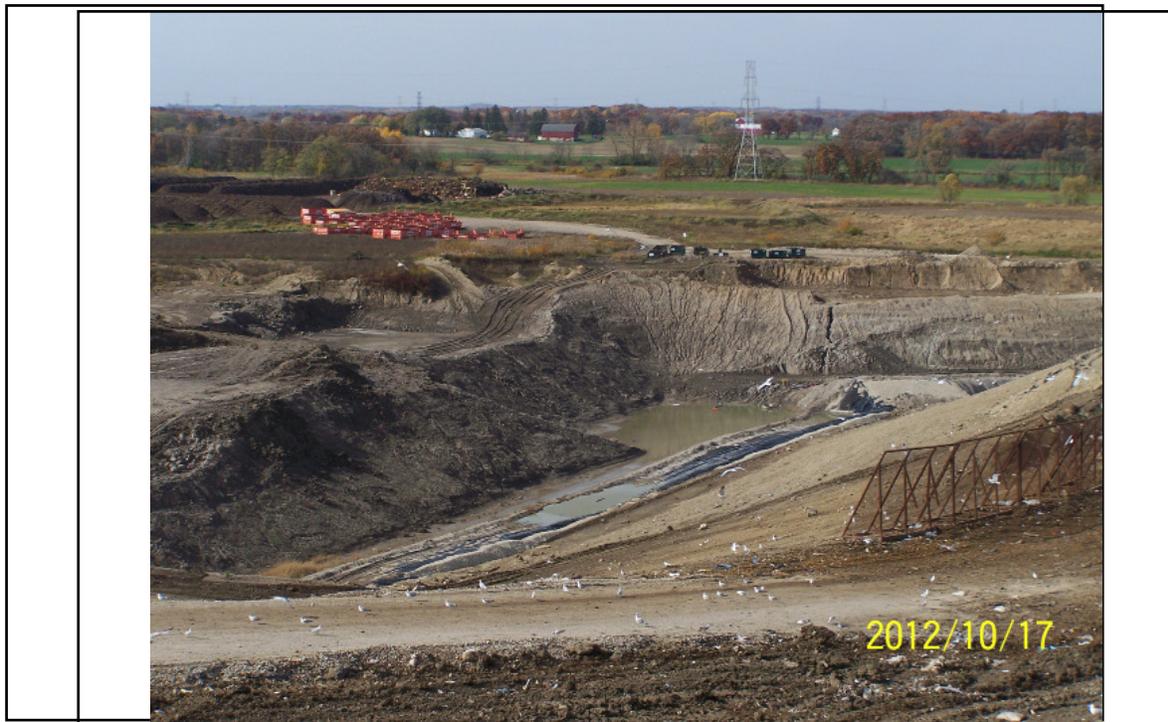
Temp Sed Bain drained prior to potential rain events.

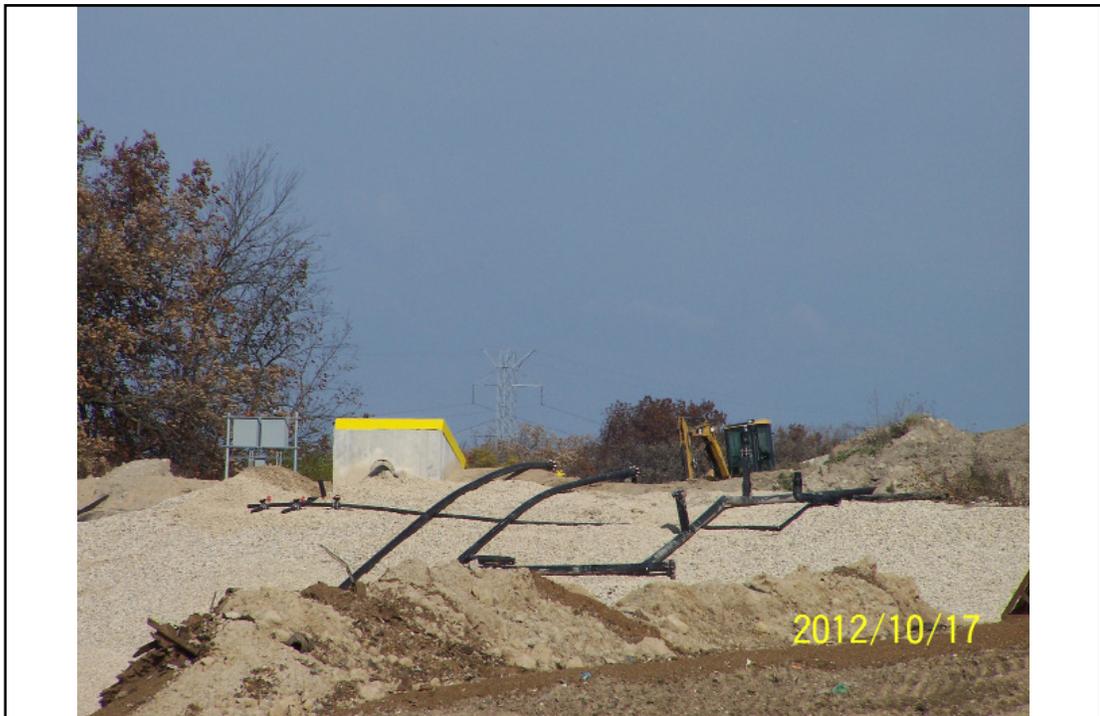
Leachate recirc lines connected to vault
