2012 Advanced Disposal Services Emerald Park Landfill Year End Compliance Officer Report and Audit Summary

TO: Veolia Emerald Park Standing Committee
FROM: Jo-Walter Spear, Jr., P.E.
COPIES: File
DATE: 04/04/13
PROJECT NUMBER: 1012.10030

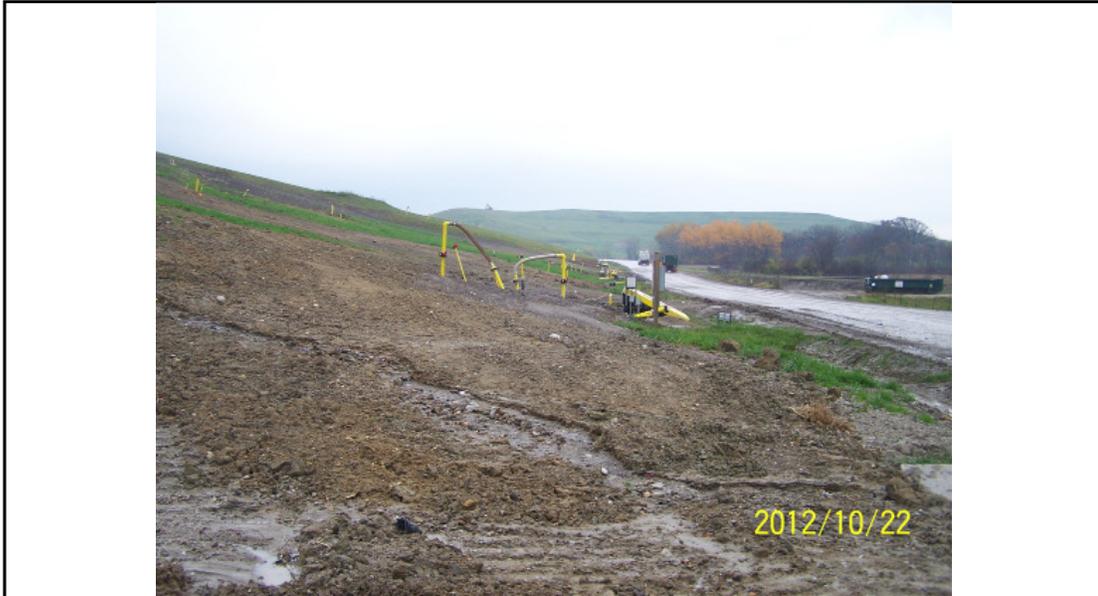
Lower portion of South slopes, top dressed and awaiting seed

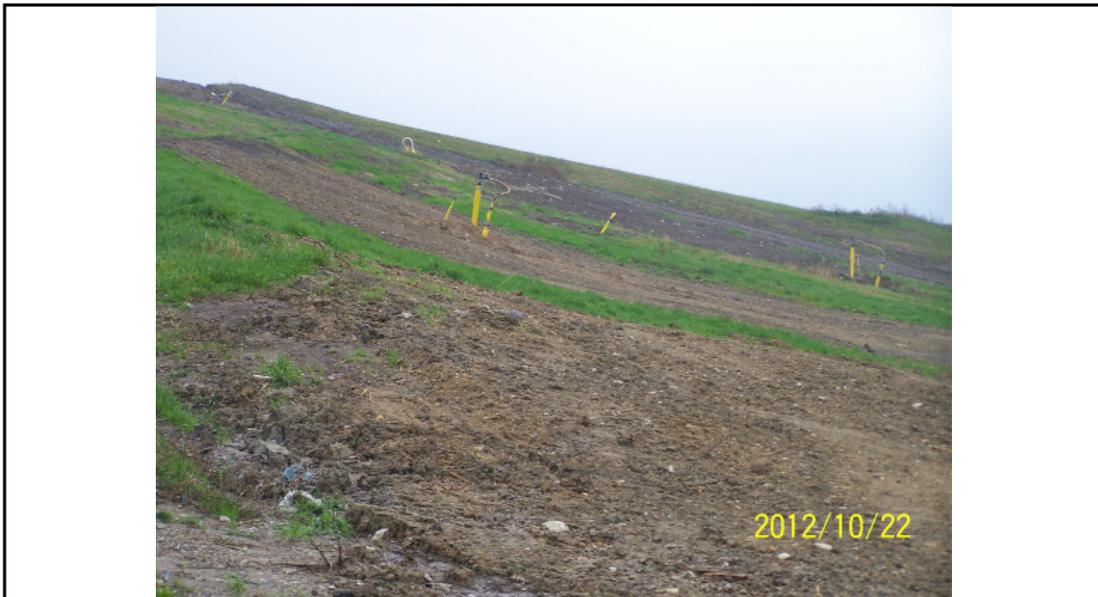
Upper portion of the South slopes top dressed and awaiting seed

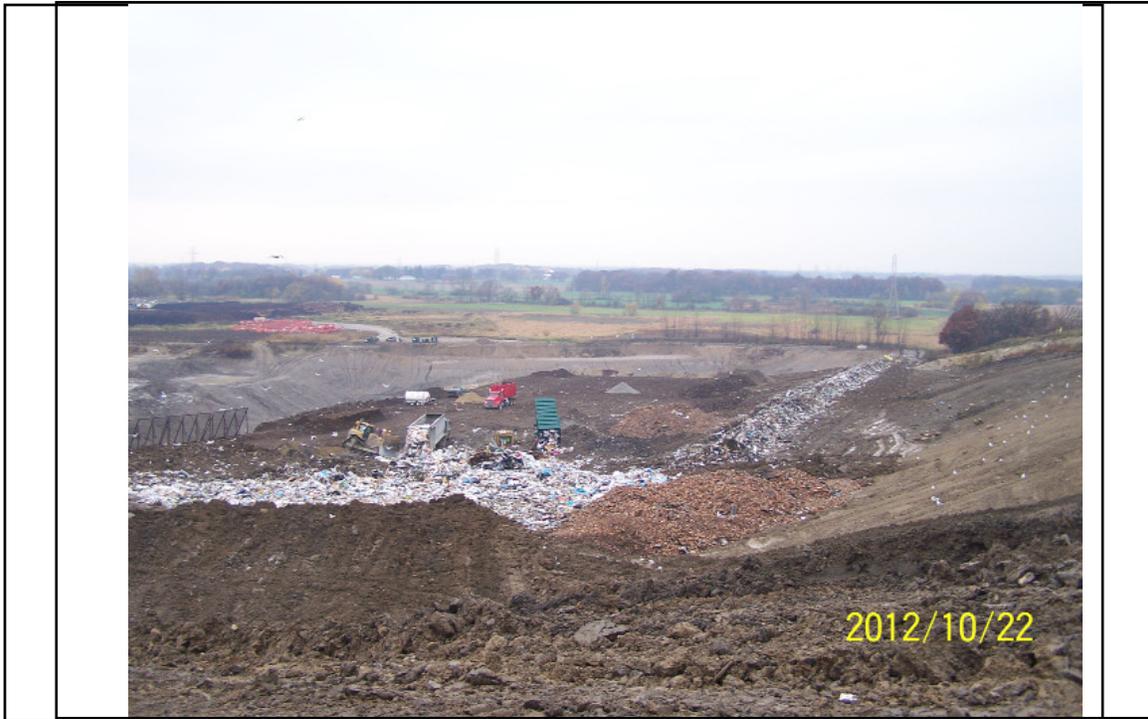
Working face incapsulated with landfill direct soils

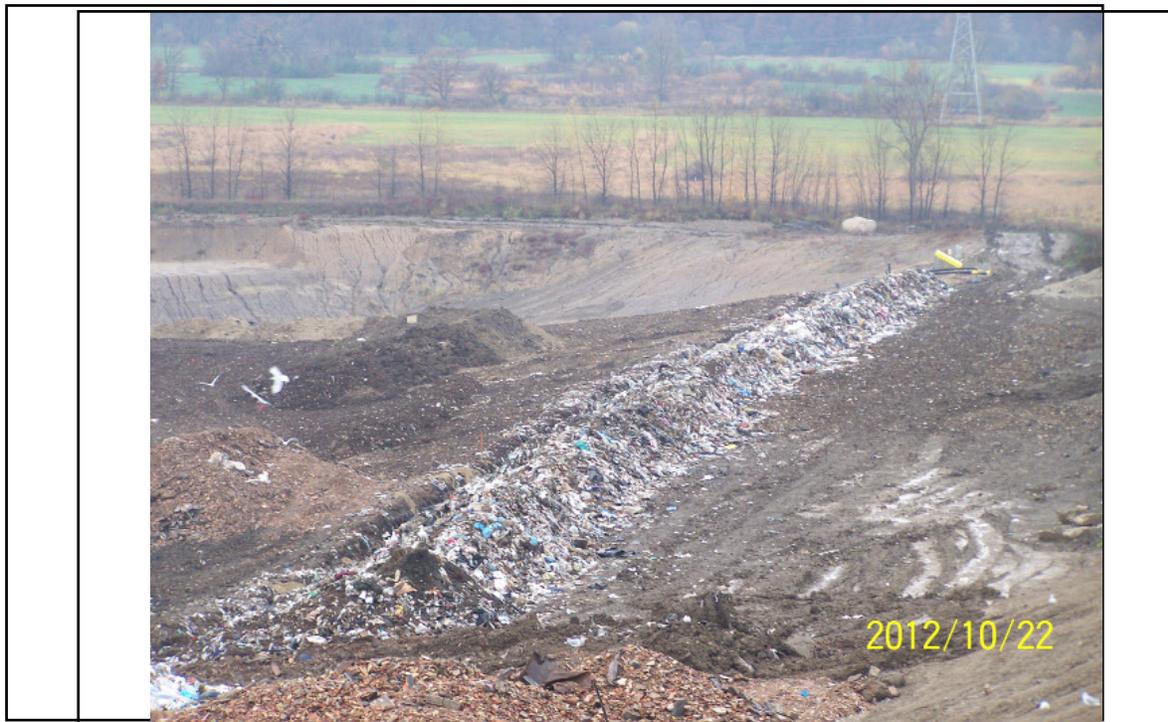
Waste removed to place header line, will be used as backfill

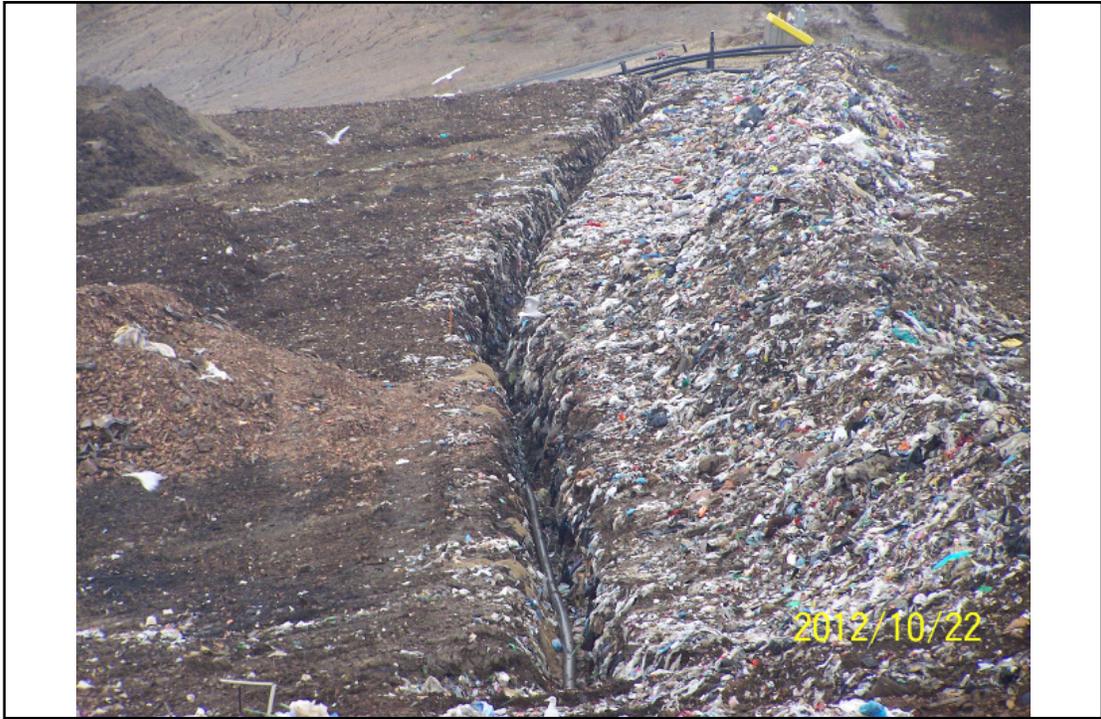
Trench and leachate header placement

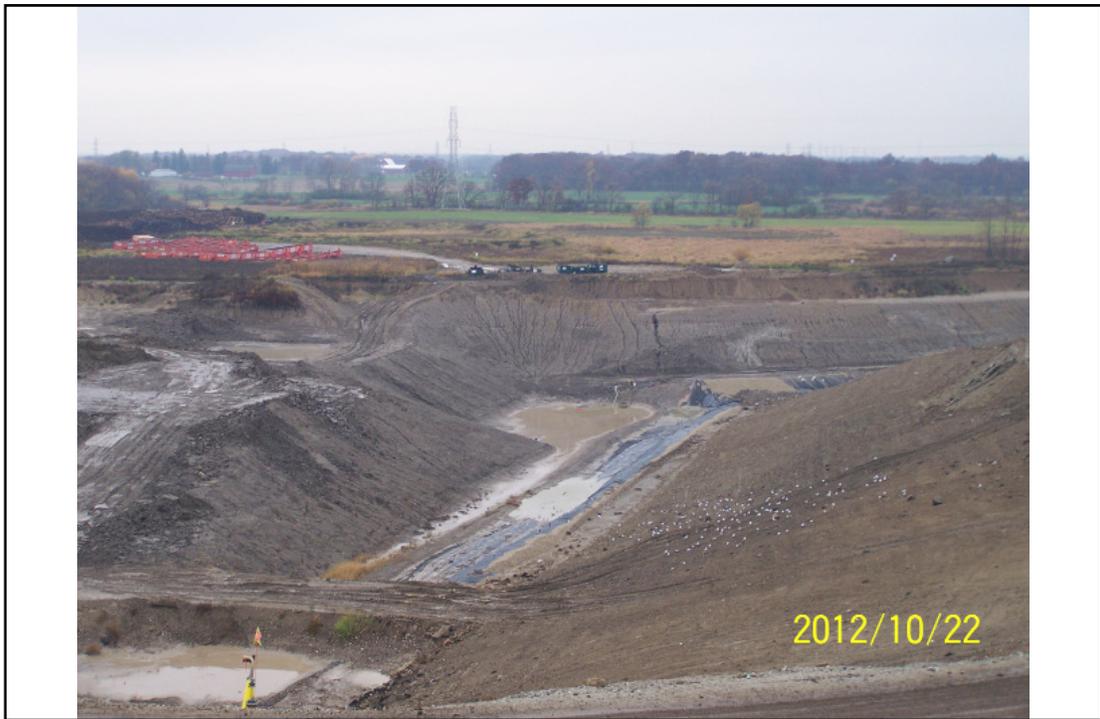
Temp sed basin with available volume

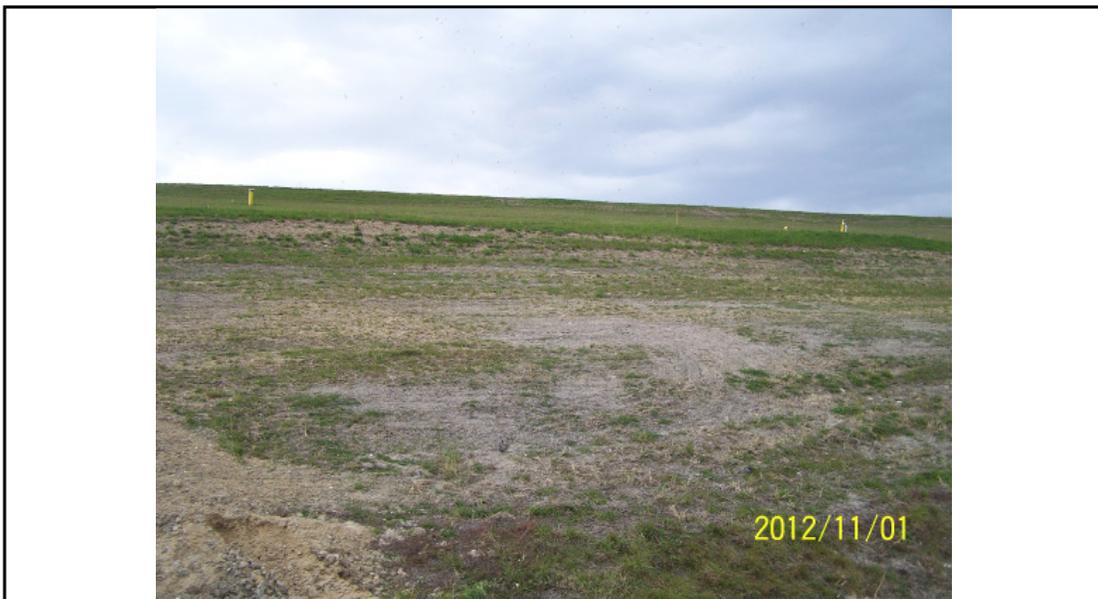
Seeded areas showing some greening in Closure area 3

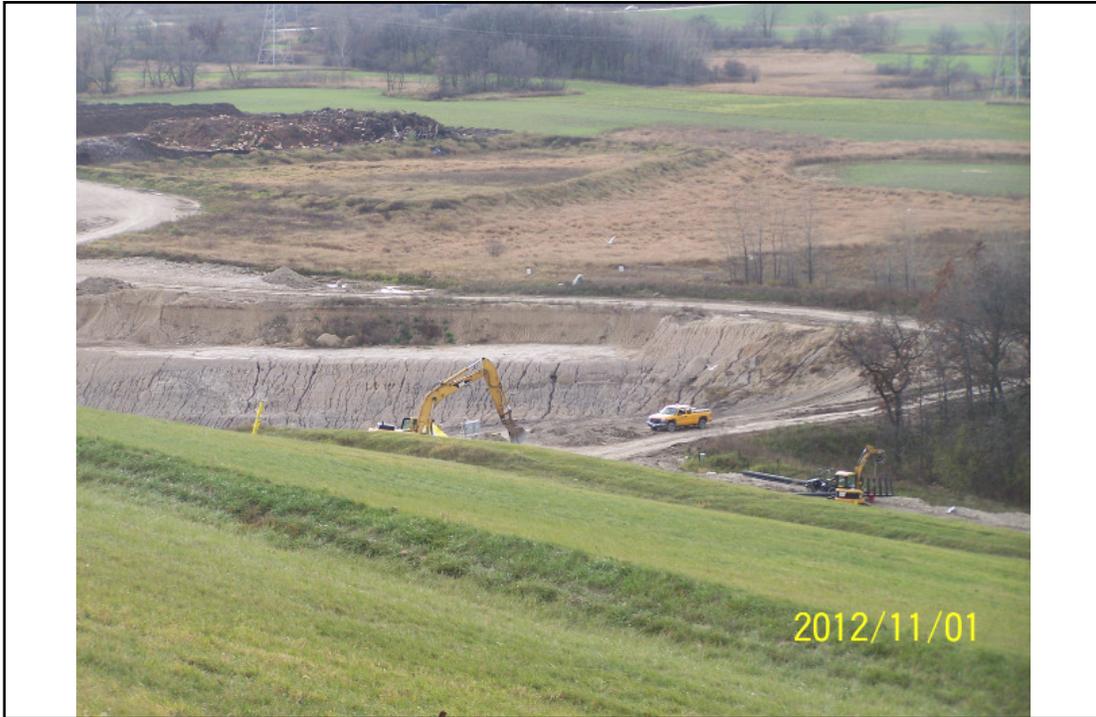
Leachate recirc connection and extent of West excavation

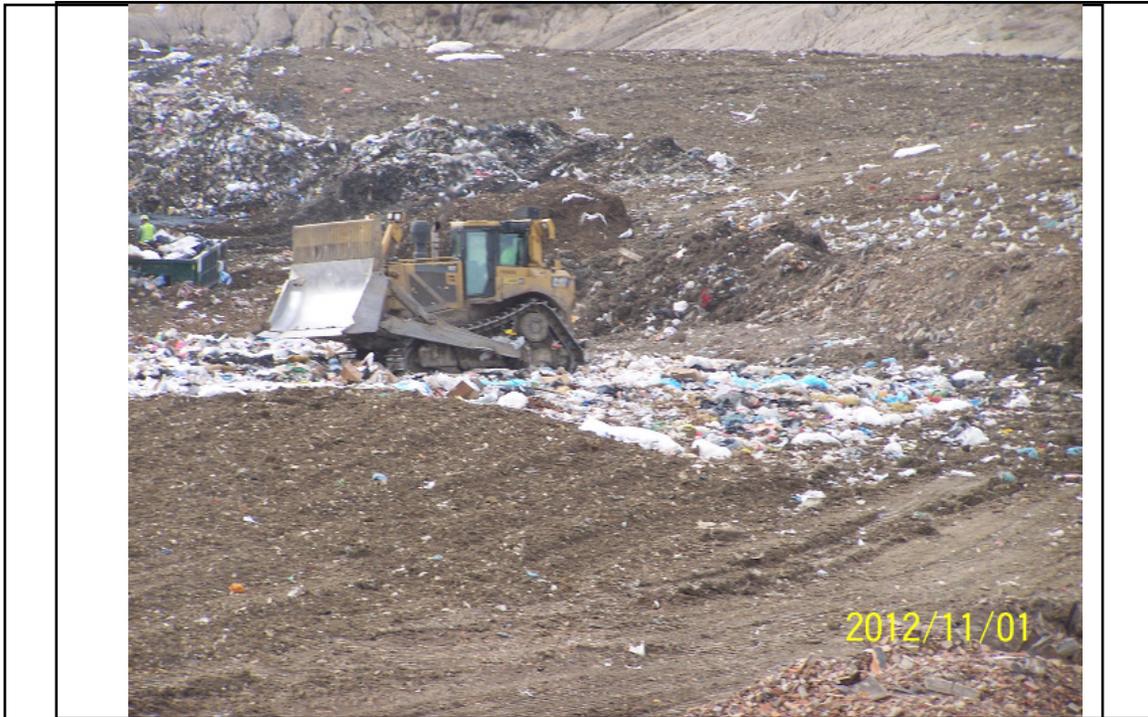
Working face being spread by dozer

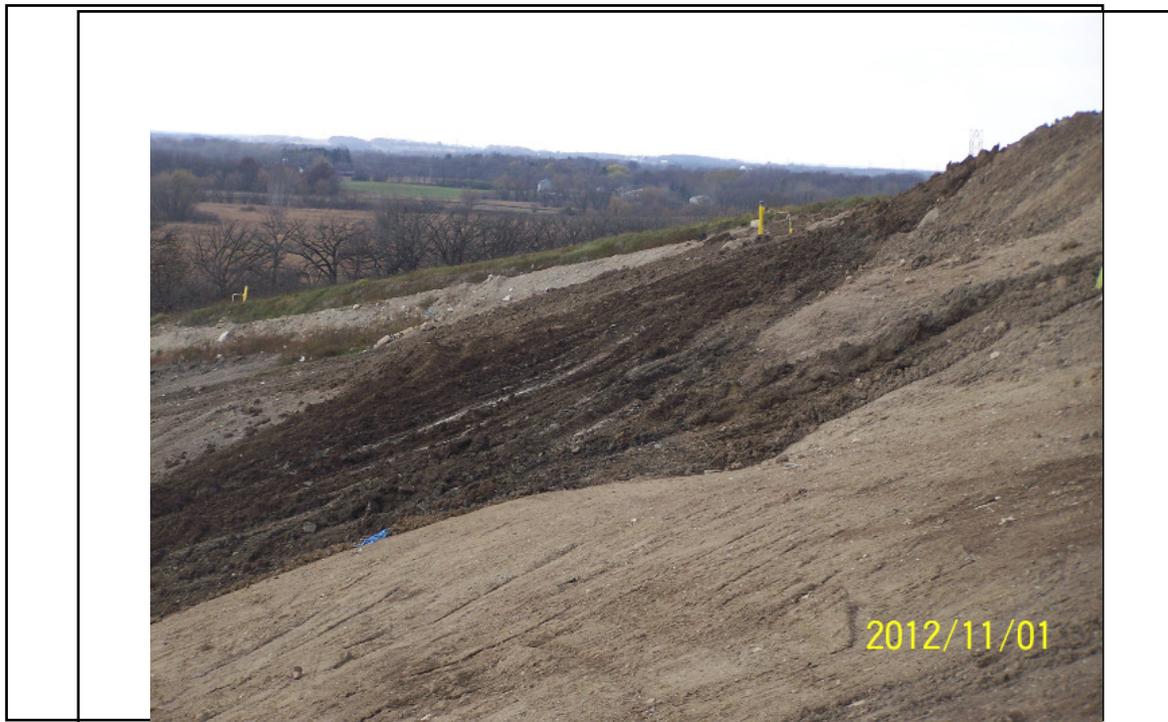
Soils spread out on Phase 2&3 South Slopes, above Phase 7

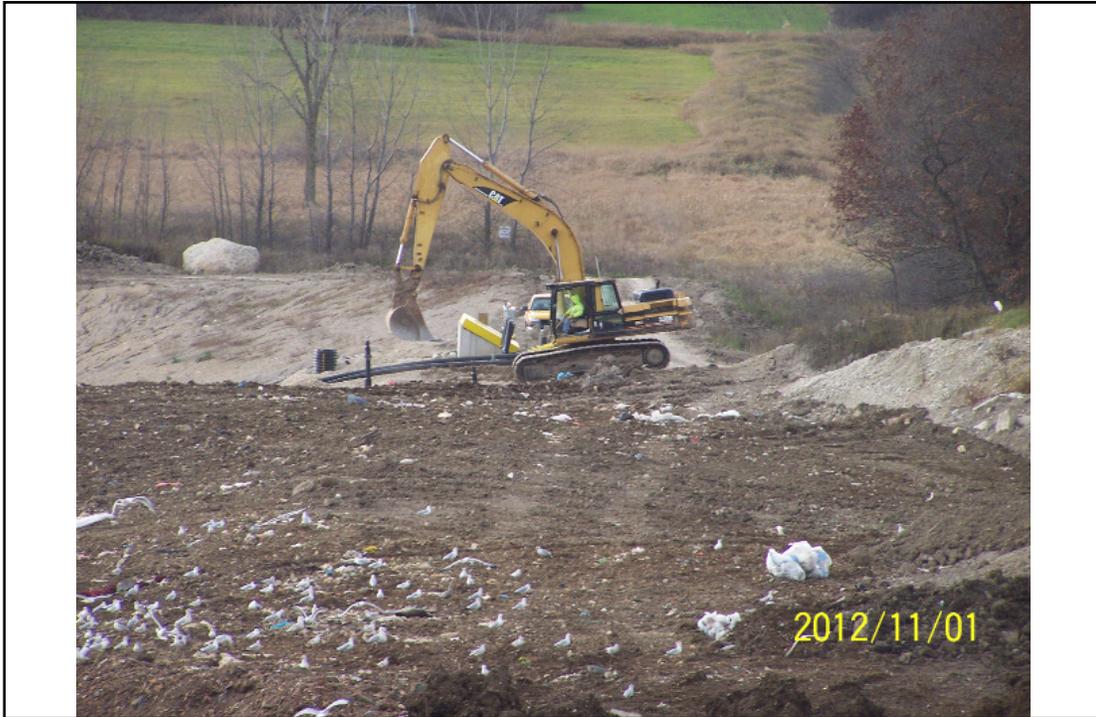
Recirc line connection to the leachate vault at the Western edge of Phase 7

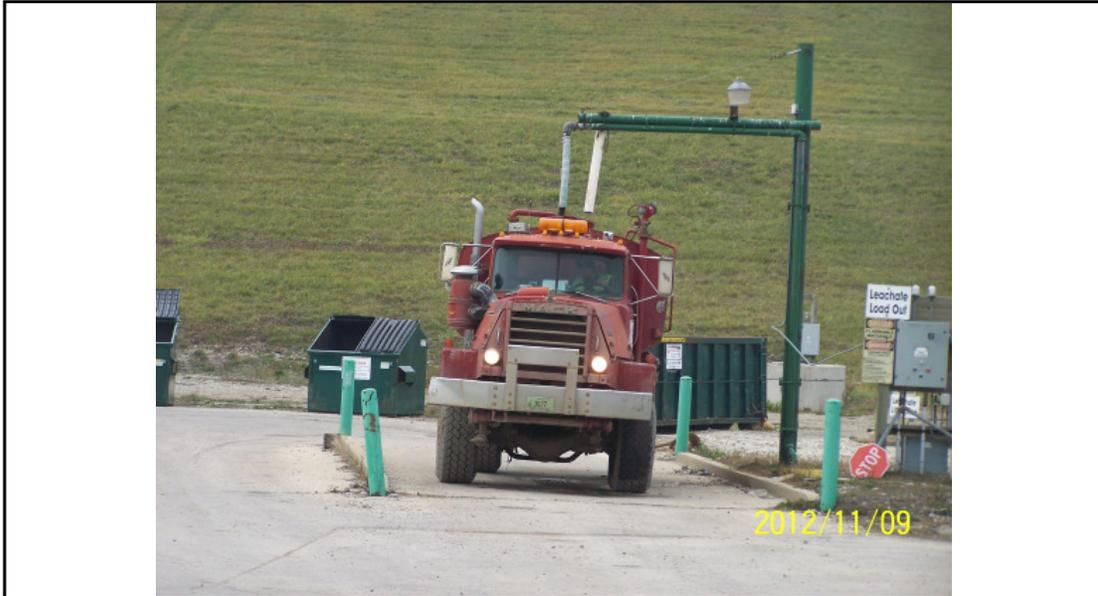
Load out of leachate to water truck for surface application in active area

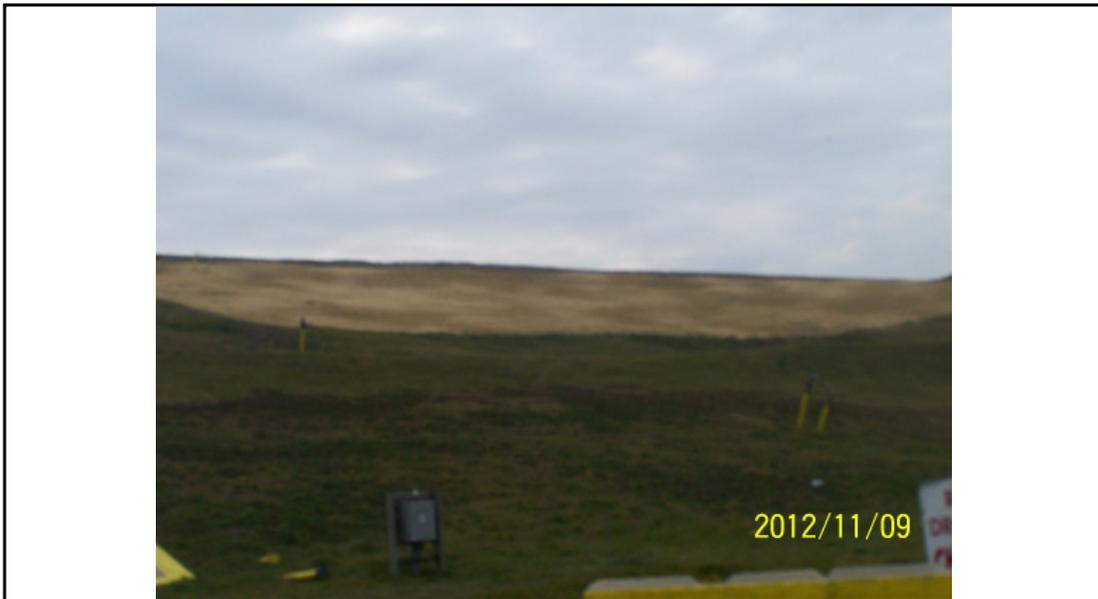
Phase 4, North slope, seeded and protected with straw

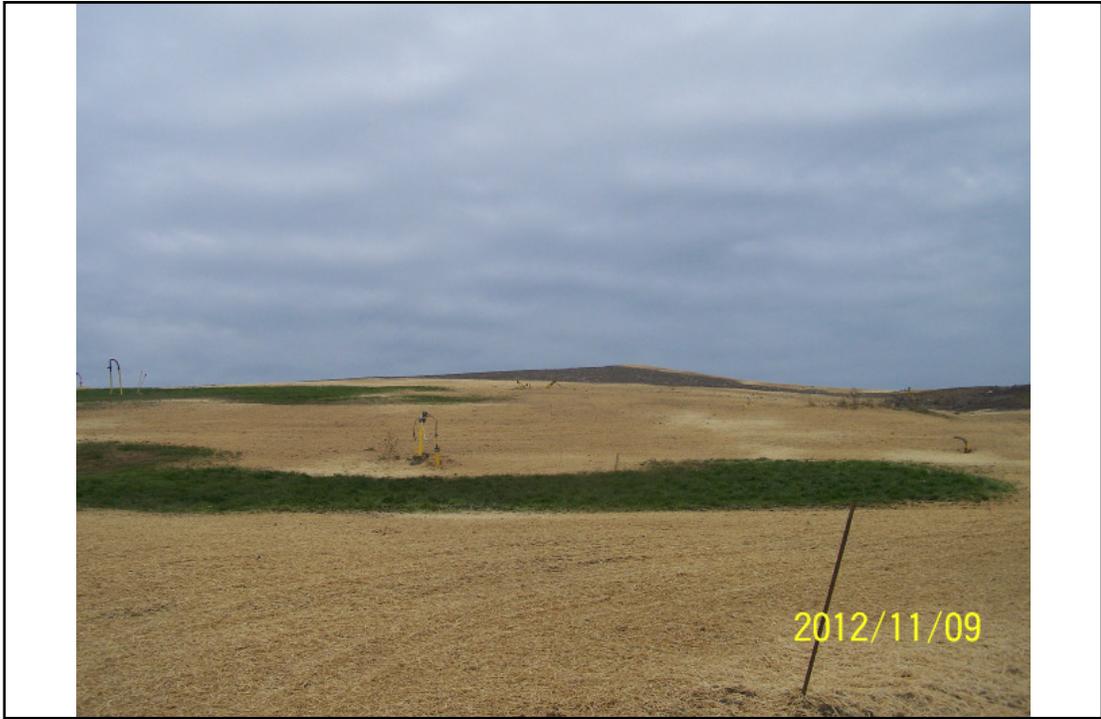
Seeded and protected slopes

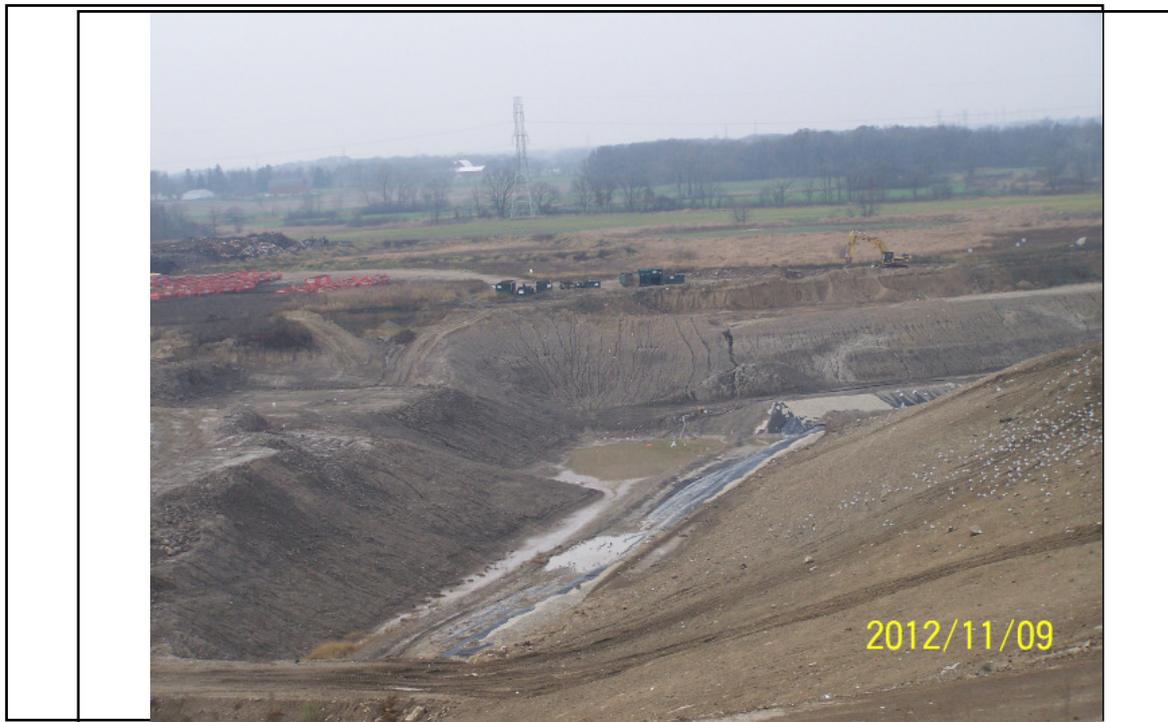
Temp sed basin with plenty of freeboard for expected weekend rains

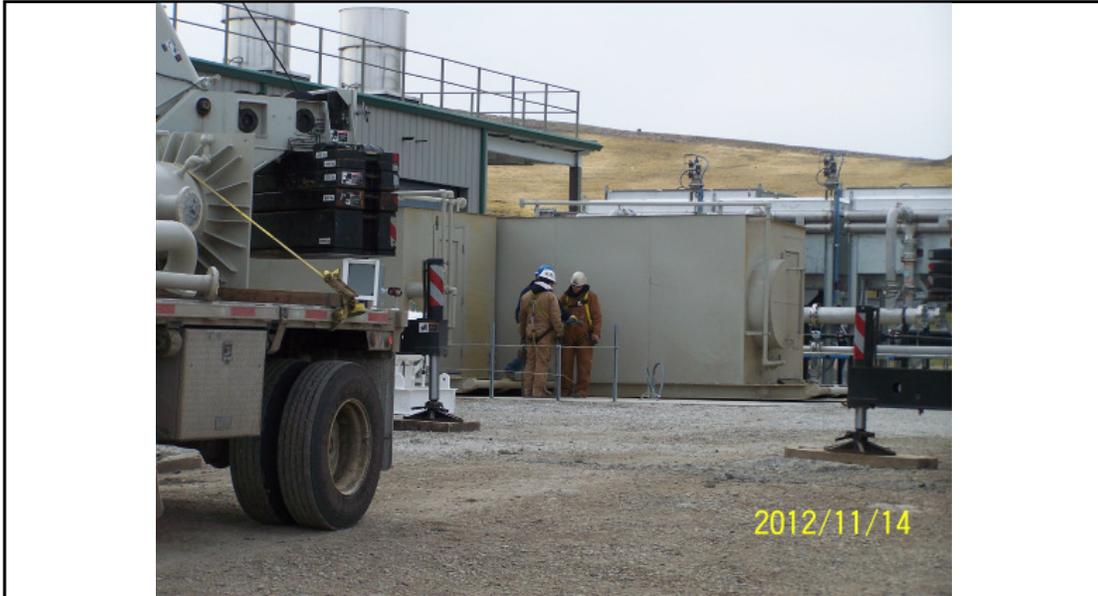
Glycol skids being installed

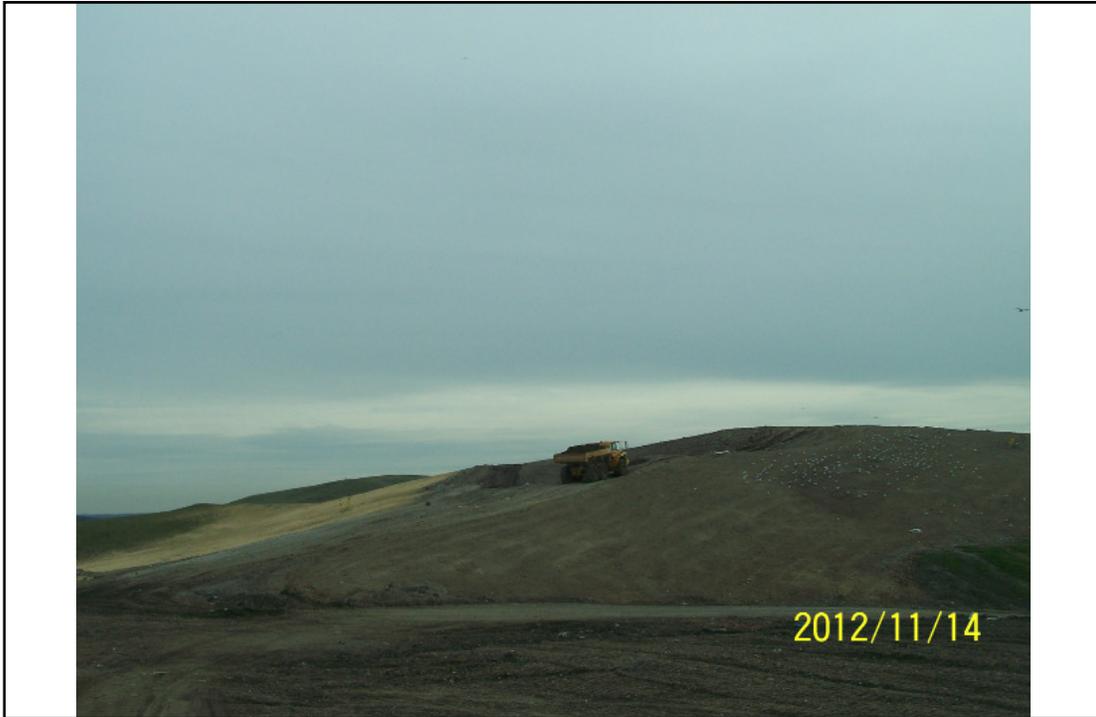
Soil placement and grading on Phase 5/6 South end

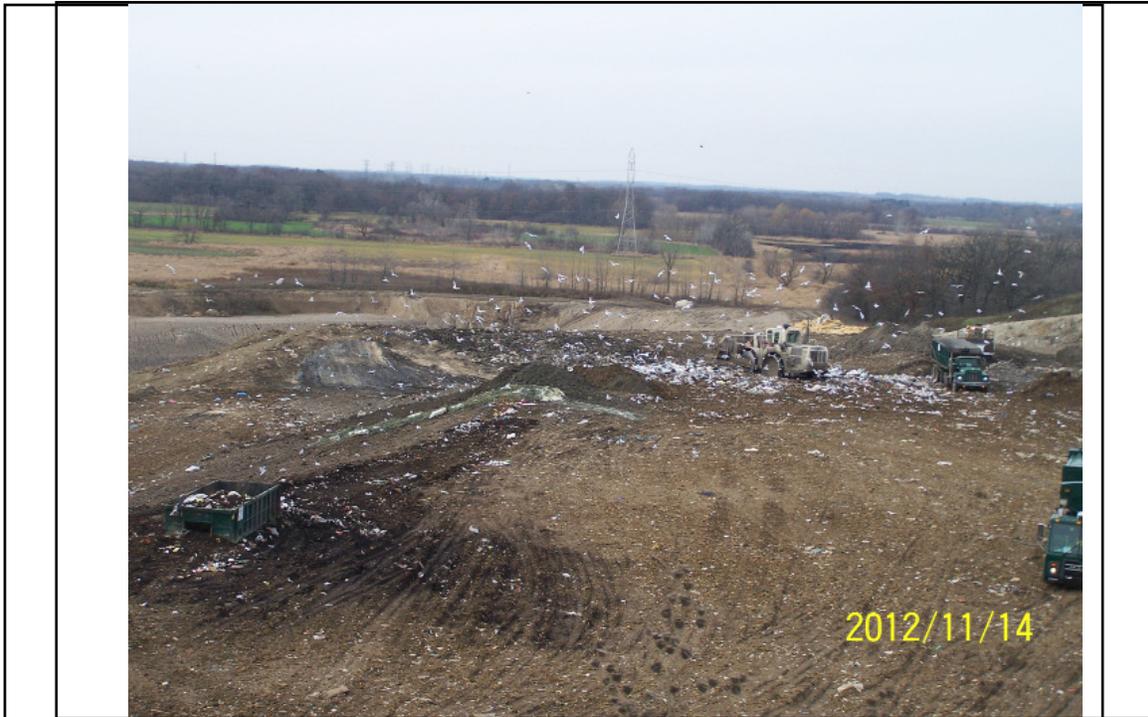
Working face in middle of Active area

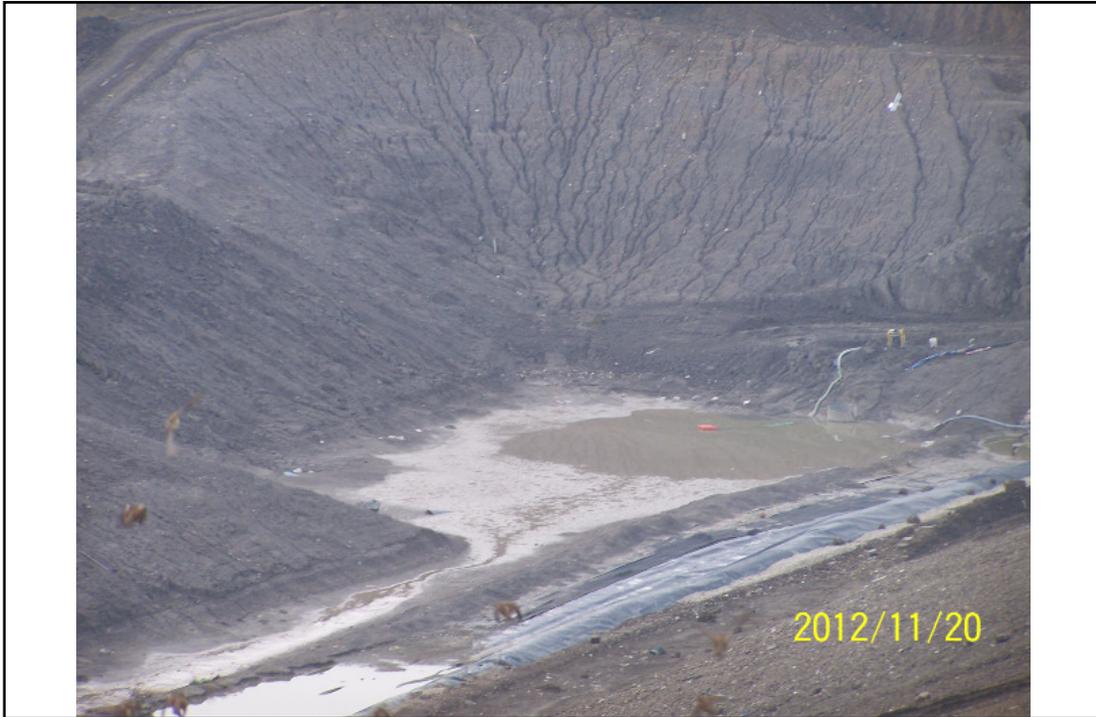
Temp sed basin drained in preparation for coming storms

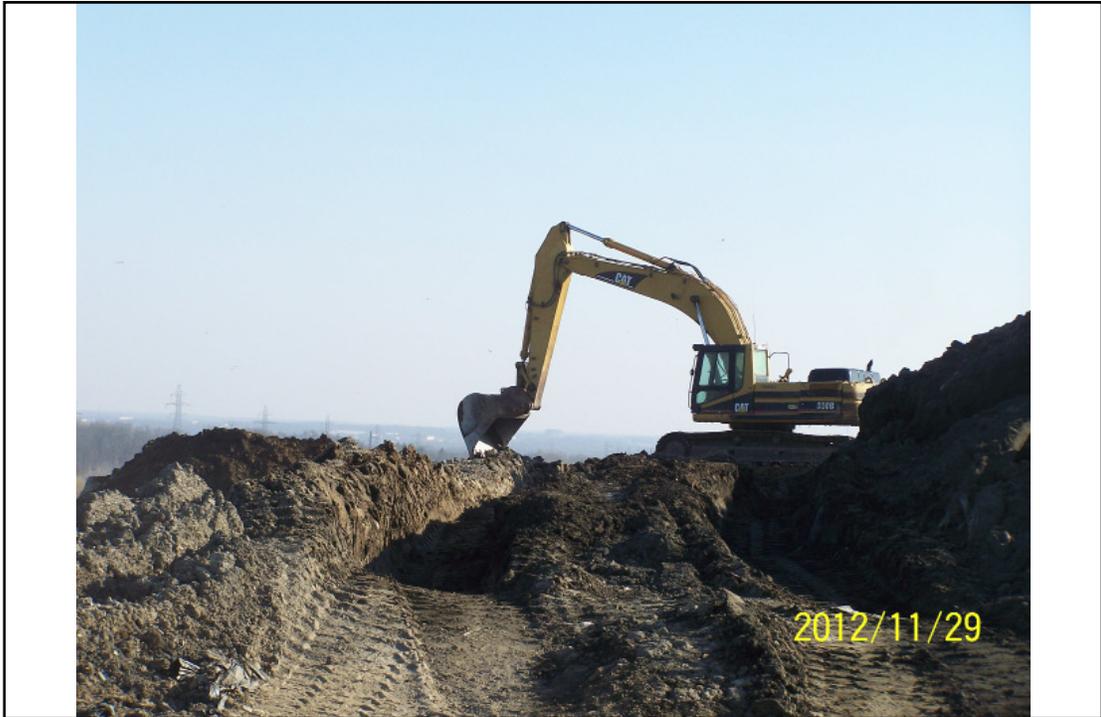
Excavator relocating soils and reducing slope pitch

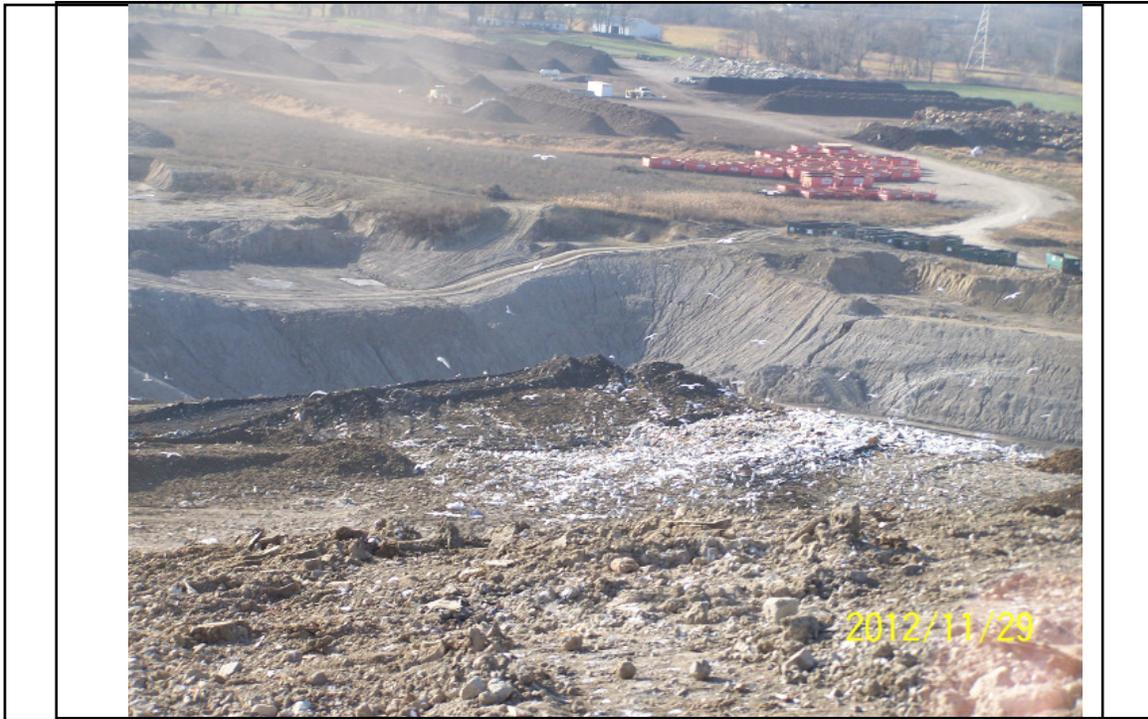
Lift covered with daily and intermediate cover

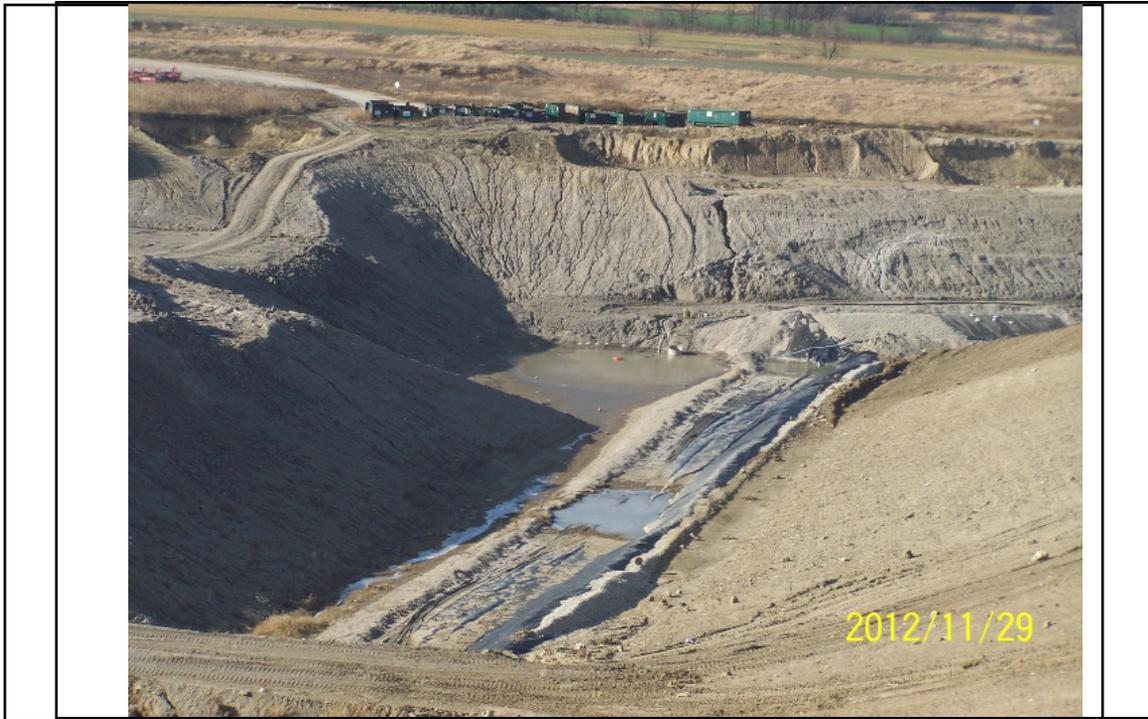
Temp sed basin drained in preparation for coming storms

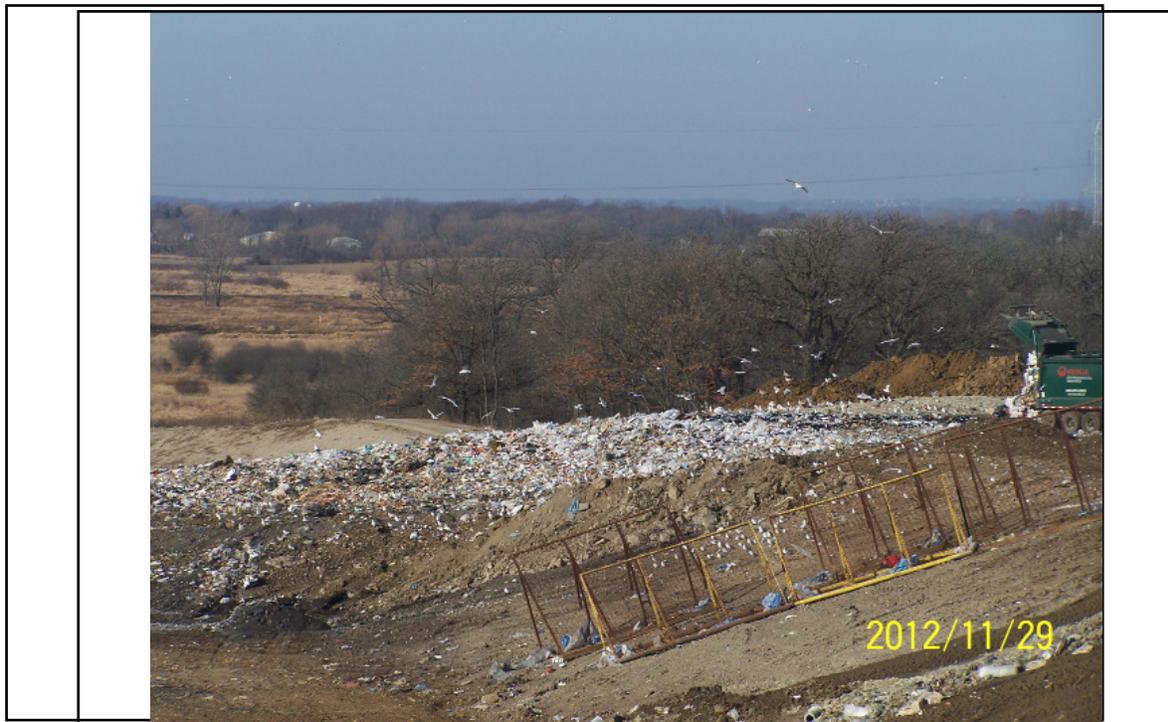
working face with a fair number of seagulls

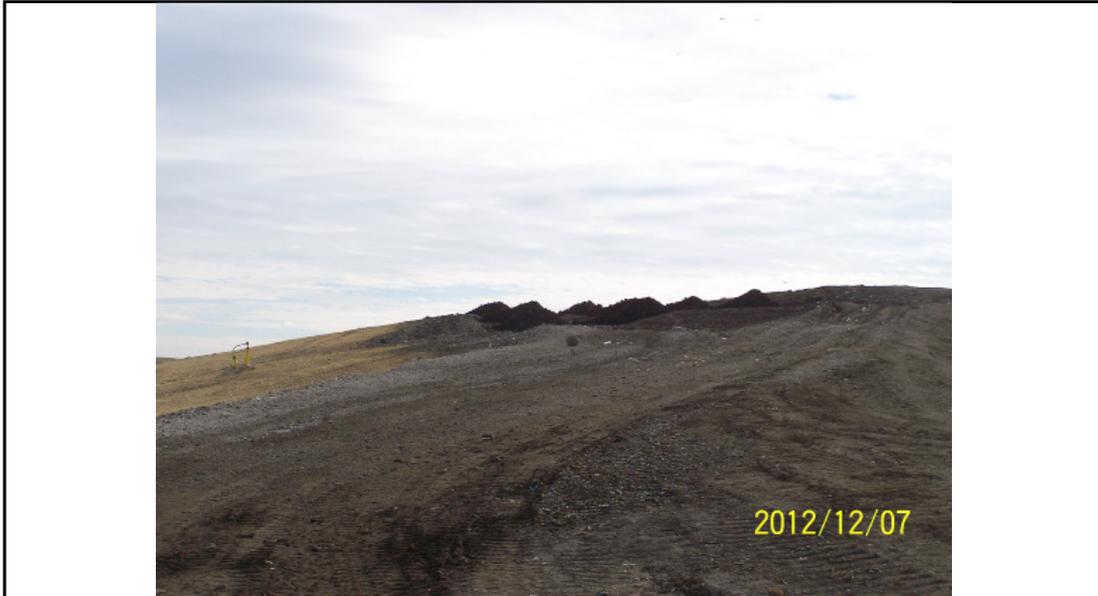
Phse 5 & 6, North Slope

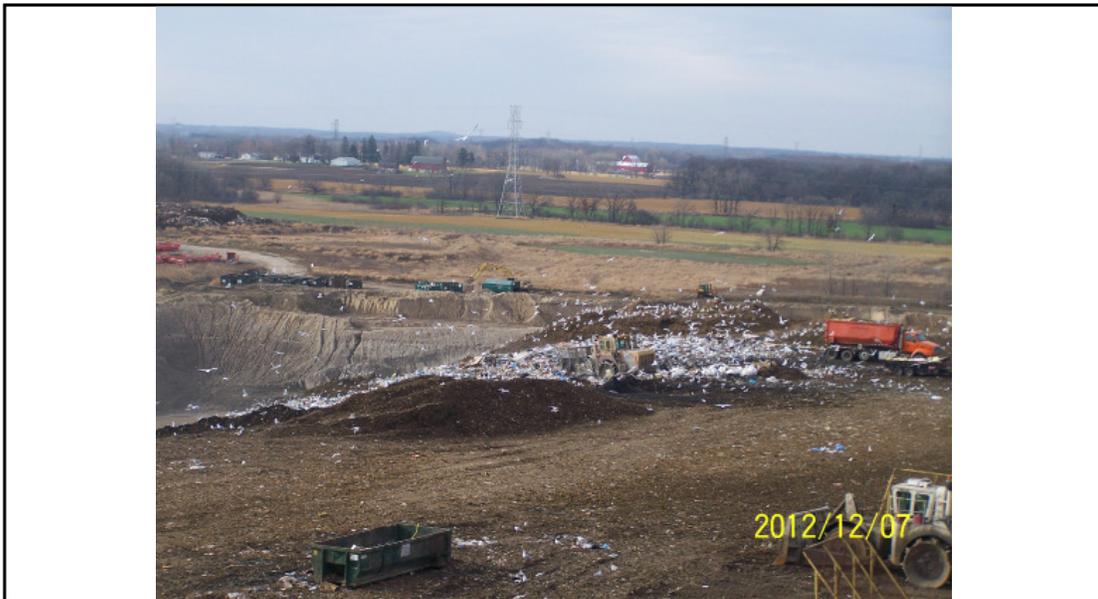
Working face

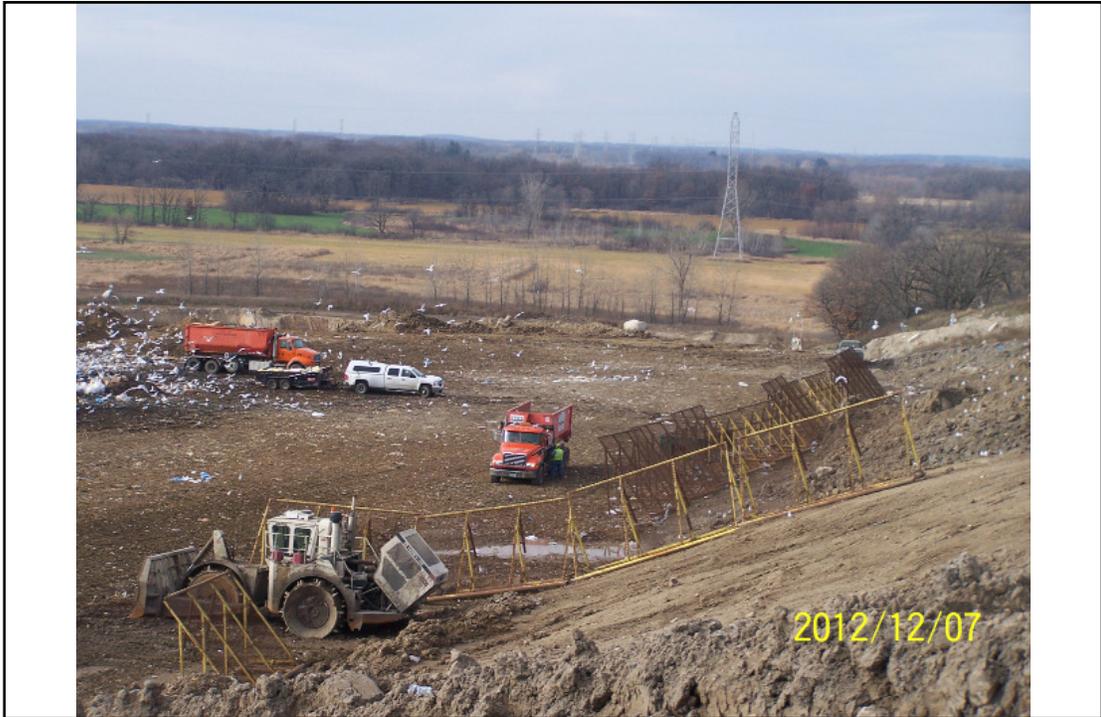
Active area

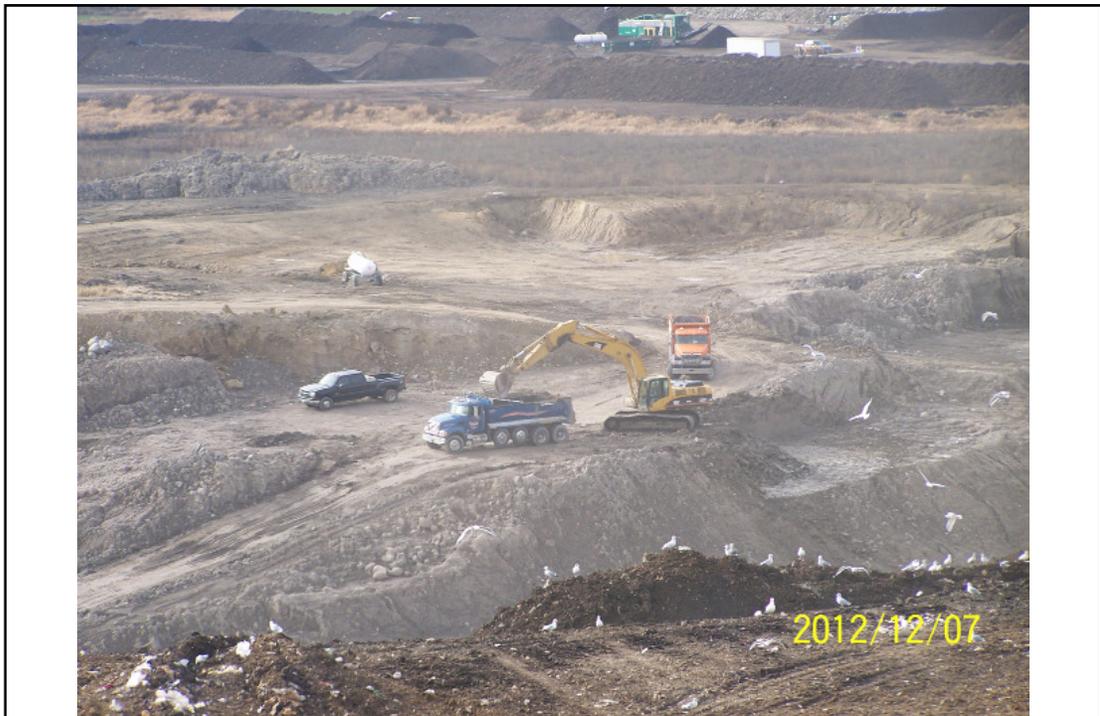
Clay excavation for off site back haul

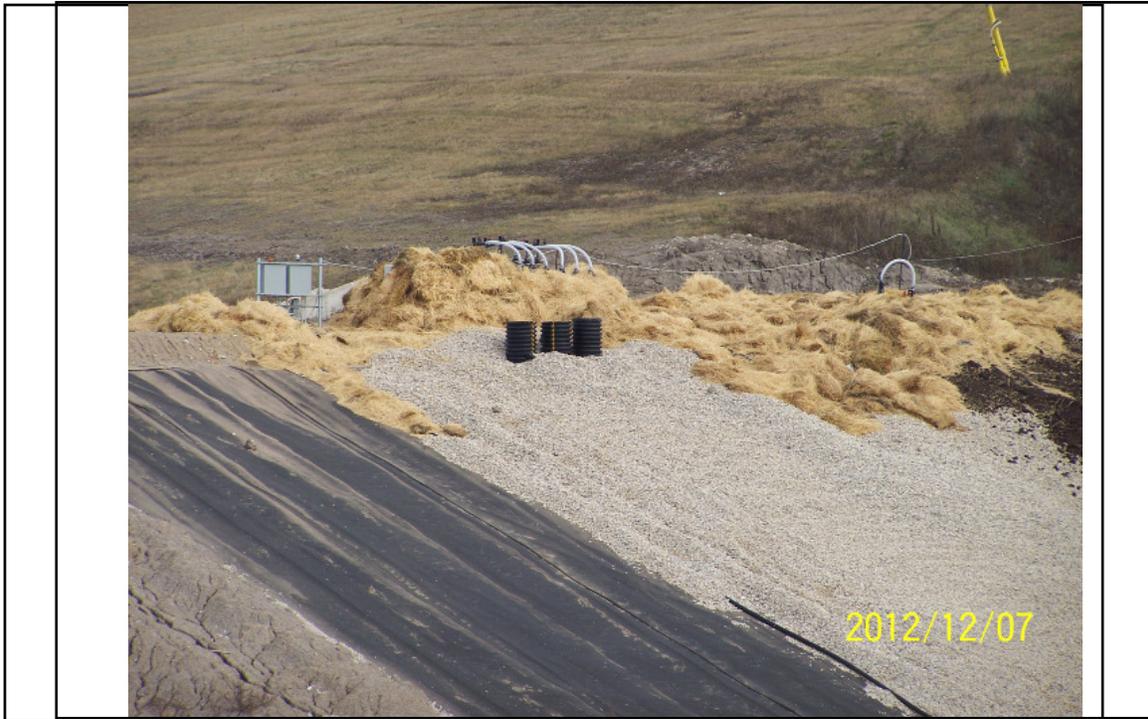
Phase 7 vault being prepared for winter conditions

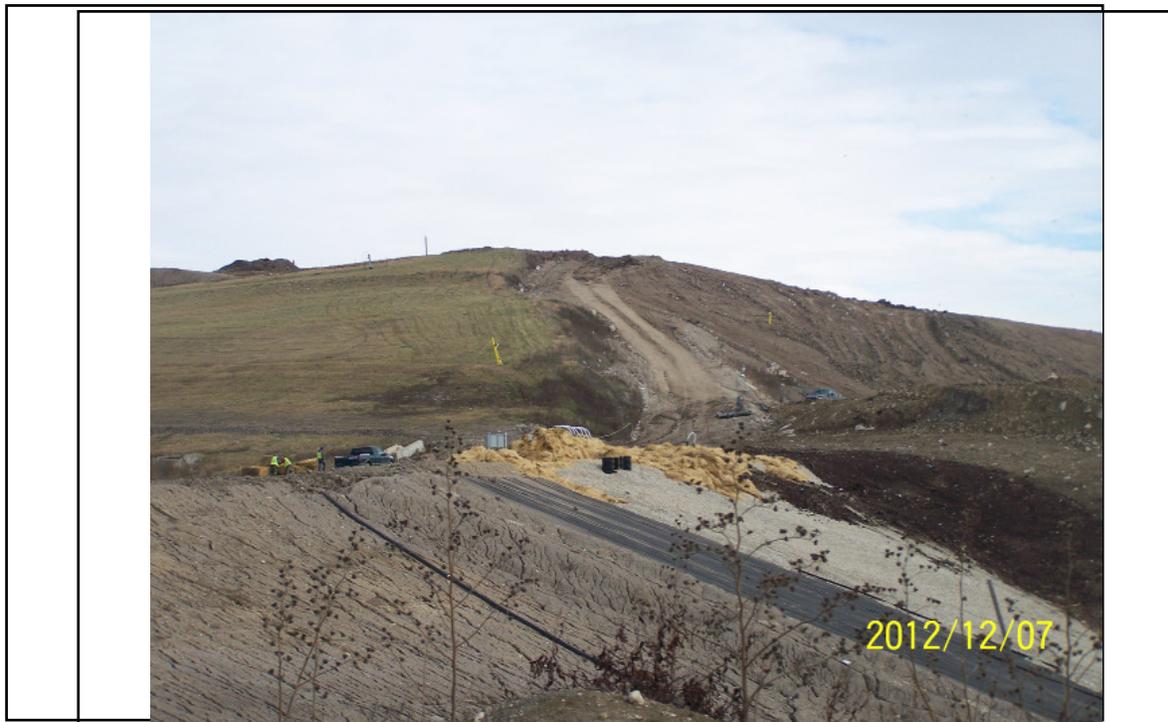
Phase 7 waste limit
