2012 Advanced Disposal Services Emerald Park Landfill Year End Compliance Officer Report and Audit Summary

TO: Veolia Emerald Park Standing Committee
FROM: Jo-Walter Spear, Jr., P.E.
COPIES: File
DATE: 04/04/13
PROJECT NUMBER: 1012.10030

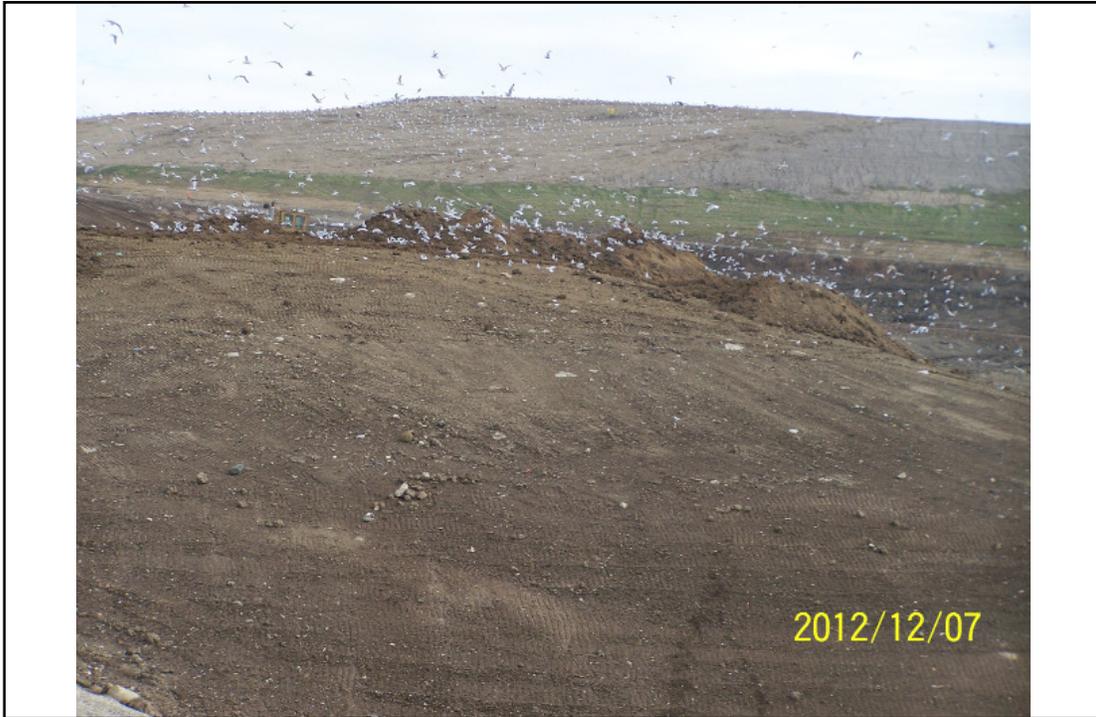
Soils tipped on Phase 5/6

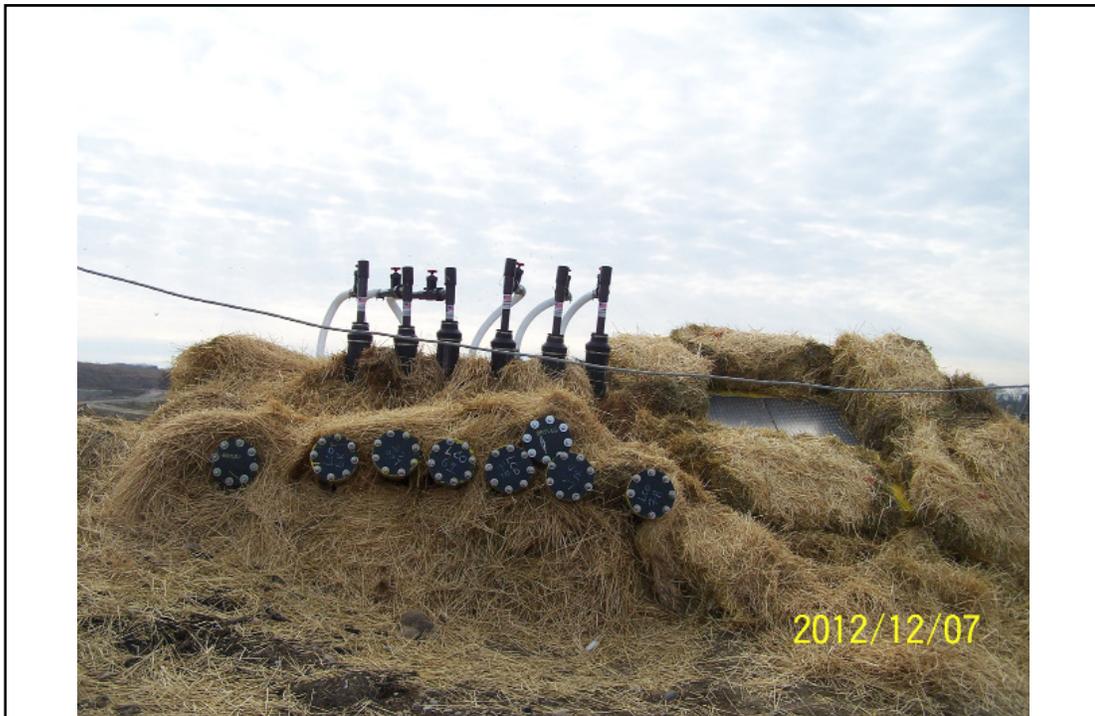
New Phase 7 vault being prepared for winter conditions

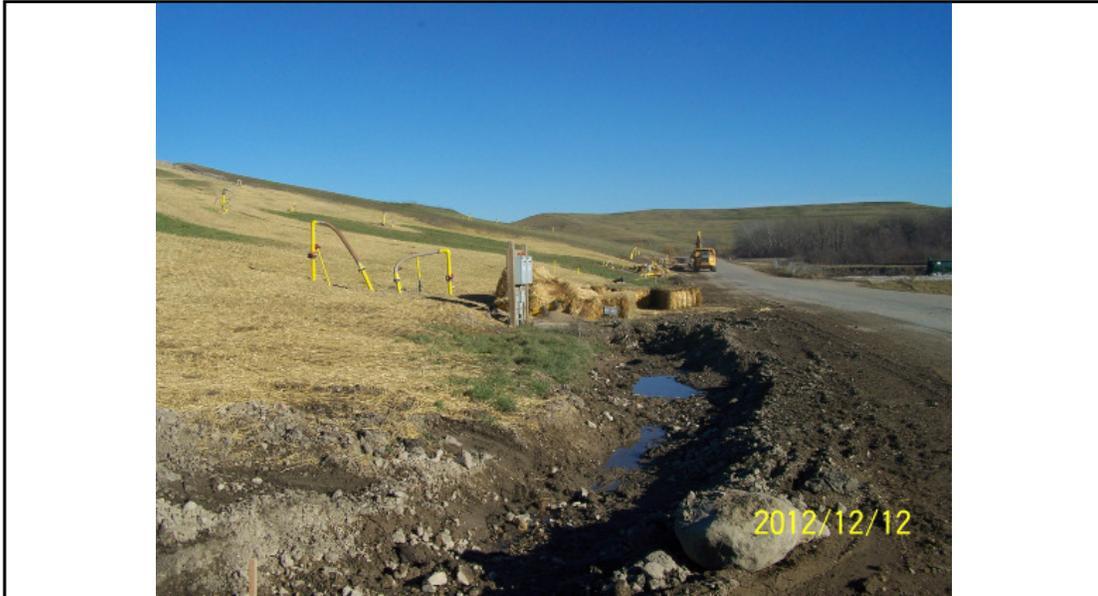
South perimeter ditch cleaning

- * Buses cleaning awaiting freezing conditions
- * MMSD Gas connection goes on line JWS with gas line purge.
- * Ditch cleaning Activities will replace all culverts on the South ditch with HDPE

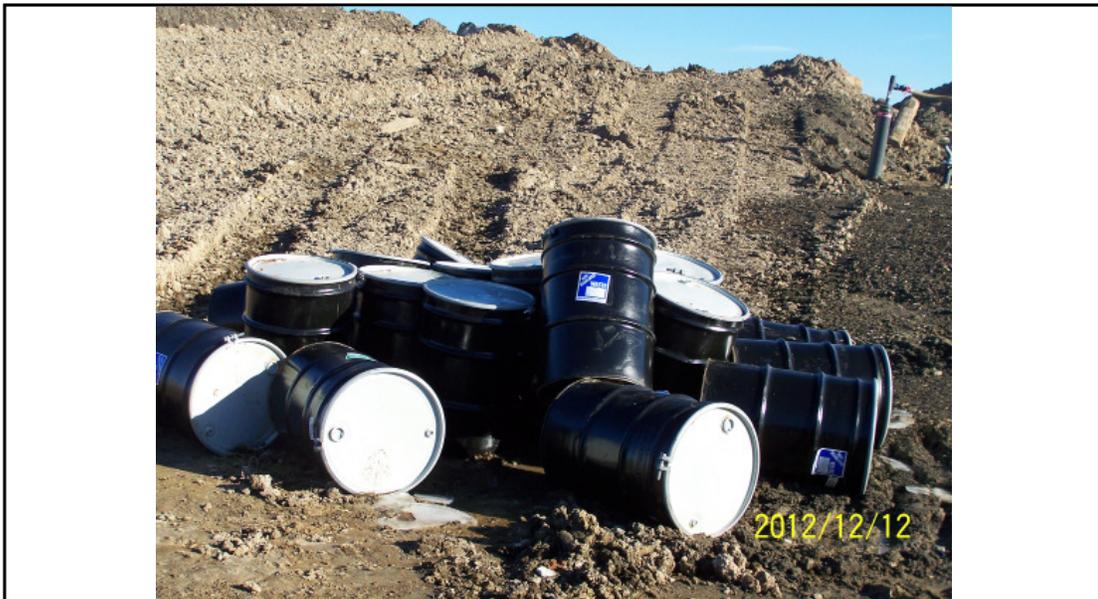
Bio-soils delivered in drums, hauling company will return to dump them

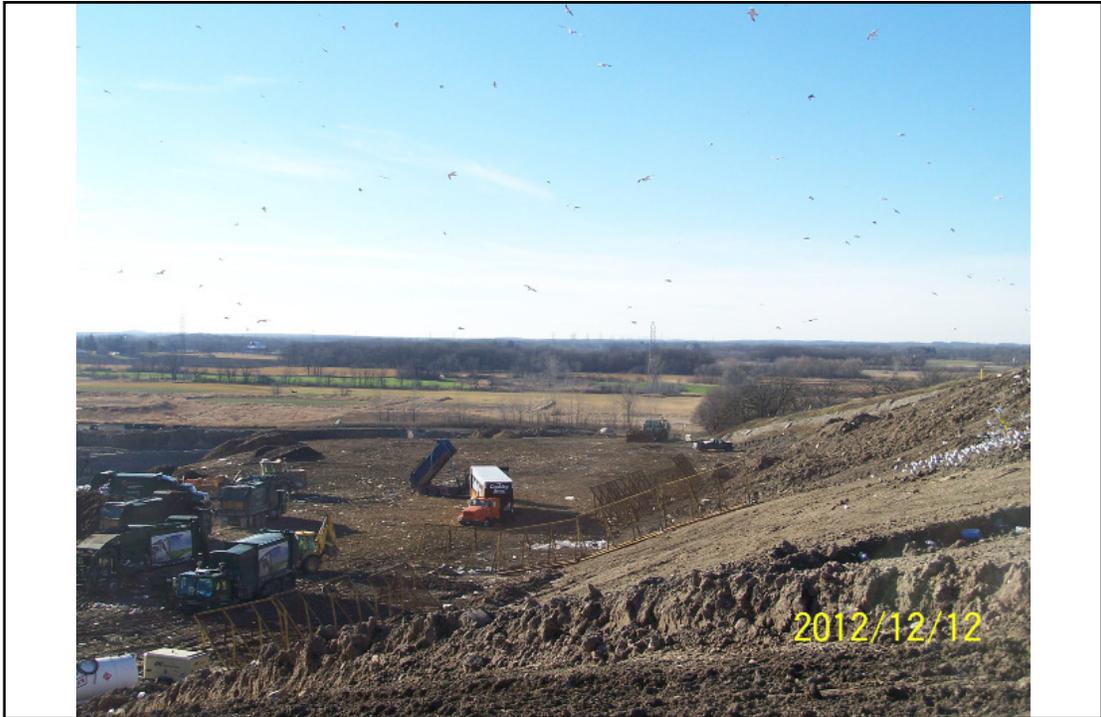
Active area Northwest of working face

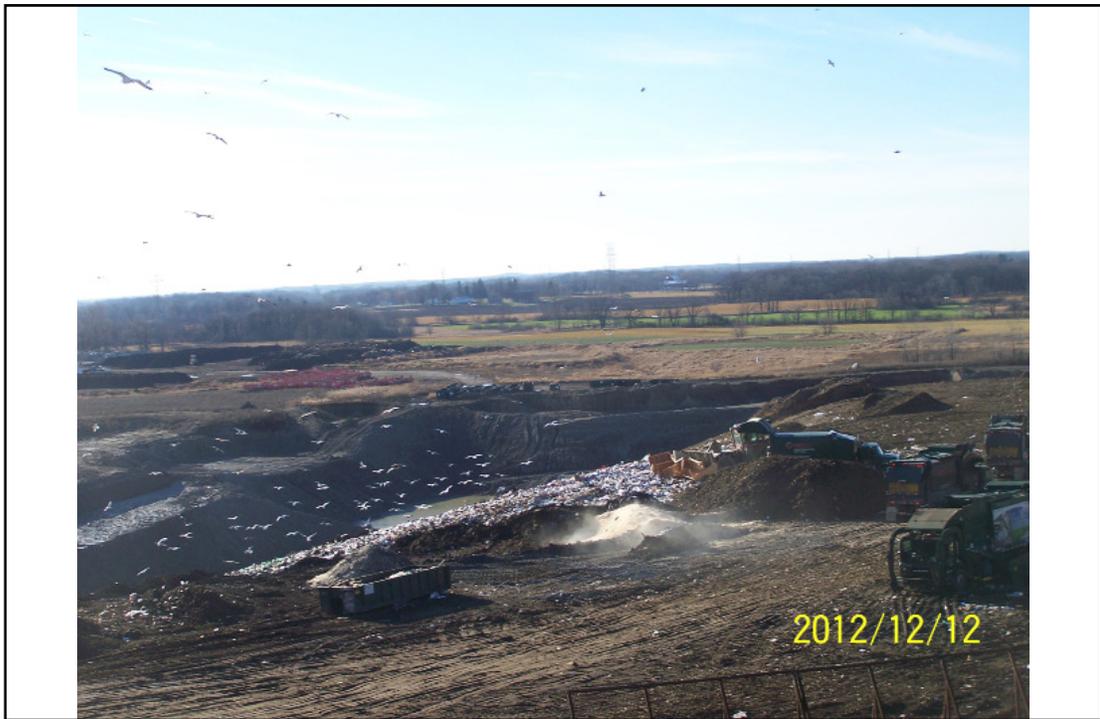
Active area, stockpiled saw dust blowing

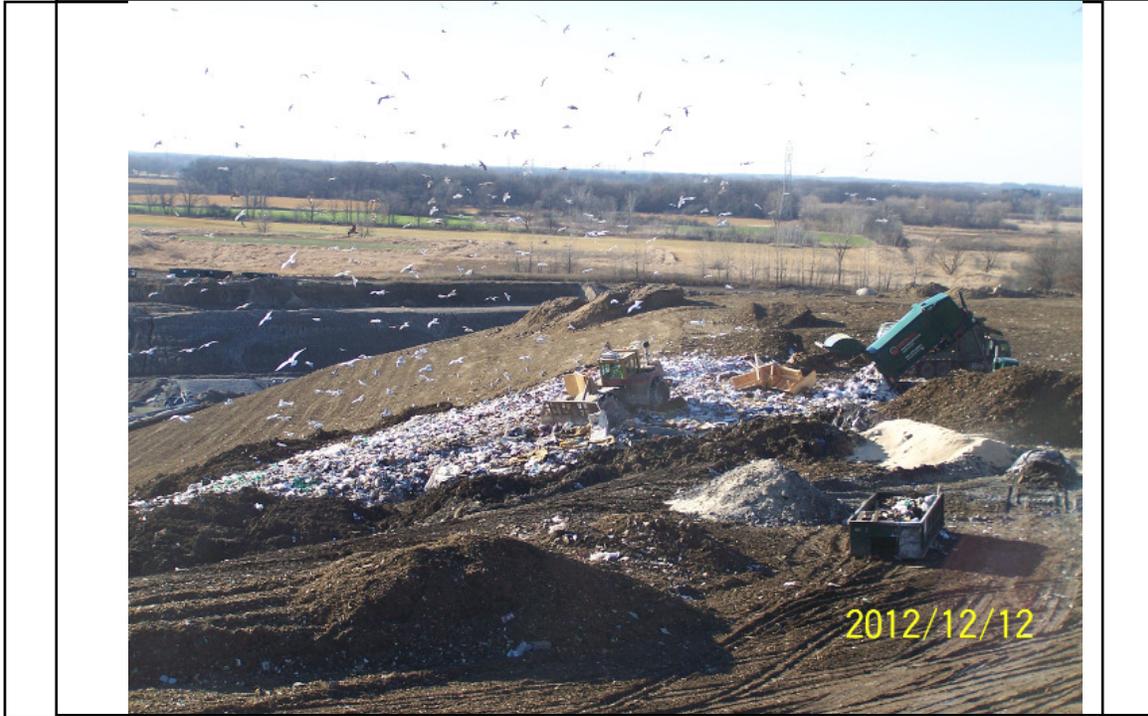
Working face surround by cover stockpiles

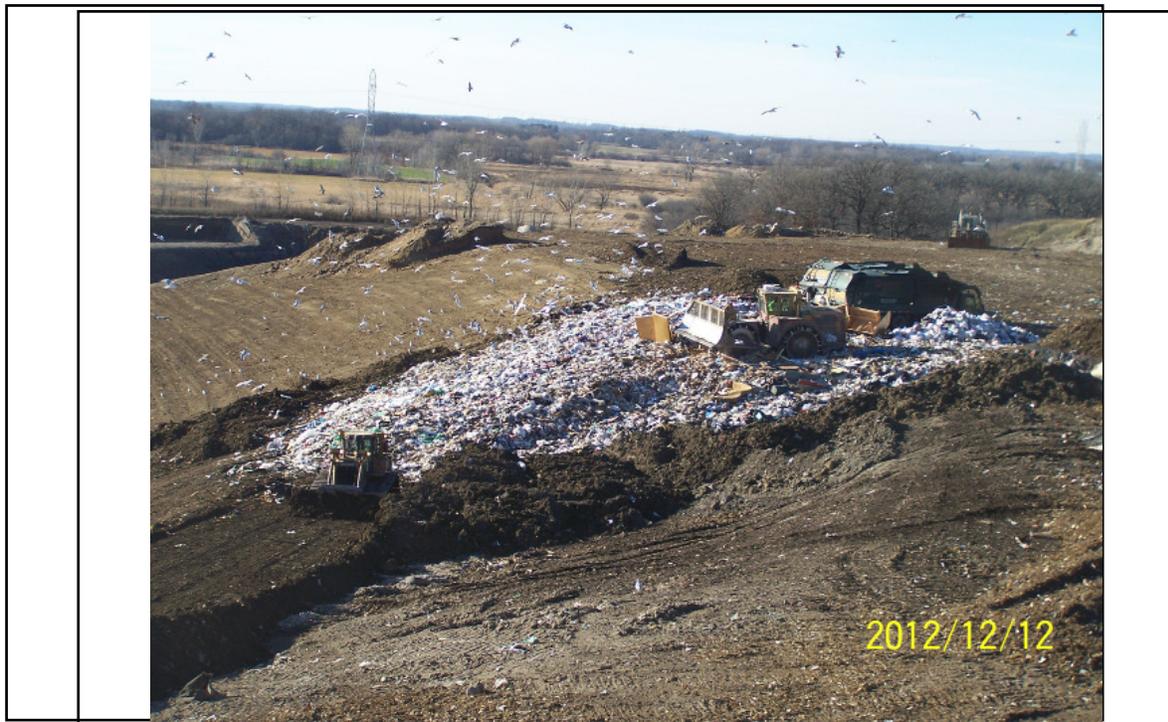
Working face

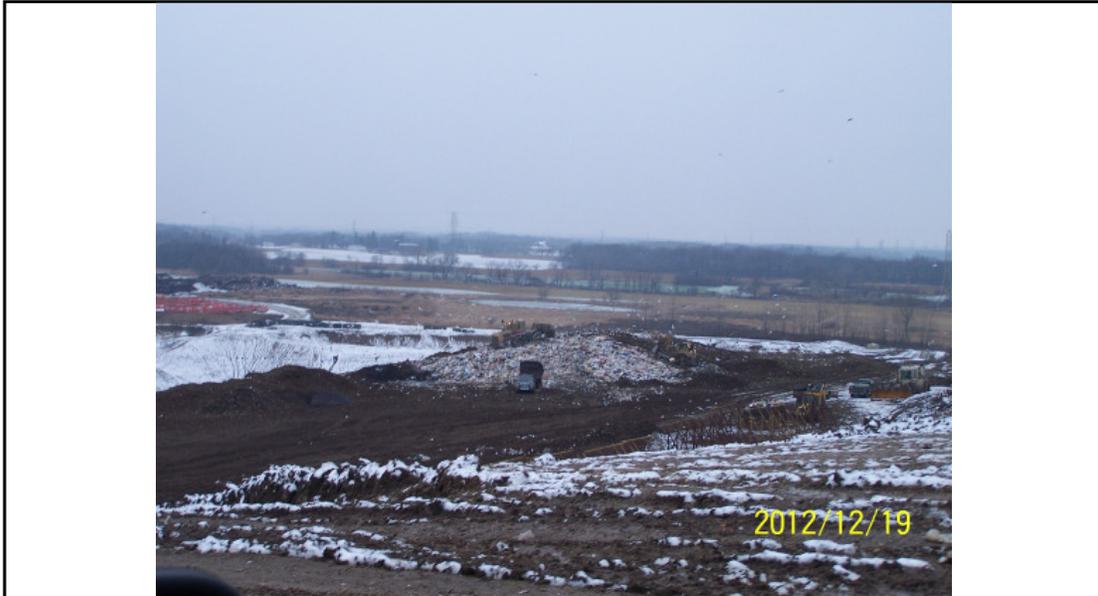
Active Area

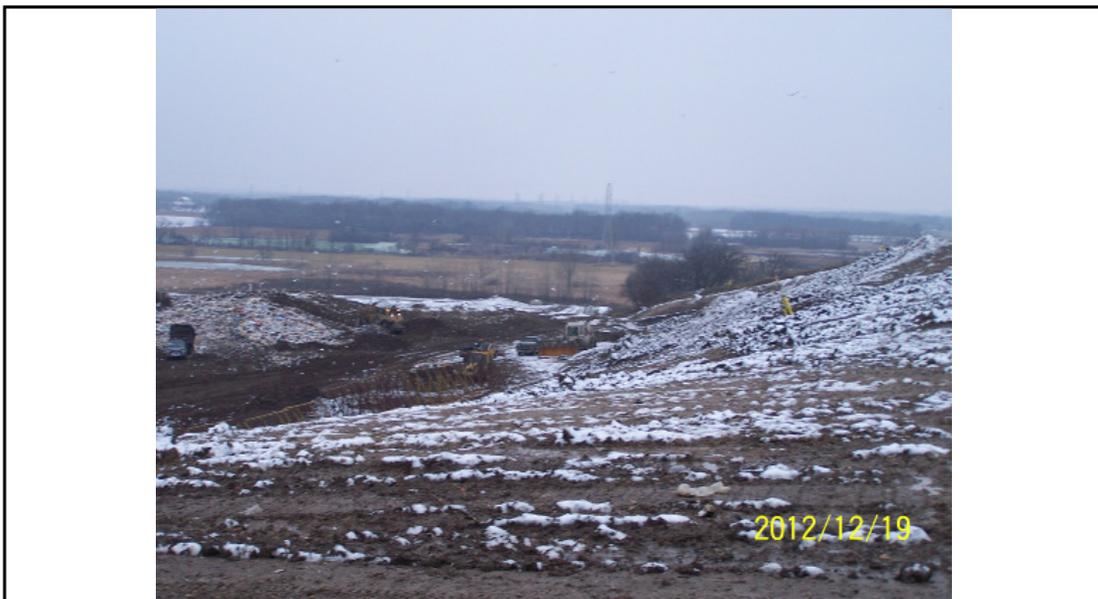
Soil slopes

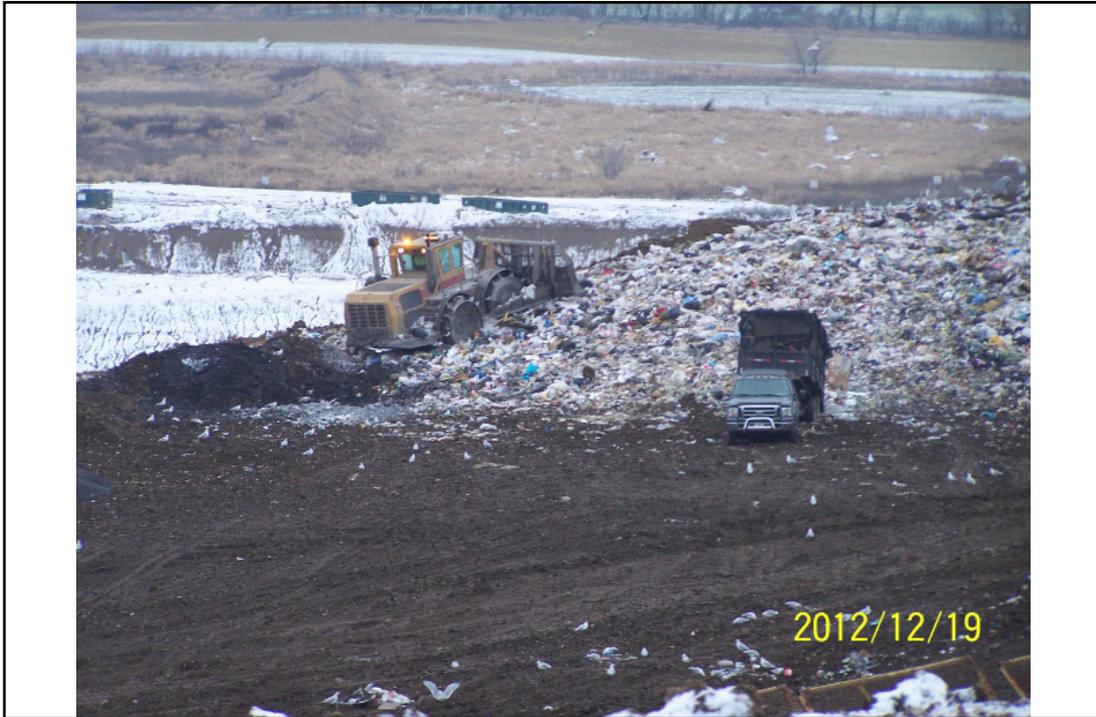
New lift started in Active Area, Southwest corner of Phase 7

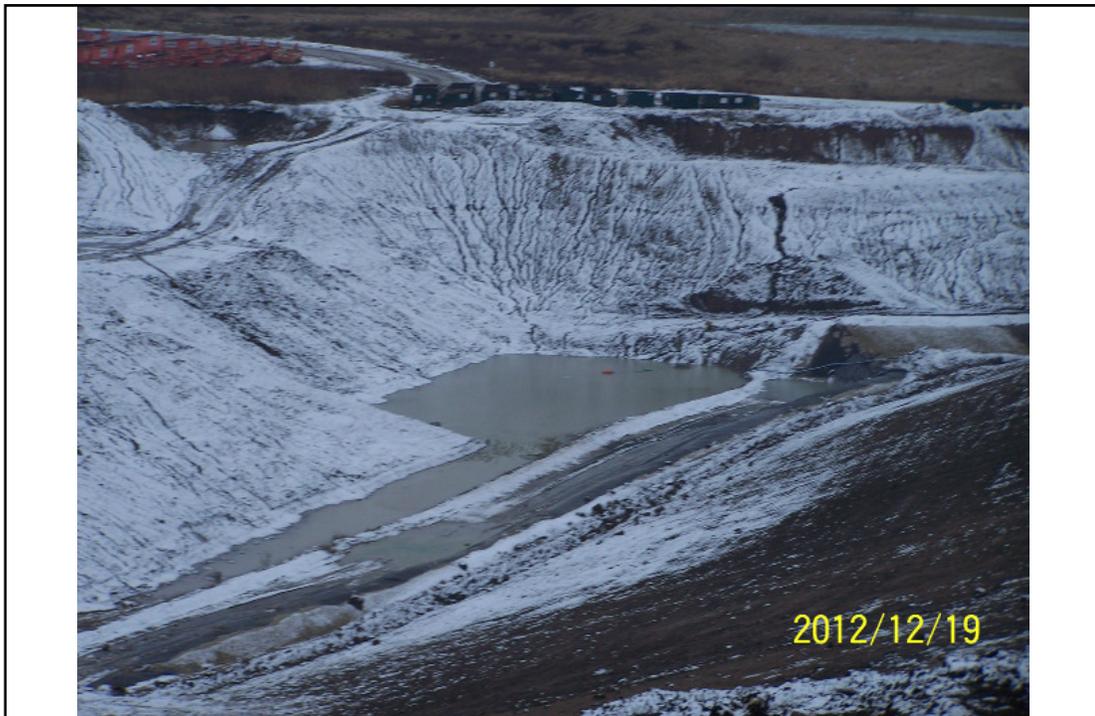
Temp Sed. Basin with plenty of capacity

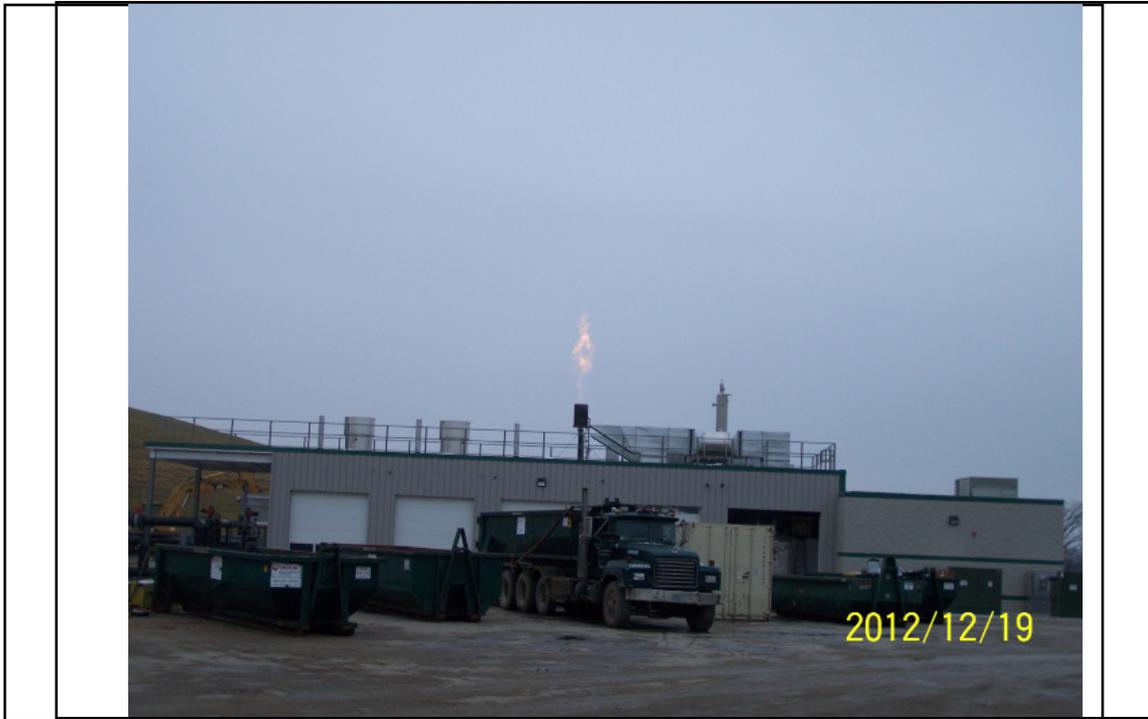
Flare over gas building

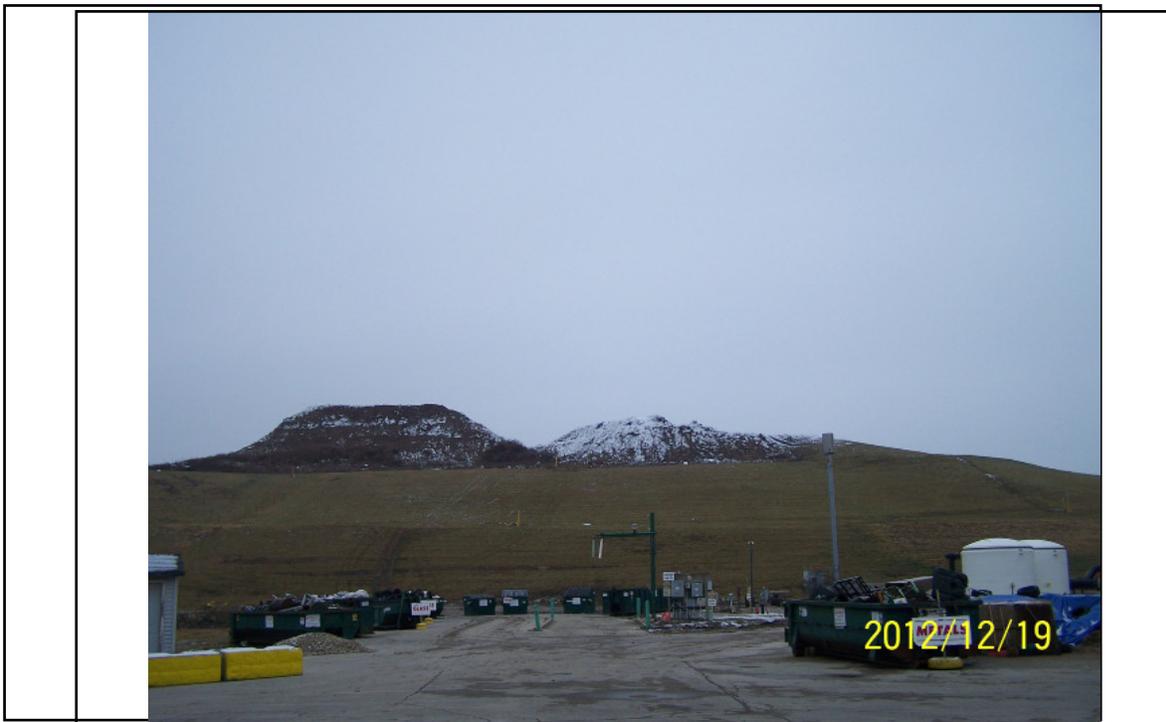
Landfill direct and bio-soil

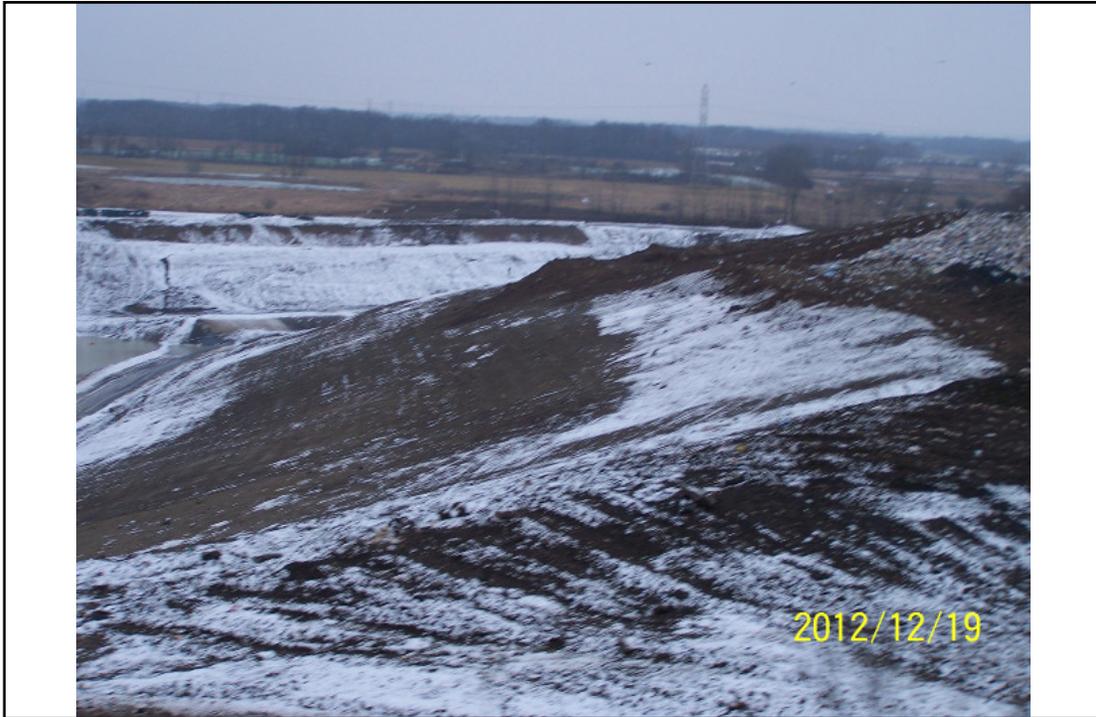
South intermediate slope of Phase 7, all soil

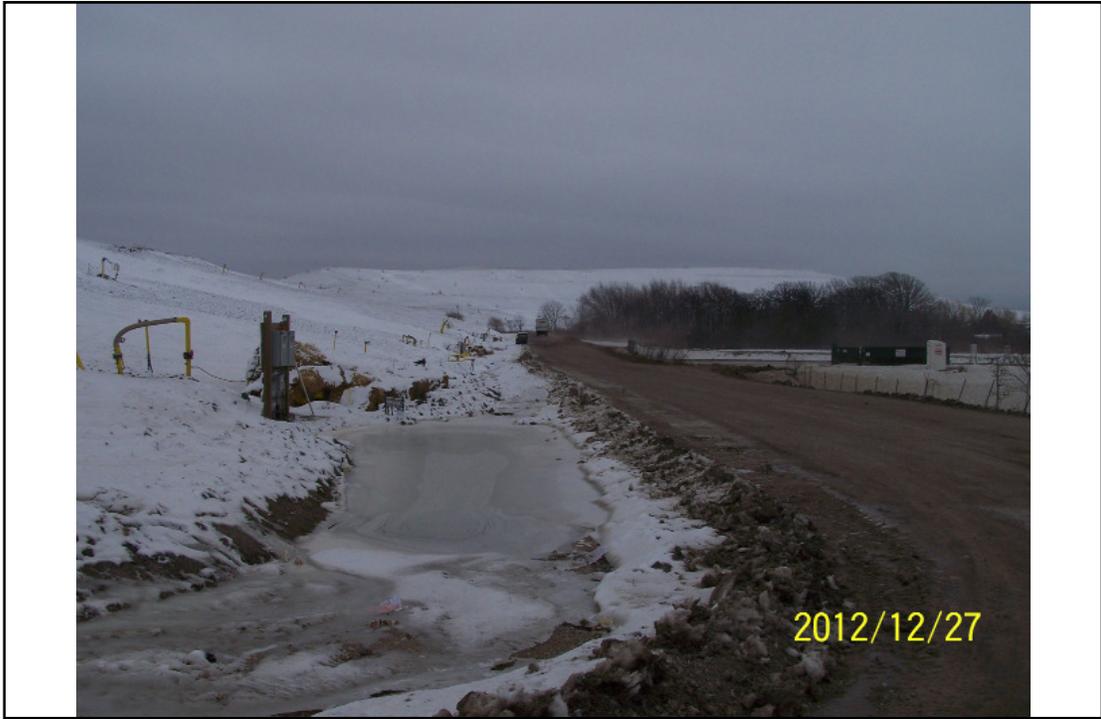
South ditch line.

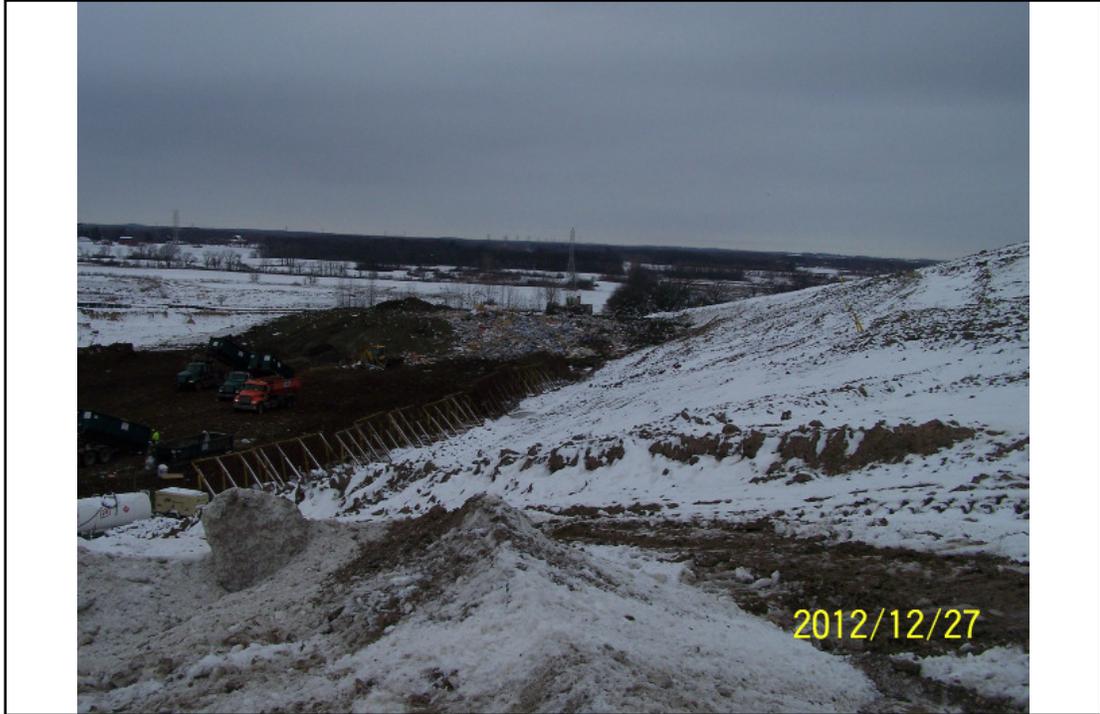
Active area, North half

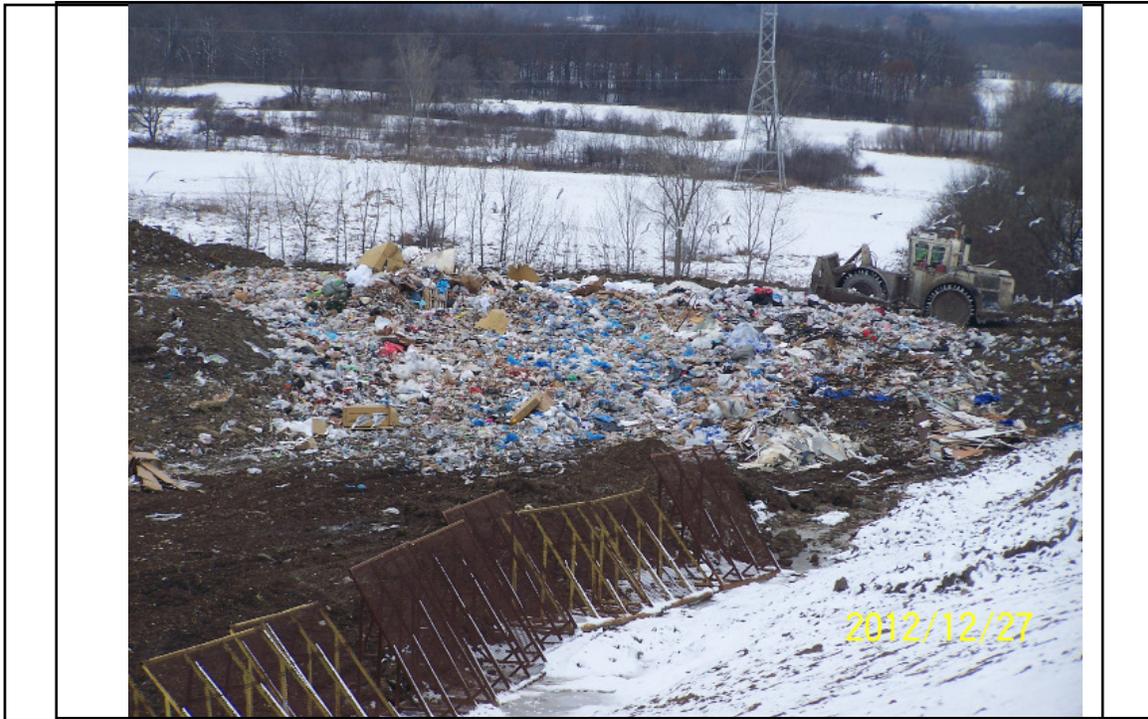
Working face

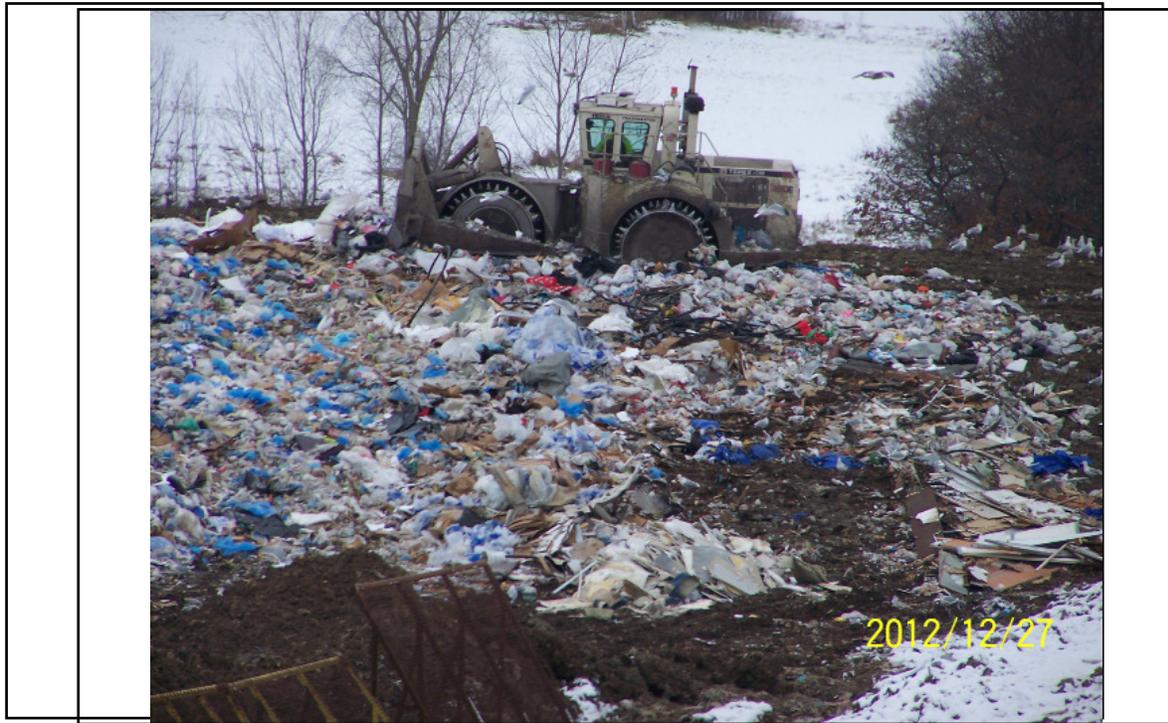
Compactor in working face

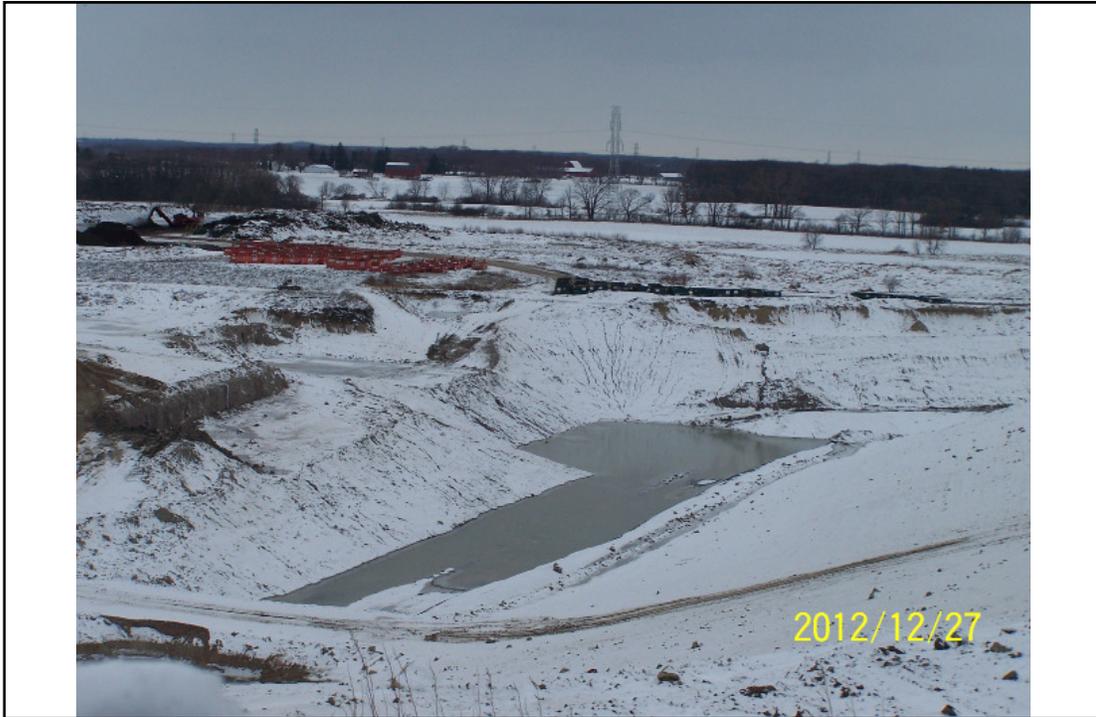
South temp. Sed Basin

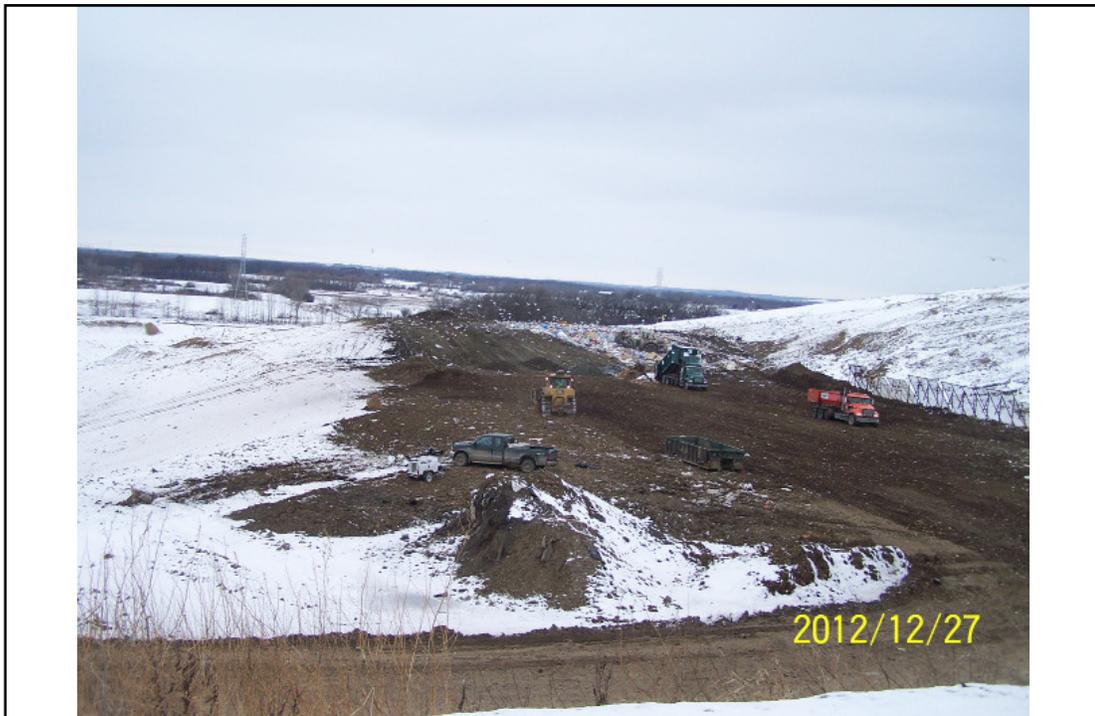
Active Area at entrance

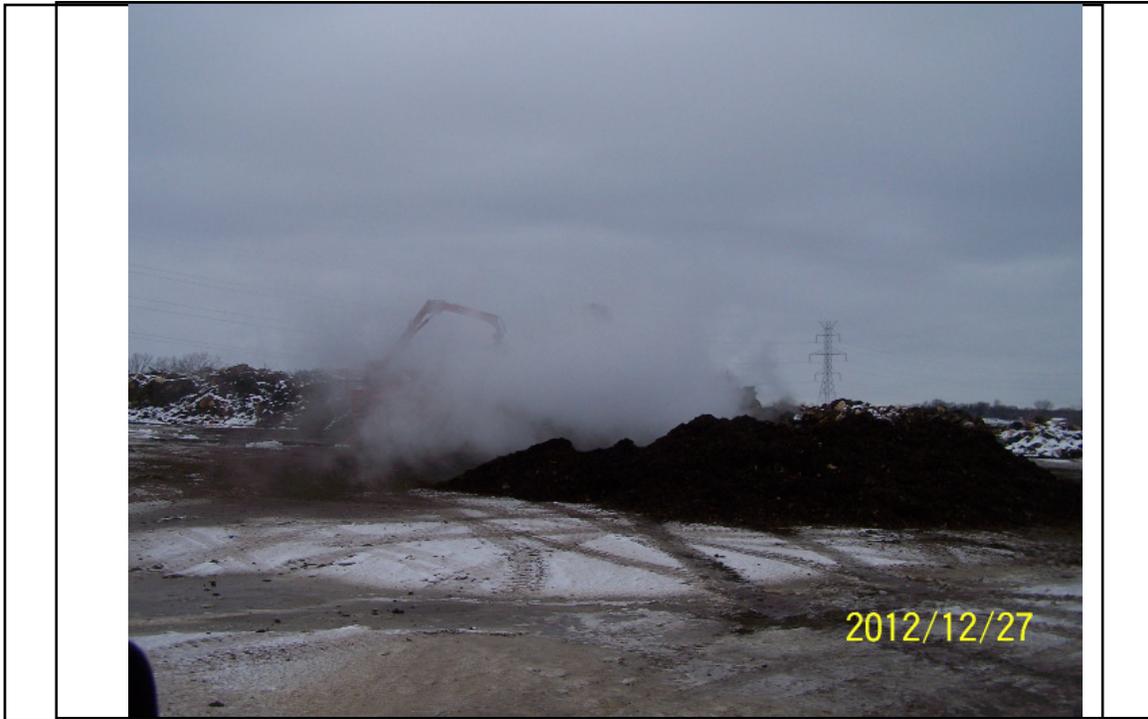
Gridning of compost and yard waste

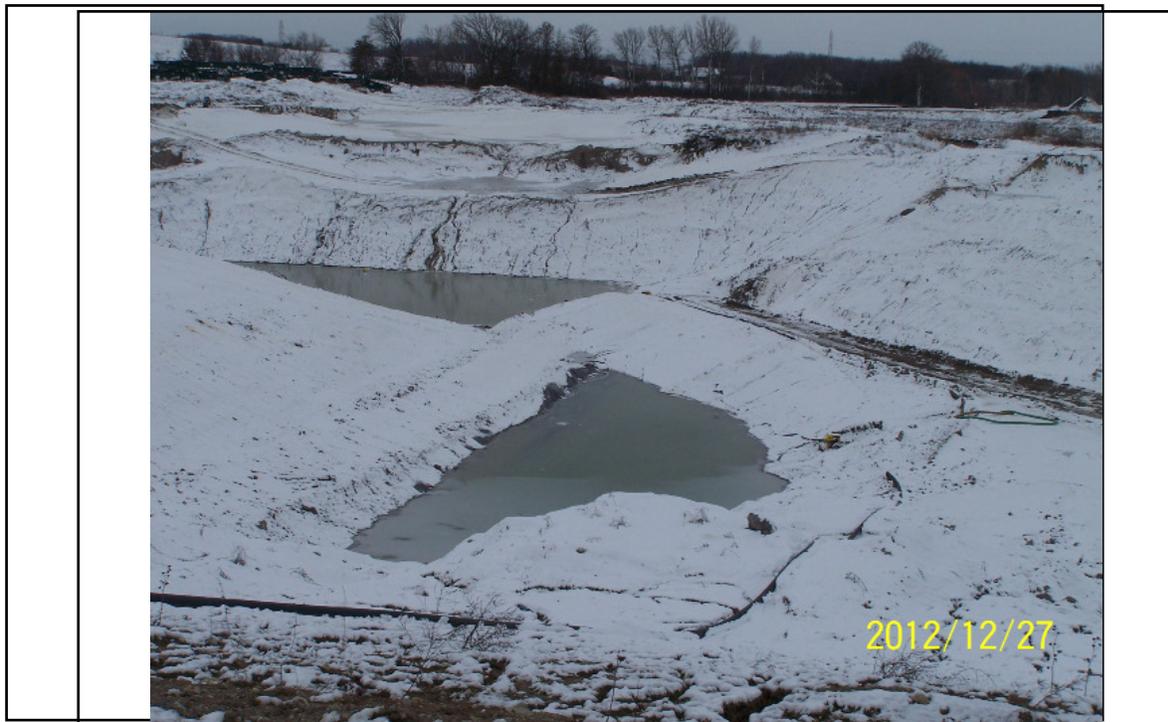
West temp. Sed. Basin for Phase 7

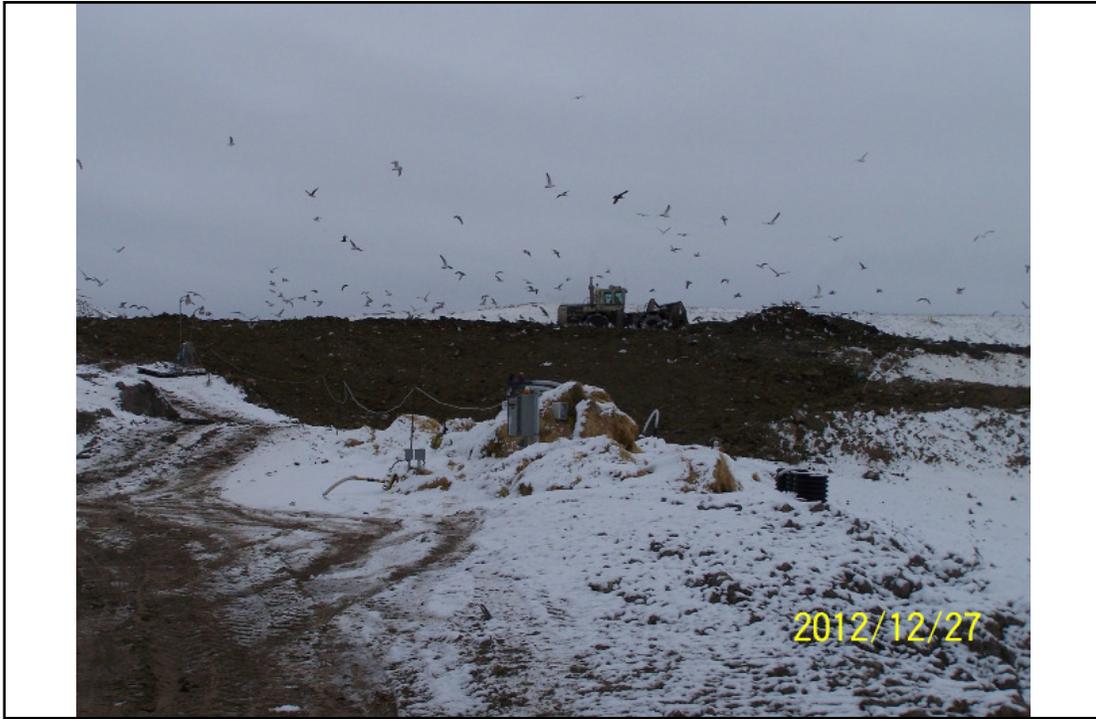
Western slope of Phase 7
